Title: Advisory Committee on Reactor Safeguards
Plant License Renewal Subcommittee

Date: Wednesday, April 4, 2007

Pilgrim Nuclear Power Station

ACRS License Renewal Subcommittee Presentation
April 4, 2007

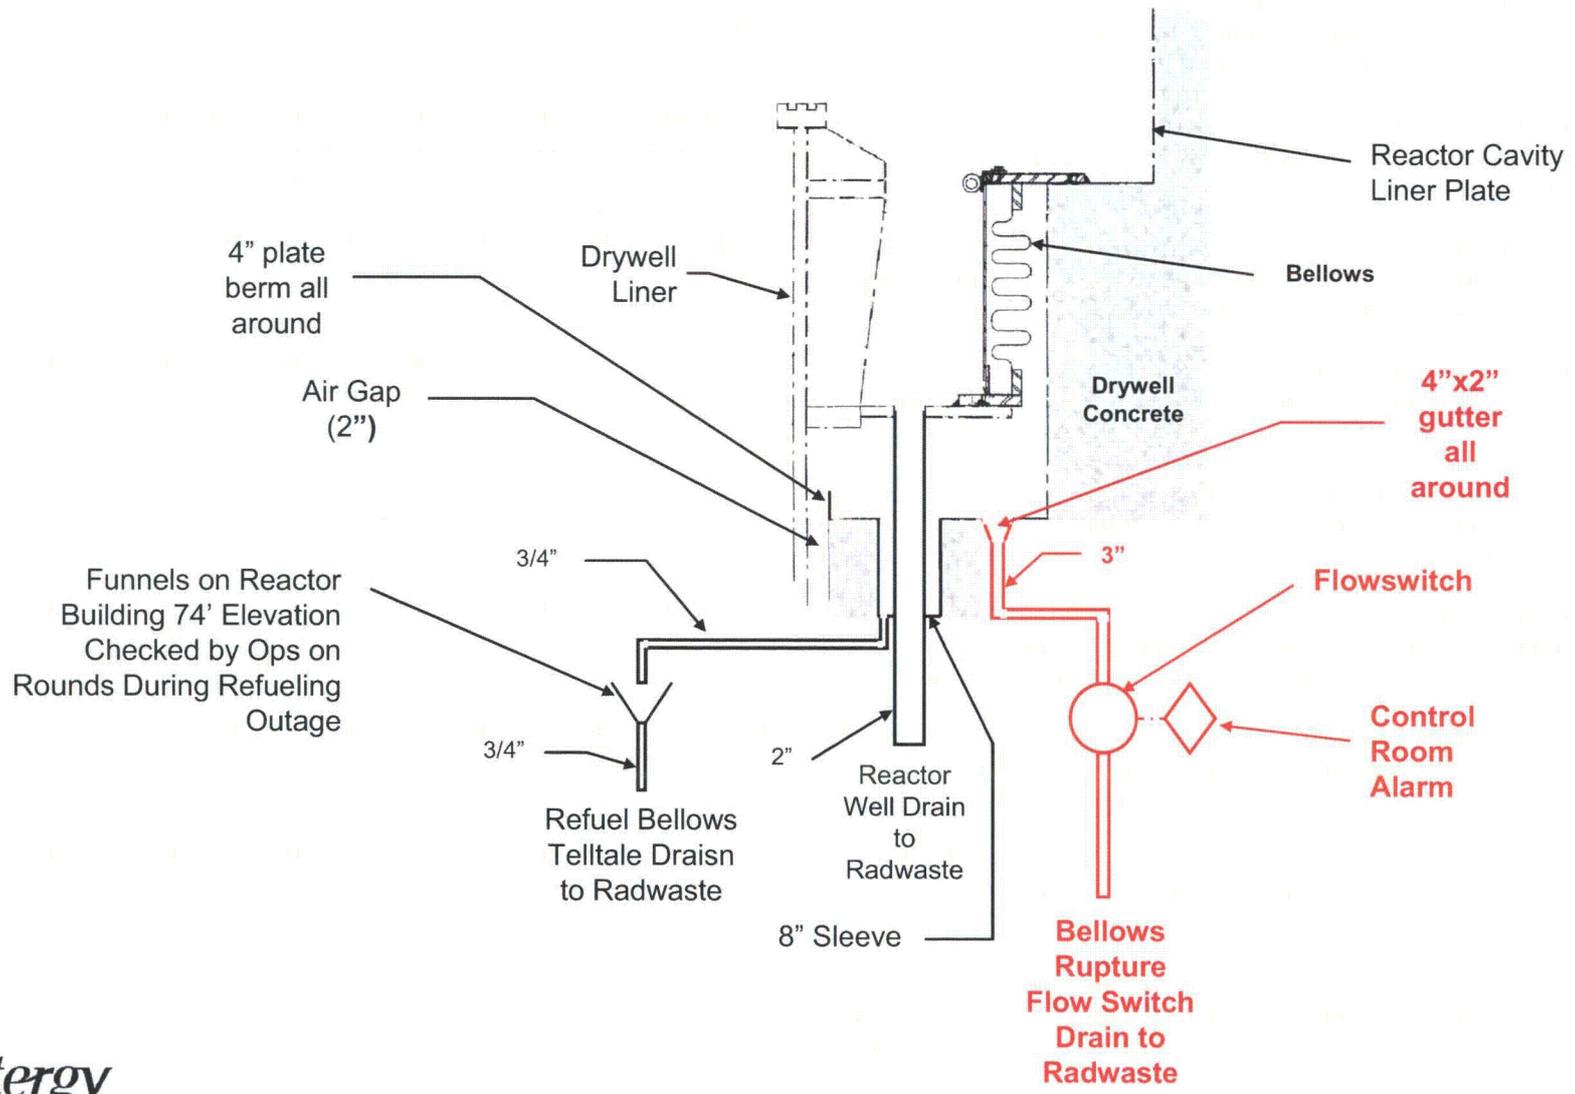
9 There was an issue raised in the
10 inspection report about this switch. It was
11 identified in late 2005 as failing surveillance. It
12 was replaced following that surveillance and
13 recelebrated. It's been recently recelebrated. It is
14 functional in anticipation of the refueling outage, as
15 I mentioned, that belongs this weekend where if we do
16 have a significant failure here, then we know that
17 this flow switch and control room alarm are
18 functional.

3" instrumented drain line alarms in control room

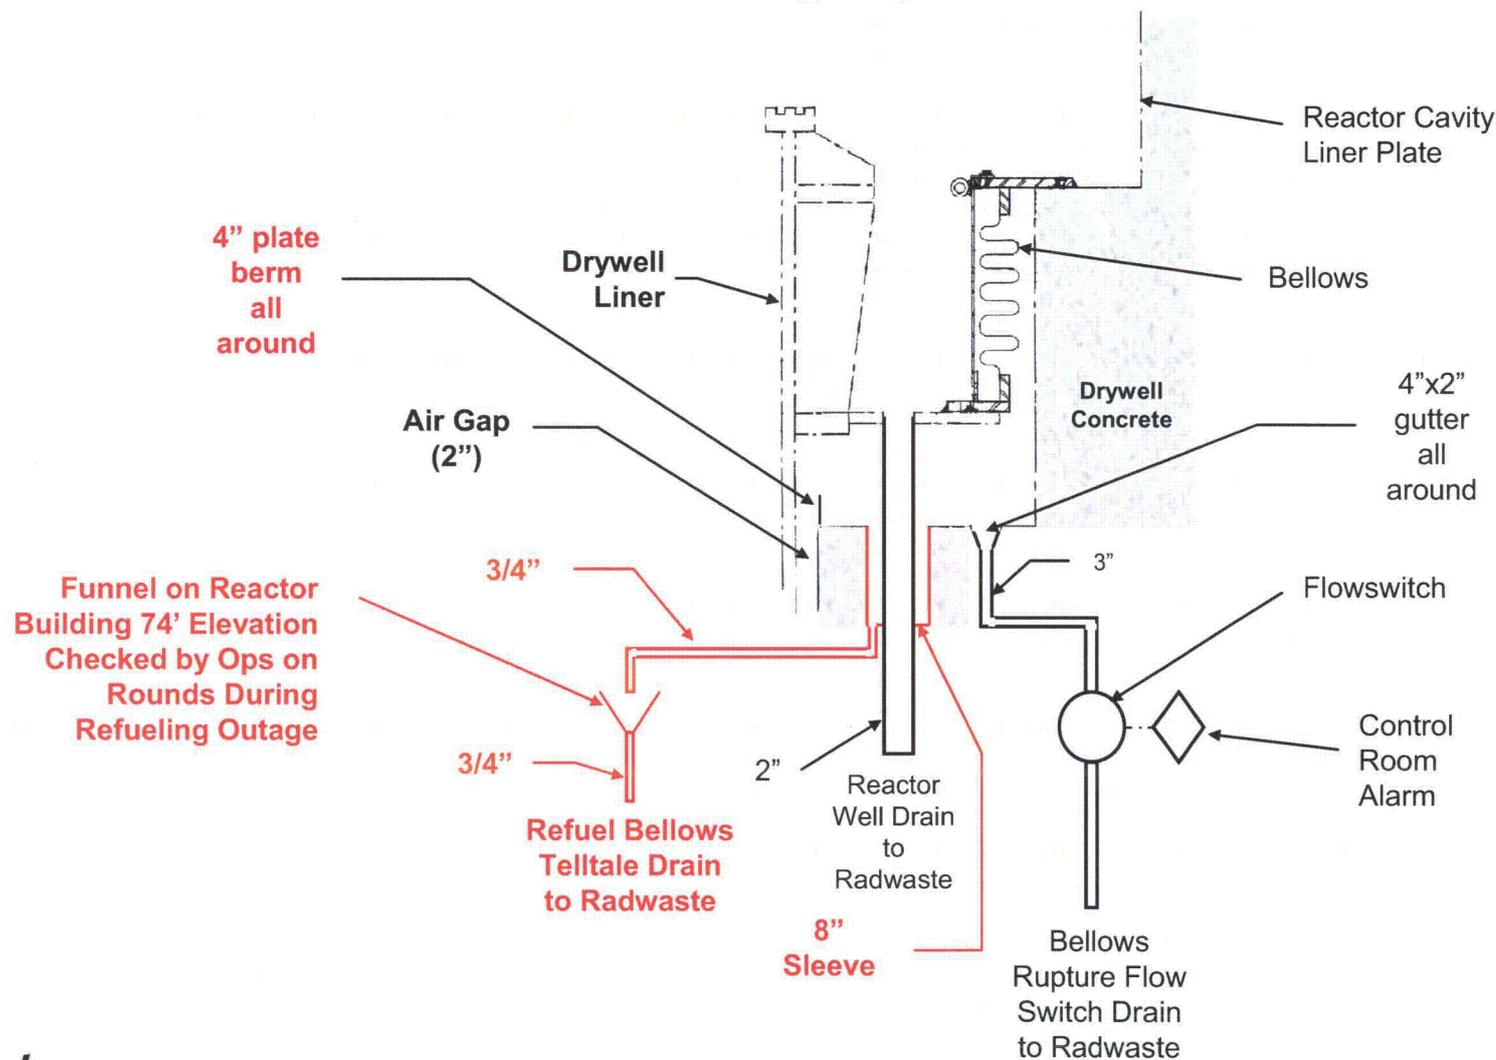
Four 3/4" drain lines which exit to 74' floor drains checked during operator tours

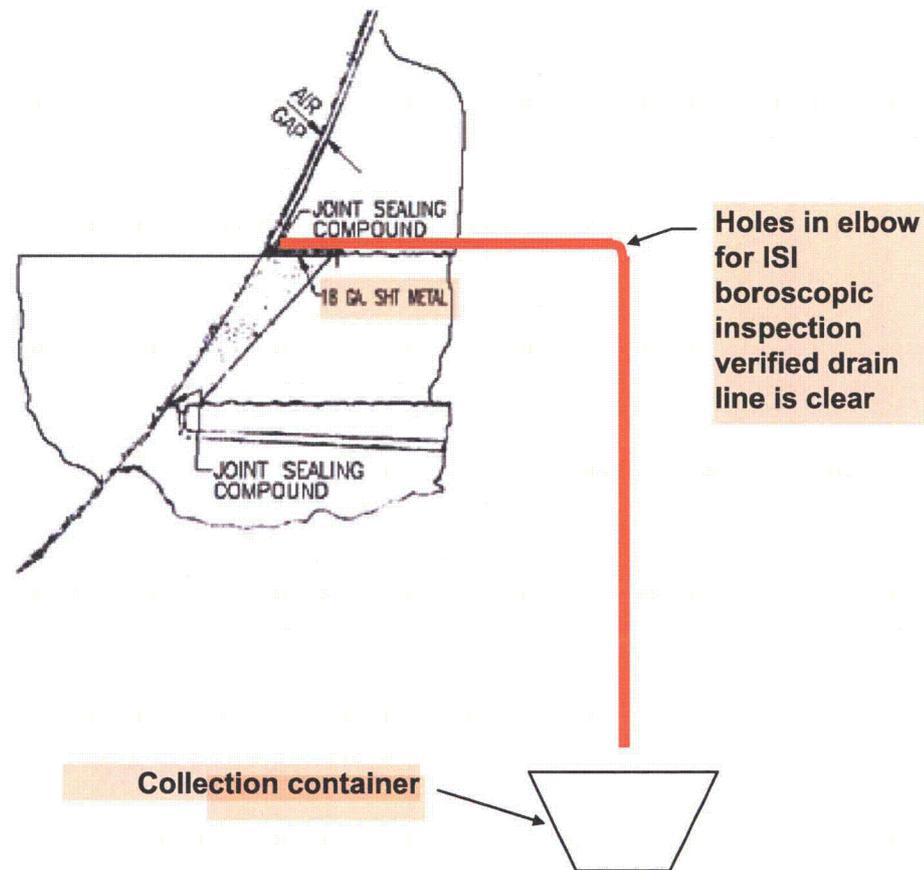
18 And just as another point of interest,
19 just back in the '80s when the concern was raised
20 about corrosion of the primary containment structure,
21 Pilgrim went into these four-inch drain lines and
22 drilled holes in the elbows and did visual inspection
23 to verify, first, that those lines were clear and
24 unobstructed, and second to do a kind of brief visual
25 inspection of the liner that they could see at the end

1 of that. And the results of those inspections showed
2 that the containment structure was in its original as
3 constructed condition with no indication of corrosion
4 or degradation of the liner.

Four 4" upper sand cushion drains drain into collection devices and are monitored at beginning and end of each RFO

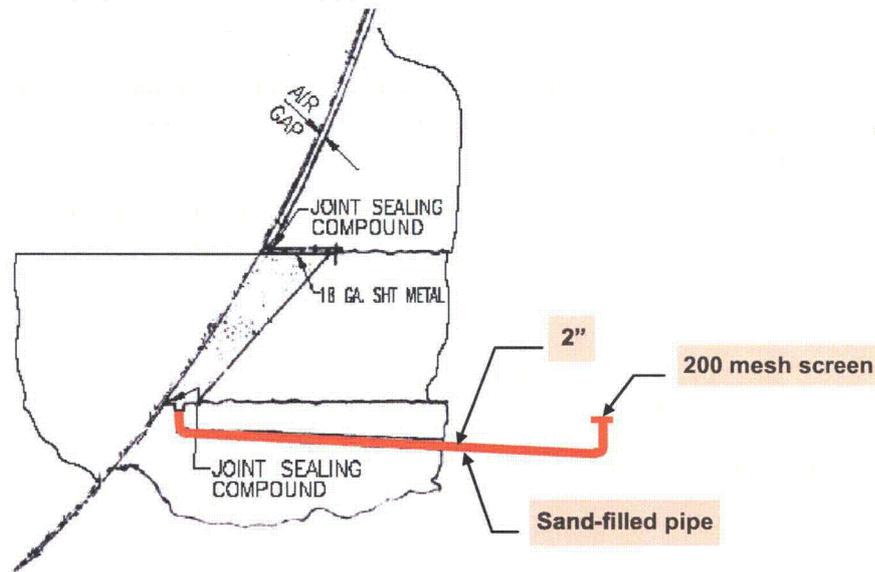
Four sand cushion drains provide further detection capabilities

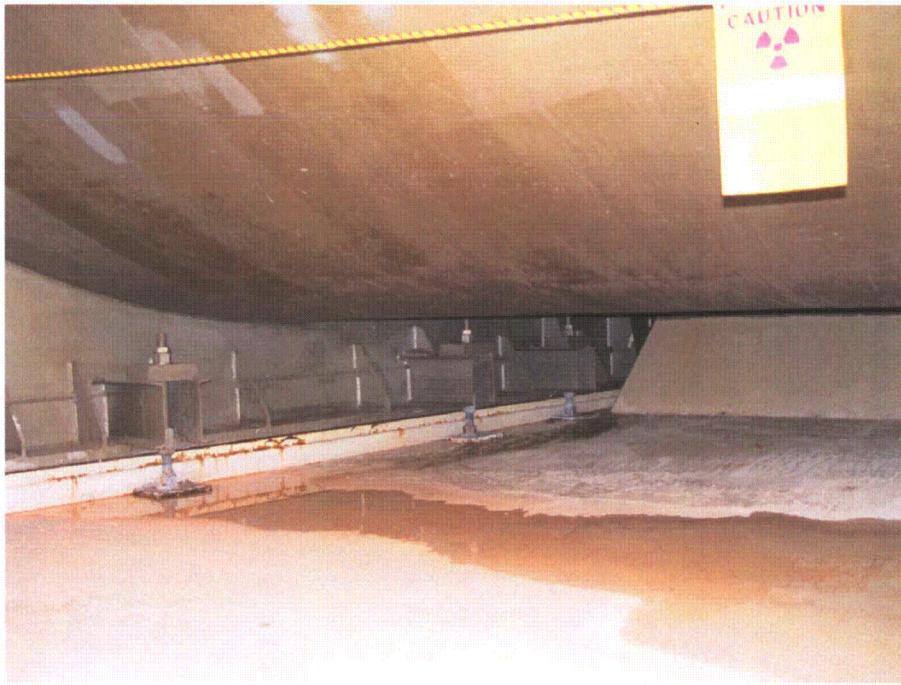
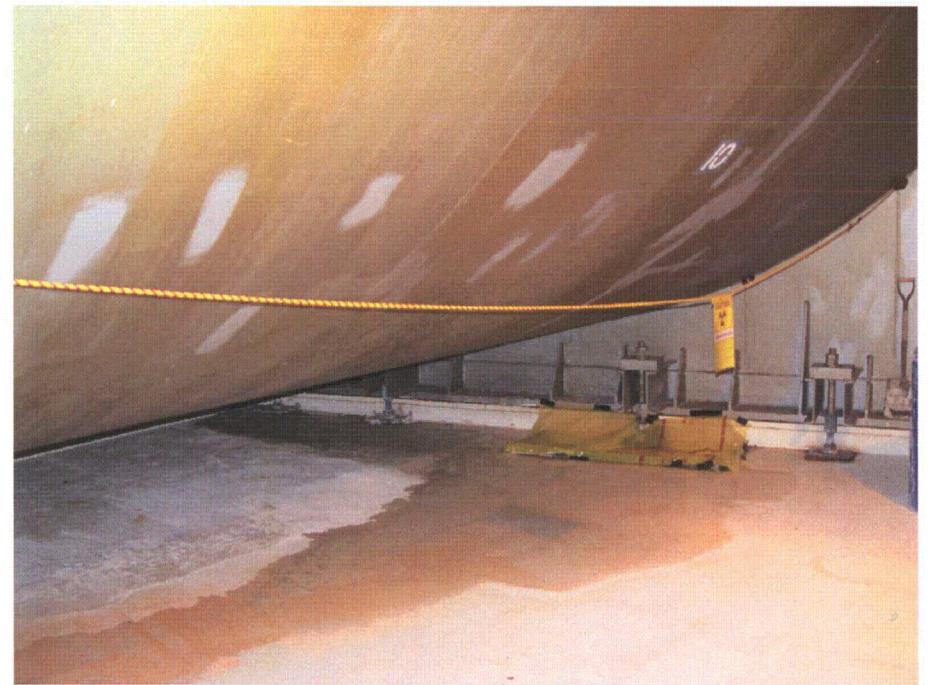
Bay 10

7 MEMBER WALLIS: Could you go back to the
8 picture with the white stuff? Now on the left hand
9 picture there there's a rust line or red line behind
10 the anchor bolts on the white. What is that?

11 MR. BETHAY: Yes, sir. That's surface
12 corrosion from this base plate. Because this floor was
13 not flat originally. You know, it has a concave
14 structure to collect water. These were an
15 afterthought in the late '70s, early '90s. This was
16 a grout pad that was poured to level the floor over
17 what was concave. And these structures were set on
18 top of that.

19 So you'll evidence -- in some areas, this
20 is -- it looks worse than it is person. This is fairly
21 minor surface corrosion --

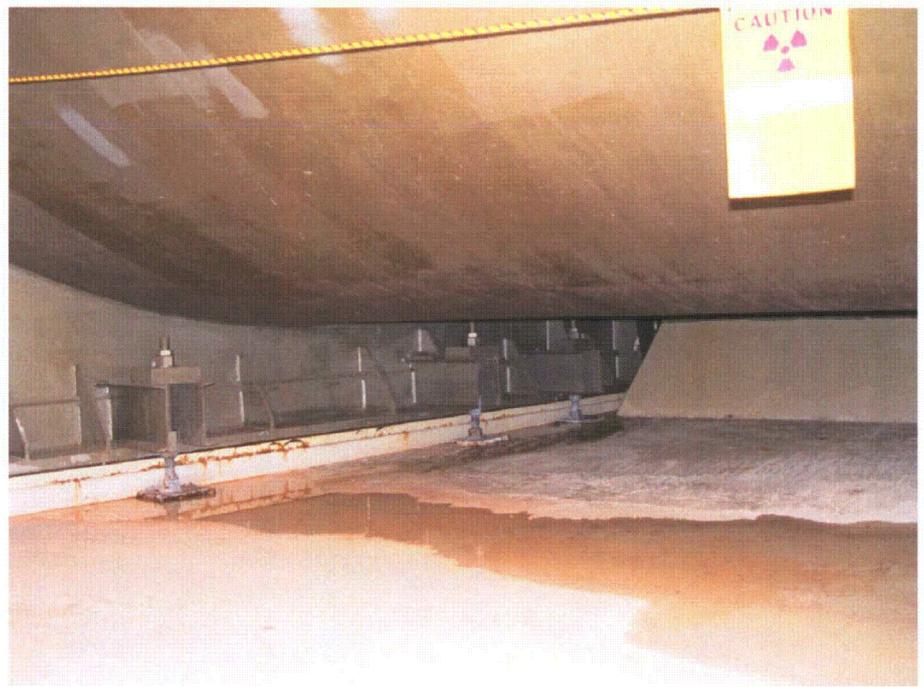
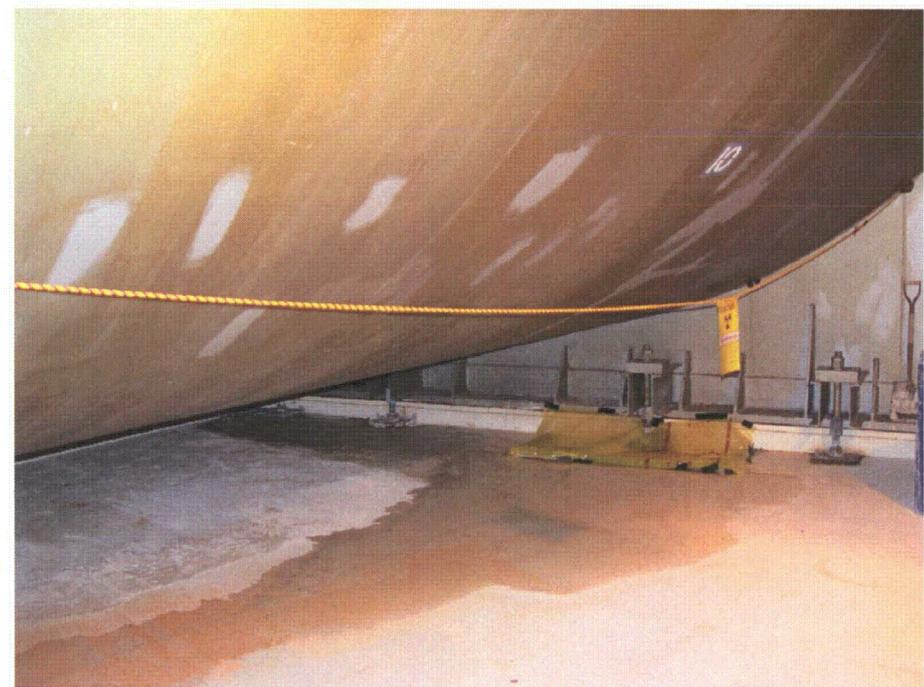
- Current Status
 - Water re-analyzed to demonstrate non aggressiveness.
 - Review over last 6-weeks shows minimal water on torus floor.
 - Seepage, mostly in Bay 10 estimated at $\frac{1}{4}$ " to $\frac{1}{2}$ " over 100 square feet.
 - Independent Assessment to demonstrate full functional capability of torus base-mat conducted.
 - Professor Franz Ulm of MIT's Department of Civil Engineering

19 This one's obviously dry, but it's a
20 better picture. What we'll do is loosen this nut on
21 several of these bolts. We'll raise this base plate up
22 and we will inspect the condition of the bolt as it
23 passes into the grout. And we will inspect the
24 condition of the grout around the hole. And based on
25 what we find, then we'll enter that in our corrective

1 action process and go wherever that leads us. But the
2 intent is to loosen this bolt, raise the plate and
3 perform an inspection of the grout, the concrete and
4 the bolt in this area.

19 That we'll verify the condition of the
20 bolts by sample in bay 10, is what we've lined out.
21 We'll do that prior to extended operation, and
22 actually that's --
