Title: Advisory Committee on Reactor Safeguards
Plant License Renewal Subcommittee

Date: Wednesday, April 4, 2007

ACRS License Renewal Subcommittee Presentation
April 4, 2007

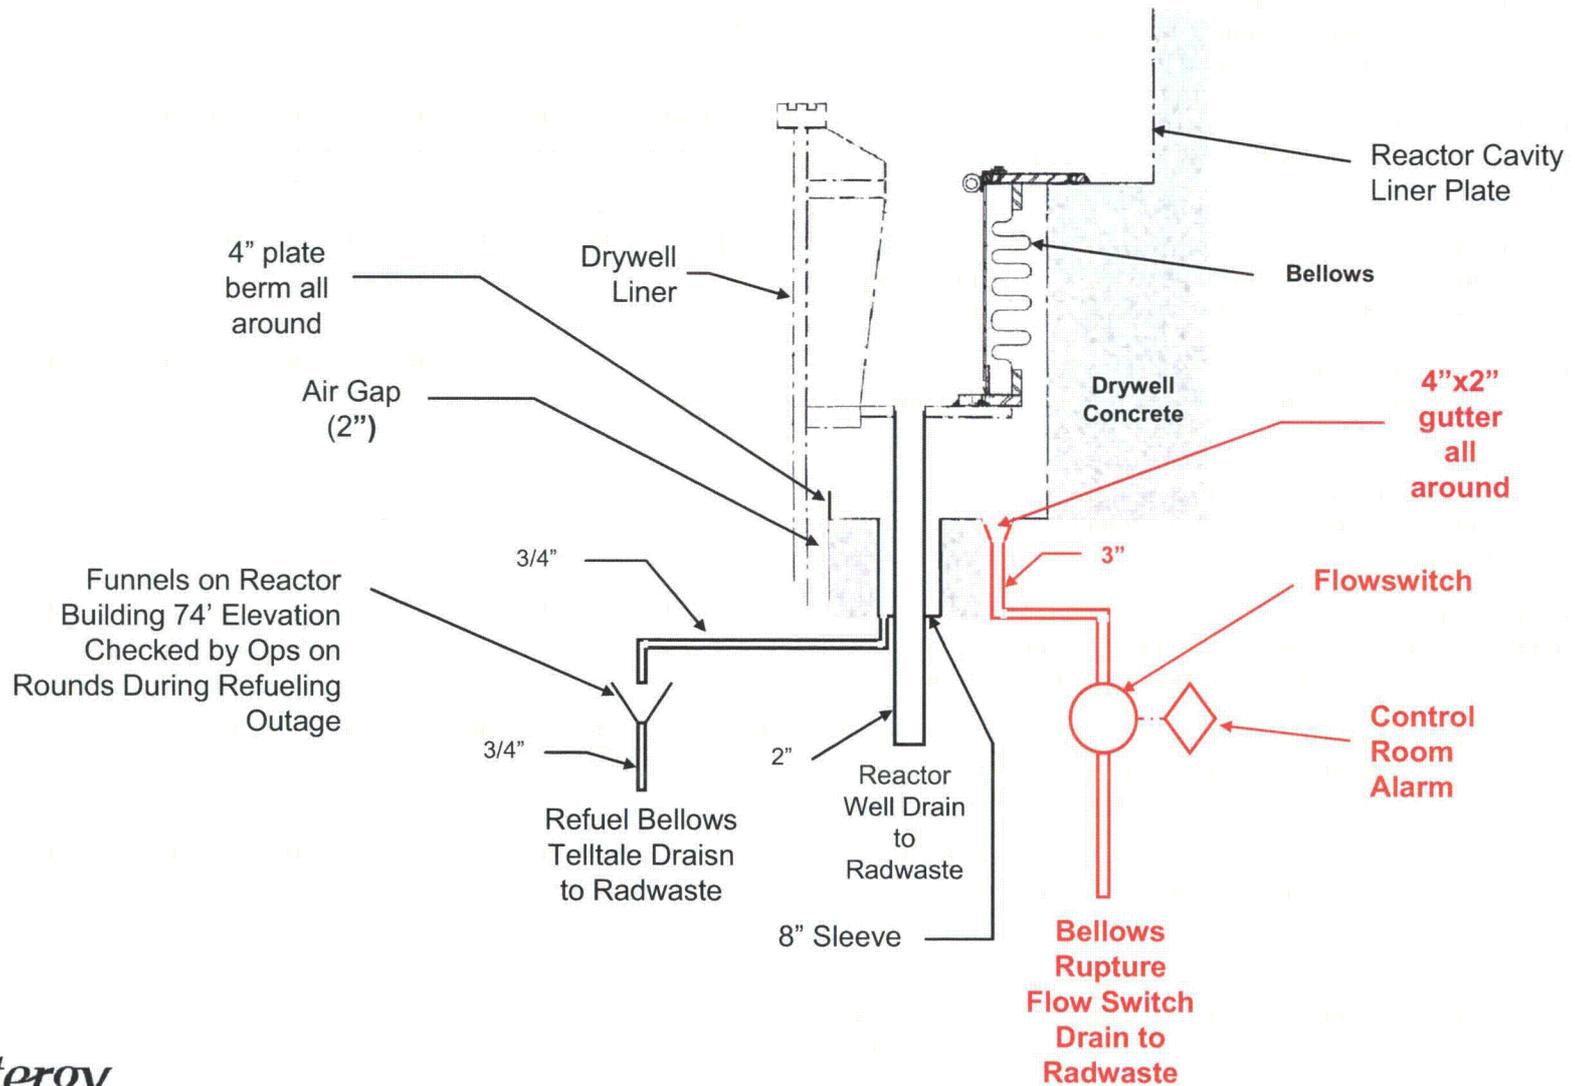
3" instrumented drain line alarms in control room

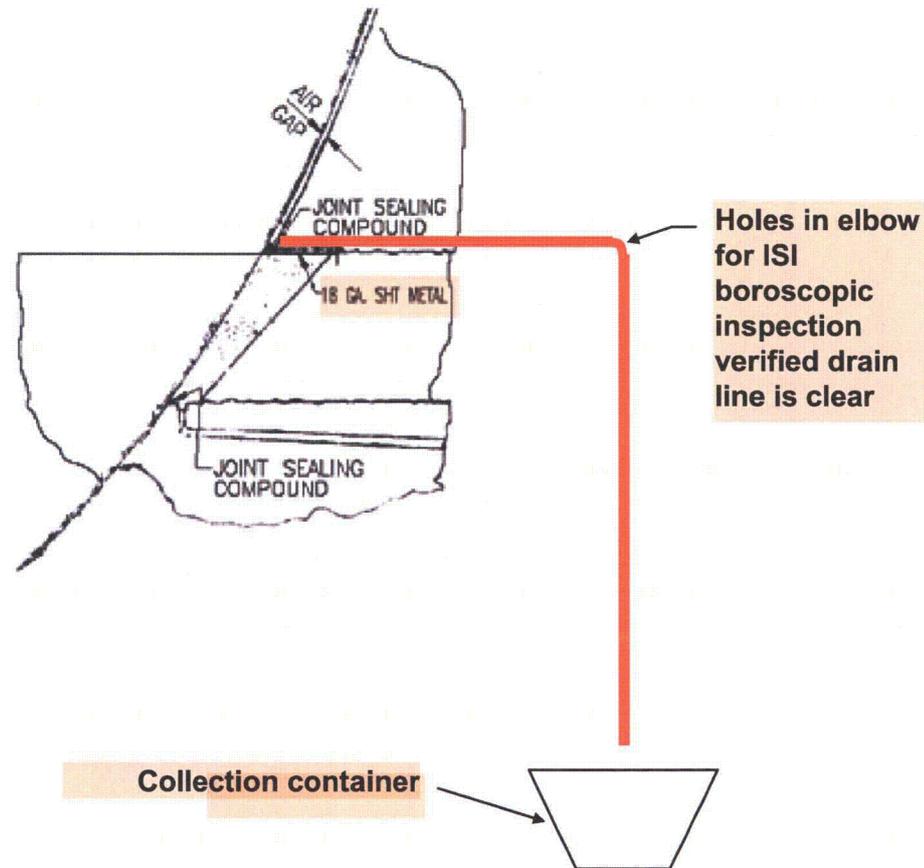
Four 4" upper sand cushion drains drain into collection devices and are monitored at beginning and end of each RFO

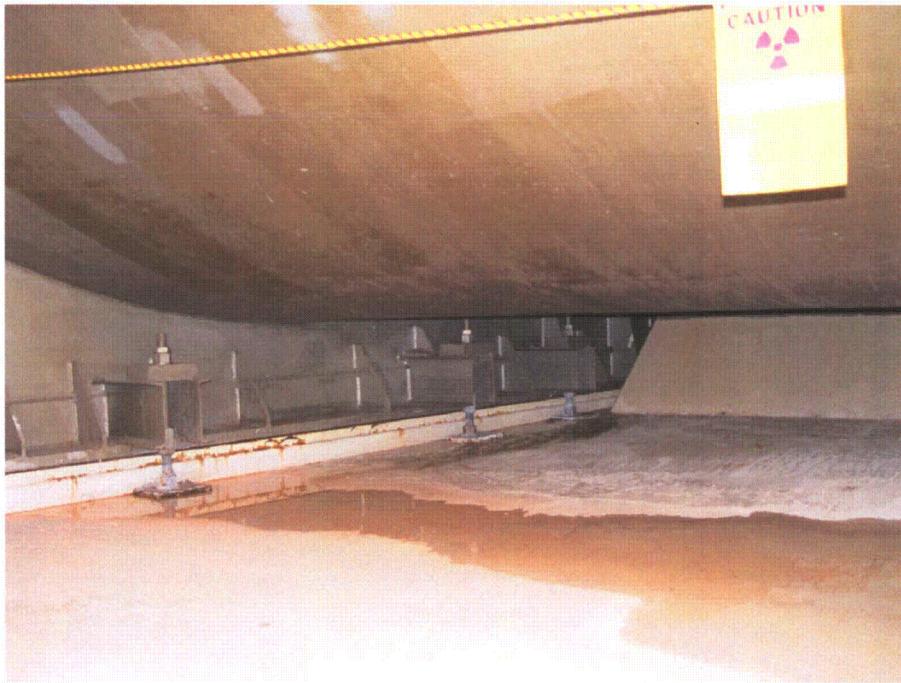
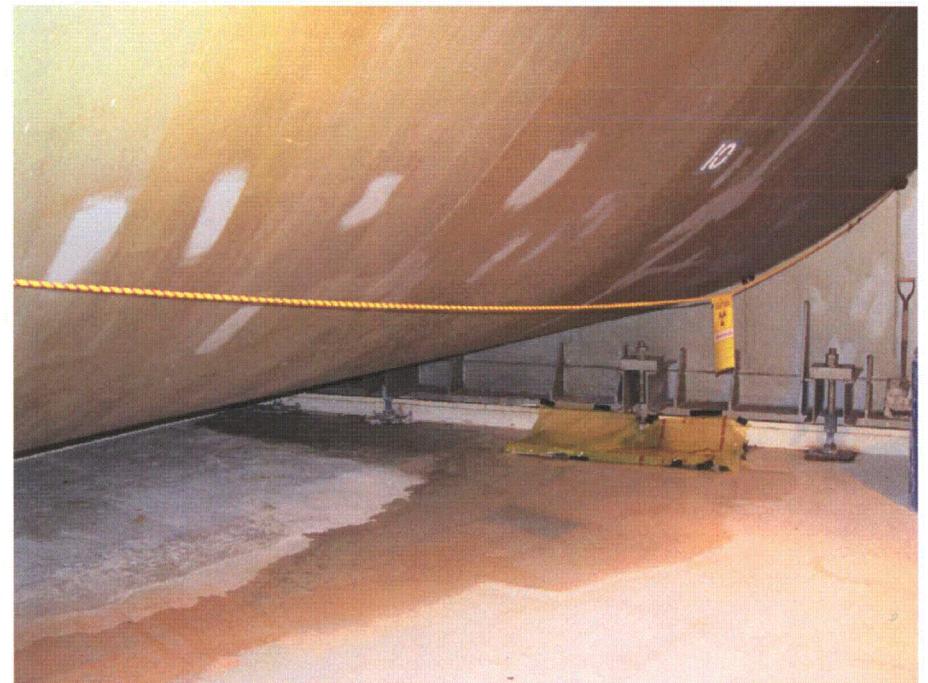
- Current Status
 - Water re-analyzed to demonstrate non aggressiveness.
 - Review over last 6-weeks shows minimal water on torus floor.
 - Seepage, mostly in Bay 10 estimated at $\frac{1}{4}$ " to $\frac{1}{2}$ " over 100 square feet.
 - Independent Assessment to demonstrate full functional capability of torus base-mat conducted.
 - Professor Franz Ulm of MIT's Department of Civil Engineering
