#### LA-13638

# A Review of Criticality Accidents

## 2000 Revision

LA-13638 Issued: May 2000

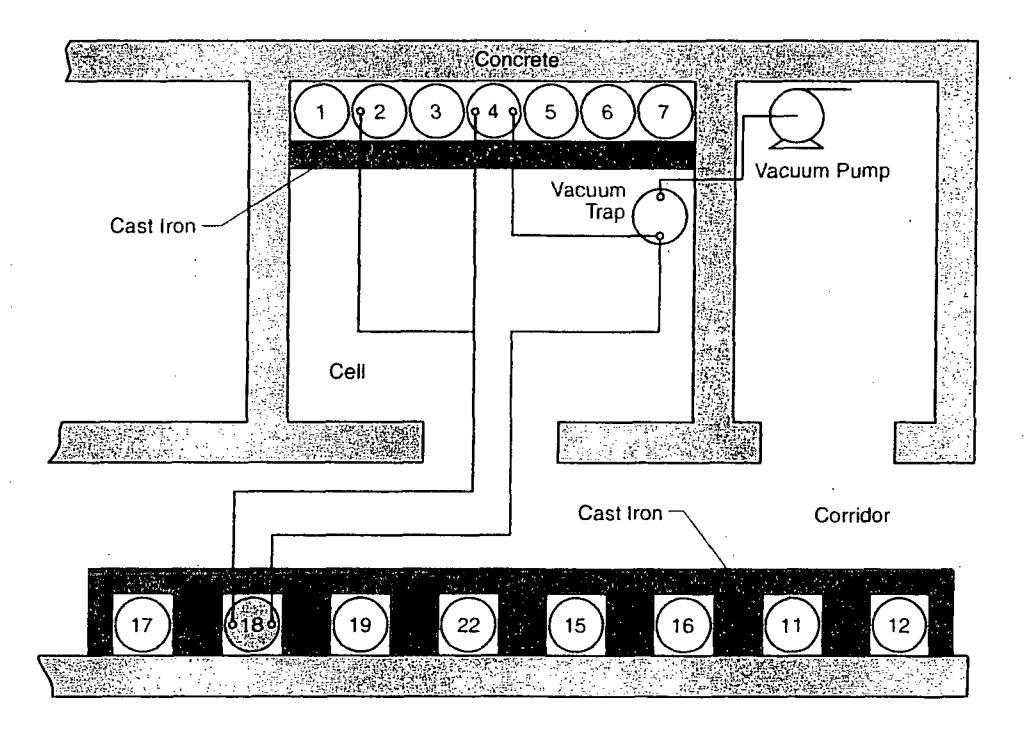
Figure 6. Layout of vessels and equipment in the staging area.

The staging area contained 15 identical short right circular cylindrical stainless steel vessels, each with a unique identification number. The vessels were 400 mm in diameter and 320 mm high with the cylindrical axis oriented vertically. The staging area was not equipped with radiation monitoring instruments. Criticality control was implemented by a 500 gram plutonium mass limit per vessel. Criticality safety support consisted of part time effort by a staff physicist. Operators were not trained in criticality safety.

As part of the investigation, both experiments and calculations were performed to estimate the conditions for criticality in vessel 18. The results determined that 30  $\ell$  of solution containing 825 g of plutonium (27.5 g/ $\ell$ ) would be required for criticality. These values agree closely with the best estimate of the contents of vessel 18 at the time of the accident, 31  $\ell$  of solution with 848 ± 45 g of plutonium (27.4 g/ $\ell$ ). One contributing cause of the accident was the unrecorded transfer of 5  $\ell$  of solution from vessel 18.

60°C temperature rise was based on the coarse observation that the solution following the accident was at or near the boiling temperature. The accident caused no physical damage to any equipment. The operator positioned in the cell received an estimated dose of 100 rad. The operator near vessel 18 received an estimated dose of 1,000 rad. He suffered severe radiation sickness and amputation of both legs. He died 35 years after the accident.

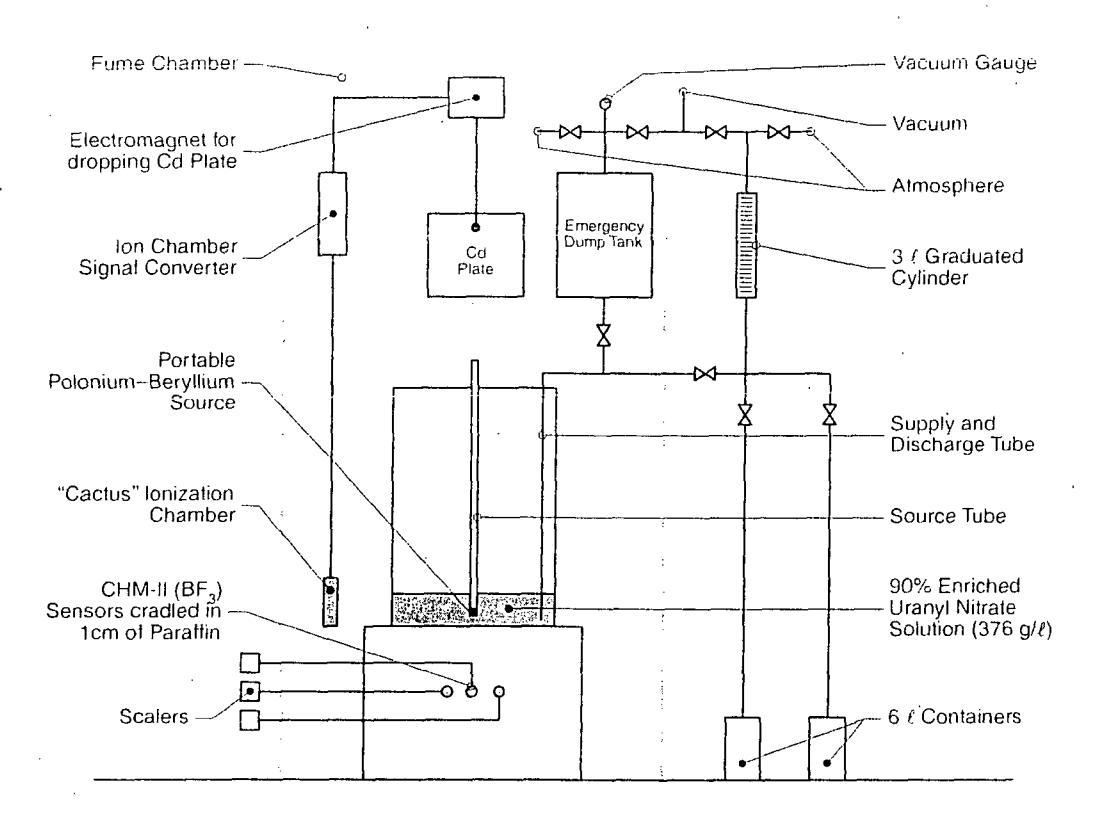
Figure 8. Layout of the experimental equipment.

They immediately noticed a flash (due to Cherenkov radiation), and simultaneously, fissile solution was violently ejected, reaching the ceiling about 5 m above. The three experimenters dropped the vessel and, along with a fourth experimenter who was located about 2.5 m away from the excursion, went immediately to the change room, showered, and were transported to the hospital. The combination of additional reflection from the three experimenters and the change in the geometry of the solution volume was sufficient to cause the system to exceed prompt critical. The small neutron background, estimated at only 100 neutrons per second, apparently also contributed to delayed initiation and thus to increased excursion energetics.

- Violation of the procedure that stipulated the complete draining of the experiment solution into 6 liter bottles.
- Unbolting and removing the experiment vessel when it contained solution. This was not specifically permitted in the operating procedure.
- The design of the experiment stand that made it relatively easy to unbolt and remove the experiment vessel.
- The additional reflection provided by the operators and by lowering it closer to the floor.
- The lack of knowledge and awareness of the operators as to the large reactivity changes that can occur with shape changes of solutions having H/D << 1.

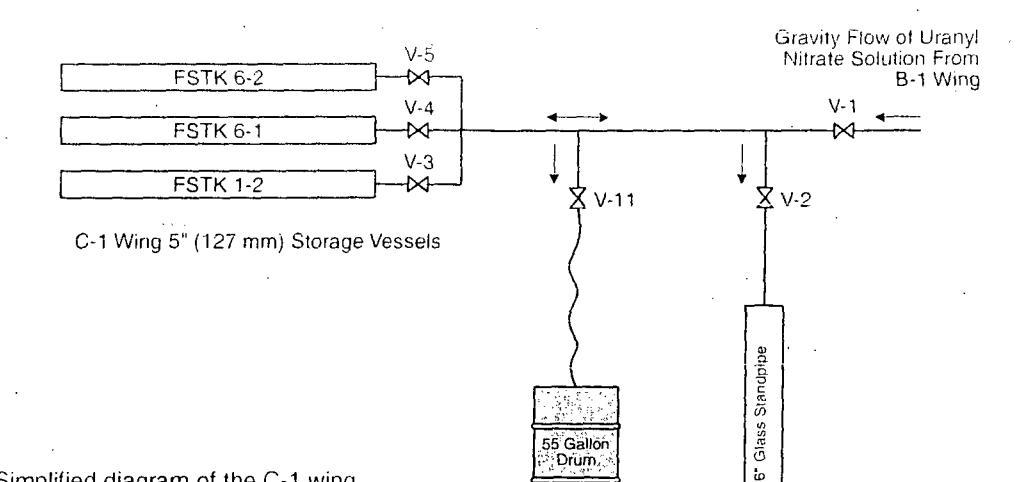
Figure 9. Simplified diagram of the C-1 wing vessels and interconnecting piping involved in the accident.

Figure 9 is a simplified diagram of the C-1 Wing vessels and equipment involved in the accident. The inventory required the disassembly and cleaning of the three, 5 inch (127 mm) diameter vessels\* (FSTK 1-2, FSTK 6-1, FSTK 6-2) used to store uranyl nitrate solution. Before resumption of operations, it was necessary to reassemble and to leak test the vessels. This entire process usually required several, 8-hour shifts to complete.

At ~01:00 during the shift preceding the accident (23:00 Sunday, 15 June, to 07:00 Monday, 16 June), the C-1 Wing supervisor noted that uranyl nitrate solution was present in a 6 inch (152 mm) diameter glass standpipe that was part of the pH adjustment station (Figure 9). He instructed an operator to drain the standpipe. At 05:00, the supervisor again noted uranyl nitrate in the standpipe and questioned the operator as to whether it had been drained earlier. The operator confirmed that it had been, and upon further investigation, they determined that solution was leaking into the standpipe through valve V-2. The valve was closed, and the standpipe was again drained.

Unknown to anyone at the time, uranyl nitrate had been leaking from the B-1 Wing through valve V-1 from the early hours of the previous shift until about 13:30, when one of the operators checked it (and by applying pressure completely closed the valve), as instructed by the supervisor. Before this, the uranyl nitrate had been collecting in vessel FSTK 1-2, because valve V-3 had also been open.

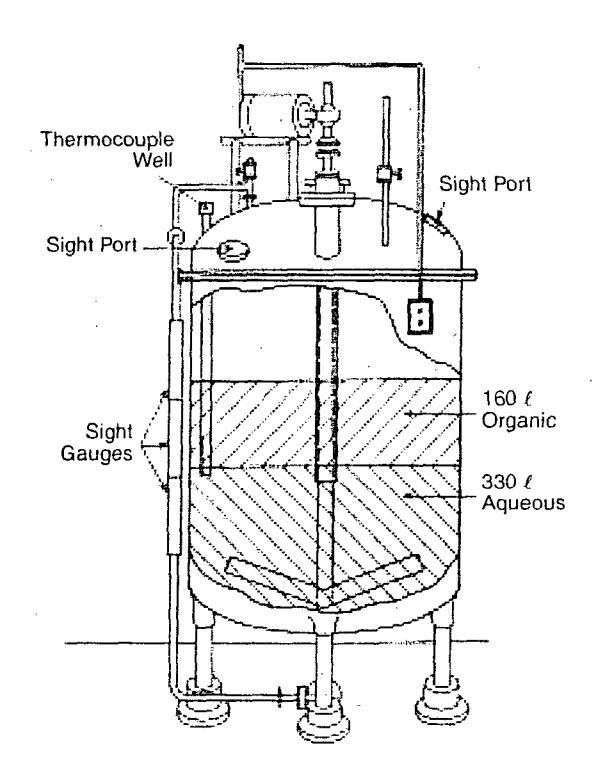
From these time intervals and the estimate that initially the system was 5 \$ subcritical, the reactivity insertion rate would have been about 5 \$/s. Using coefficients appropriate for the solution, this insertion rate leads to a spike yield of  $2.2 \times 10^{17}$  fissions with the spike completed in 1.65 seconds, that is, 0.45 seconds after prompt criticality was reached. To obtain the observed yield  $(1.5 \times 10^{17} \text{ fissions})$  in a single spike, the reactivity insertion rate would have to be reduced to about 2 \$/s. Because this is inconsistent with the time involved (about 3 seconds before complete mixing), the only alternative is to assume that the rate was somewhat less than 5 \$/s and that the excursion was terminated in about 3 seconds by the stirring action. One can surmise that the initial action was thickening of the upper layer at the same time reflection was added by the aqueous liquid. This was followed almost immediately by distortion into a less critical, vortex-like shape by the action of the stirring blades and then permanent shutdown due to a uniform concentration of less than 7 g/ $\ell$ .

Figure 11. Configuration of solutions (aqueous and organic) in the vessel before the accident.

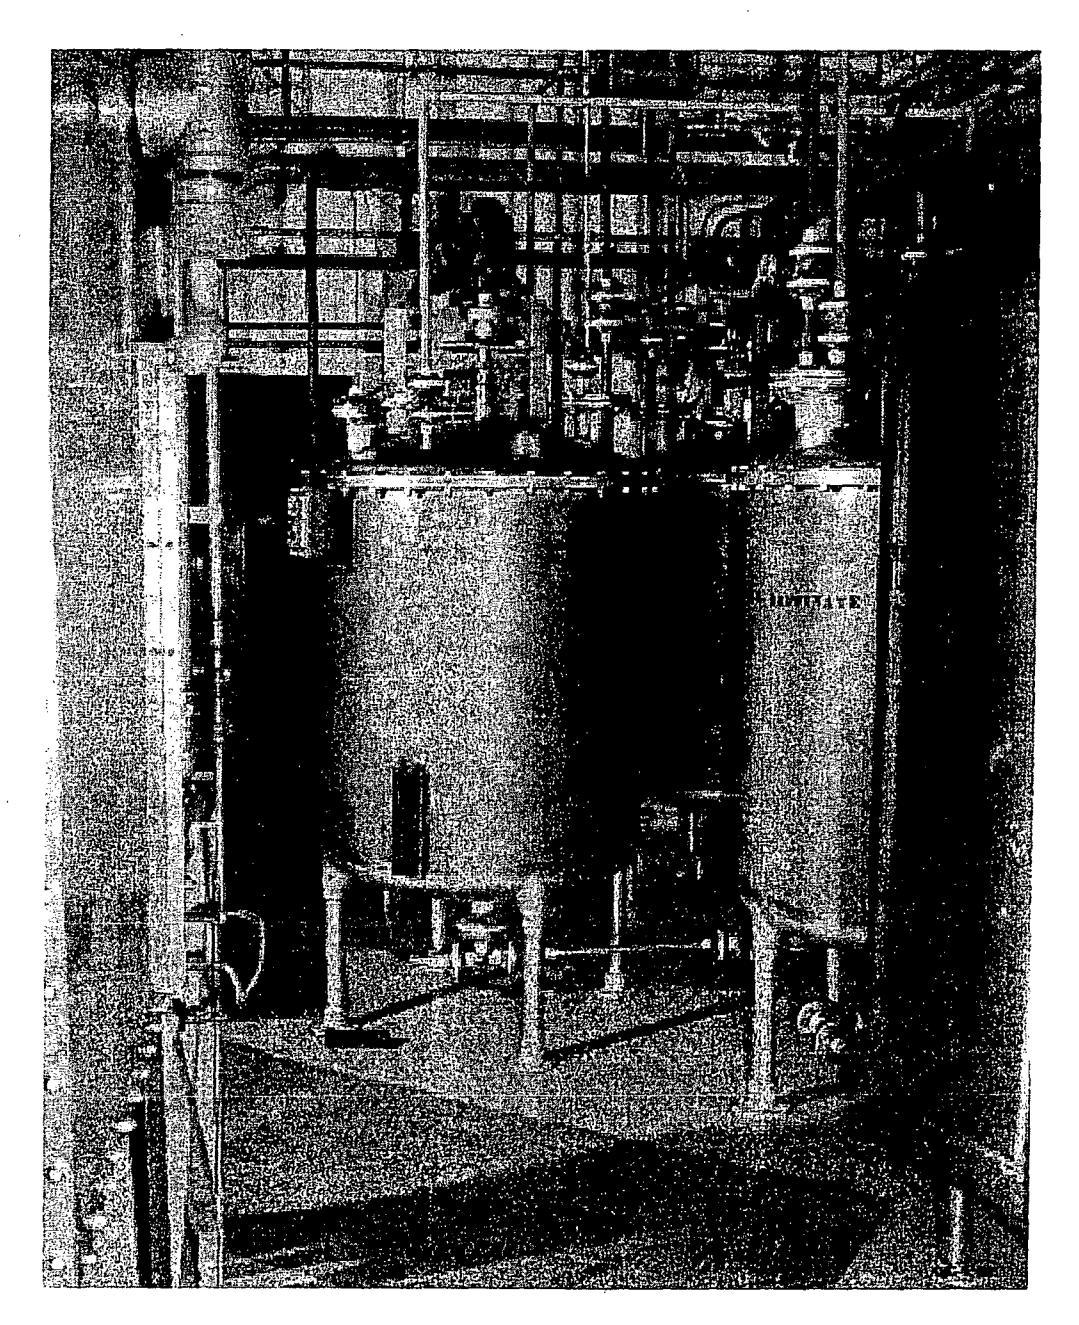
The accident resulted in the death, 36 hours later, of the operator who was looking into a sight glass when the motor was turned on. The dose to his upper torso was estimated to have been  $12,000 \pm 50\%$  rem. Two other persons apparently suffered no ill effects after receiving radiation doses of 134 and 53 rem. No equipment was contaminated or damaged even though the shock associated with off-axis bubble generation displaced the tank about 10 mm at its supports.

Figure 12. Vessel in which the 1958 Los Alamos process criticality accident occurred.

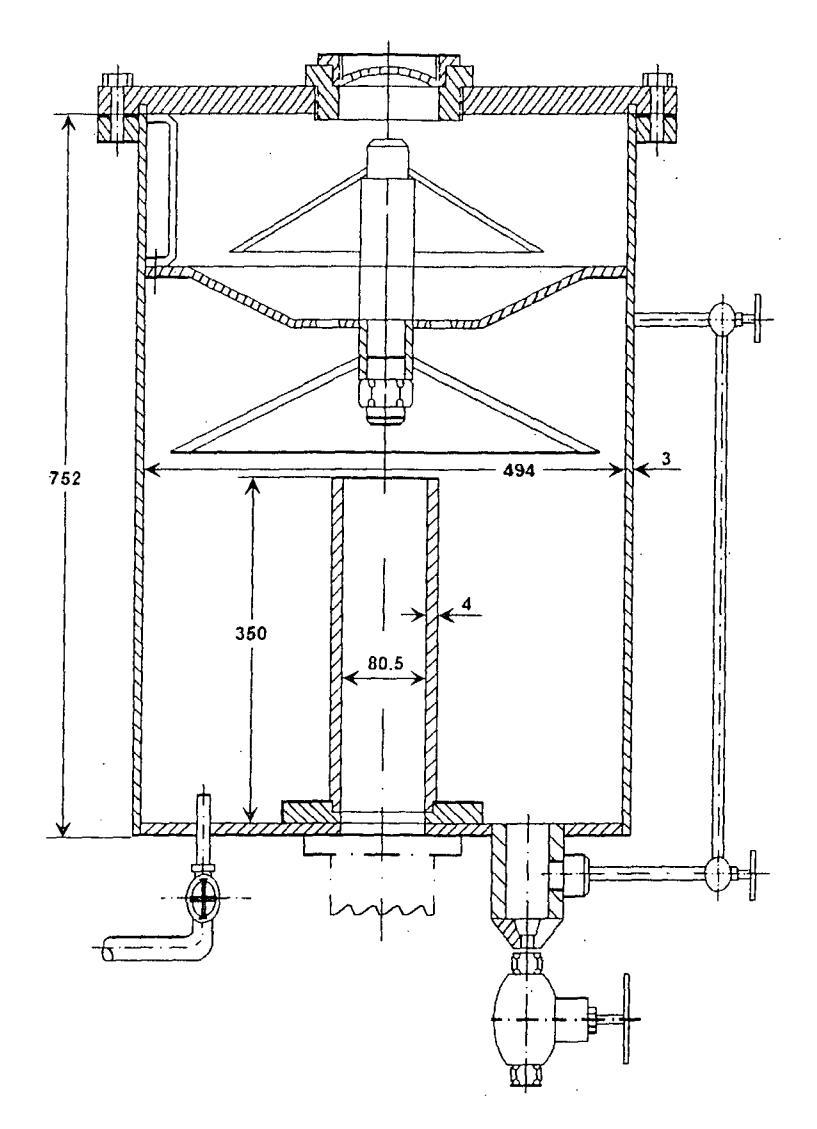
Figure 16. Oil reservoir (Dimensions are in mm).

When the pump was turned on at 07:30, the oil in the pump's cavities was forced out into the central pipe of the oil reservoir. This sudden injection of oil containing uranium led to the second and much larger excursion. The shutdown of this excursion was due to a combination of temperature rise and radiolytic gas. generation, which caused ejection of the oil from this central pipe back into the pump's cavities and the gas purification equipment. As with the first excursion, the

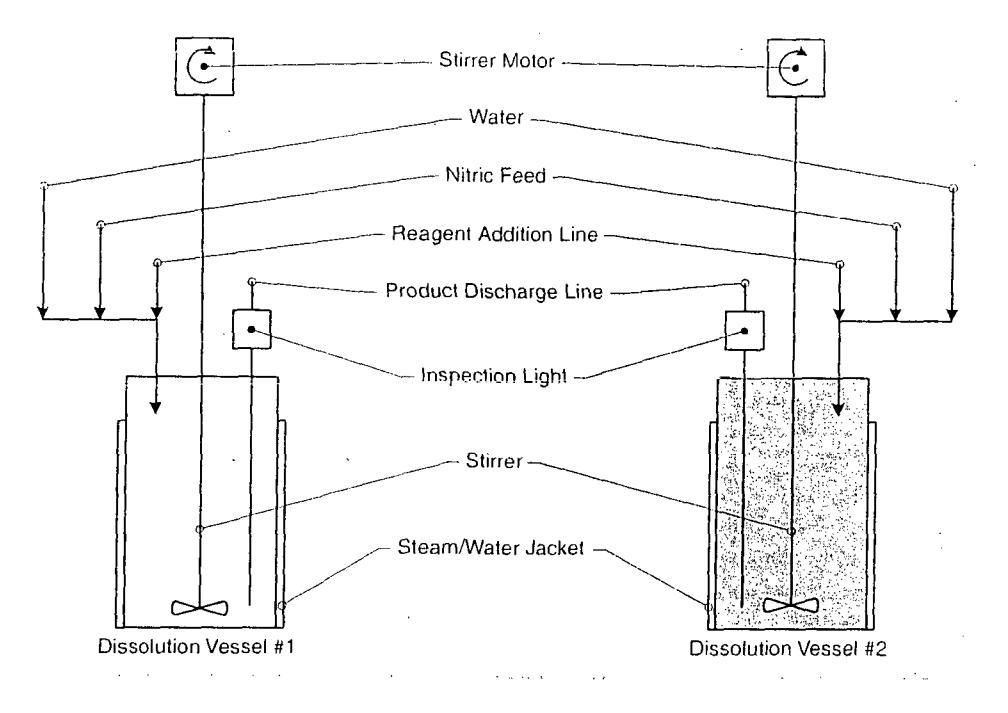
Figure 17. Layout of glovebox equipment.

Fifteen minutes after the first excursion, unsuccessful attempts were made to remotely open a line and drain vessel 2. Further attempts at remote recovery included heating and mixing of the solution, temporarily lowering the reactivity of the system. A short while later the

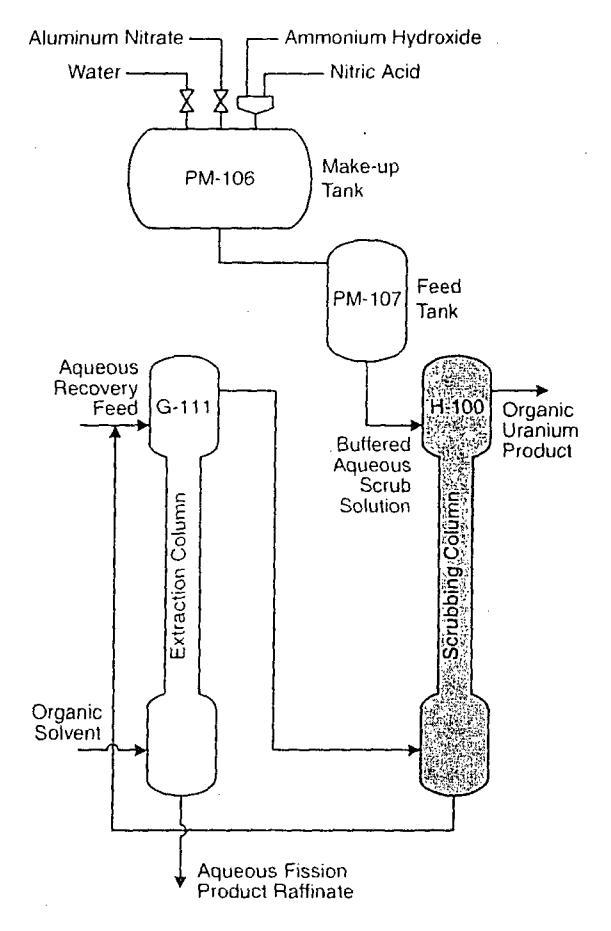
for the scrubbing column. H-100, had been leaking for about a month prior to the accident. Over time, this leak caused a dilution of the feed solution from 0.75 M to 0.08 M. The 13.400 *t* make-up tank was equipped with a density alarm that would have indicated the discrepancy, but the alarm was inoperable. A density alarm was scheduled to be installed on the 3,000 l process feed tank (PM-107) that was filled, as necessary, from the make-up tank, but this had not been done. The make-up tank was instrumented with a strip-chart recorder showing the solution level in the tank. However, the leak into the tank was so slow that the change in level would have not have been discernible unless several days worth of the chart was analyzed. To complicate matters, the chart recorder had run out of paper on 29 September and it was not replaced until after the accident. Furthermore, procedures that required the taking of samples from the feed tank, PM-107, to confirm the density, were not being followed.

Figure 27. First cycle extraction line equipment. The accident occurred in the lower disengagement section of the H-100 column.

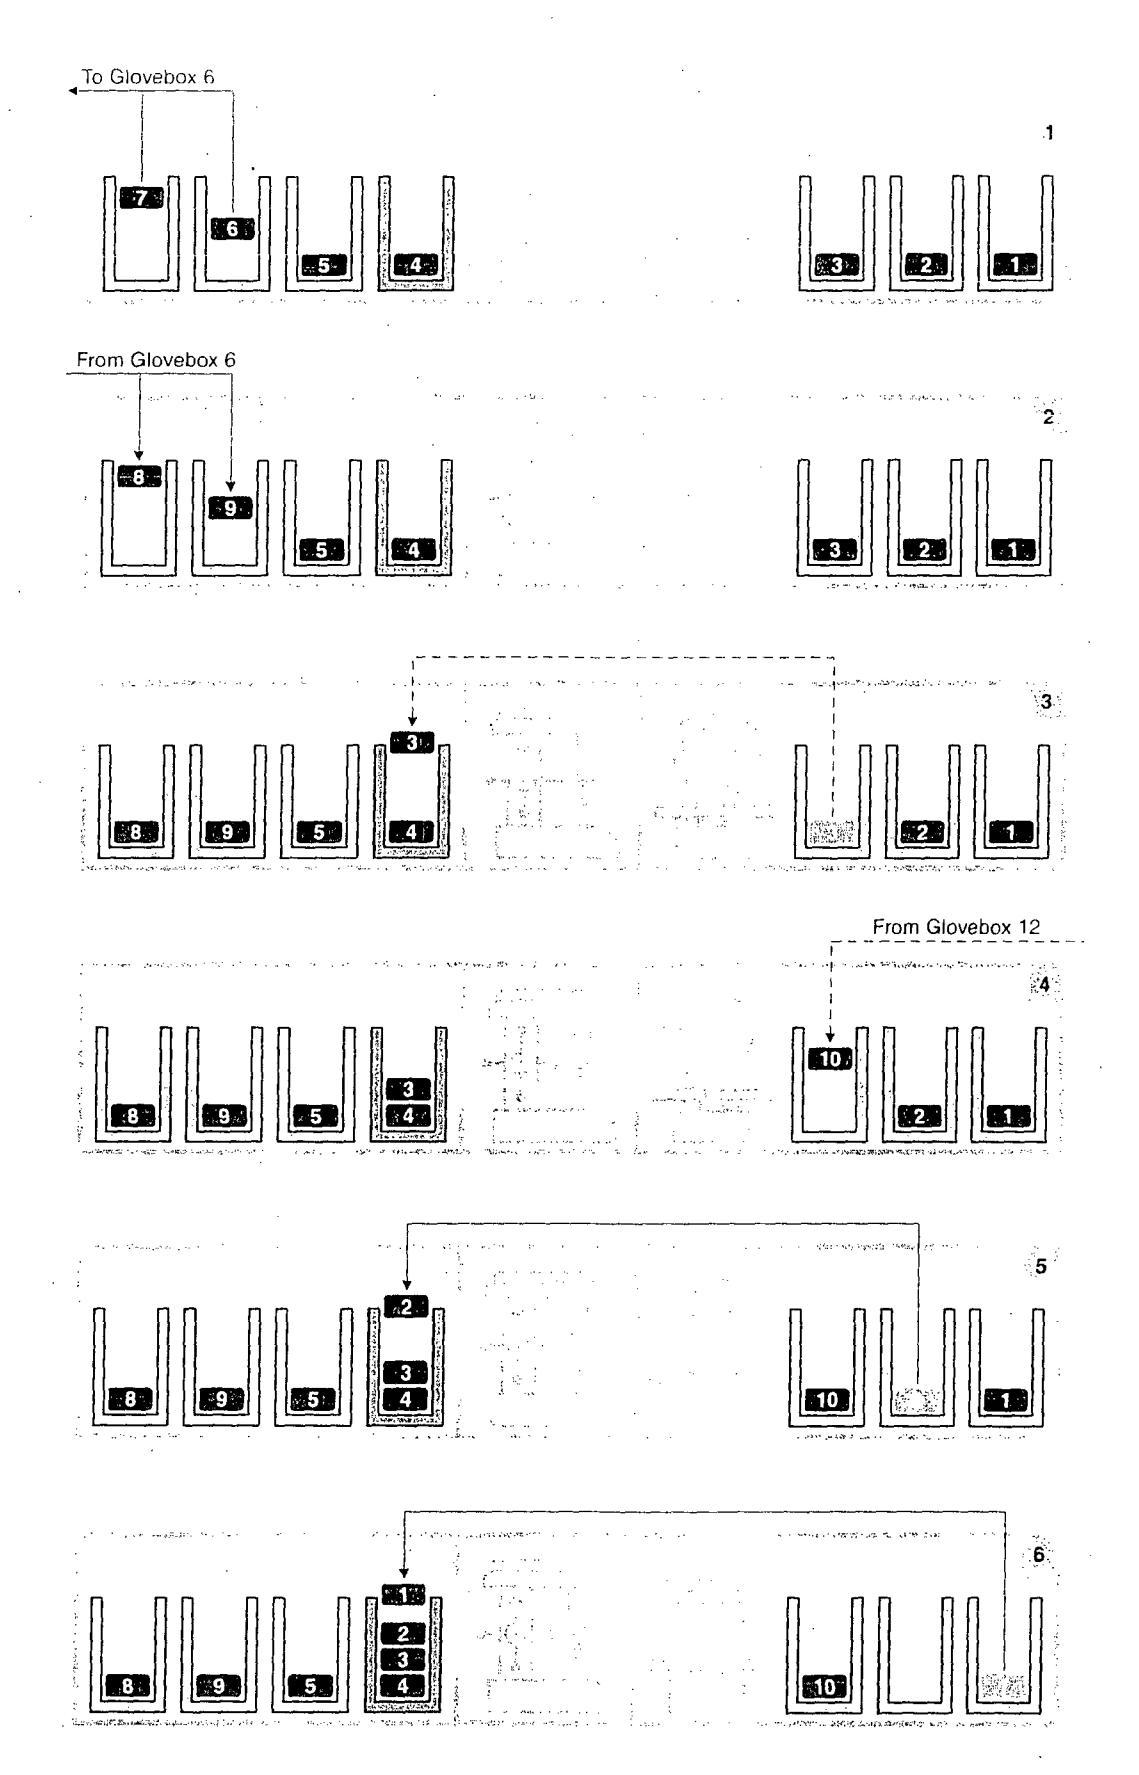
Figure 31. Actual order of ingot transfers from and to Glovebox 13. The solid lines represent the actions of operator A and the dotted lines the actions of operator B.

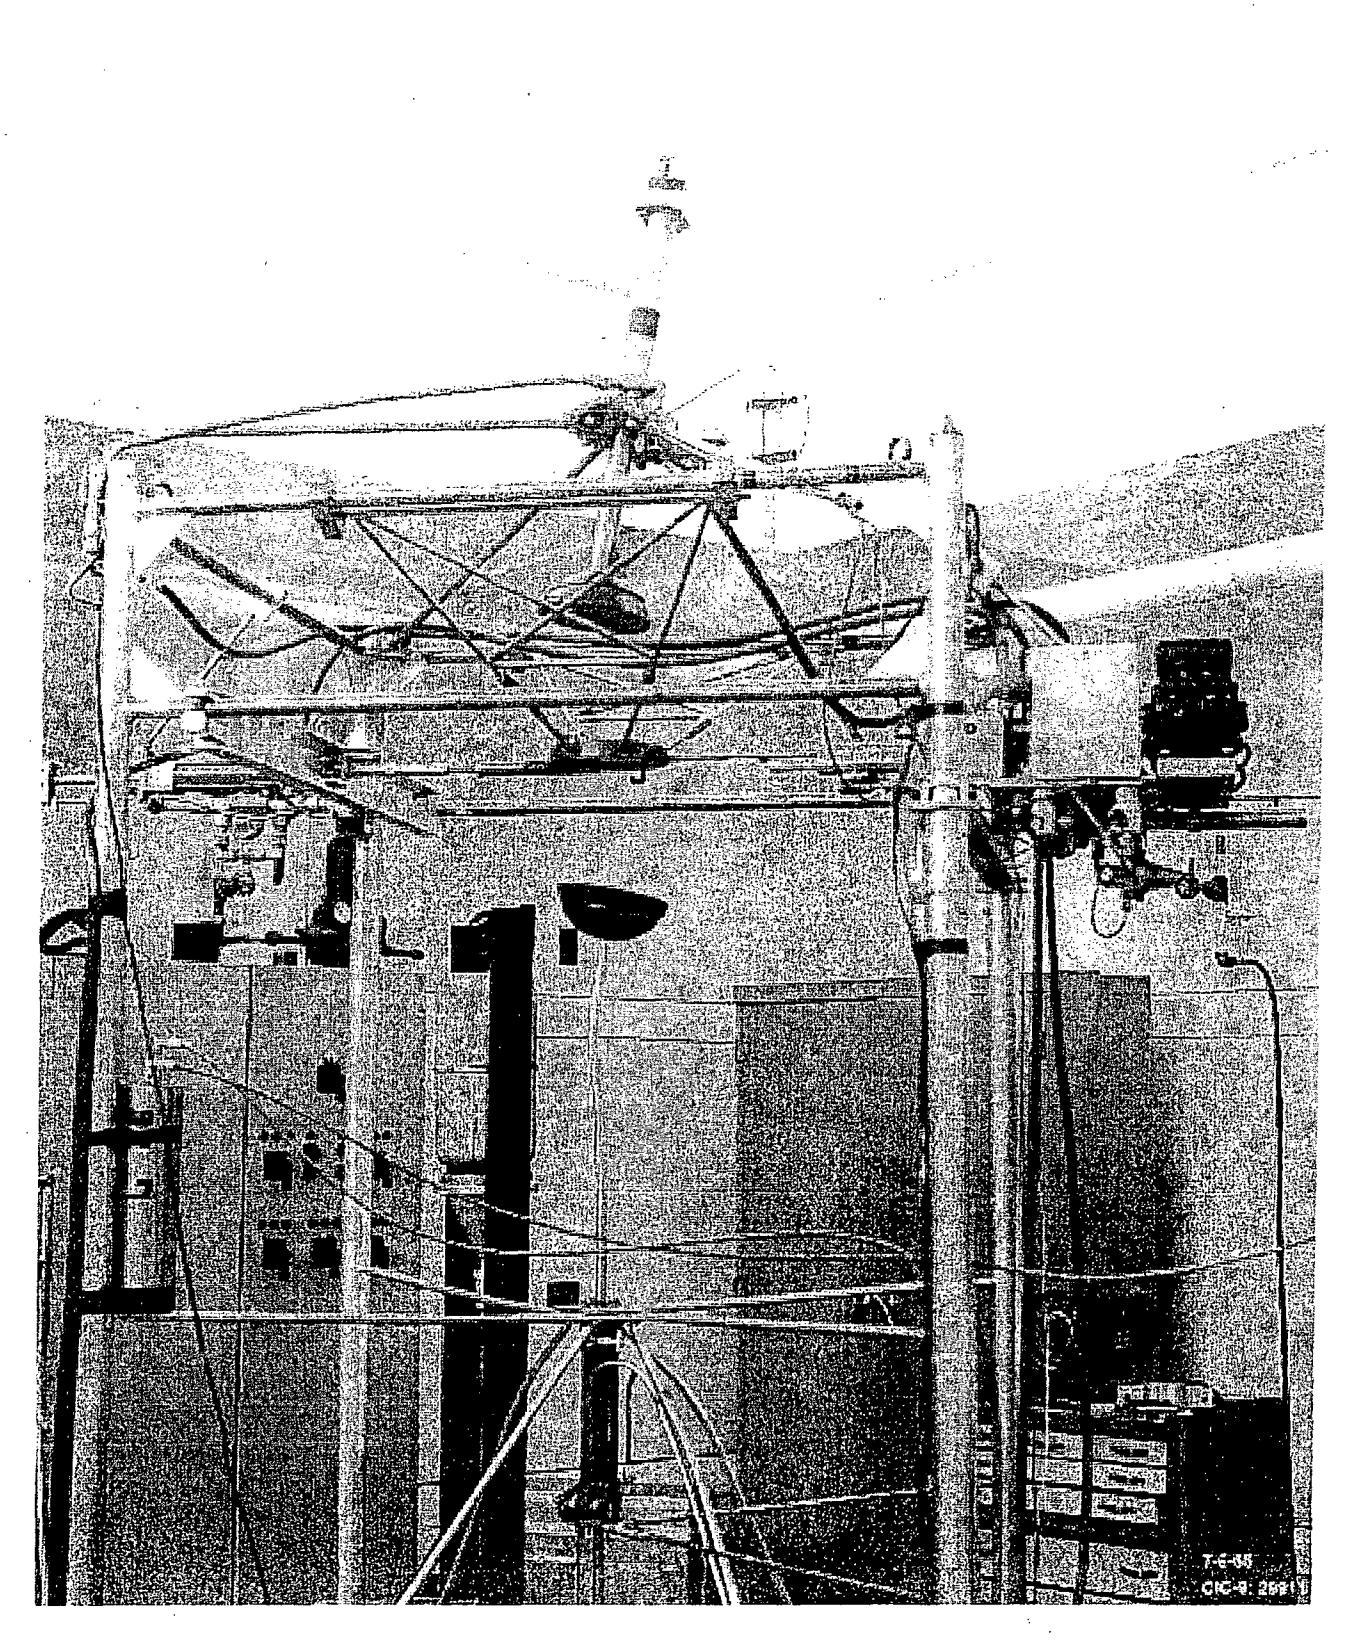
Figure 49. Lady Godiva after the excursion of 3 February 1954.

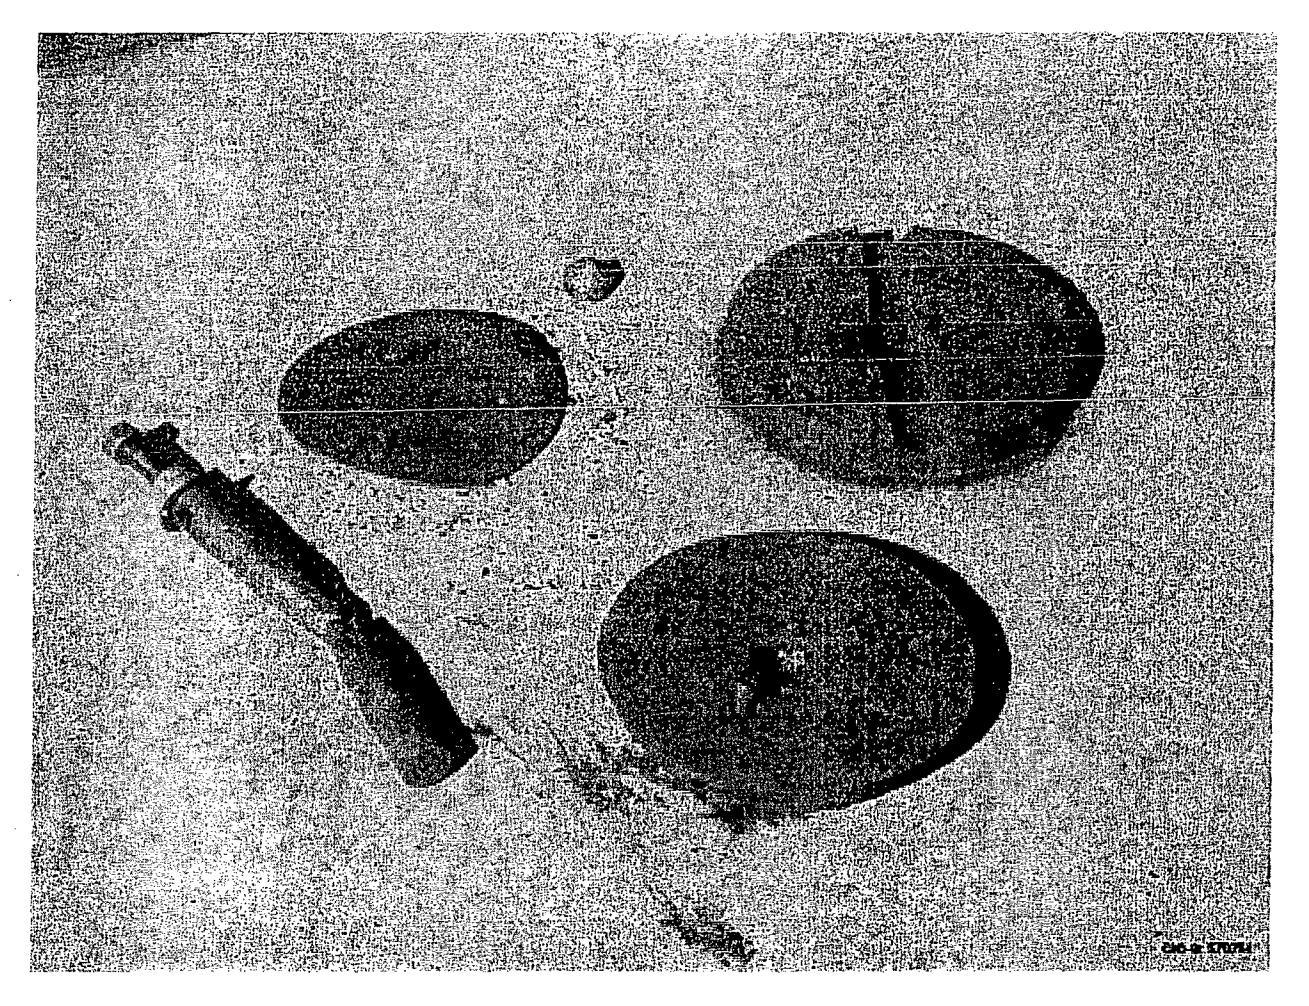
Figure 50. Burst rod and several sections of Lady Godiva showing oxidation and warpage that accompanied the second accident, 12 February 1957.

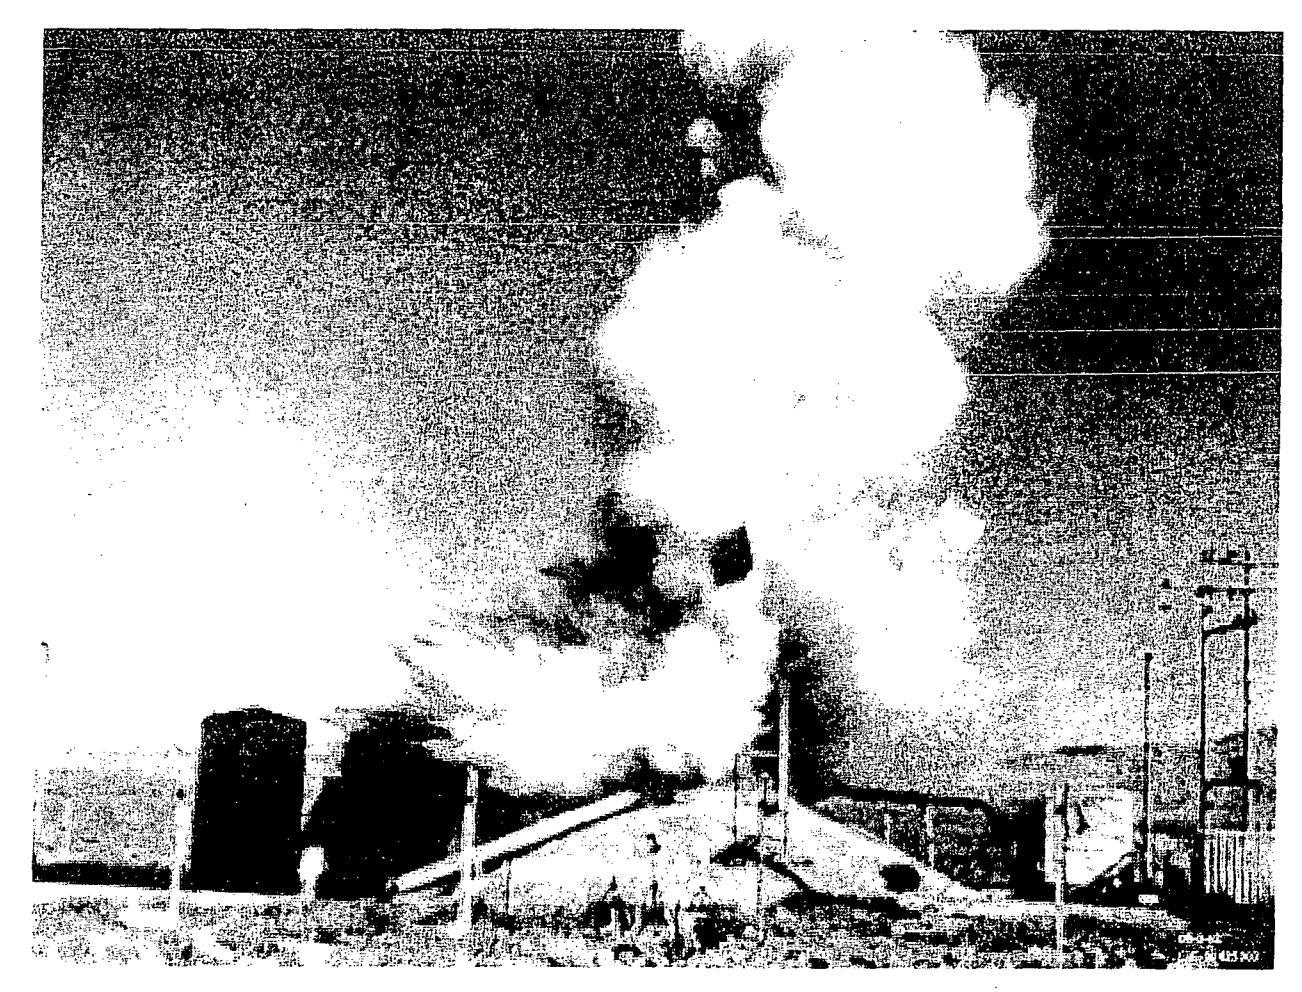
Figure 59. The destructive excursion in BORAX, 22 July 1954.
