Response to NRC Request for Additional Information Related Repair of the Core Shroud Stabilizer Assemblies (TAC NO. MD4918)

LETTER NUMBER: 2.07.039

Entergy Response to NRC Request for Additional Information Related to Repair of Pilgrim Core Shroud Stabilizer Assemblies (TAC No. MD4918)

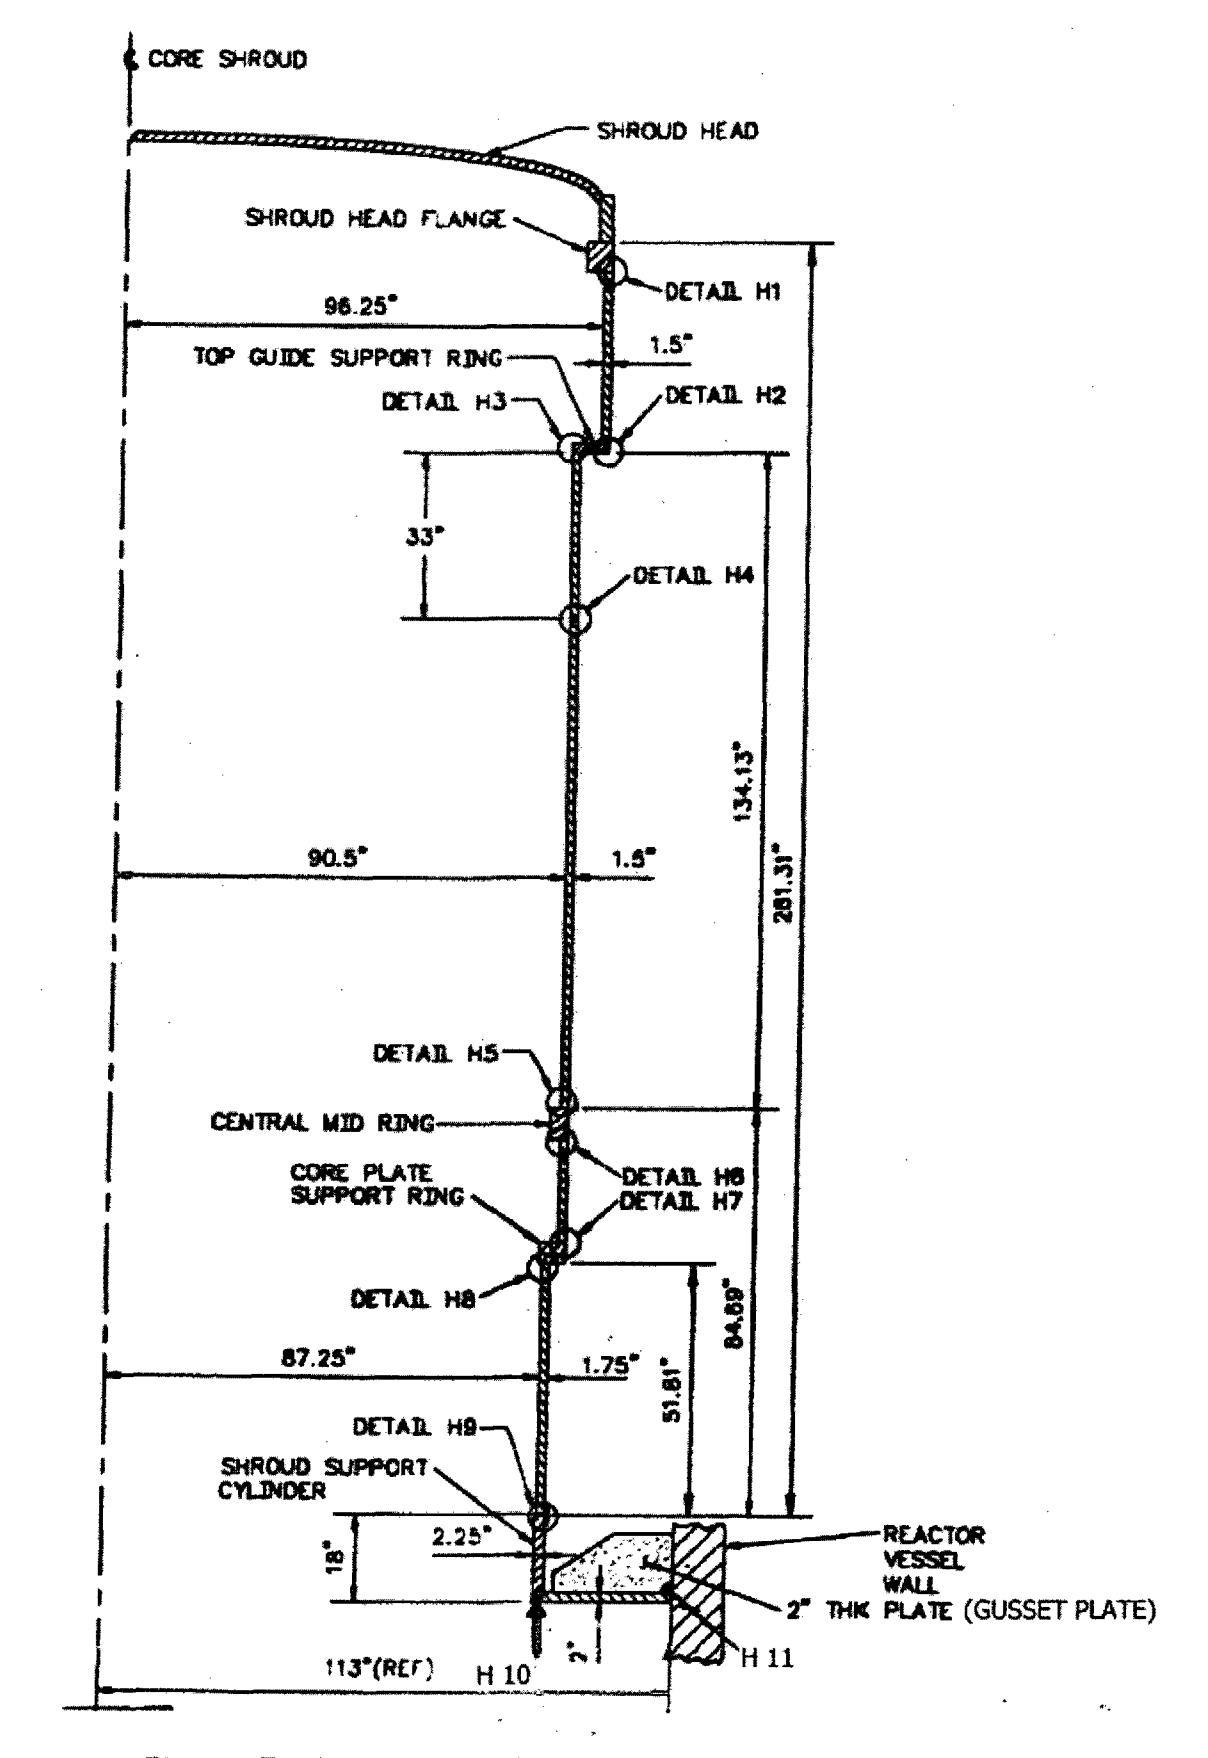
Figure B-12.1 - PNPS Shroud Cross-section

The following figures provide a cross section of the core shroud and the tie rod inspection points. As shown, the H11 weld is between the vessel and core support plate. The gusset plates are being inspected by EVT-1 methods during the current refueling outage. The inspection plan includes the locations necessary for assuring the structural integrity of the repair hardware. Future inspections will be performed consistent with the BWRVIP recommendations provided in BWRVIP-38 and BWRVIP-76-A.

Examination frequency complies with BWRVIP-38 guidelines. No relevant indications noted on these examinations.

In addition, Pilgrim has inspected 100% of the shroud support weld (top surface of H11) to the RPV wall in RFO15 with no relevant indications noted.
