Crystal River Nuclear Plant Docket No. 50-302 Operating License No. DPR-72

- Subject: Crystal River Unit 3 90-Day Response to NRC Generic Letter 2007-01, "Inaccessible or Underground Power Cable Failures that Disable Accident Mitigation Systems or Cause Plant Transients"

90-Day Response to Generic Letter 2007-01, "Inaccessible or Underground Power Cable Failures that Disable Accident Mitigation Systems or Cause Plant Transients"

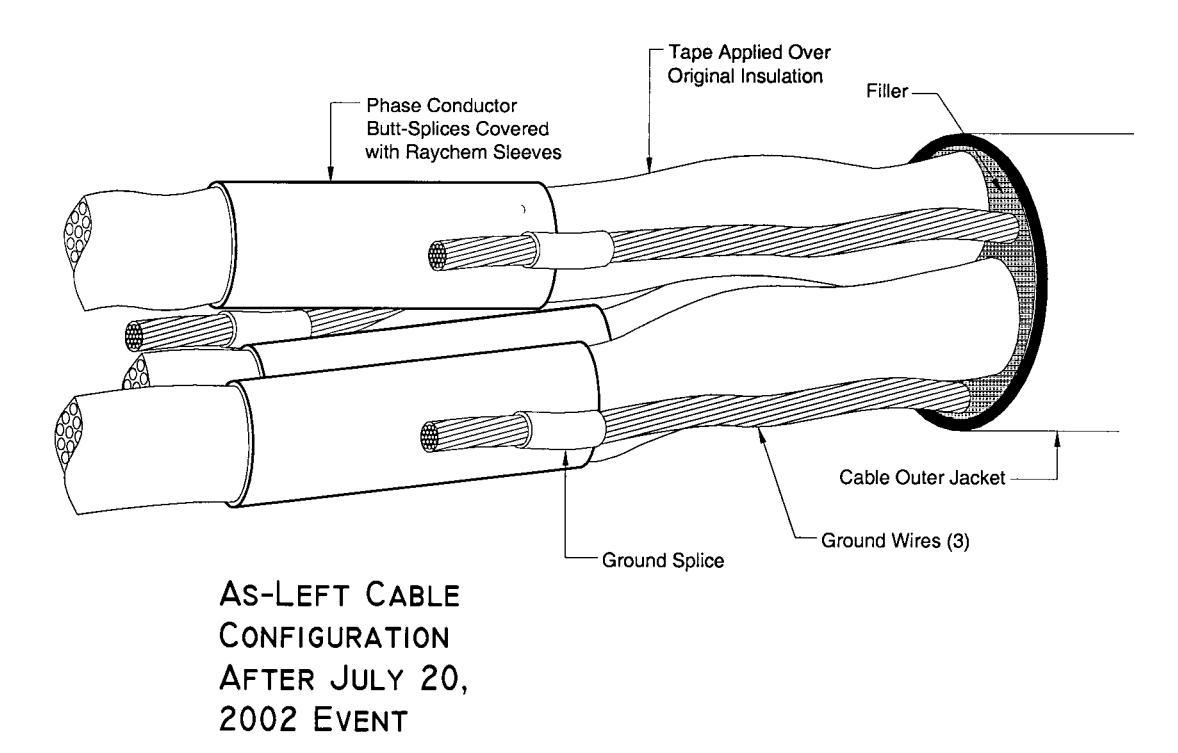
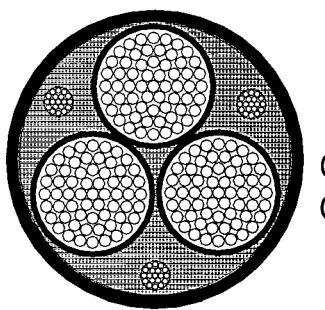
ORIGINAL CABLE CONFIGURATION

A potential contributing factor to the last two occurrences was the as-left configuration of the cables following the June 2002 repairs. The conductors and cable grounds were bundled together and covered with the zippered protective cover. In an unspliced cable, filler material maintains a separation of approximately a quarter inch between the conductor and ground cables. Following the June 2002 repairs, water that had collected in the duct bank, and subsequently, in the zippered jackets, had leached out this filler material. As such, the separation it provided between the conductor and ground cables was most likely compromised.
