EVALUATION OF DISSIMILAR METAL WELD EXAMINATIONS PERFORMED AT NINE MILE POINT UNIT 1 DURING REFUELING OUTAGE 19 (N1R19)

IR-2007-271

AUTOMATED ULTRASONIC WELD EXAMINATION SUMMARY REPORT FOR RECIRCULATION INLET NOZZLE-TO-SAFE END WELD NO. 32-WD-164 (Page 94 of 186 thru page 140 of 186)

Automated Ultrasonic WELD EXAMINATION SUMMARY Report # W-1-1105-07-007
1. 1. 1.	Site: <u>Nine Mile</u> Unit: <u>1</u> Outage #: <u>N1R19</u> Procedure # <u>N/DI-SSP-1105</u> Revision: <u>0</u>
	System: <u>Recirc</u> Component ID: <u>32-WD-164</u> Component Config: <u>Safe End to Nozzle</u>
	Examiner: <u>Thomas Walsh</u> Level: <u>II</u> Examiner: <u>Liarry Musgrave</u> Level: <u>II</u>

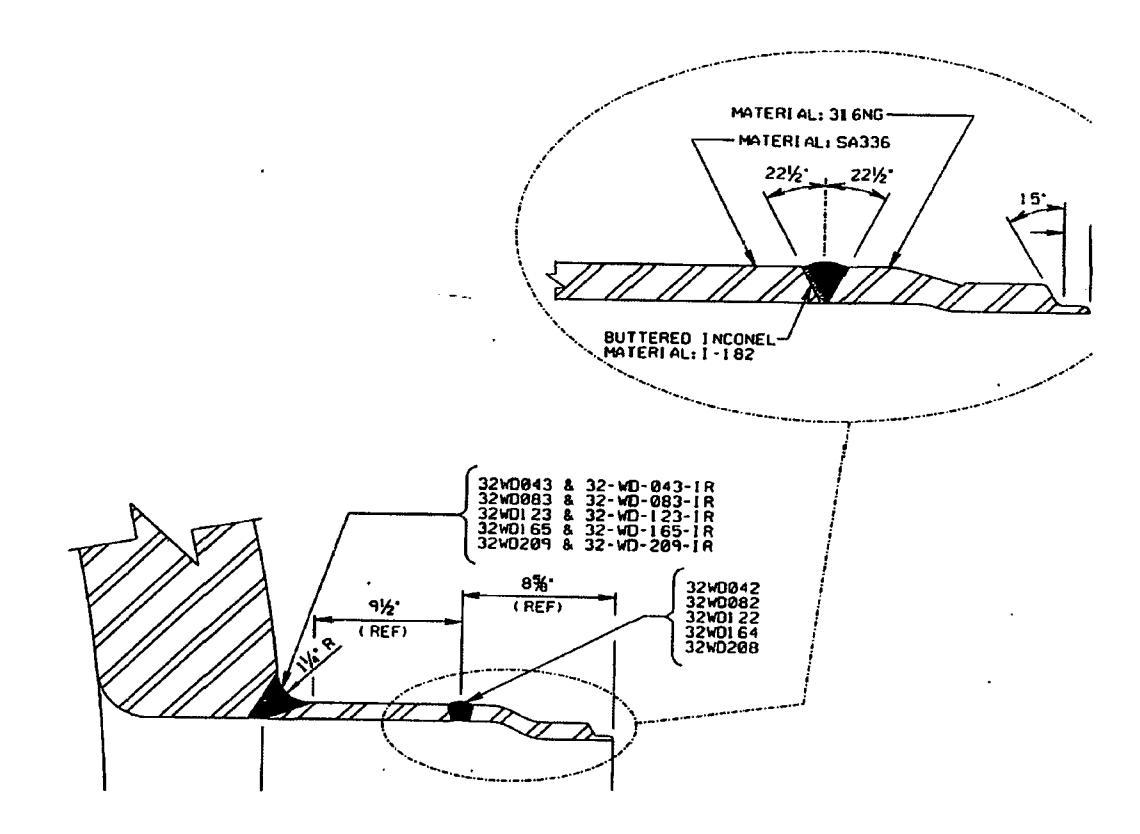
Figure 1-1 N2 Configuration The examinations of the N2C and N2D safe-end-to-nozzle welds were performed during RF019 by Nine Mile's inspection vendor, WESDYNE International, using a automated technique defined in procedure WDI-SSP-1105 Revision 0, titled "Generic Procedure for the Automated (IntraSpect) Ultrasonic Examination of Dissimilar Metal Welds using WDI-STD-119A." As documented on the applicable Performance Demonstration Qualification Statement (PDQS No. 523) dated February 16, 2006, the procedure meets the requirements of the Performance Demonstration Initiative's implementation of The American Society of Mechanical Engineers Boiler and Pressure Vessel Code, Section XI, Appendix VIII, Supplement 10.

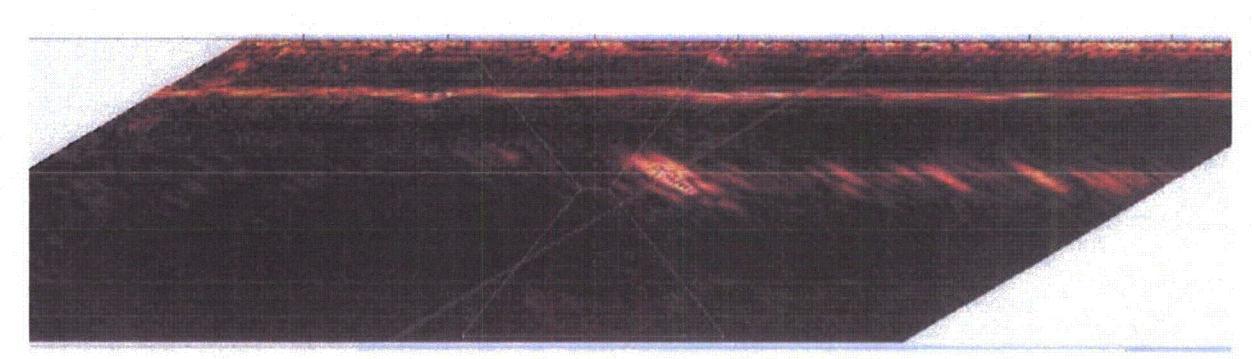
Figure 7-2 Cladding Fabrication Flaw Reported during 2007 Examination

A thorough review of both the 1999 and the 2007 automated data confirm that the reported indication is clearly a fabrication flaw located near the transition between the stainless steel cladding and the nozzle butter (see Figure 7-1). The flaw is 1.3" long on the ID and is wholly contained in the cladding. It does not propagate into either the carbon steel base material or the inconel butter material. See Figures 7-2 and 7-3 below for images of the flaw collected from the 1999 and the 2007 data.

Data provided by WESDYNE from the examination of N2C supports their conclusion that the flaw reported in the N2C weld is consistent with a fabrication flaw. This flaw is 1.3" long on the ID located near the transition between the stainless steel cladding and the nozzle butter and is wholly contained in the cladding. The flaw does not appear to propagate into either the carbon steel base material or the inconel butter material and is typical of a cladding defect.

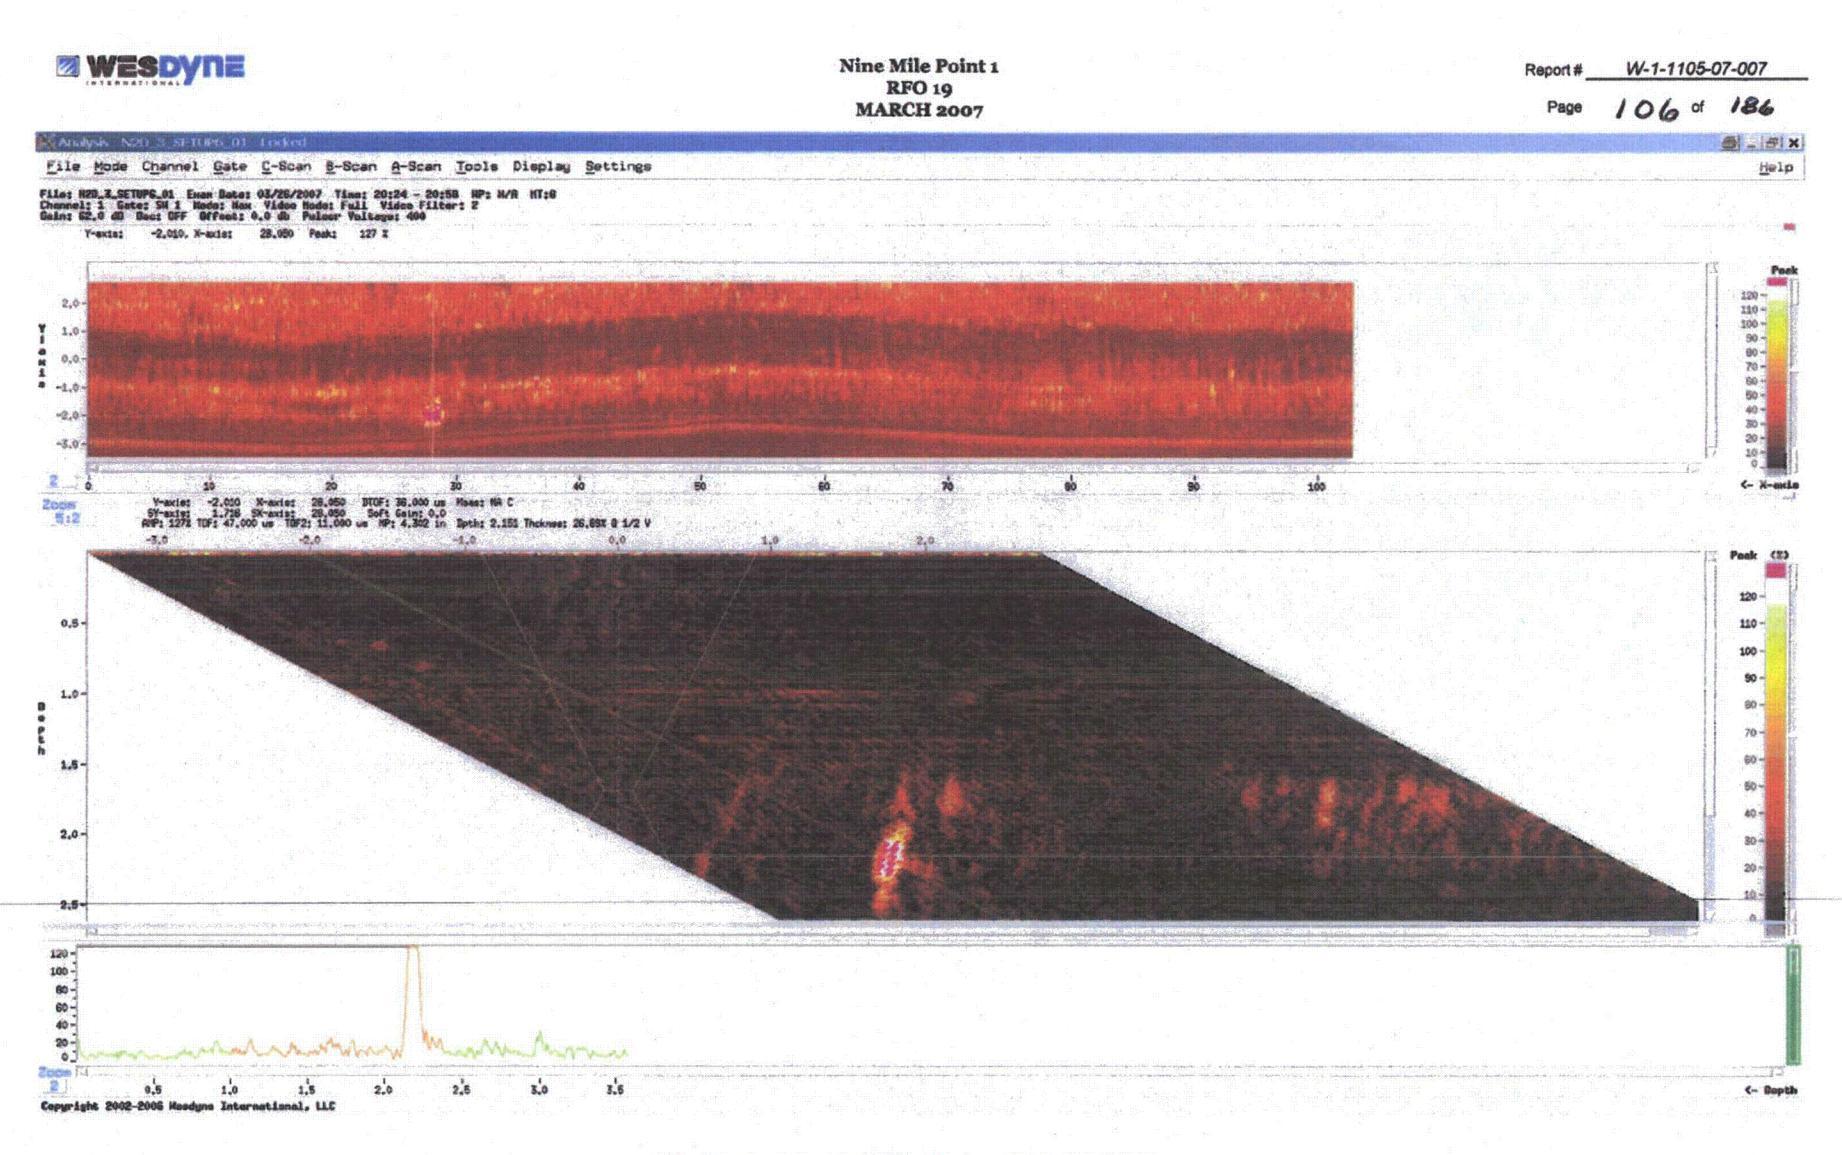
NRI - Shear component of 60RL reflecting off Indication #1 shown

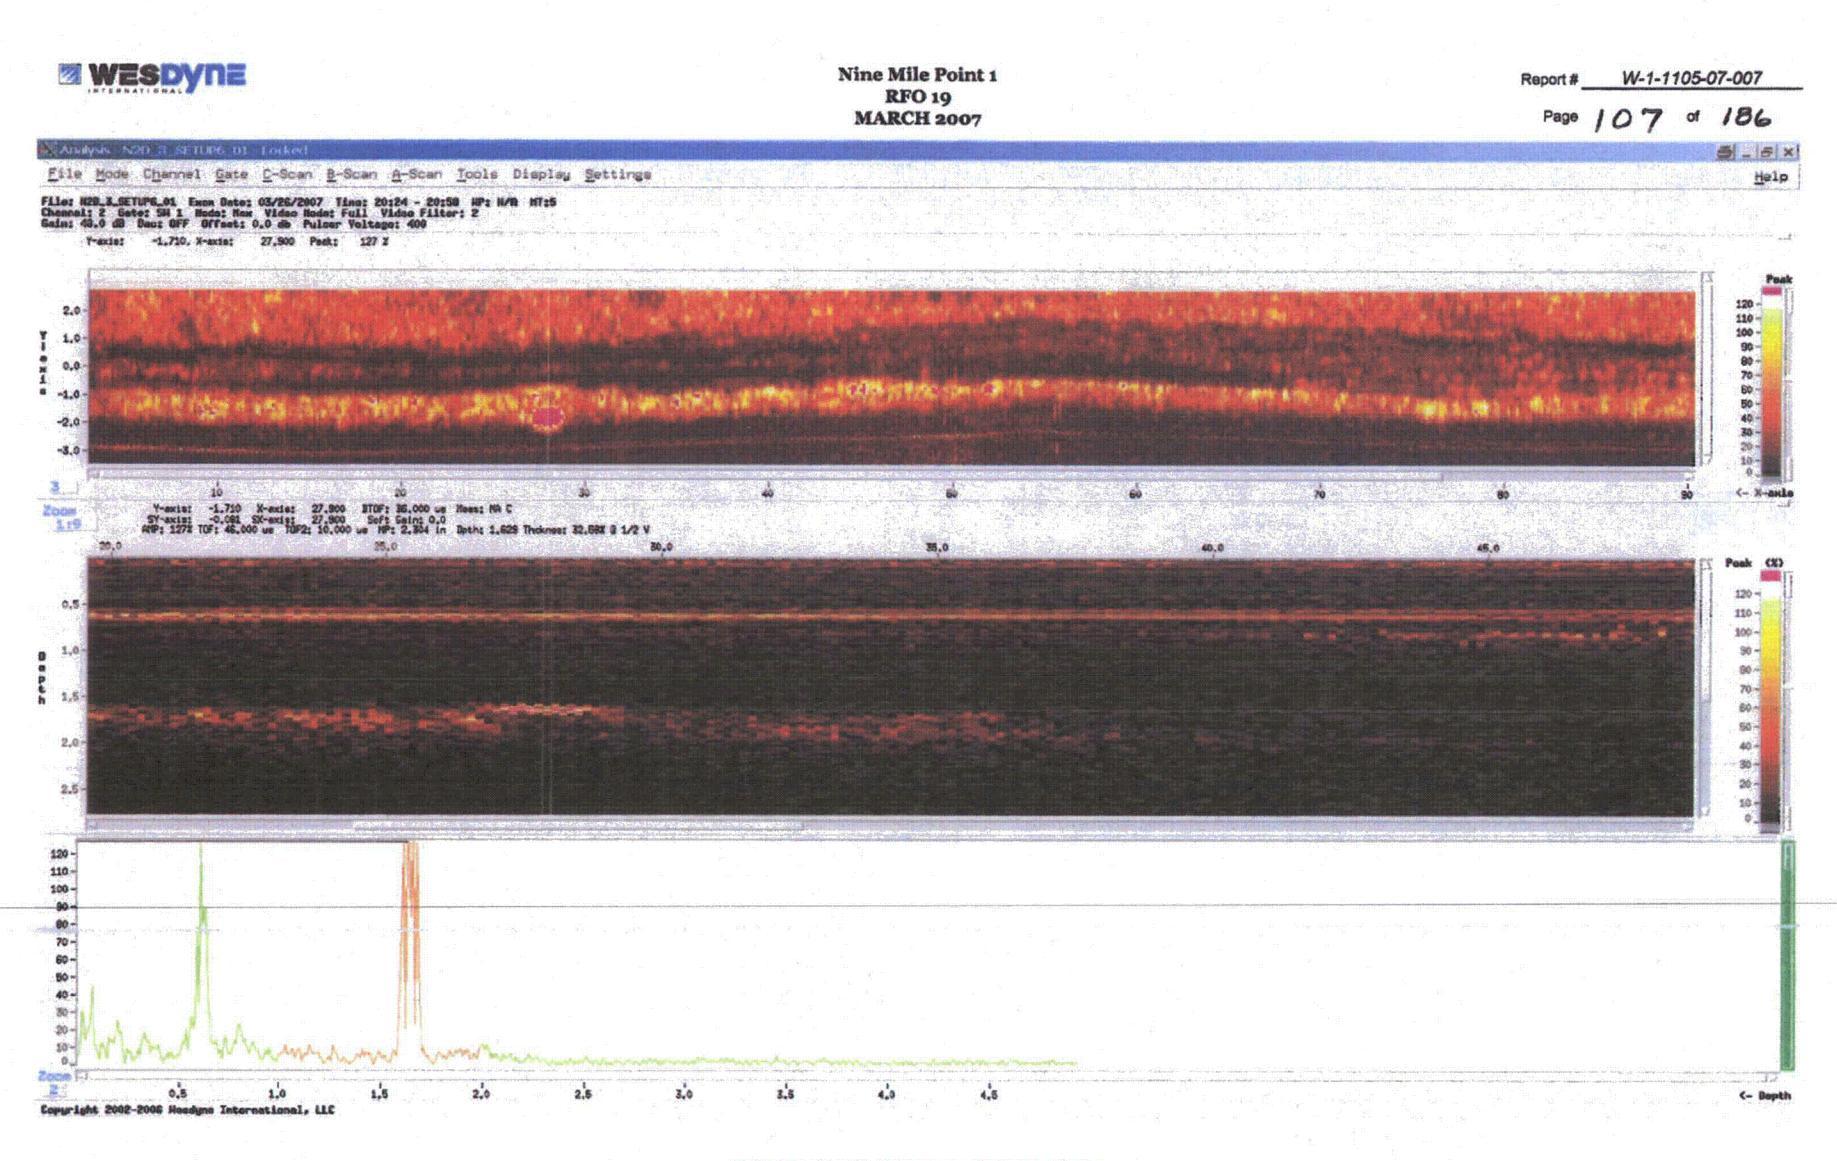
Indication #1 - W measurement does not vary

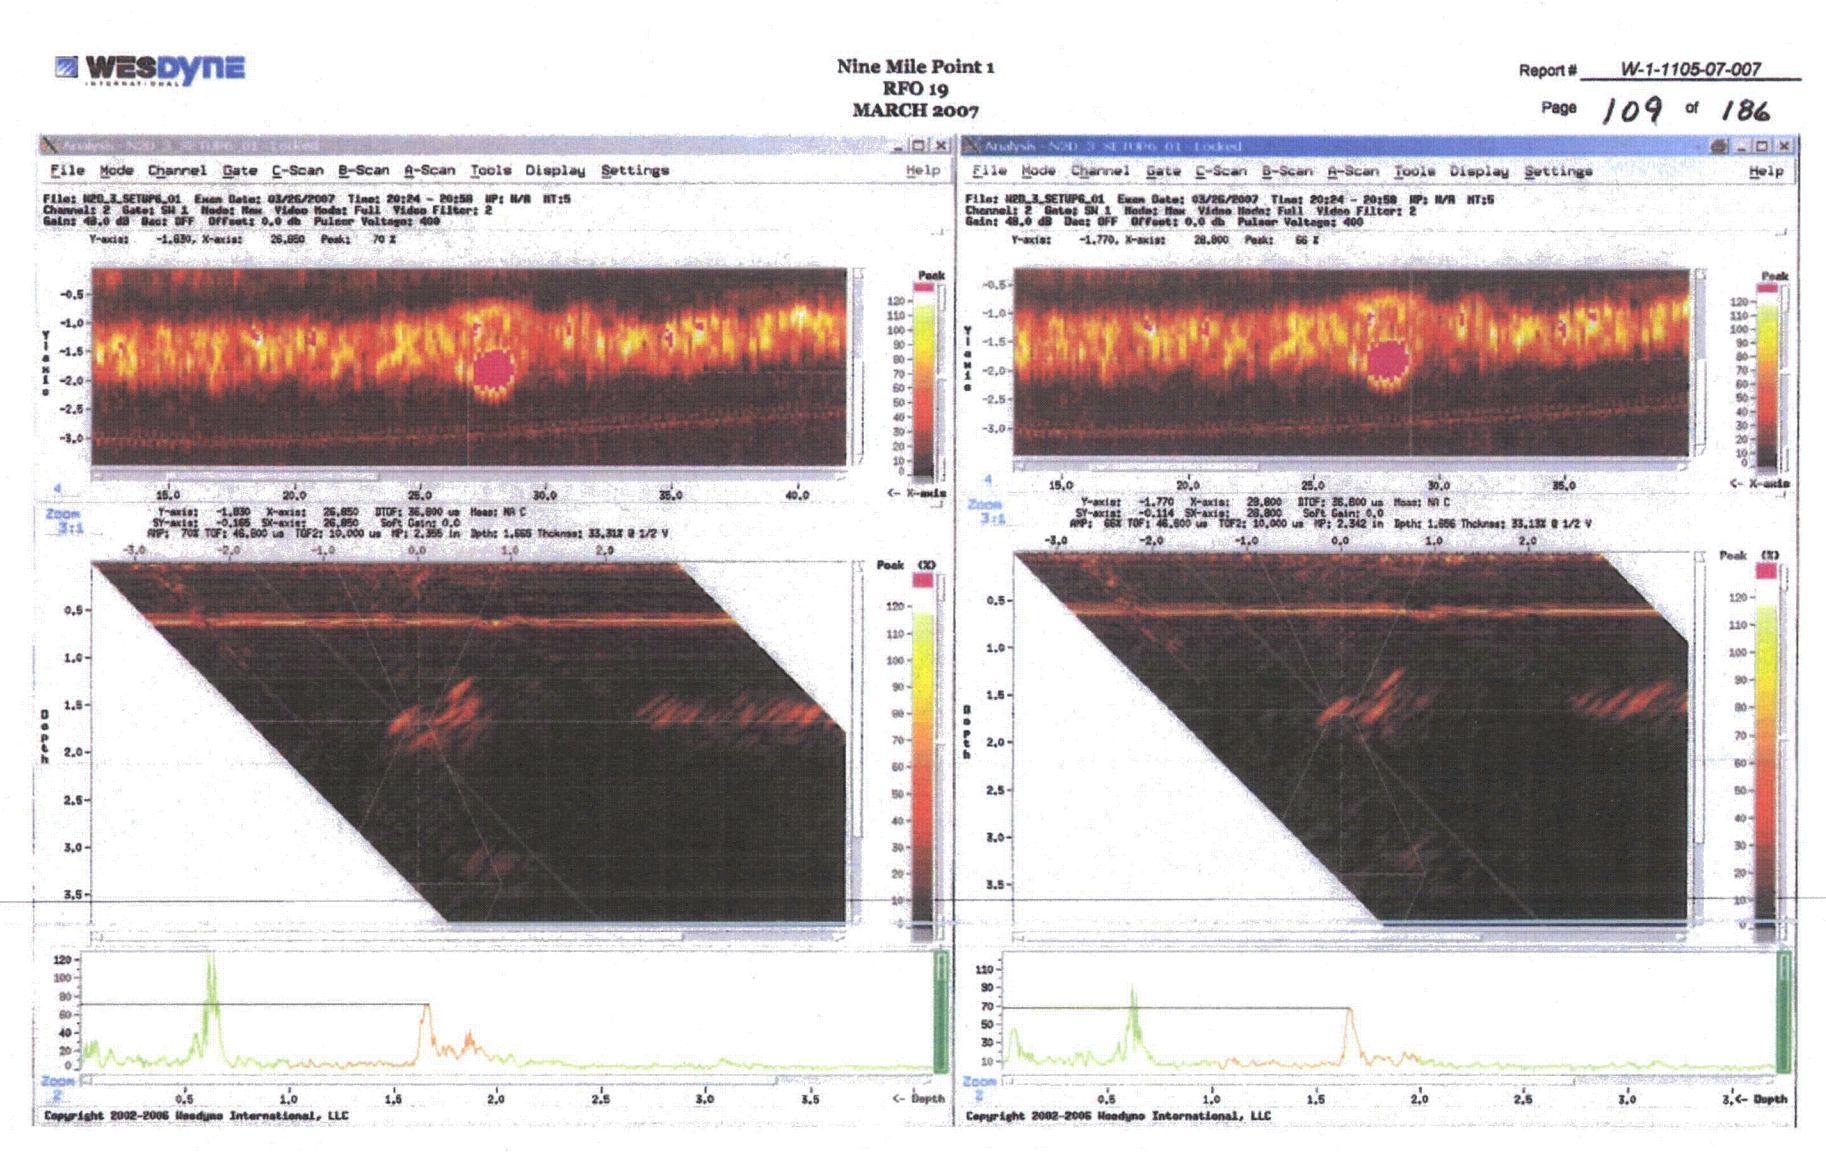
Indication #1 - End points (Length)

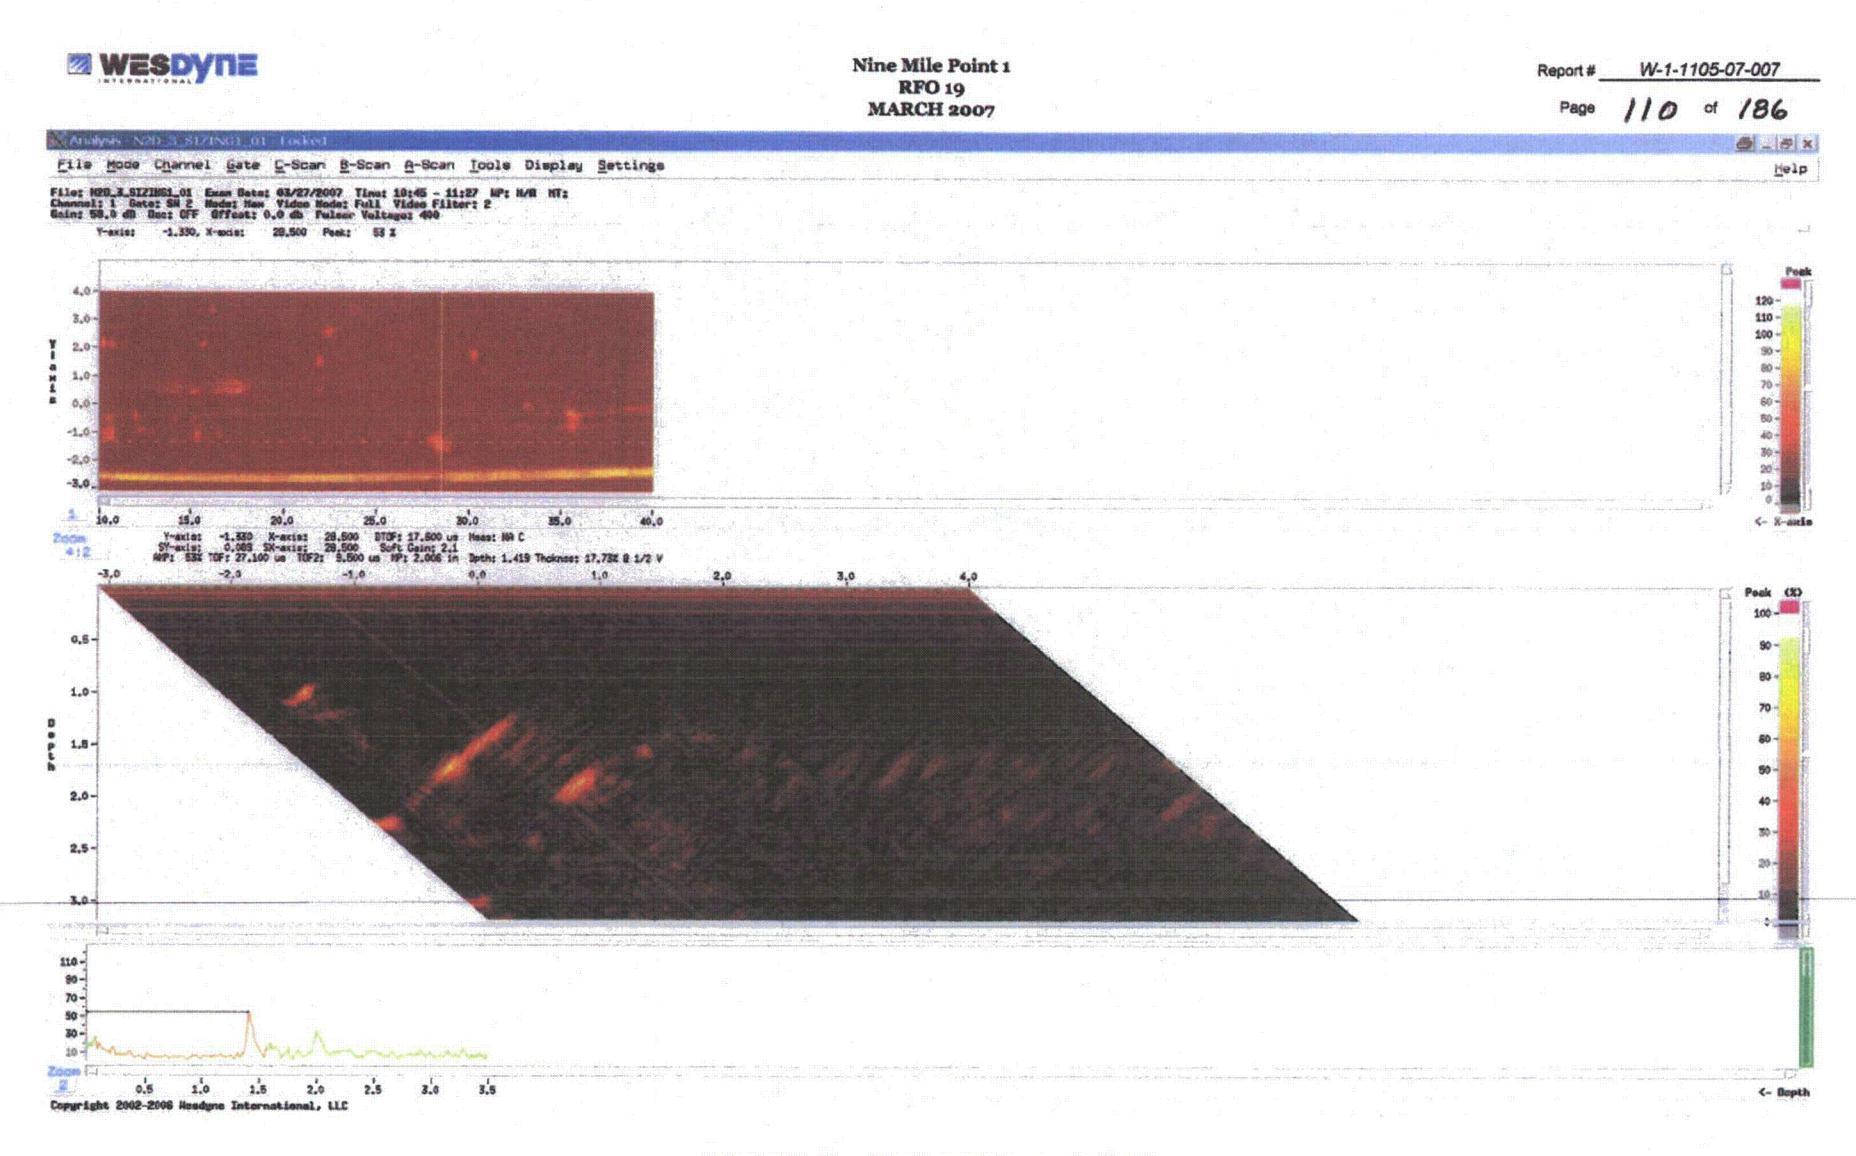
Indication #1 - Remaining Ligament shown under 'Depth'

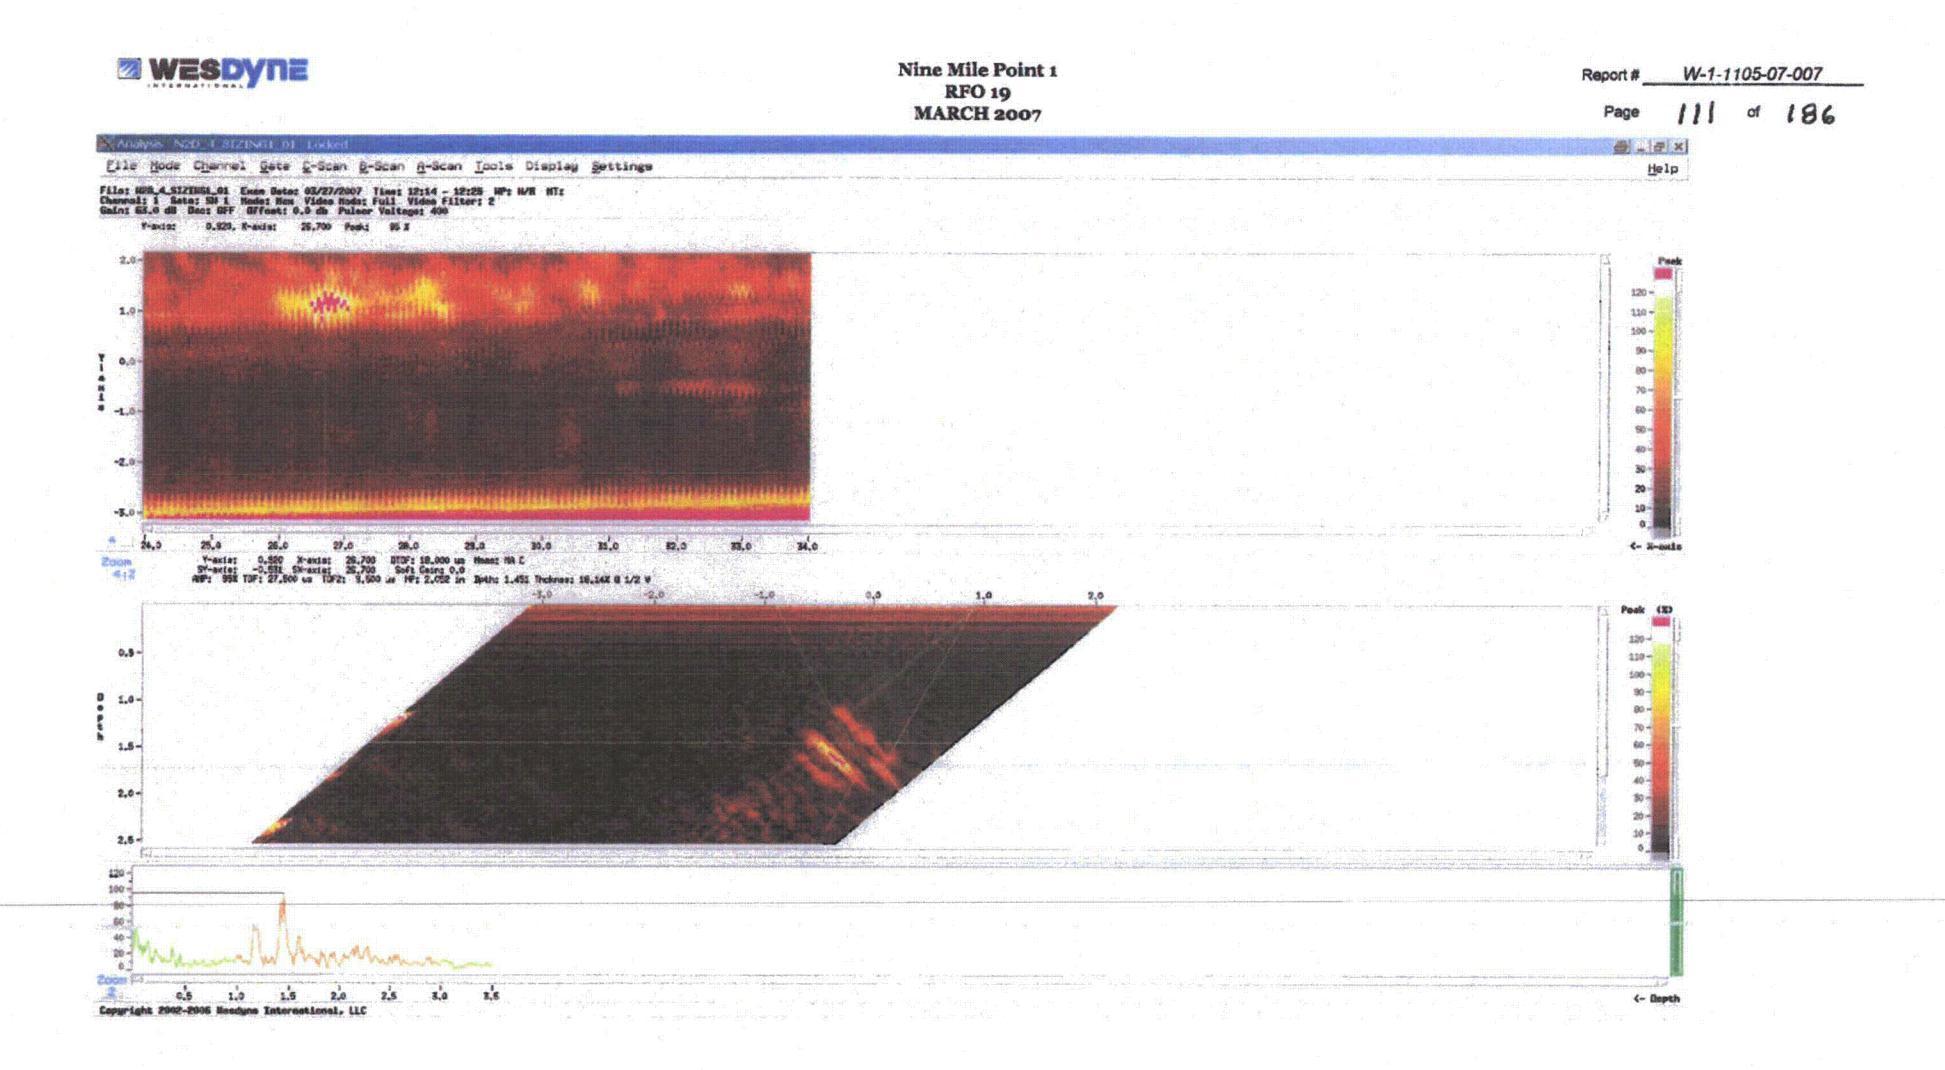
Indication #1 - from nozzle side

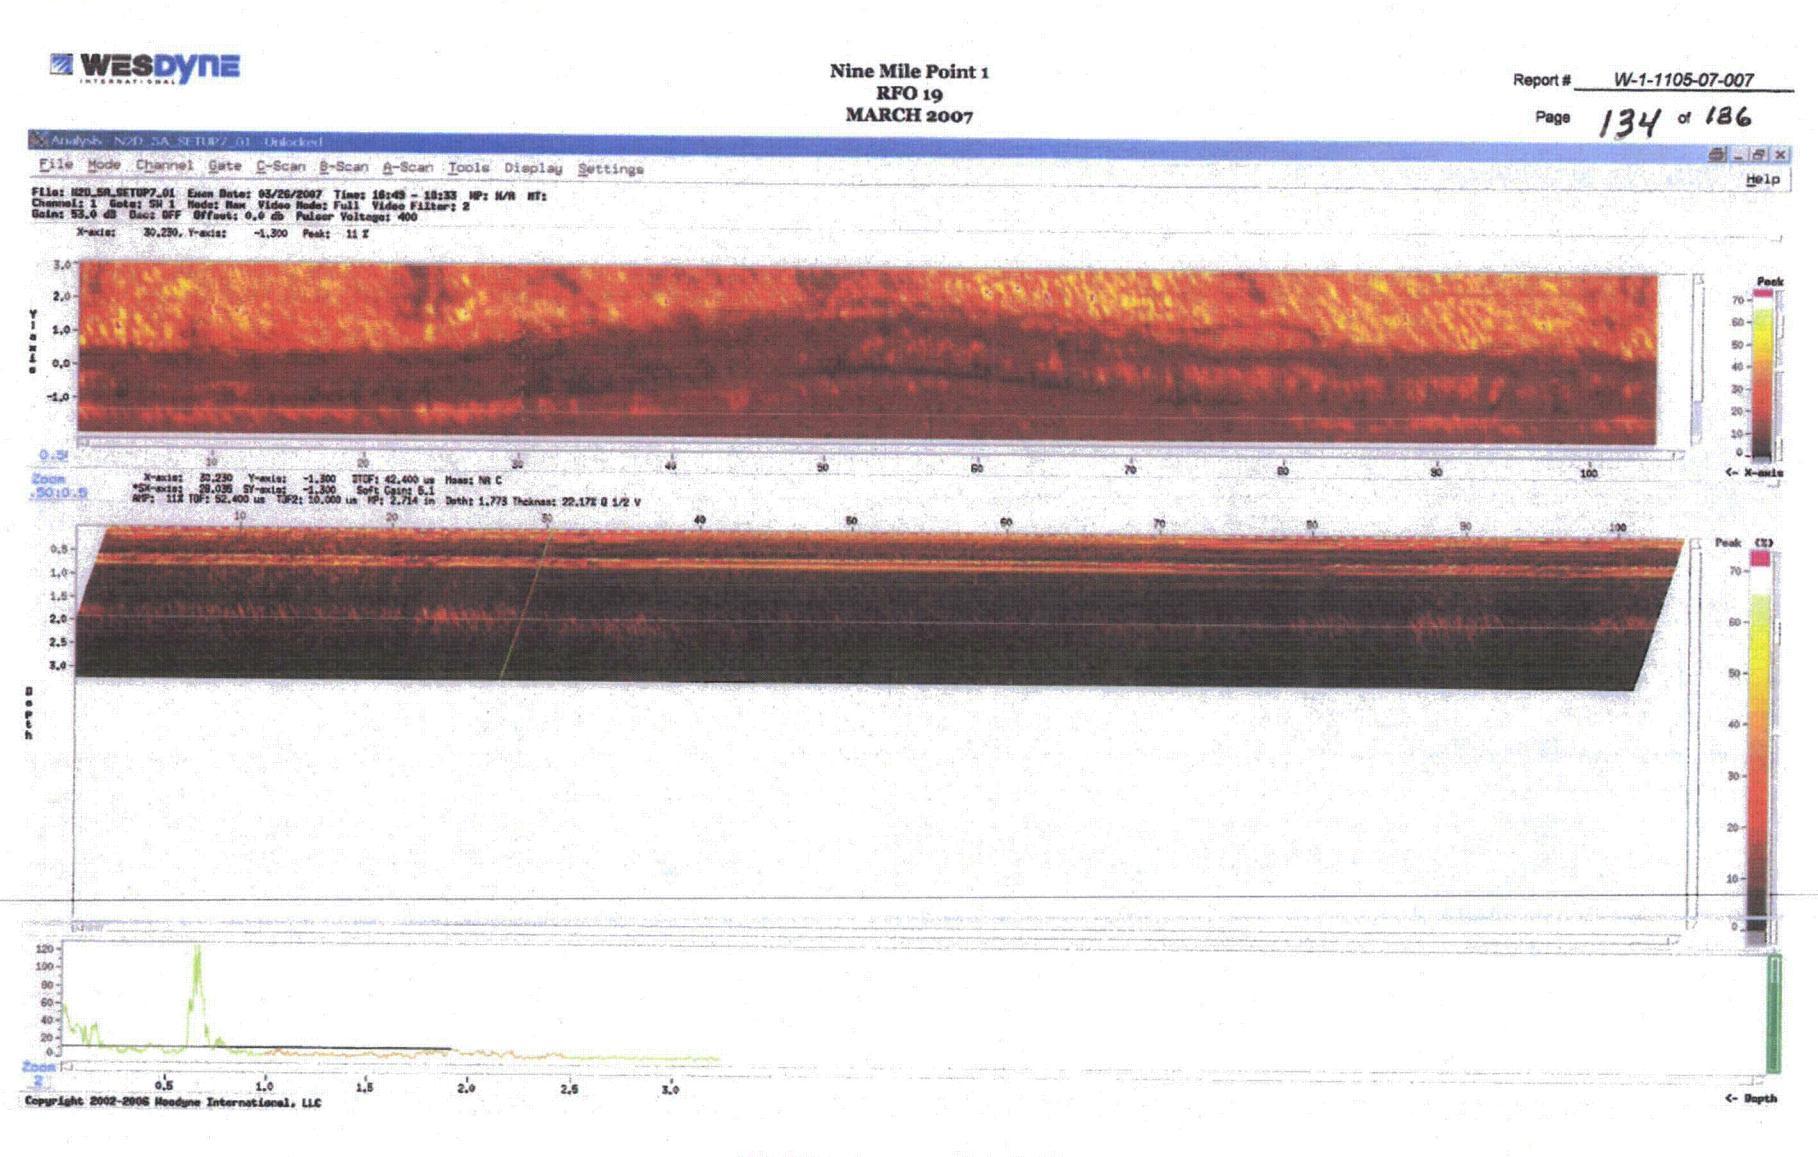
NRI - B-Scan shows area of Indication #1

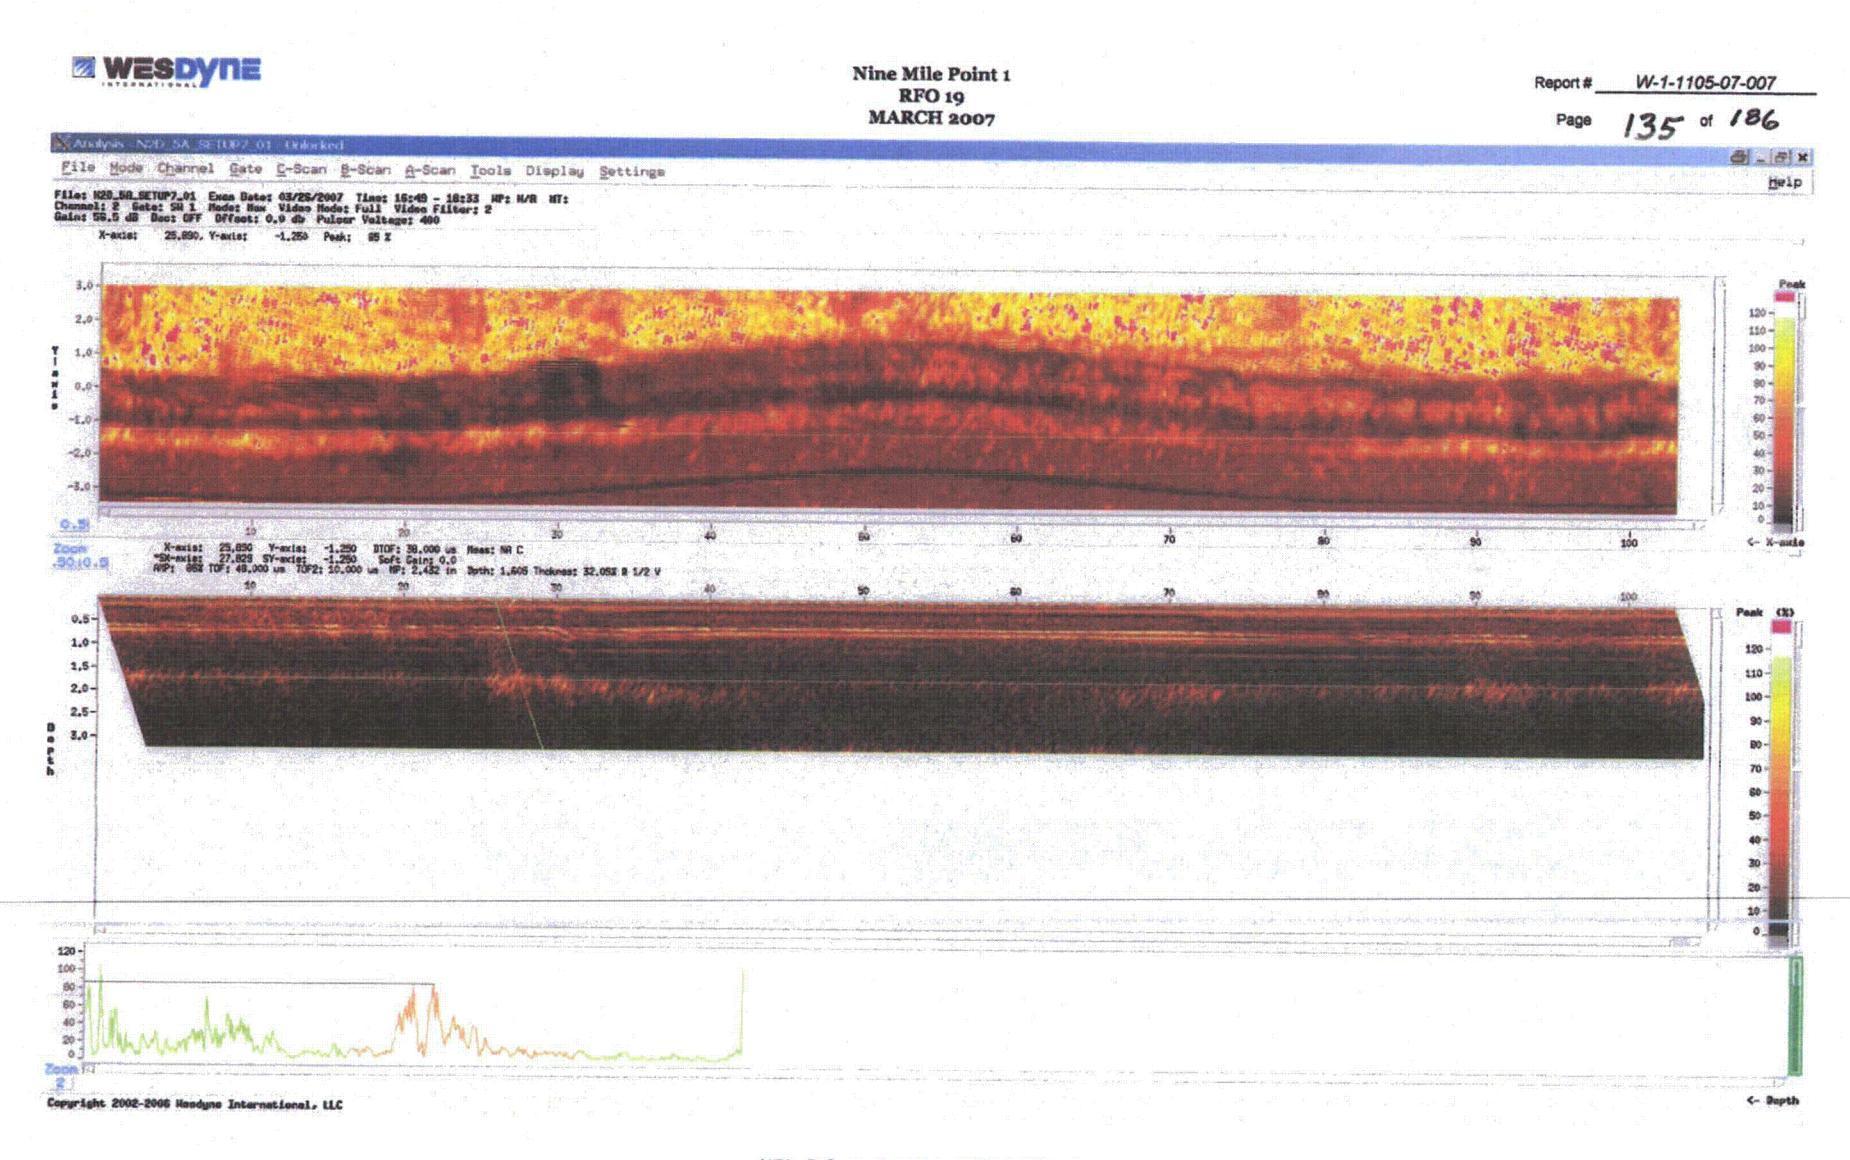
NRI - B-Scan shows area of Indication #1
