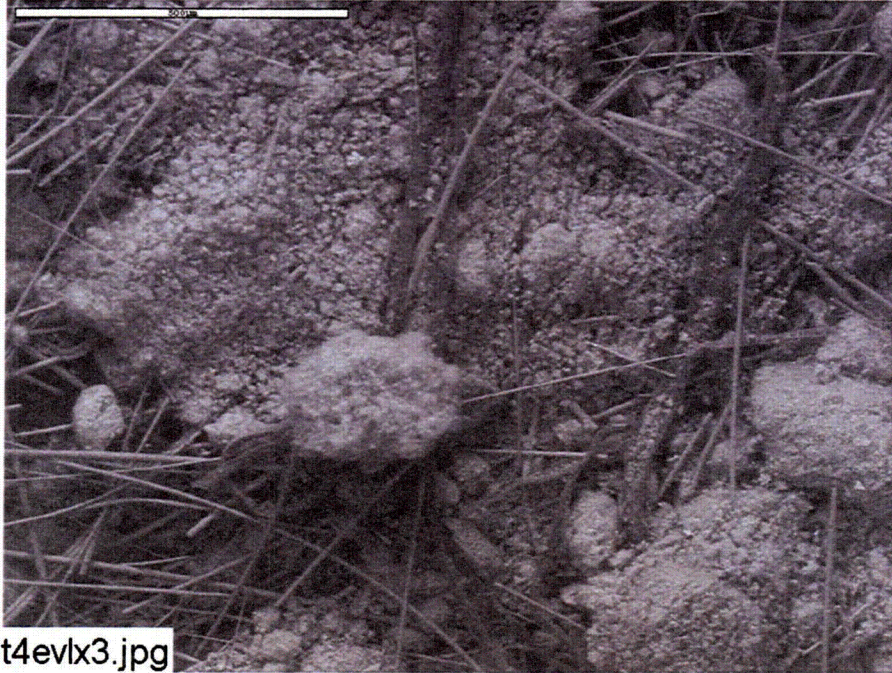
t4evlx3.jpg

Compared to other Day-30 low-flow fiberglass samples, a significant amount of particulate deposits was observed on the exterior of the Day-30 low-flow samples in the big envelope. The big envelope sat on the tank bottom and was in contact with the test sediment on the bottom of the envelope. Figure 3-120 shows the sediment after the samples were lifted out of the tank. However, no particulate deposits were observed on the fiberglass interior. In addition, some large flat fibers were found on the exterior fiberglass samples (see Figure 3-51). These large flat fibers were likely from cal-sil (see Appendix D). It is possible that the particulate deposits and cal-sil fibers were physically attached/retained on the exterior of the fiberglass samples. Figures 3-50 through 3-53 show the results from the Day-30 low-flow fiberglass enclosed in the big envelope. In contrast to other samples, these samples were gently rinsed with RO water and no film was found on either the exterior or the interior of the fiberglass. The disappearance of the film is likely caused by the rinse of RO water to keep the sample moist before ESEM analysis. Based on the control experiment noted earlier (see Appendix C4), the film is soluble.

Figure 3-50. ESEM image magnified 100 times for a Test #4, Day-30 exterior low-flow fiberglass sample in a big envelope. (t4evlx3.jpg)

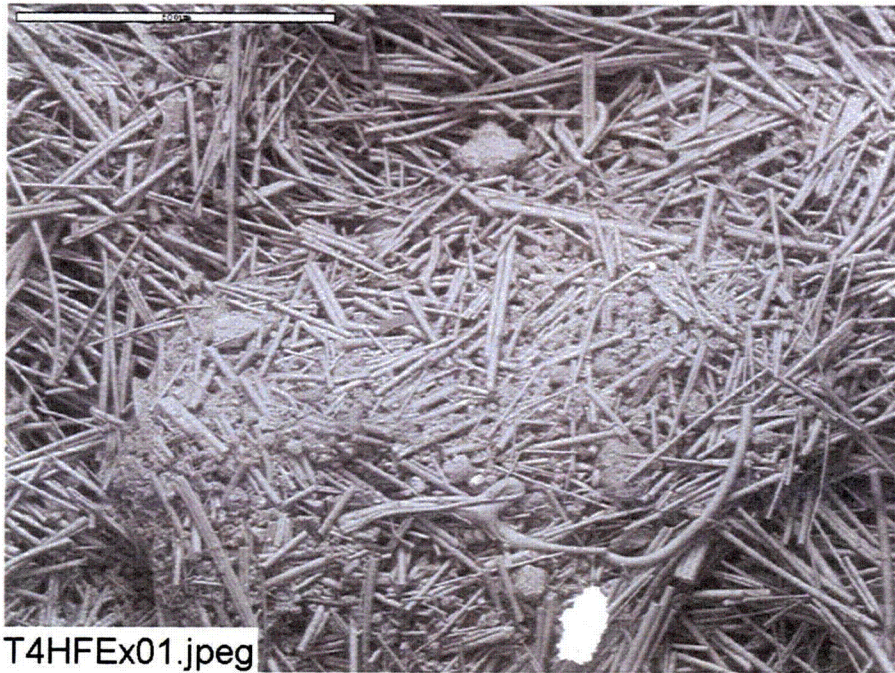
Compared to Day-30 low-flow fiberglass samples, a significant amount of particulate deposits and fiberglass debris were found on high-flow exterior samples. However, no particulate deposits were found on the interior. This result suggests that these particulate deposits were physically attached/retained on the fiberglass exterior. However, similar film deposits were found on both of the fiberglass exterior and the interior. The EDS result shows the film was composed of O, Na, Ca, C, Mg, Al, K, and possibly Si, which is similar to other EDS results. Figures 3-54 through 3-61 show the Day-30 high-flow fiberglass results. Figures 3-60 and 3-61 show fiberglass after it was rinsed with RO water.

Figure 3-54. ESEM image magnified 100 times for a Test #4, Day-30 exterior high-flow fiberglass sample. (T4HFEx01.jpg)

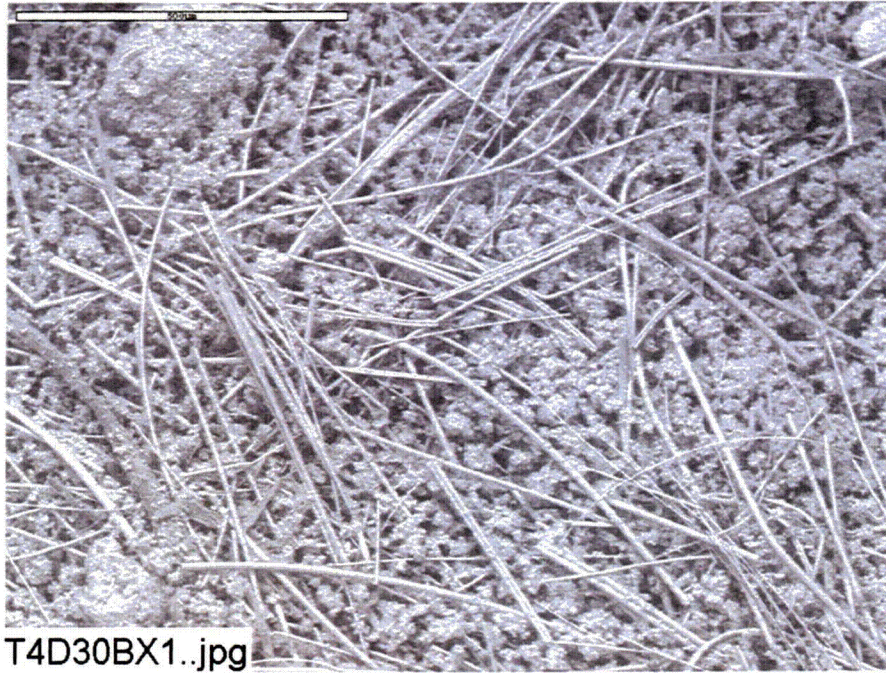
T4D30BX1..jpg

For the Day-30 fiberglass sample within the birdcage, the SEM images indicate a significant amount of particulate deposits (see Figure 3-80) on the exterior of the fiberglass. The location of the birdcage was on top of a large cal-sil sample that sat on the bottom of the tank and was in direct contact with the sediment. The birdcage, however, was not in direct contact with the sediment. The amount of particulate deposits was greater than the amounts on the high- and low-flow fiberglass samples, but less than the drain collar exterior. The EDS result shows that the particulate deposits were composed of O, Si, Ca, Na, Al, and C, which is consistent with the drain collar exterior. Again, the high content of Si and Ca suggests these particulate deposits were from cal-sil debris. Compared to the exterior, the interior sample was relatively clean. Only film deposits were found. These film deposits were similar to the observed high- and low-flow fiberglass samples, which were likely caused by chemical precipitation during the drying process. Again, this result suggests that almost all of the particulate deposits were physically retained at the fiberglass exterior, consistent with Day-30 high-flow and drain collar fiberglass samples. Figures 3-80 through 3-85 show the birdcage fiberglass results.

Figure 3-80. ESEM image magnified 100 times for a Test #4, Day-30 exterior fiberglass sample within the birdcage. (T4D30BX1.jpg)

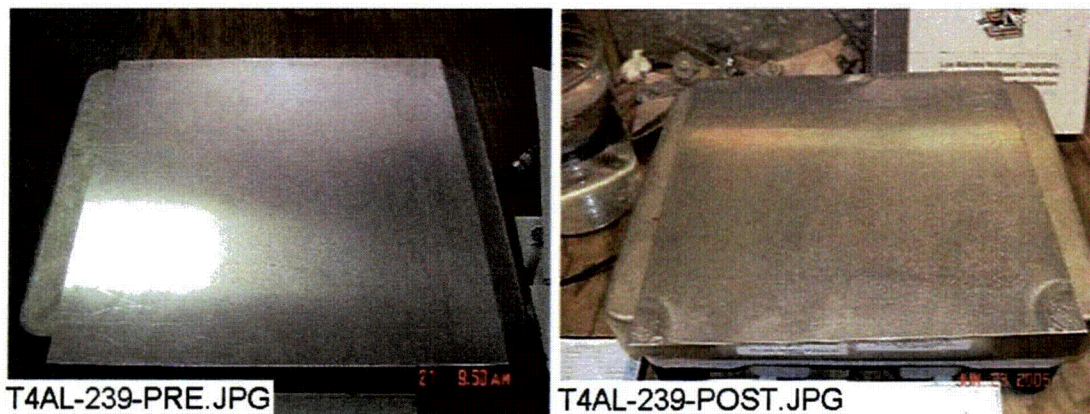
There are three submerged aluminum coupons in each test. Figures 3-98 through 3-100 display the pre- and post-test pictures of those coupons that were in Test #4. The relative locations of the aluminum coupons from east to west of the tank are: Al-239, Al-238, and Al-237. Al-239 and Al-238 were the two aluminum coupons that were isolated next to the concrete coupon. There were no visual differences between the three coupons after they were removed from the tank. The overall appearance of the aluminum coupons did not significantly change from their pre-test appearance. The post-test coupons appeared to have a light film on them and had lost their pre-test shiny appearance.

Figure 3-100. Al-239 submerged, pre-test (left) and post-test (right).

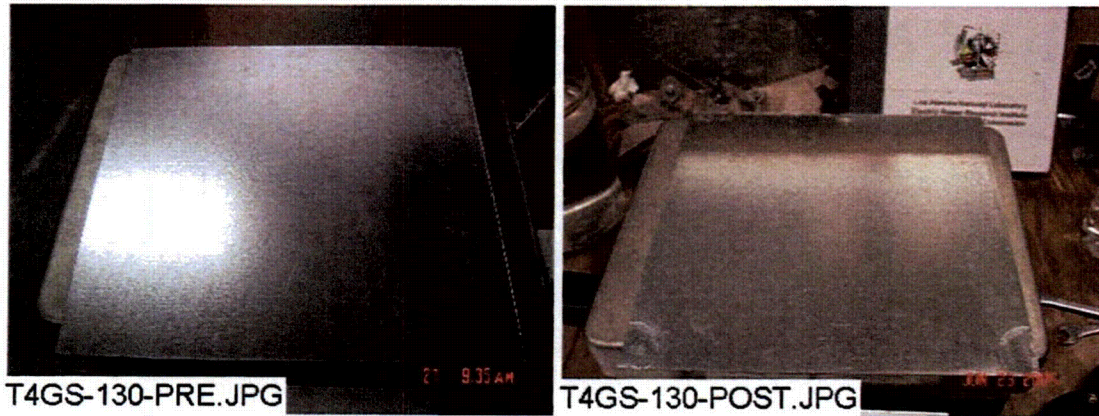
Figures 3-101 through 3-103 present the pre- and post-test pictures of three submerged galvanized steel coupons. The galvanized steel coupons did not experience any significant observable change. The coupons appeared to be relatively clean and the only noticeable marks of any sort are the circular marks caused by the racks that they are mounted in. GS-130 does appear to have some particle deposition that is concentrated mainly on the bottom corners and on the top where the coupon resides in the rack.

Figure 3-101. GS-130 submerged, pre-test (left) and post-test (right).

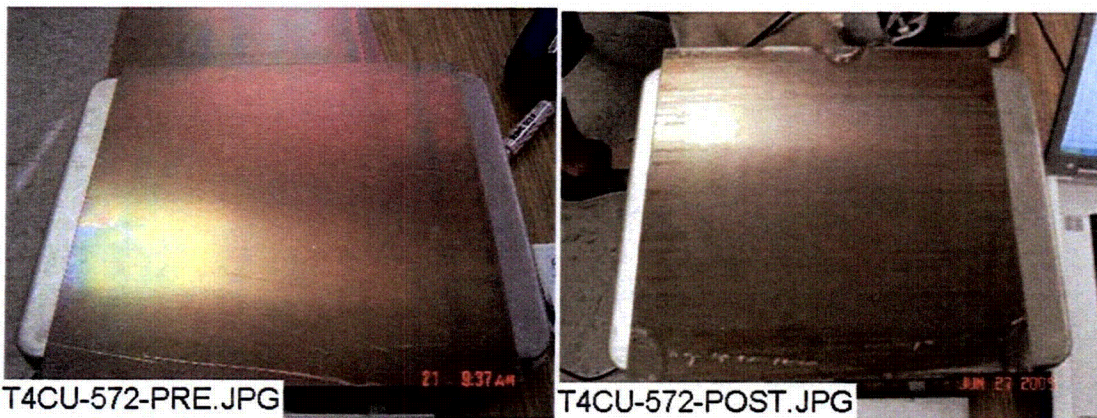
Figures 3-106 and 3-107 present the pre- and post-test pictures of two submerged copper coupons. The copper coupons were mainly unchanged. Like the other coupons, there is a very light concentration of particulate deposits in the areas where the coupons contact the rack.

Figure 3-107. Cu-572 submerged, pre-test (left) and post-test (right).

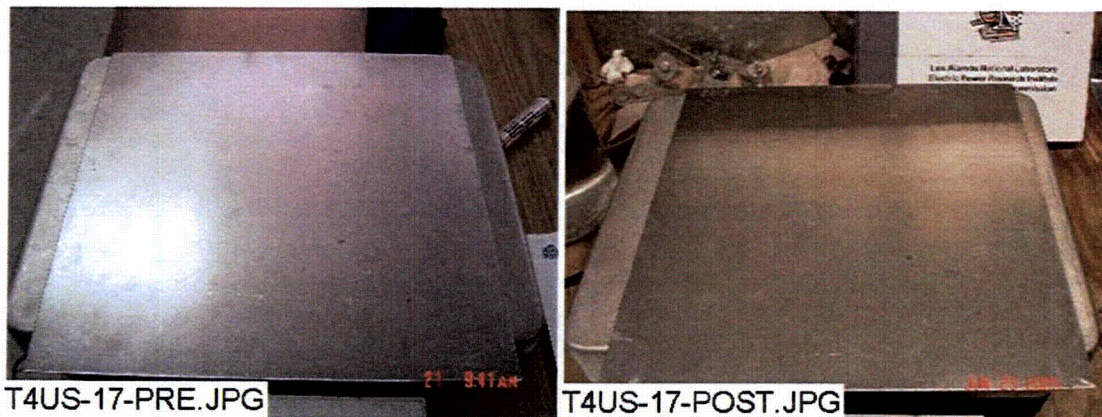
Figure 3-108 presents the pre- and post-test pictures of the submerged carbon steel coupon. Other than some discoloration, there was no change. There was a small amount of rust on the bottom corners.

Figure 3-108. US-17 submerged, pre-test (left) and post-test (right).

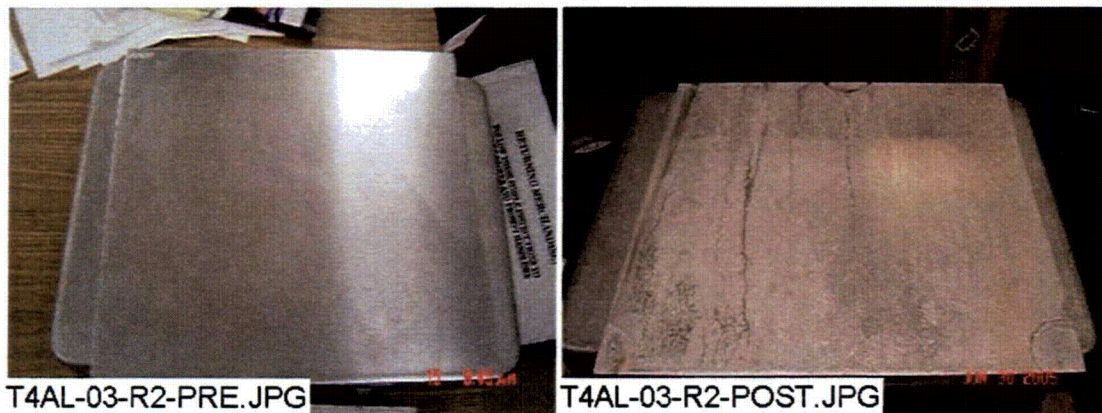
Figures 3-110 and 3-111 show the pre- and post-test pictures of two unsubmerged aluminum coupons. Each unsubmerged aluminum coupon accumulated a white particle deposition along with some areas of a brownish color. This coating caused the surface of the aluminum coupons to become coarse and rough. The photo of Al-229 shows that most of the surface is coated with the particle deposition, however, in the upper right hand corner the surface is relatively smooth with a color change observable. This is likely caused by uneven spray on the coupons. Even though the four spray nozzles were set to spray uniformly across their spray radius, the spray was not a perfect mist. There were some non-uniform areas, and the positions of the six coupon racks also interfered with the sprays. Al-003 was loaded in Rack 2 (bottom tier, southernmost), and Al-229 was loaded in Rack 7 (upper tier, northernmost).

Figure 3-110. Al-003 unsubmerged, pre-test (left) and post-test (right).

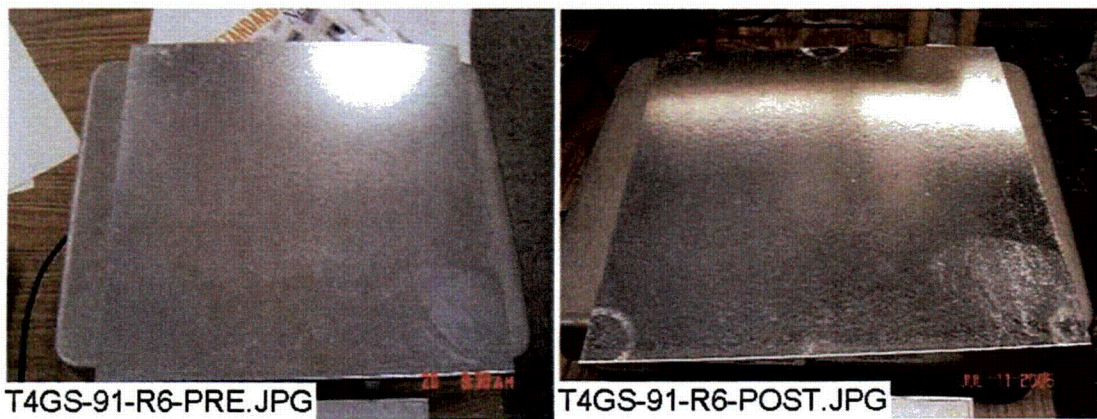
Figures 3-112 and 3-113 show the pre- and post-test pictures of two unsubmerged galvanized steel coupons. There was some white deposition on the surface of these coupons although it was in small amounts. The post-test coupons were relatively clean,

with little change. GS-33 was mounted in Rack 3 (bottom tier, middle rack), and GS-91 was mounted in Rack 6 (upper tier, middle rack).

Figure 3-113. GS-91 unsubmerged, pre-test (left) and post-test (right).

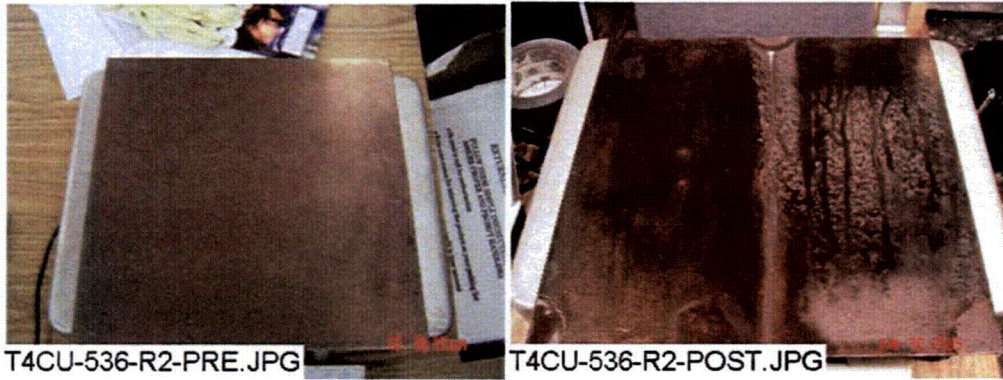
Figures 3-114 and 3-115 present the pre- and post-test pictures of two unsubmerged copper coupons. All of the copper coupons had vertical water marks that were caused by water flowing downward on the coupon surface during the spray portion of the test. The copper coupons did not appear to accumulate any particle deposition. Cu-536 was mounted in Rack 2 (bottom tier, southernmost), and Cu-584 was mounted in Rack 7 (upper tier, northernmost).

Figure 3-114. Cu-536 unsubmerged, pre-test (left) and post-test (right).

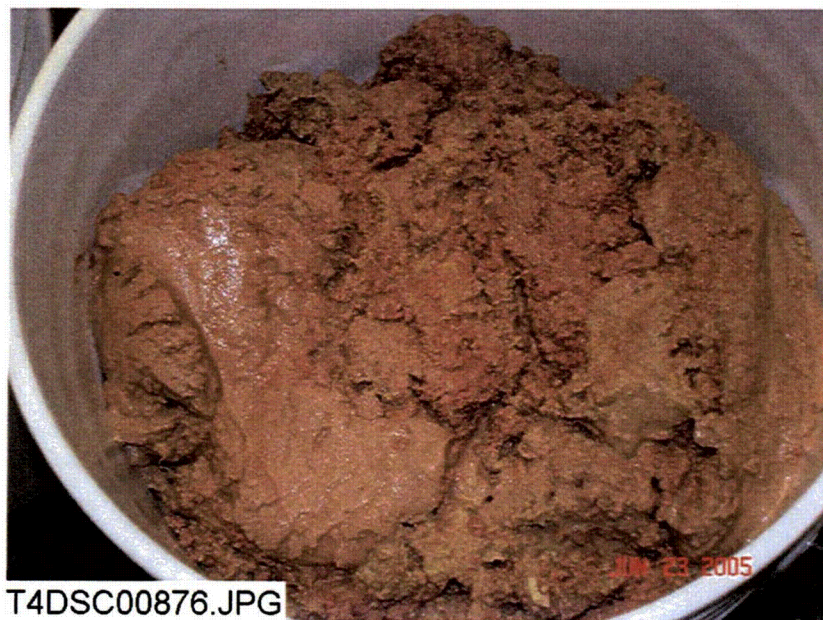
Figure 3-119. Sediment removed from the tank.

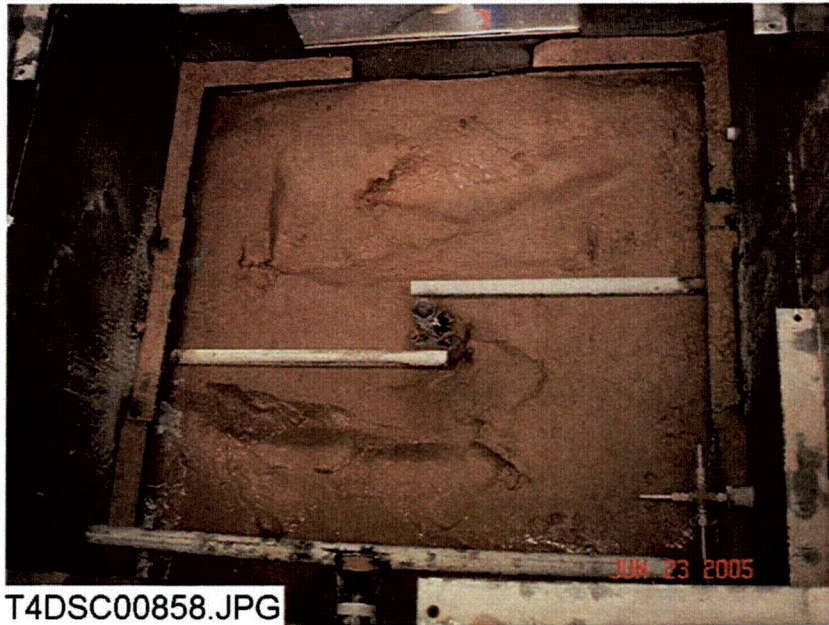
Figure 3-120. Sediment on the tank bottom.

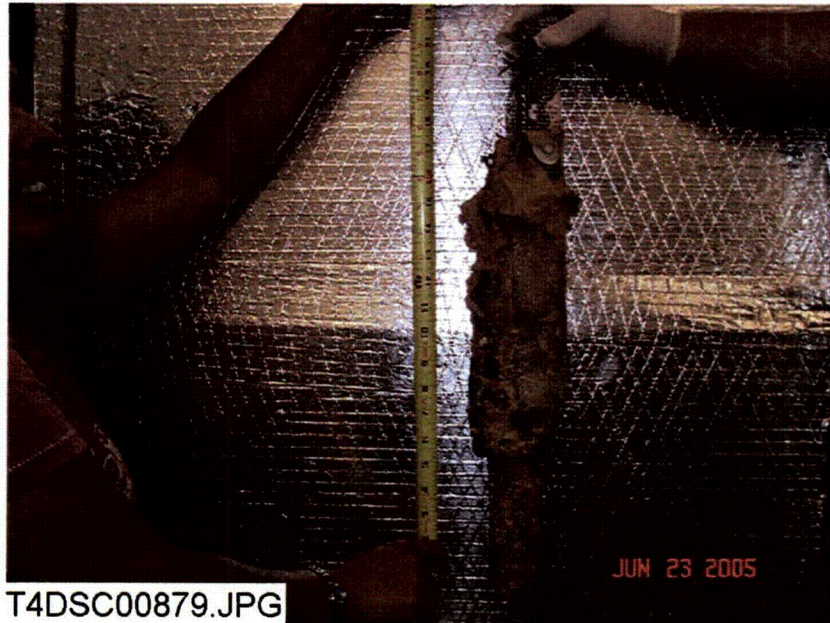
Figure 3-122. Drain collar and drain screen removed from the tank.

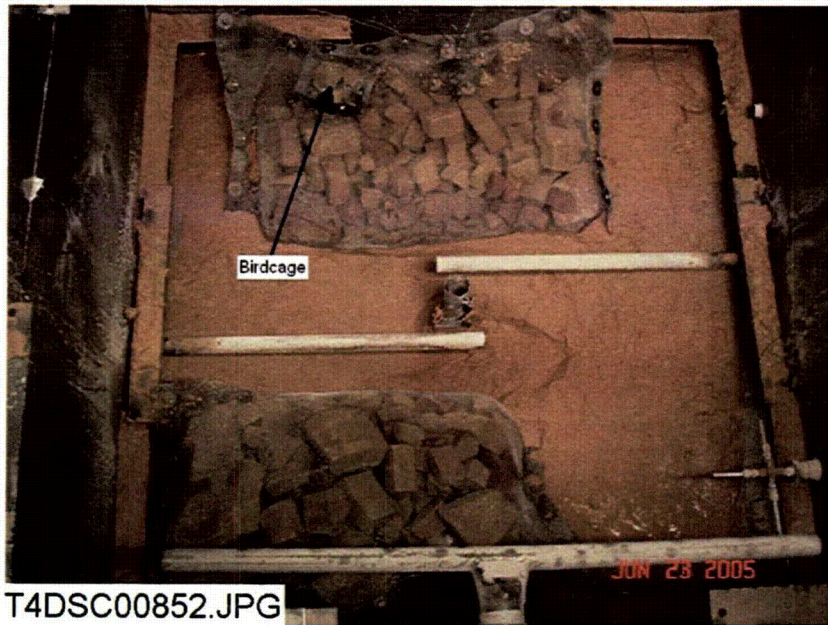
Figure 3-123. Birdcage and cal-sil baskets after the tank was drained.

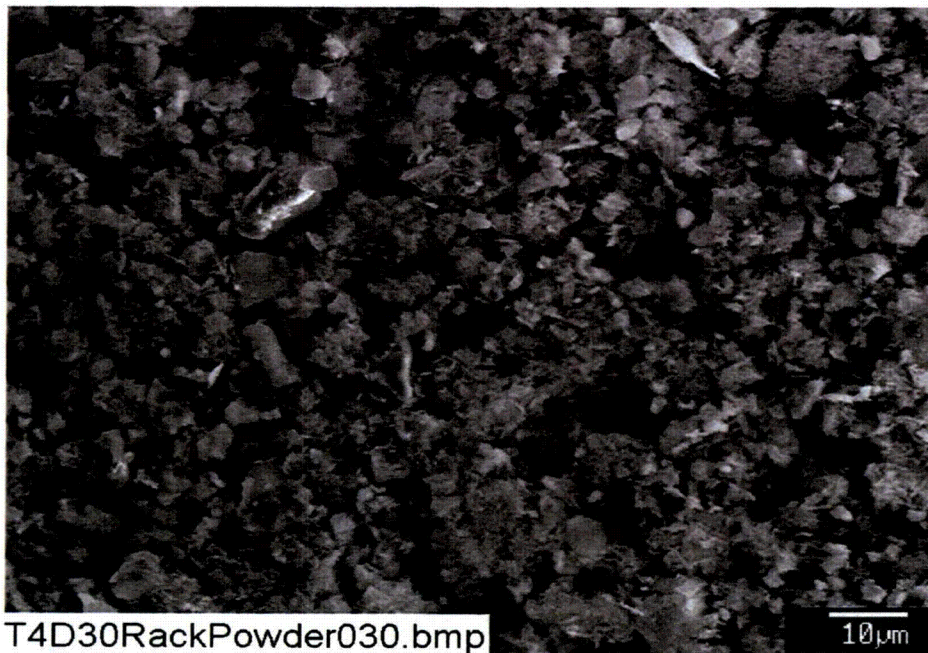
The deposition of debris/corrosion products in the tank after it was drained was observed on the submerged objects in the tank. These corrosion/deposition products, which looked like a fine powder, were collected for analysis. Those collected were from the submerged CPVC coupon rack. SEM/ EDS results indicated that these fine powders were mainly composed of O, Ca, Si, Na, Al, and C. The high content of Ca and Si suggests that the powders were likely from cal-sil and fiberglass debris.

Figure 3-130. SEM image magnified 1000 times for a Test #4, Day-30 fine powder on the submerged rack. (T4D30RackPowder030.bmp)
