U.S. Department of Energy Office of Legacy Management

2004 Annual Site Inspection and **Monitoring Report for Uranium Mill Tailings Radiation Control Act Title I Disposal Sites**

December 2004

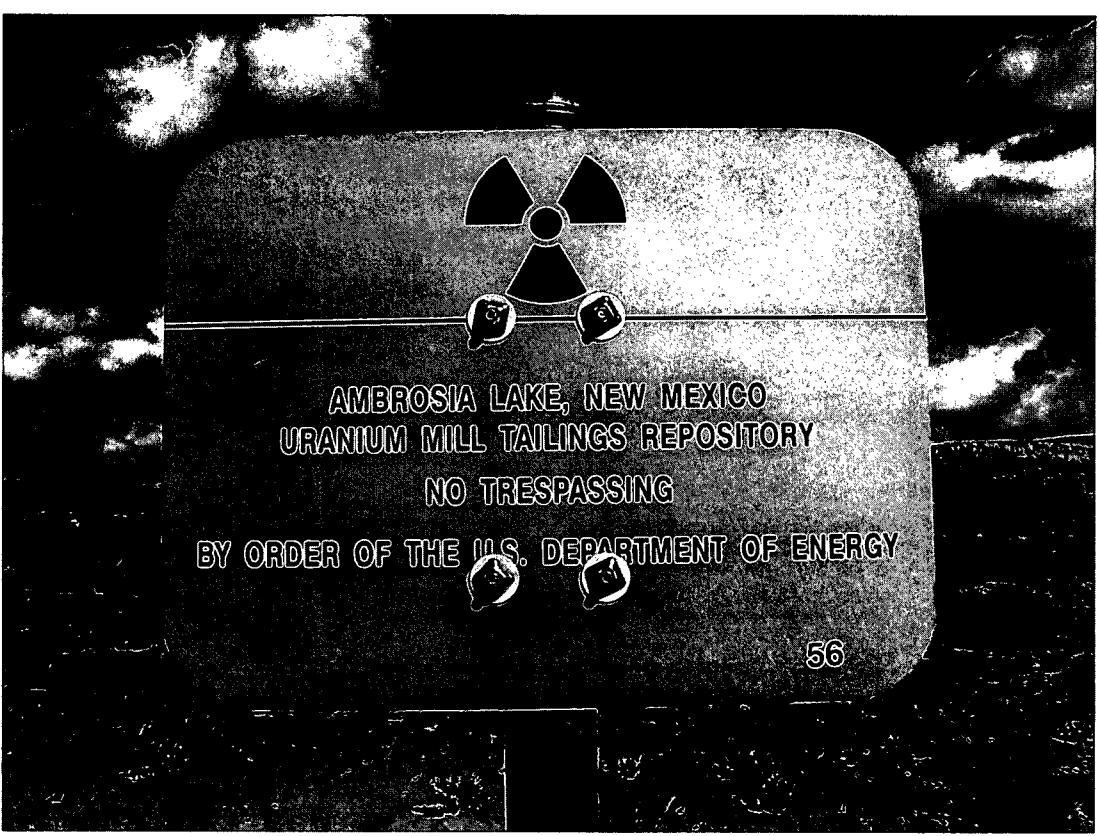
The entrance and all perimeter signs were in good condition (PL-1). Wind has eroded sandy soil from around the base of perimeter sign P12, but the post is stable. Posts for perimeter signs P1 through P10 include mining restriction warning signs.

AMB 9/2004. PL-1. Perimeter sign P56 near the southeast corner of the disposal cell.

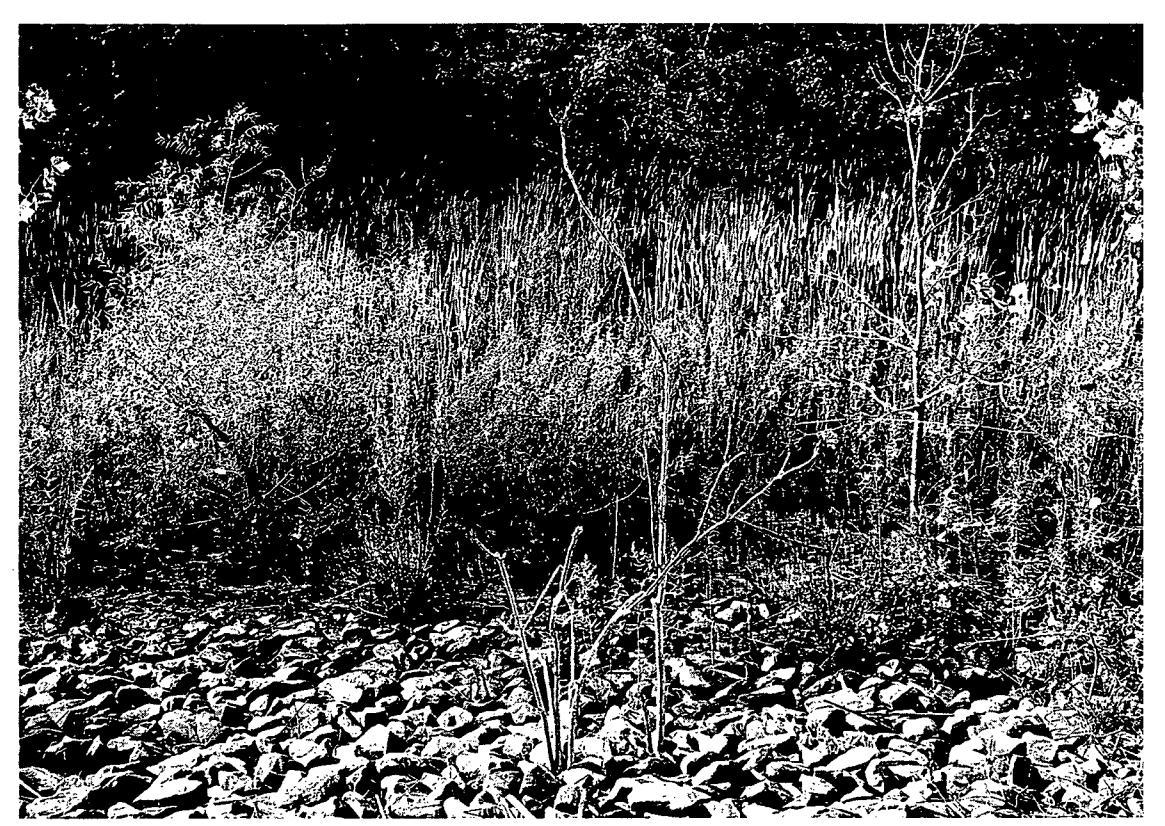
BUR 9/2004. PL-2. Standing water and flood watermarks on the plants in the slough.

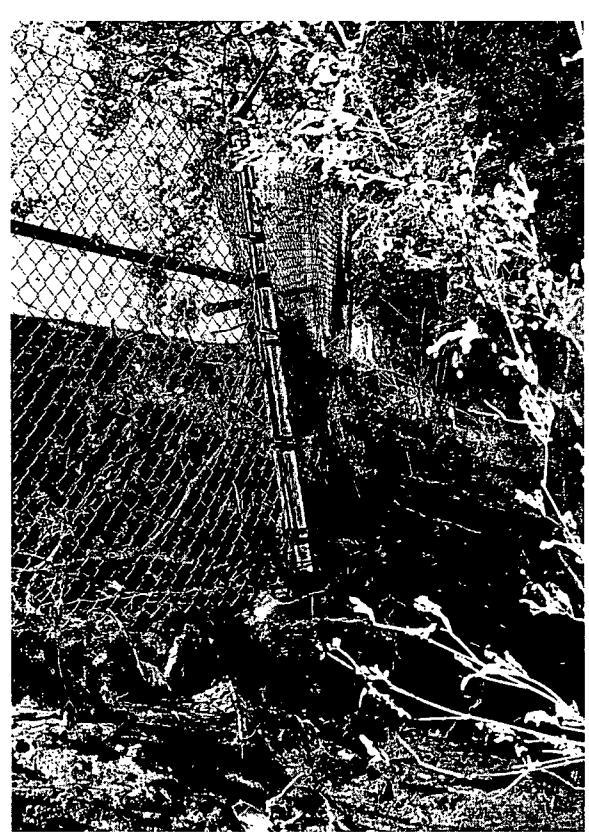
CAN 9/2004. PL-1. Damaged fence corner post caused by flooding.

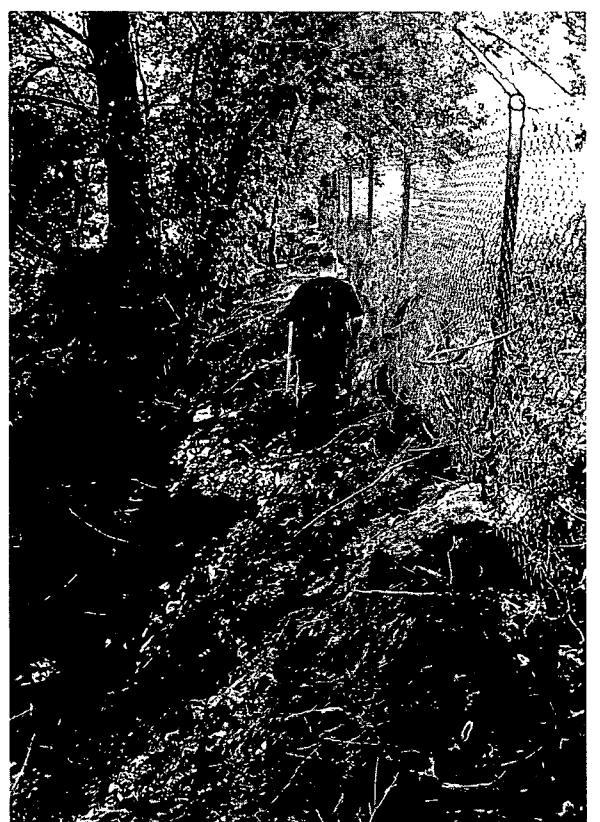
CAN 9/2004. PL–2. Stream bank erosion along the north fence line.

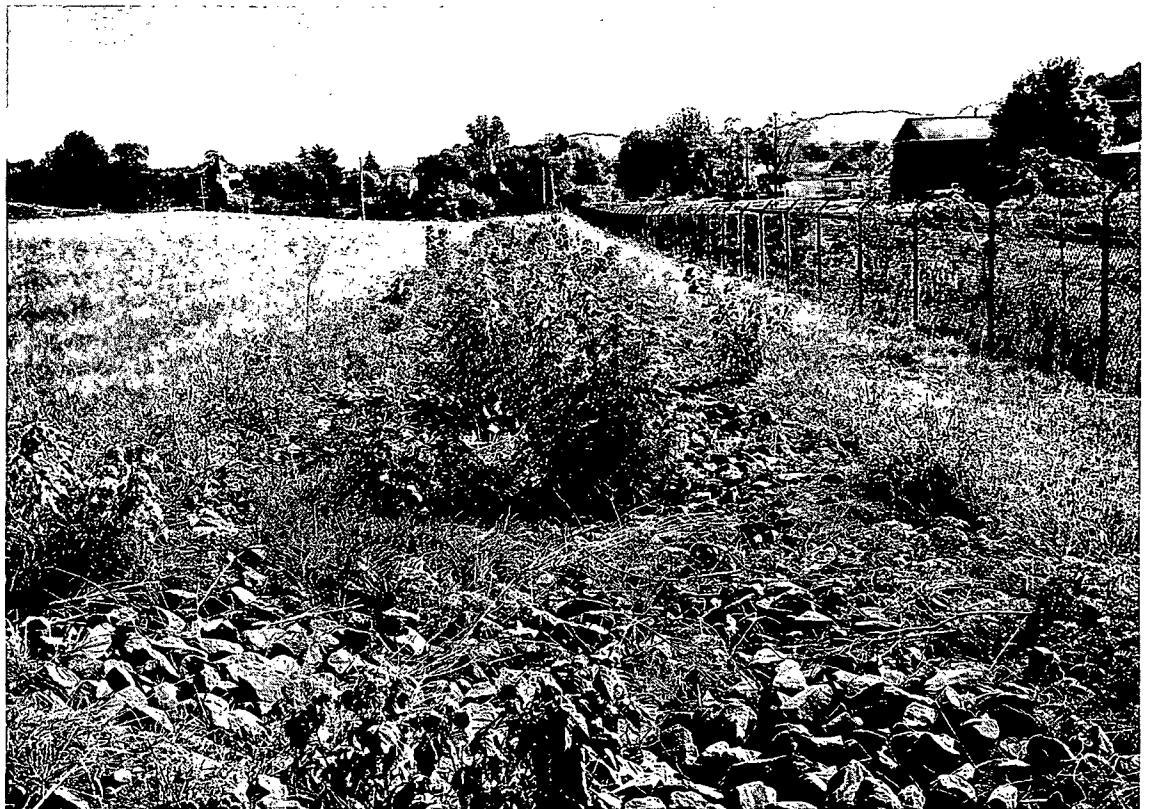
CAN 9/2004. PL–3. Vegetation encroachment in the perimeter ditch along the south property boundary.

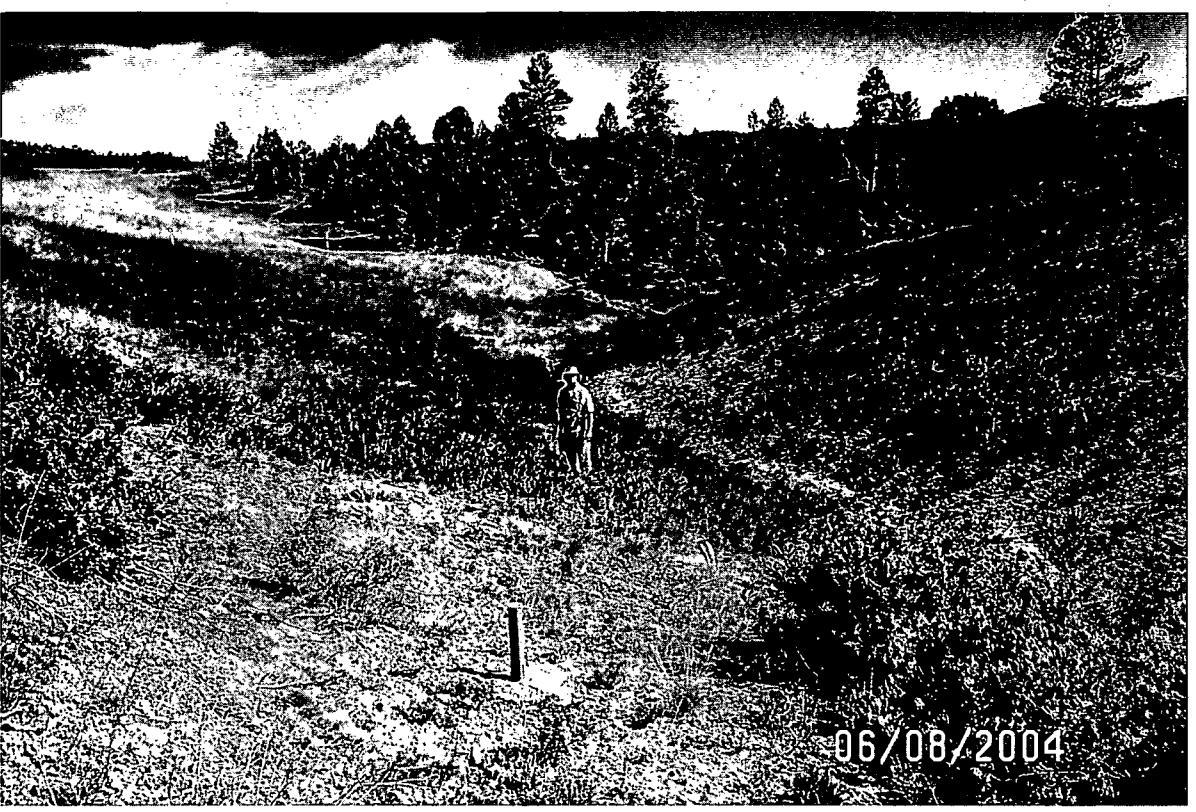
DUR 6/2004. PL-1. Inspector marks the location of missing boundary monument BM-6; the north witness corner is in the foreground.

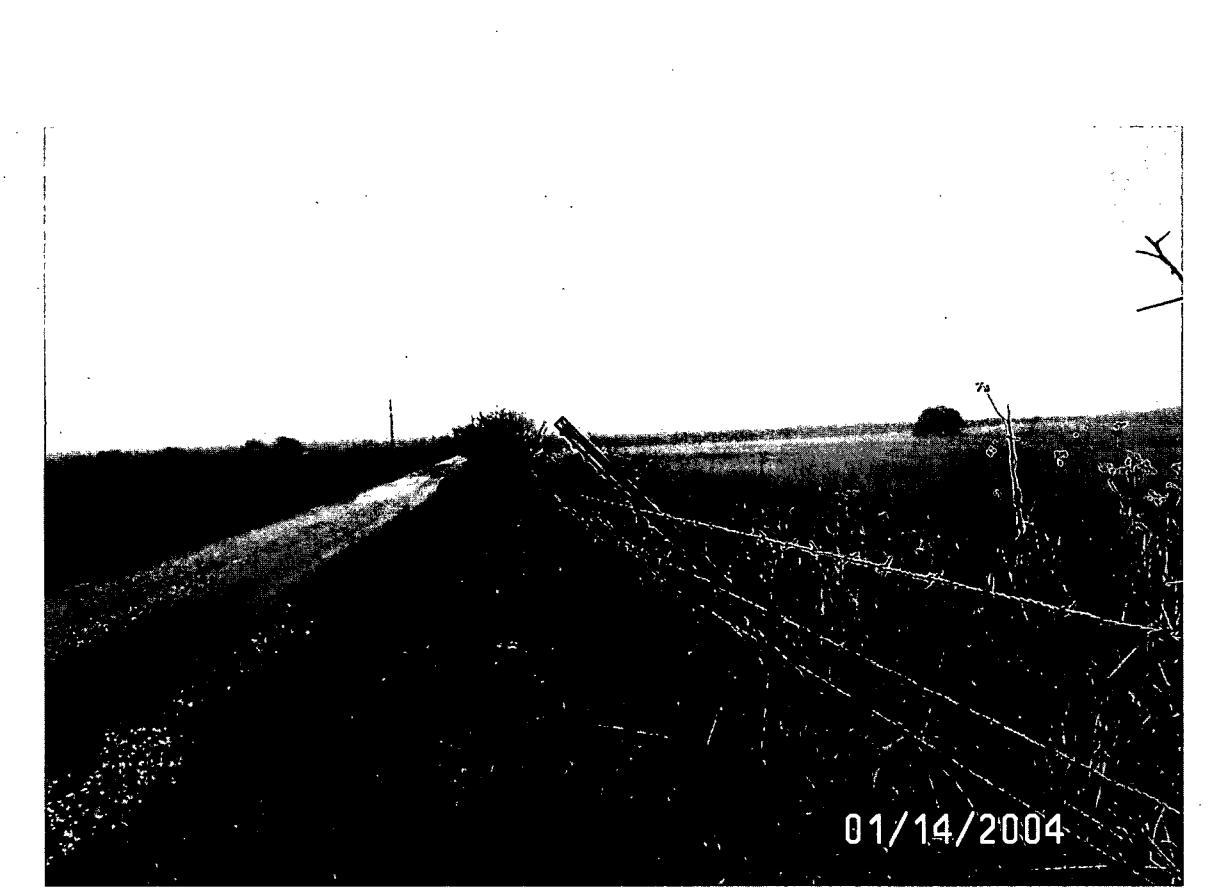
FCT 1/2004. PL–1. Section of perimeter fence leaning outward, located near perimeter sign P38 along County Road 202.

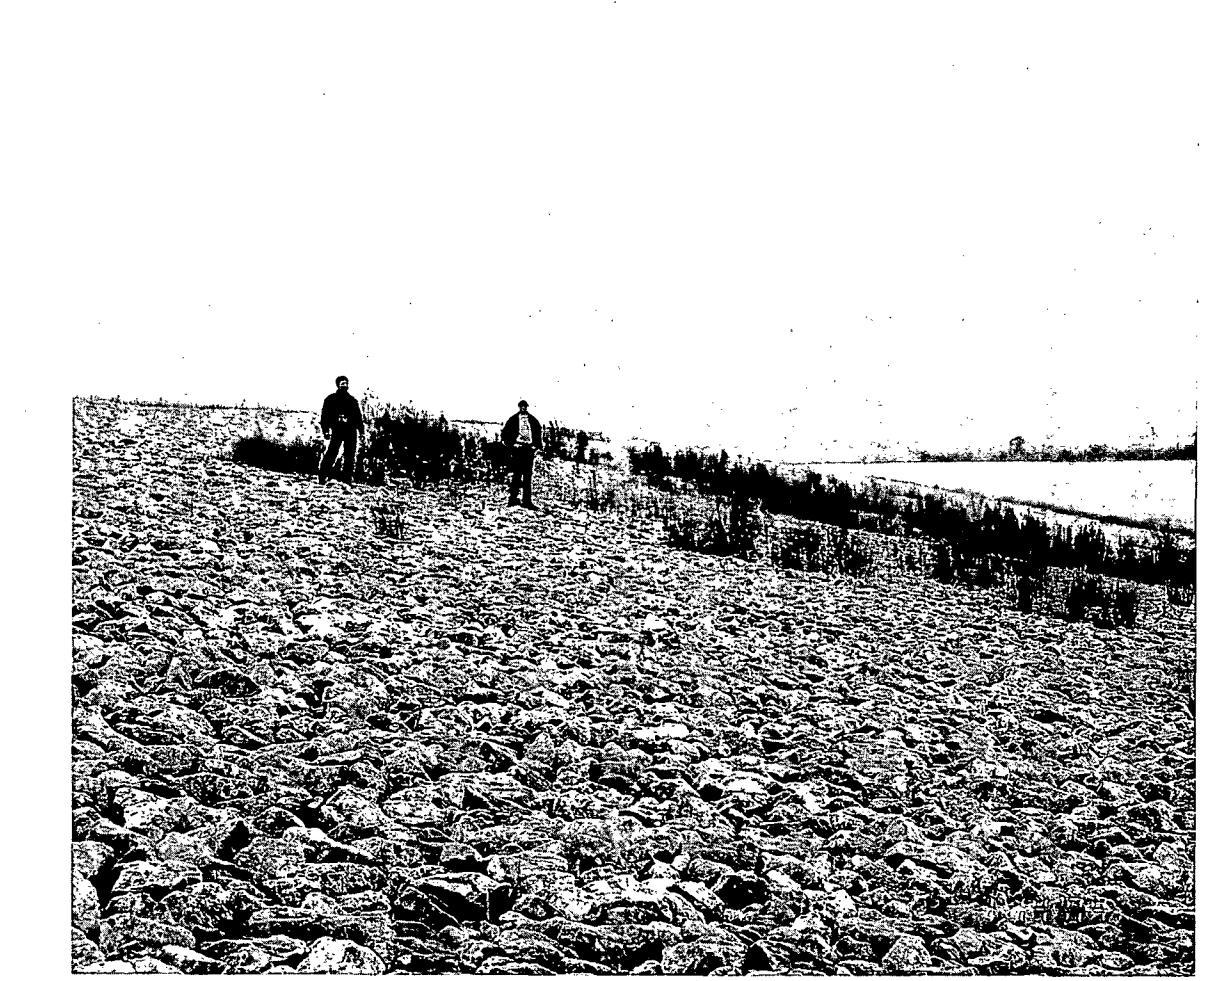
FCT 1/2004. PL-2. Typical vegetation growth found on the side slopes of the disposal cell.

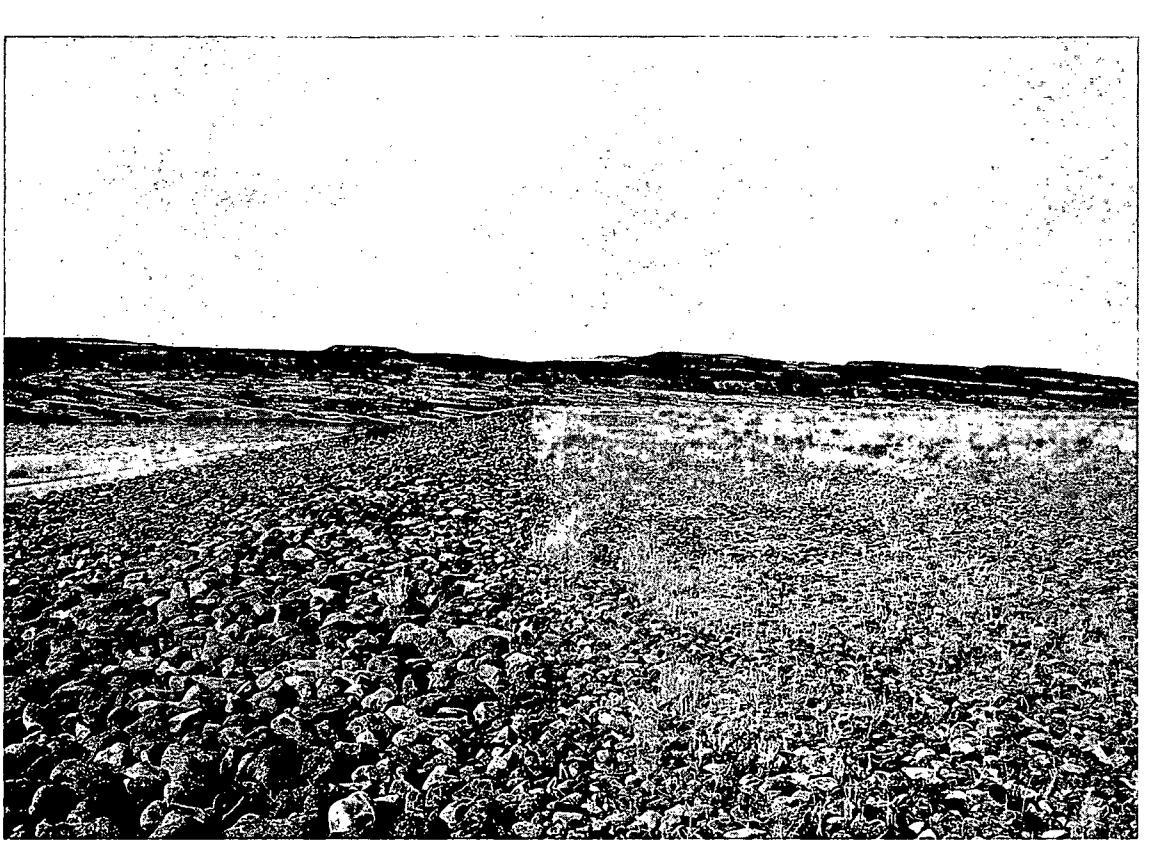
Minimal plant encroachment was observed on the side slopes. However, plant encroachment is occurring on the cell top, mostly on the southeastern part of the cell (PL-1). Deep-rooted plants,
6A which were cut back and treated with herbicide in 2001, potentially could change the performance characteristics of the radon/infiltration barrier. An investigation is underway by DOE to evaluate whether or not the deep-rooted vegetation needs to be controlled.

GRJ 3/2004. PL–1. Southern edge of the disposal cell cover and the south side slope showing the excellent condition of the rock cover and the distribution of vegetation.

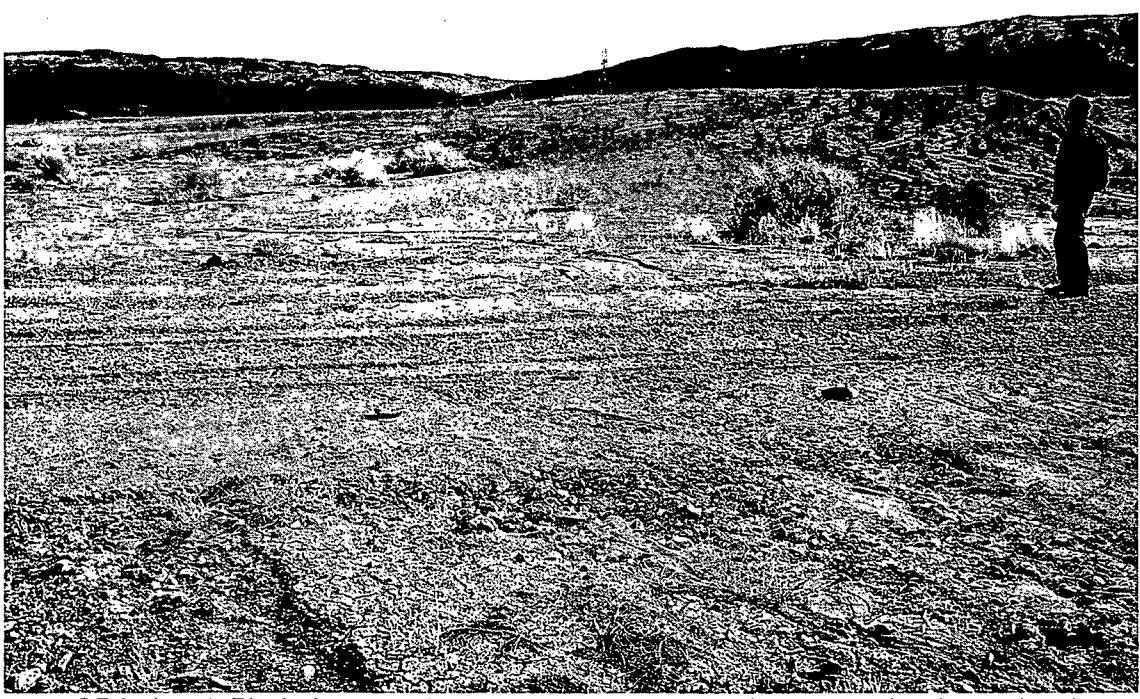
GRJ 3/2004. PL-2. An area where sediment-laden sheet flow crossed a site road and discharged into the adjacent south diversion channel.

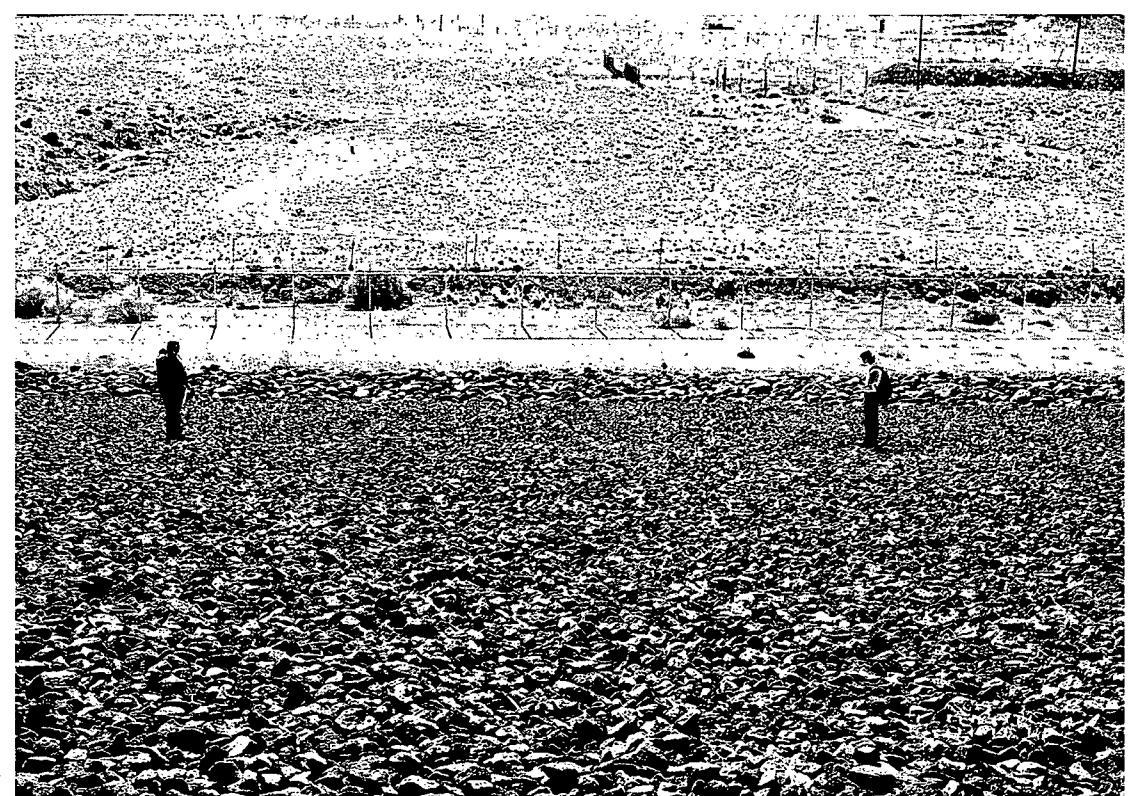
GRN 3/2004. PL-1. Inspectors standing in a slight depression area near the base of the southeast side slope of the disposal cell.

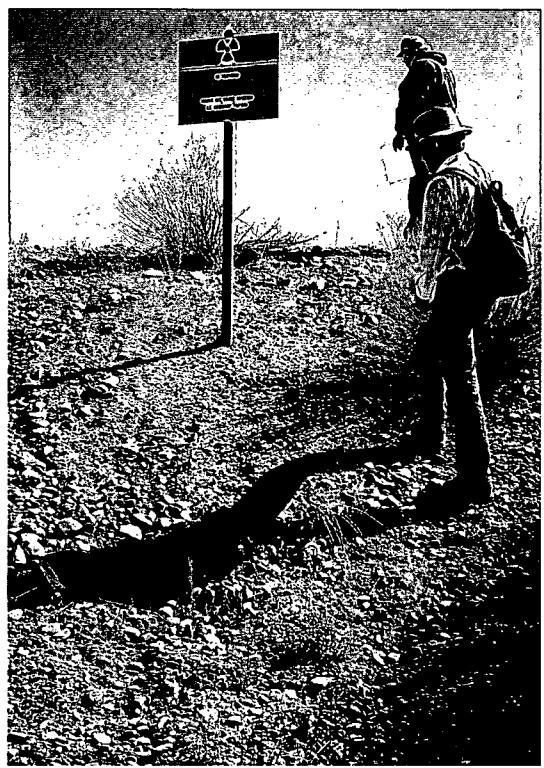
GRN 3/2004. PL–3. Repairs made to erosional rills at perimeter sign P4.

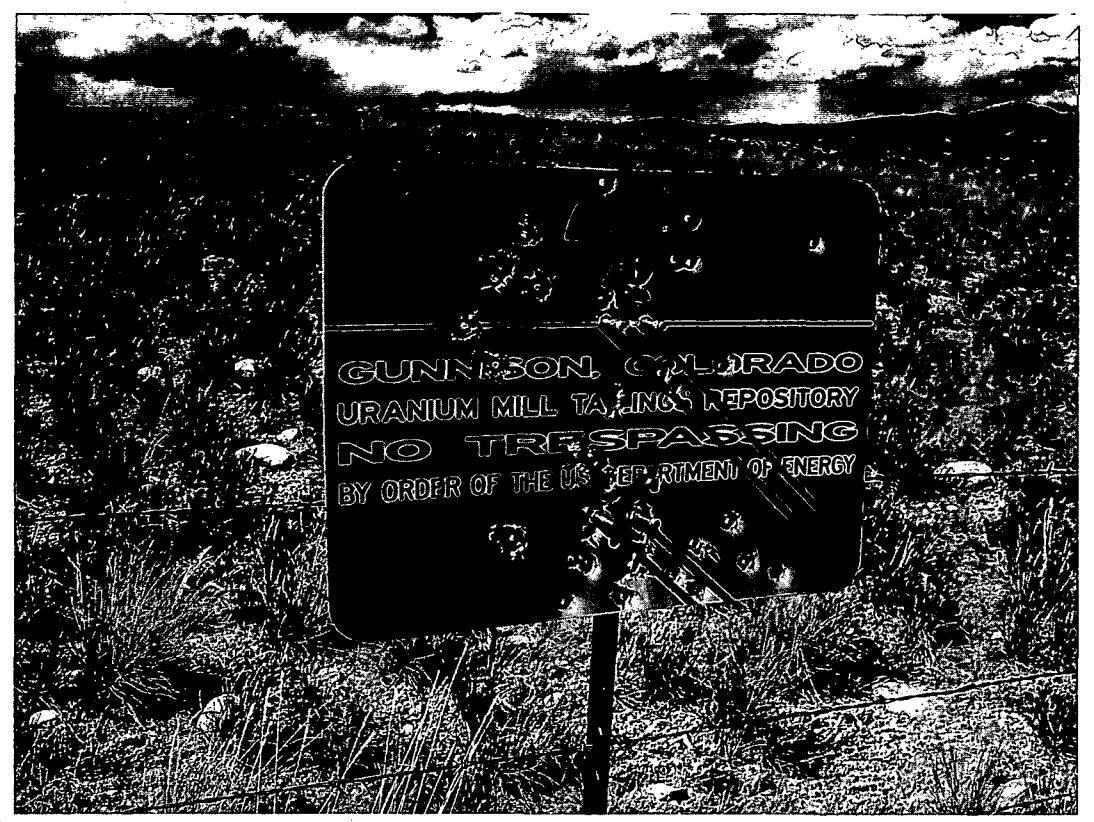
GUN 5/2004. PL-1. Damaged perimeter sign P41 near the site access road.

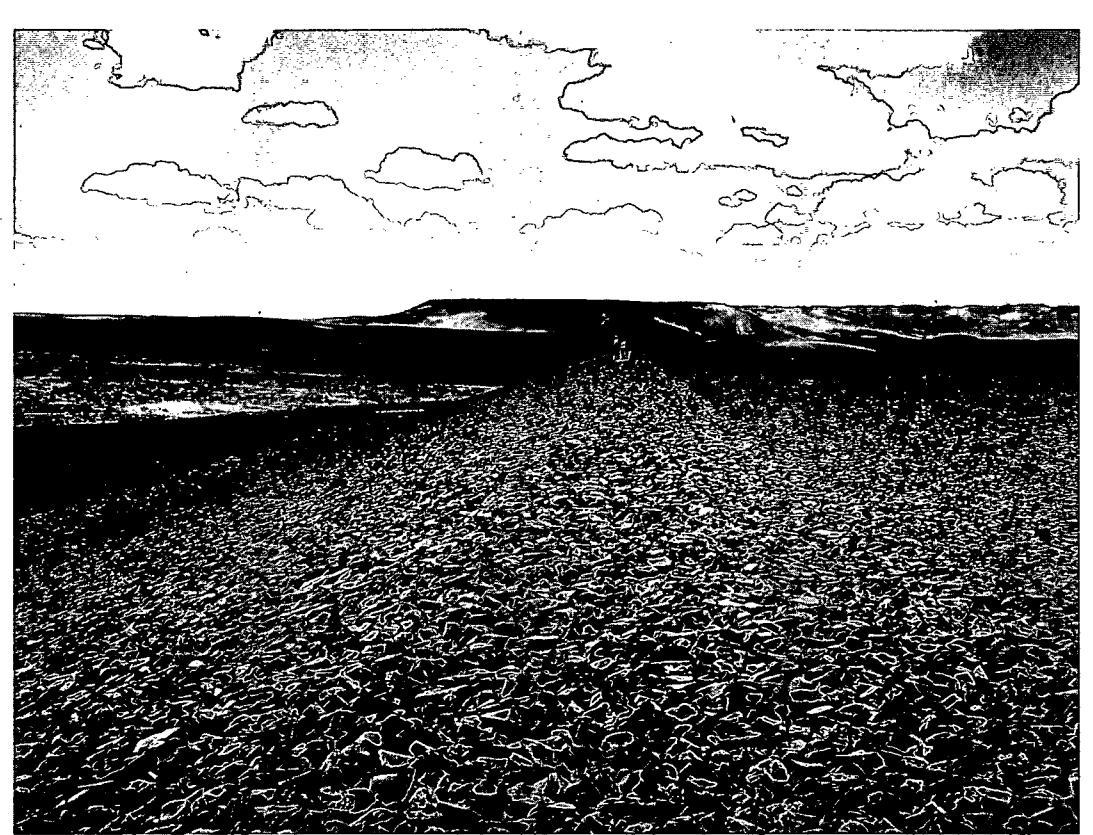
GUN 5/2004. PL-2. Southwest portion of the cell showing the excellent condition of the cell top and the southwest side slope.

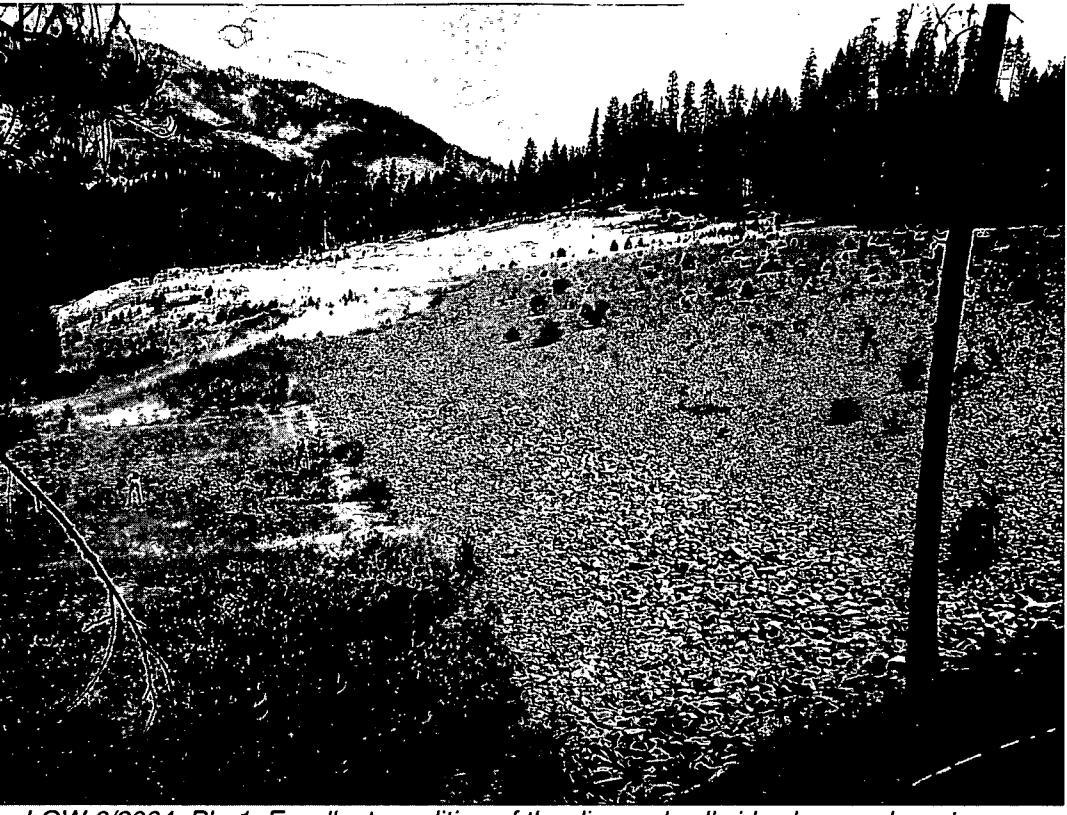
LOW 6/2004. PL-1. Excellent condition of the disposal cell side slope and west apron.

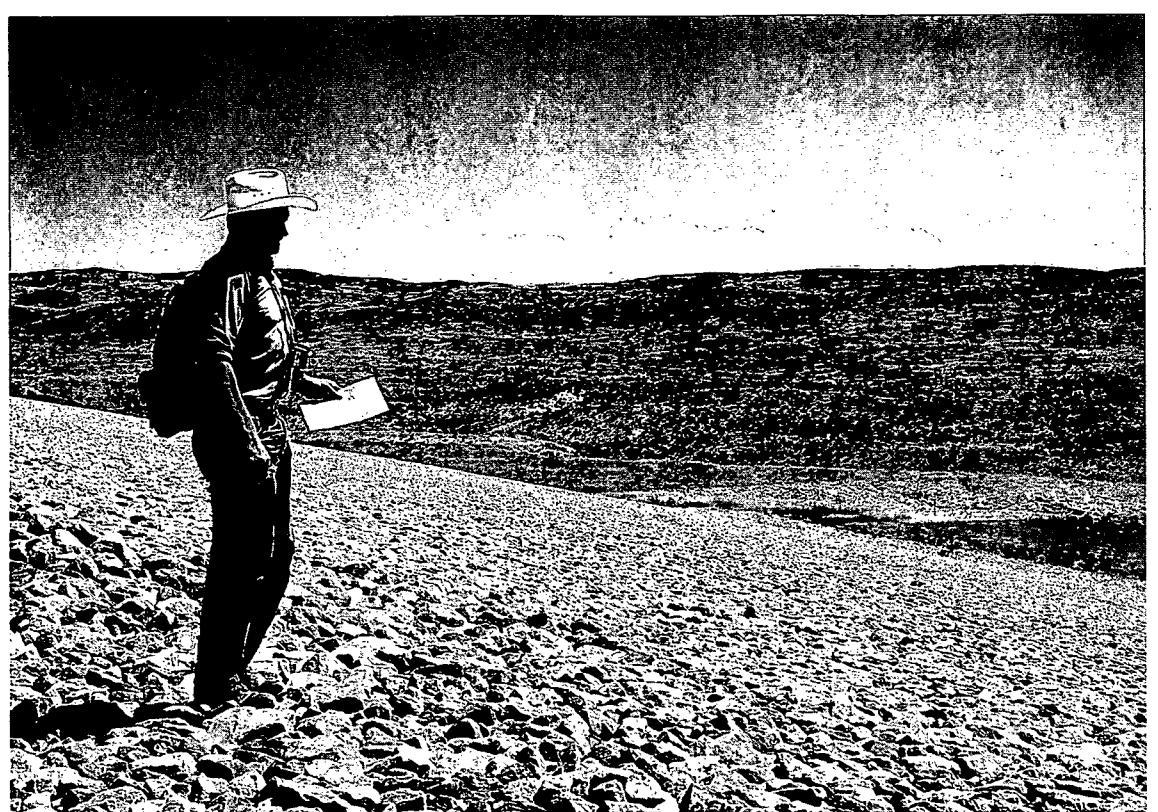
MAY 8/2004. PL-1. Rock-armored side slope at the east corner of the disposal cell.

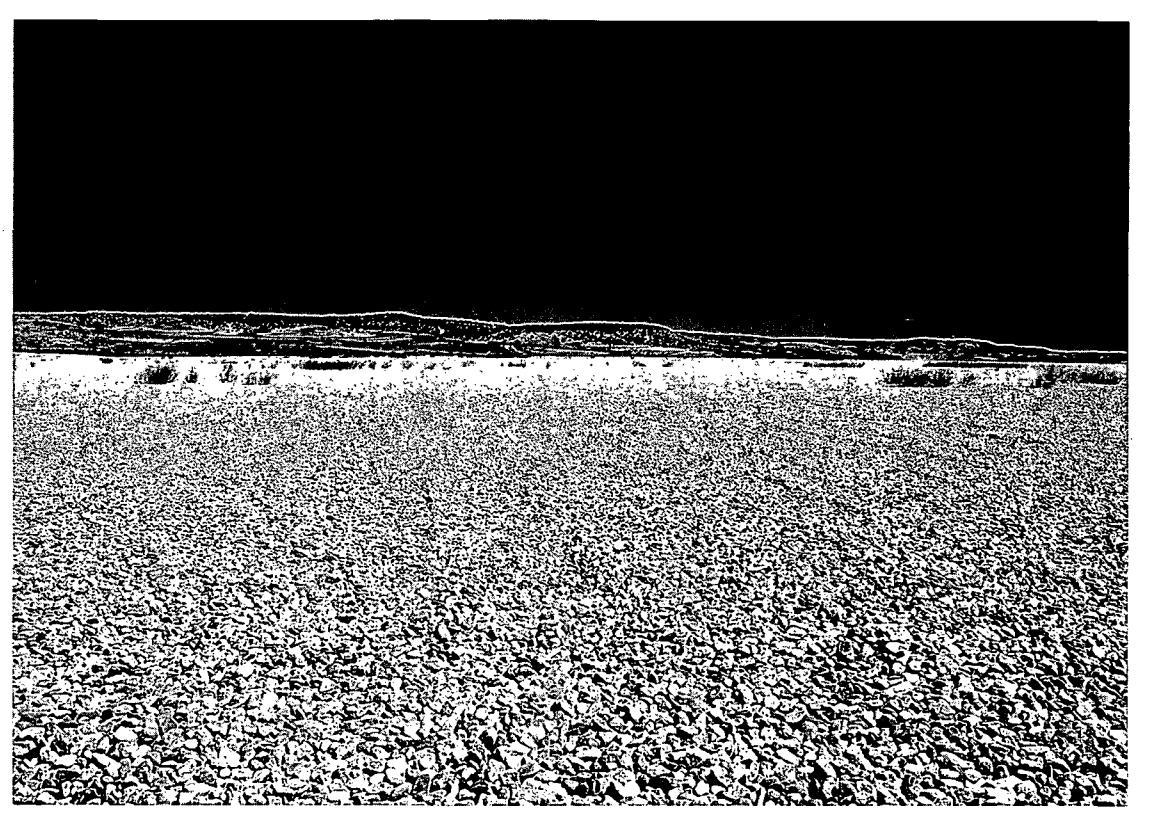
Patches of plants consisting of deep-rooted species, grasses, and annual weeds were observed on the cell top and side slopes (PL-2). Deep-rooted woody plants were cut and their stems were treated with herbicide, and patches of unidentified thistle were sprayed with herbicide. Previously treated areas showed no evidence of new growth.

MAY 8/2004. PL-2. Typical distribution of vegetation found growing on top of the disposal cell.

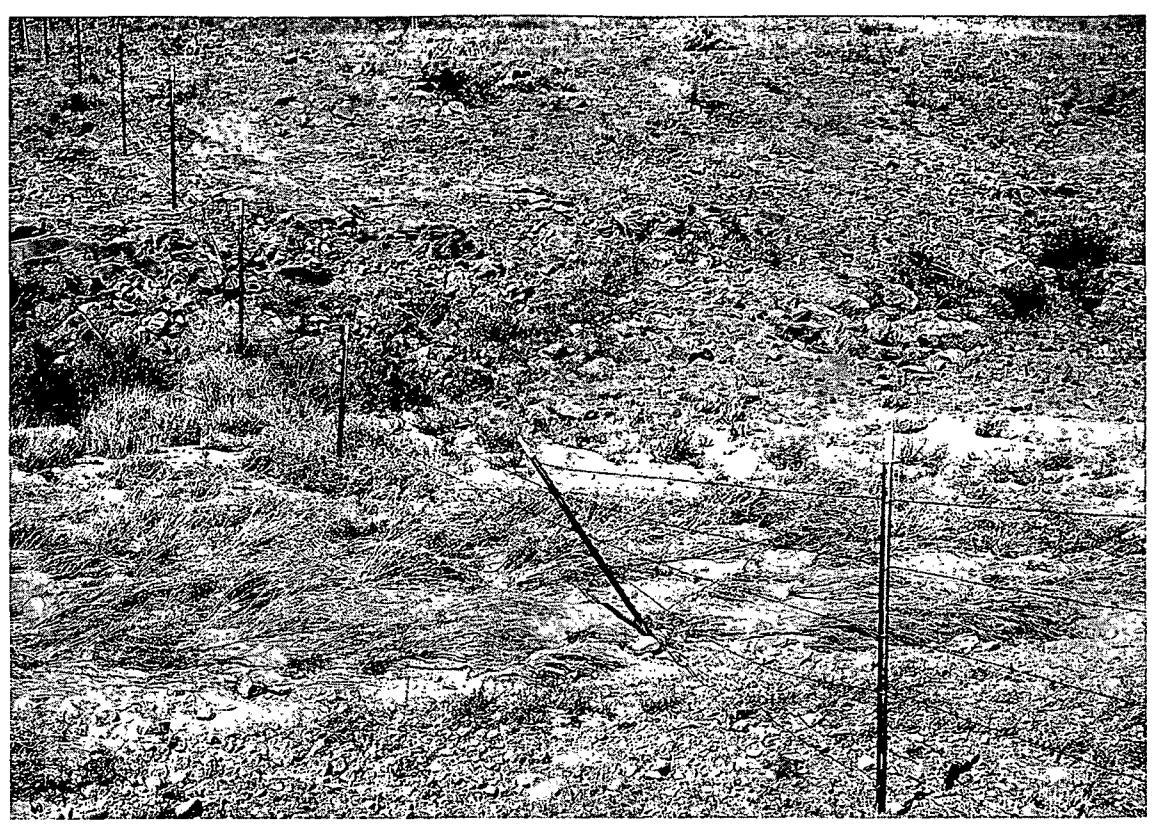
HAT 9/2004. PL-1. Perimeter fence damage at the outfall of West Ditch.

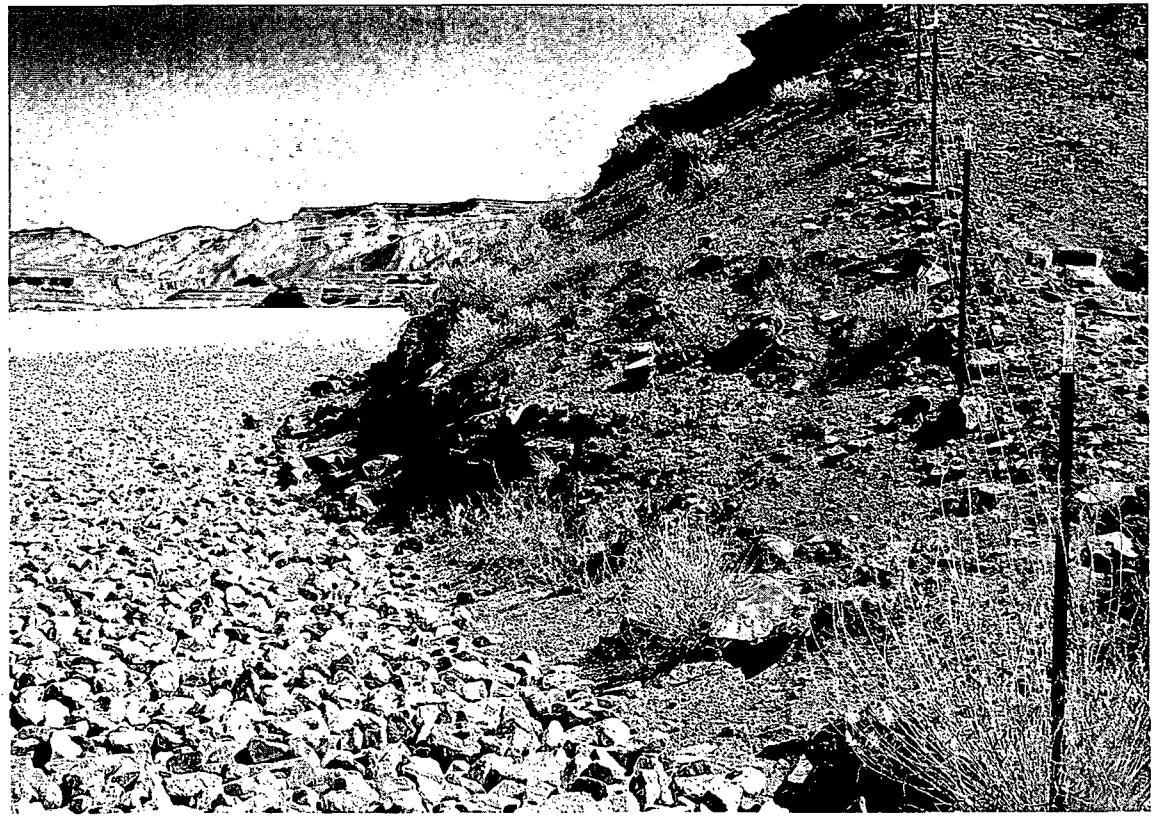
HAT 9/2004. PL-2. Rock debris along the edge of the south apron.

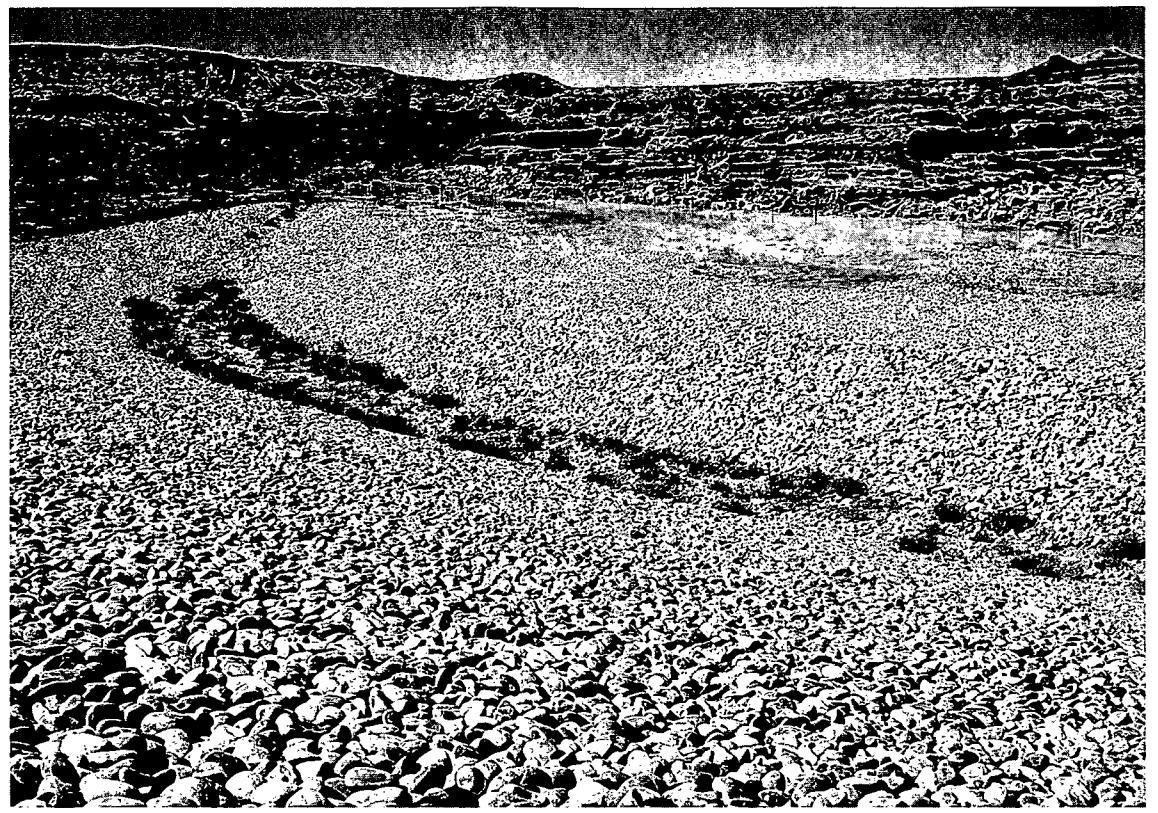
Off-site upgradient areas continue to erode and transport sediment onto the site and into the channels of West Ditch and Southwest Ditch. Plant growth, primarily annual weeds, is establishing where the sediment has accumulated in West Ditch (PL–3). The sediment

HAT 9/2004. PL-3. Minor sediment accumulation and associated plant growth in West Ditch.

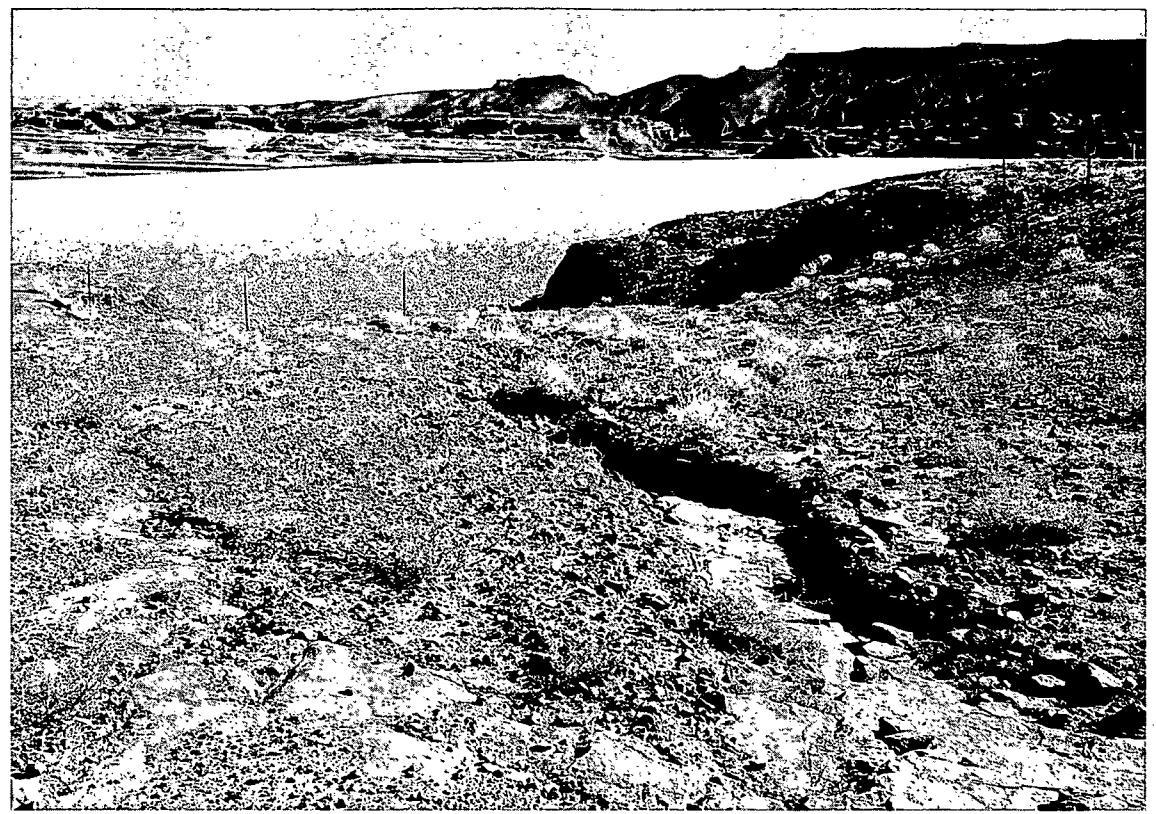
HAT 9/2004. PL-4. Stabilizing rills and gullies upstream of Southwest Ditch.

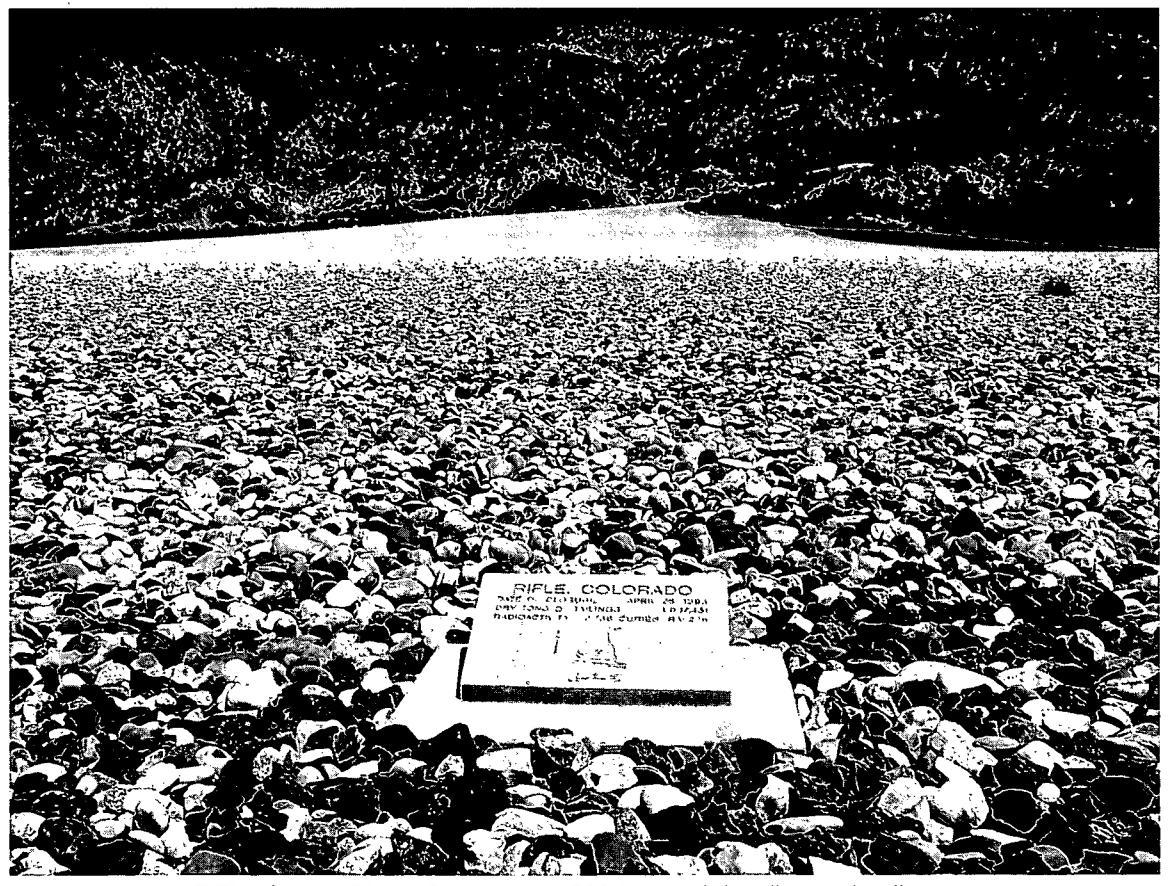
RFL 8/2004. PL-2. Site marker SMK-2 and the disposal cell cover.

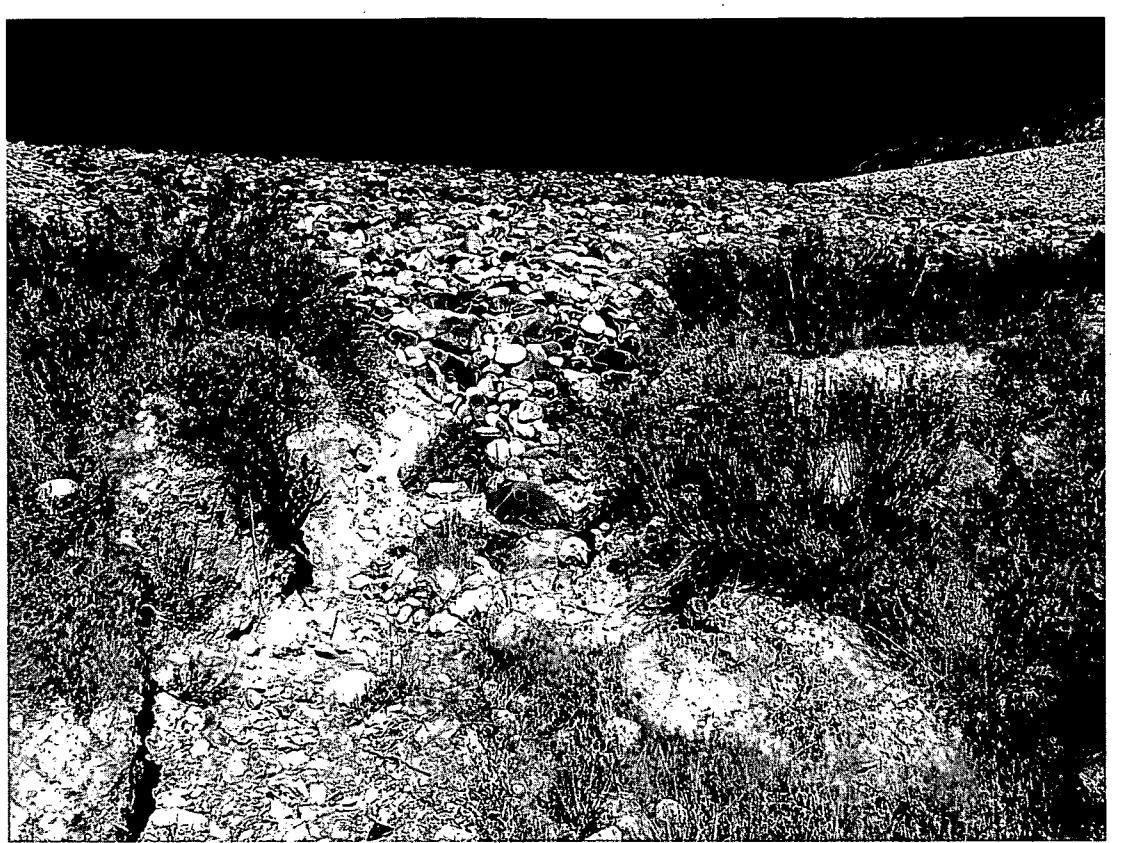
RFL 8/2004. PL-3. Self-armoring at the toe ditch outlet.

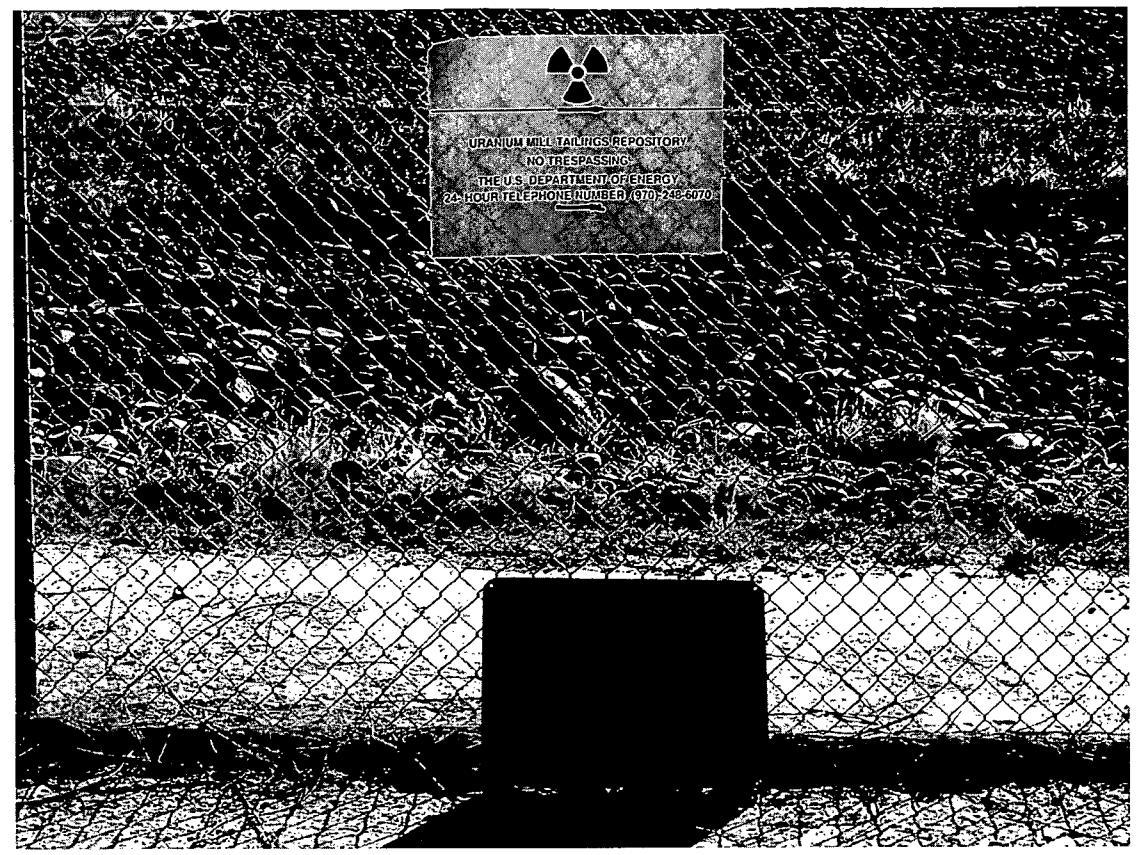
SLC 3/2004. PL-1. New perimeter sign P5.
