U.S. Department of Energy Office of Legacy Management

2004 Annual Site Inspection and **Monitoring Report for Uranium Mill Tailings Radiation Control Act Title I Disposal Sites**

December 2004

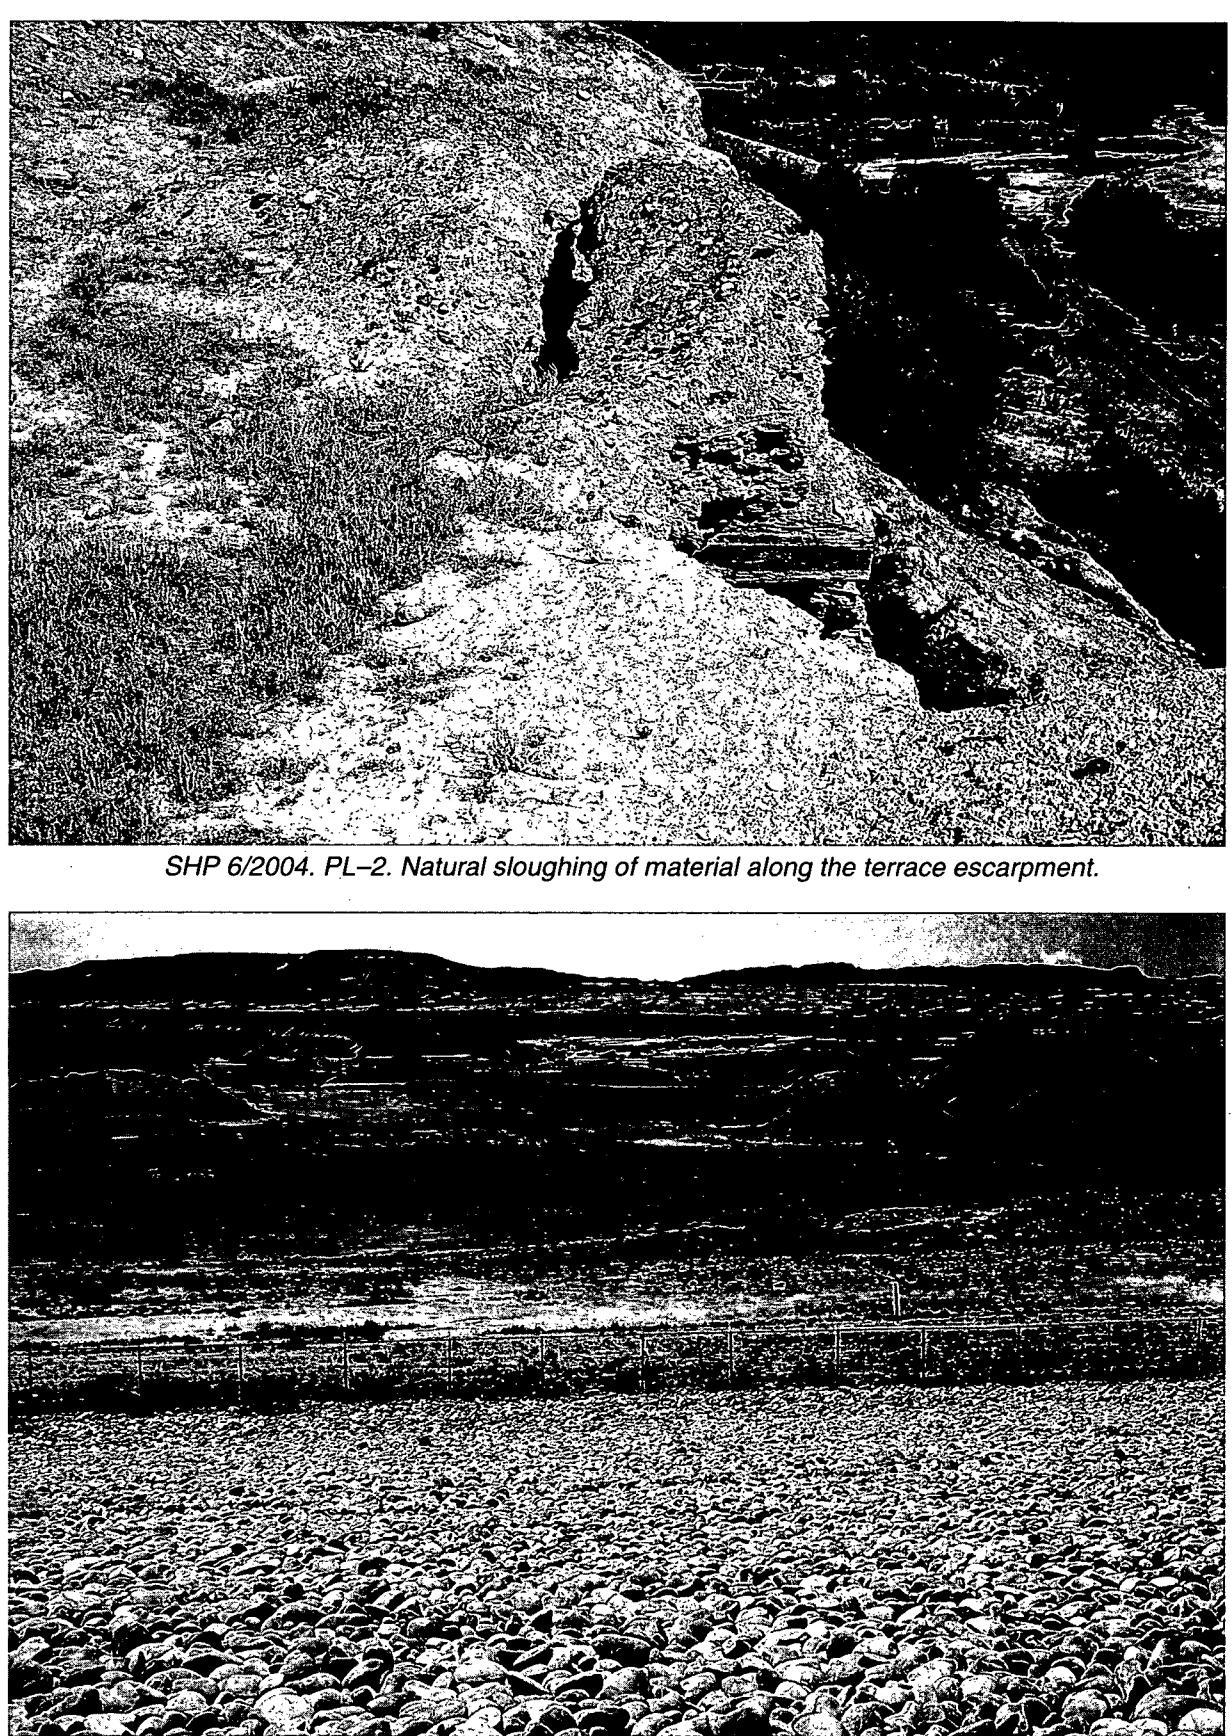
SHP 6/2004. PL–3. View of the idle Navajo Engineering and Construction Authority gravel pit along the southeast side of the disposal site.

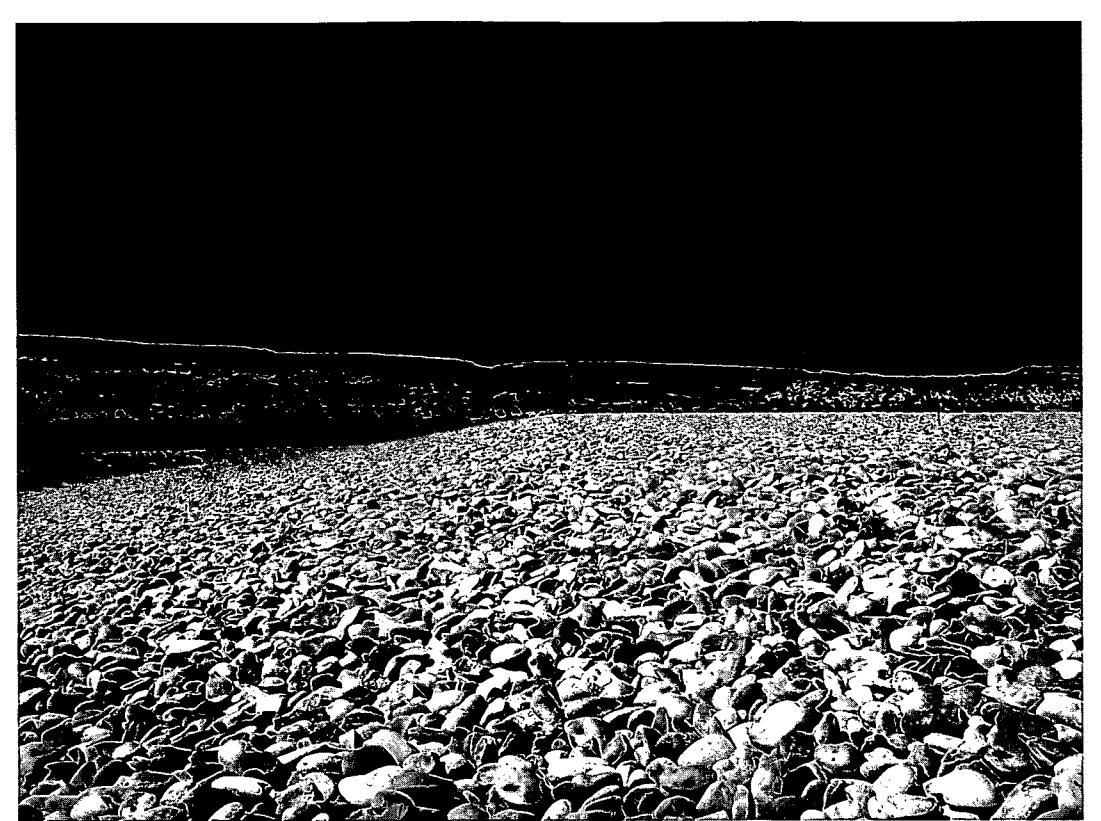
SRK 4/2004. PL-1. View showing integrity of rock-covered surfaces along the southeast side of the disposal cell.

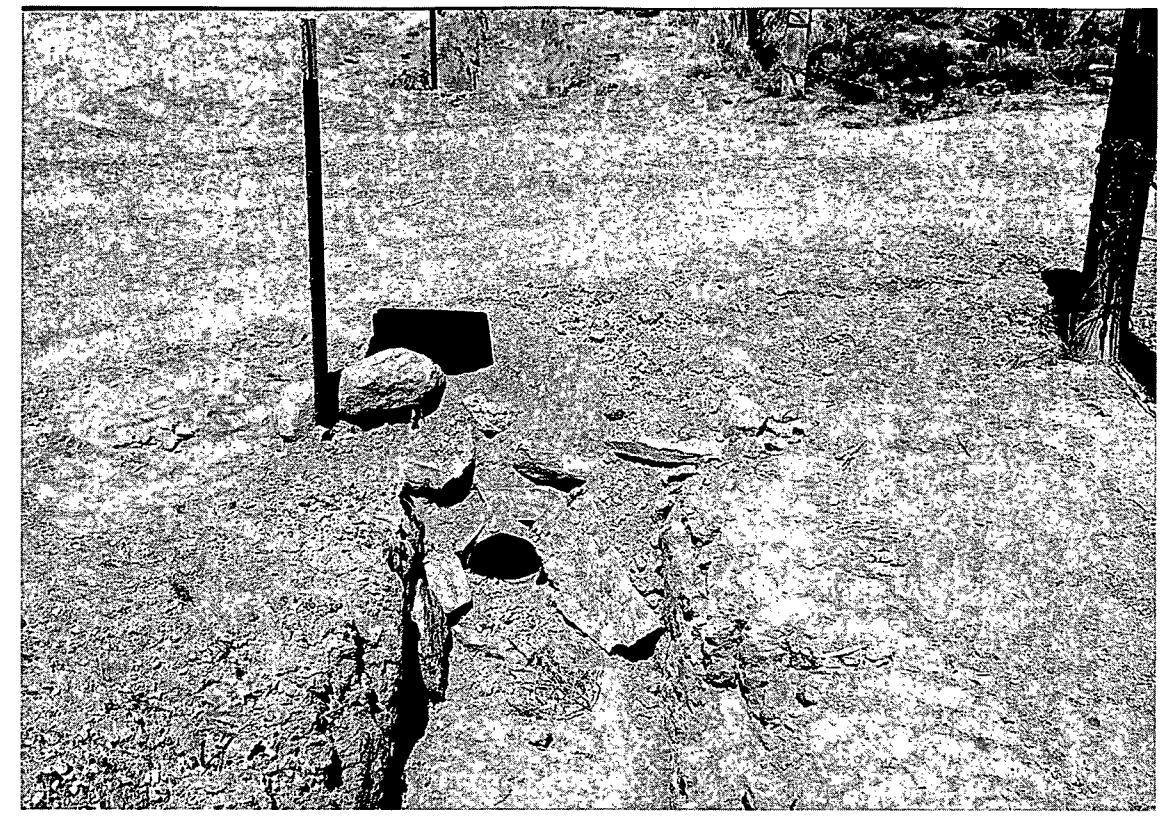
SRK 4/2004. PL–2. New 8-inch diameter culvert and regraded road at the site entrance following erosion repair.

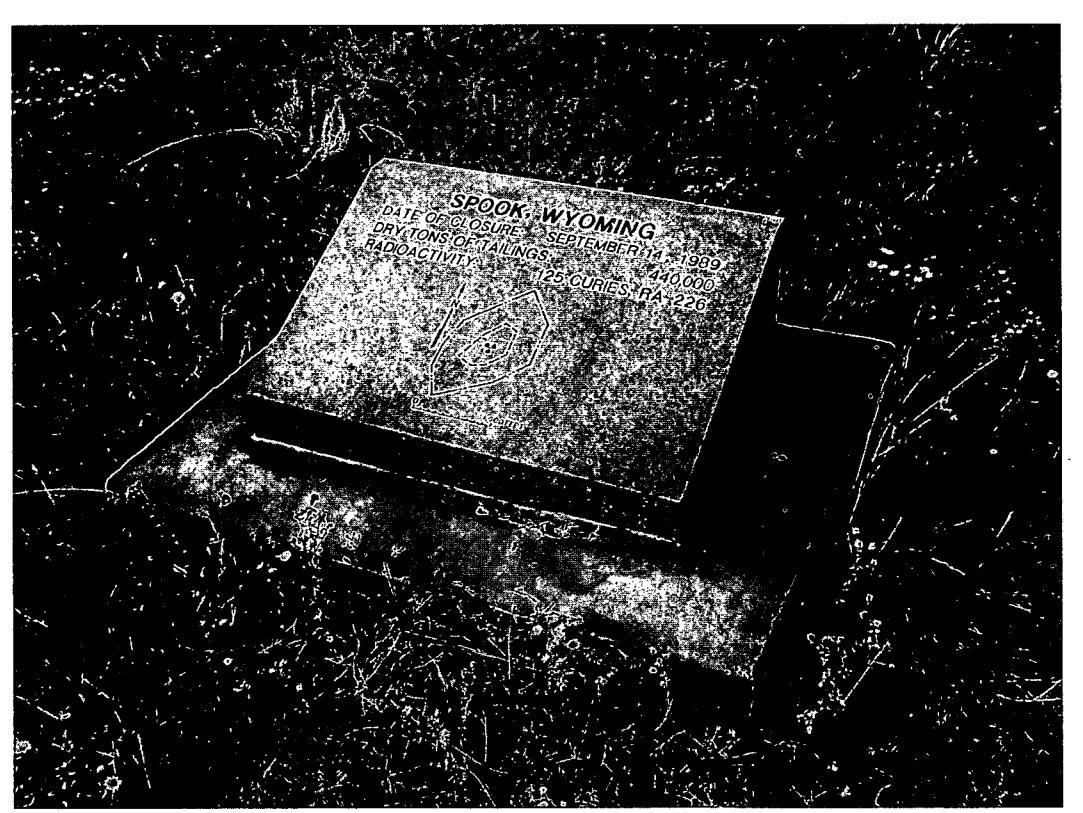
SPK 8/2004. PL-1. Site marker SMK-1, showing spalling concrete on its base.

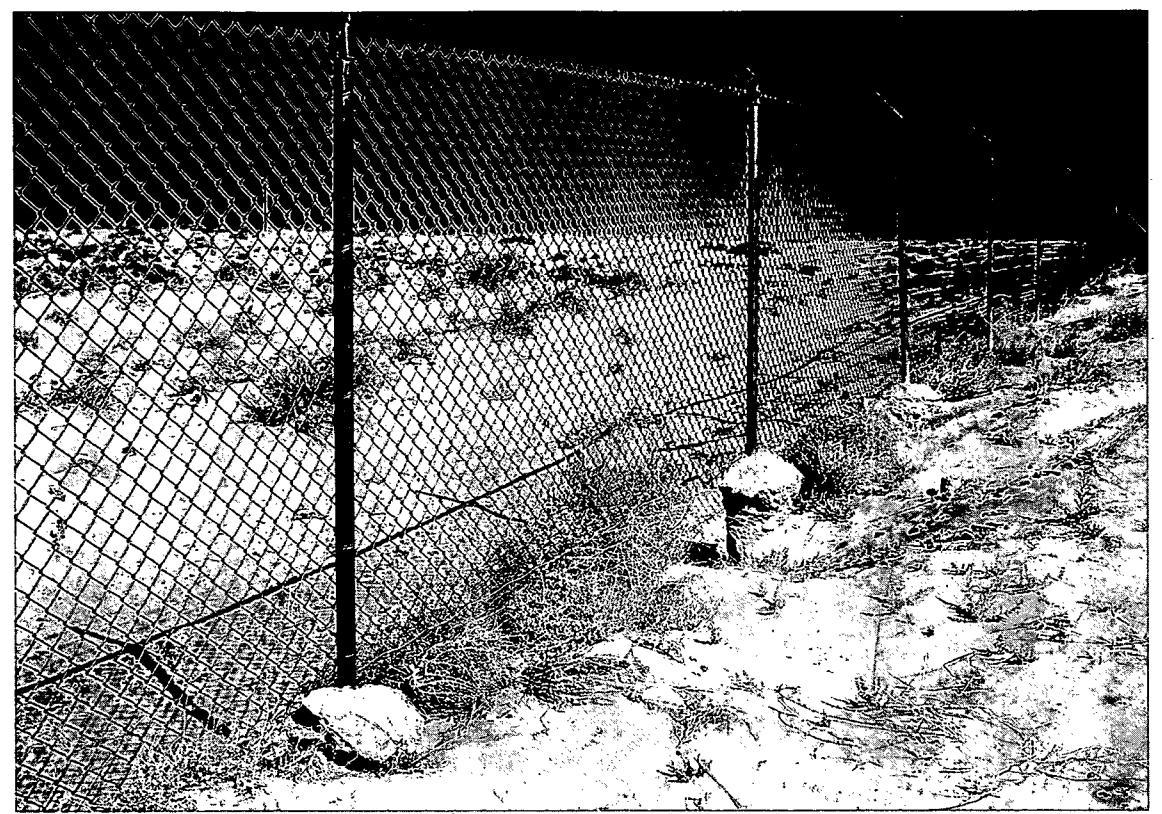
TUB 9/2004. PL-1. Gap at the base of the security fence due to wind erosion.
