Re: South Tar Pond Area Radiological Investigation Plan
Molycorp Washington, PA Remediation Project
License Number SMB-1393

Radiological Investigation Plan
South Tar Pond Area
Molycorp Washington Remediation Project

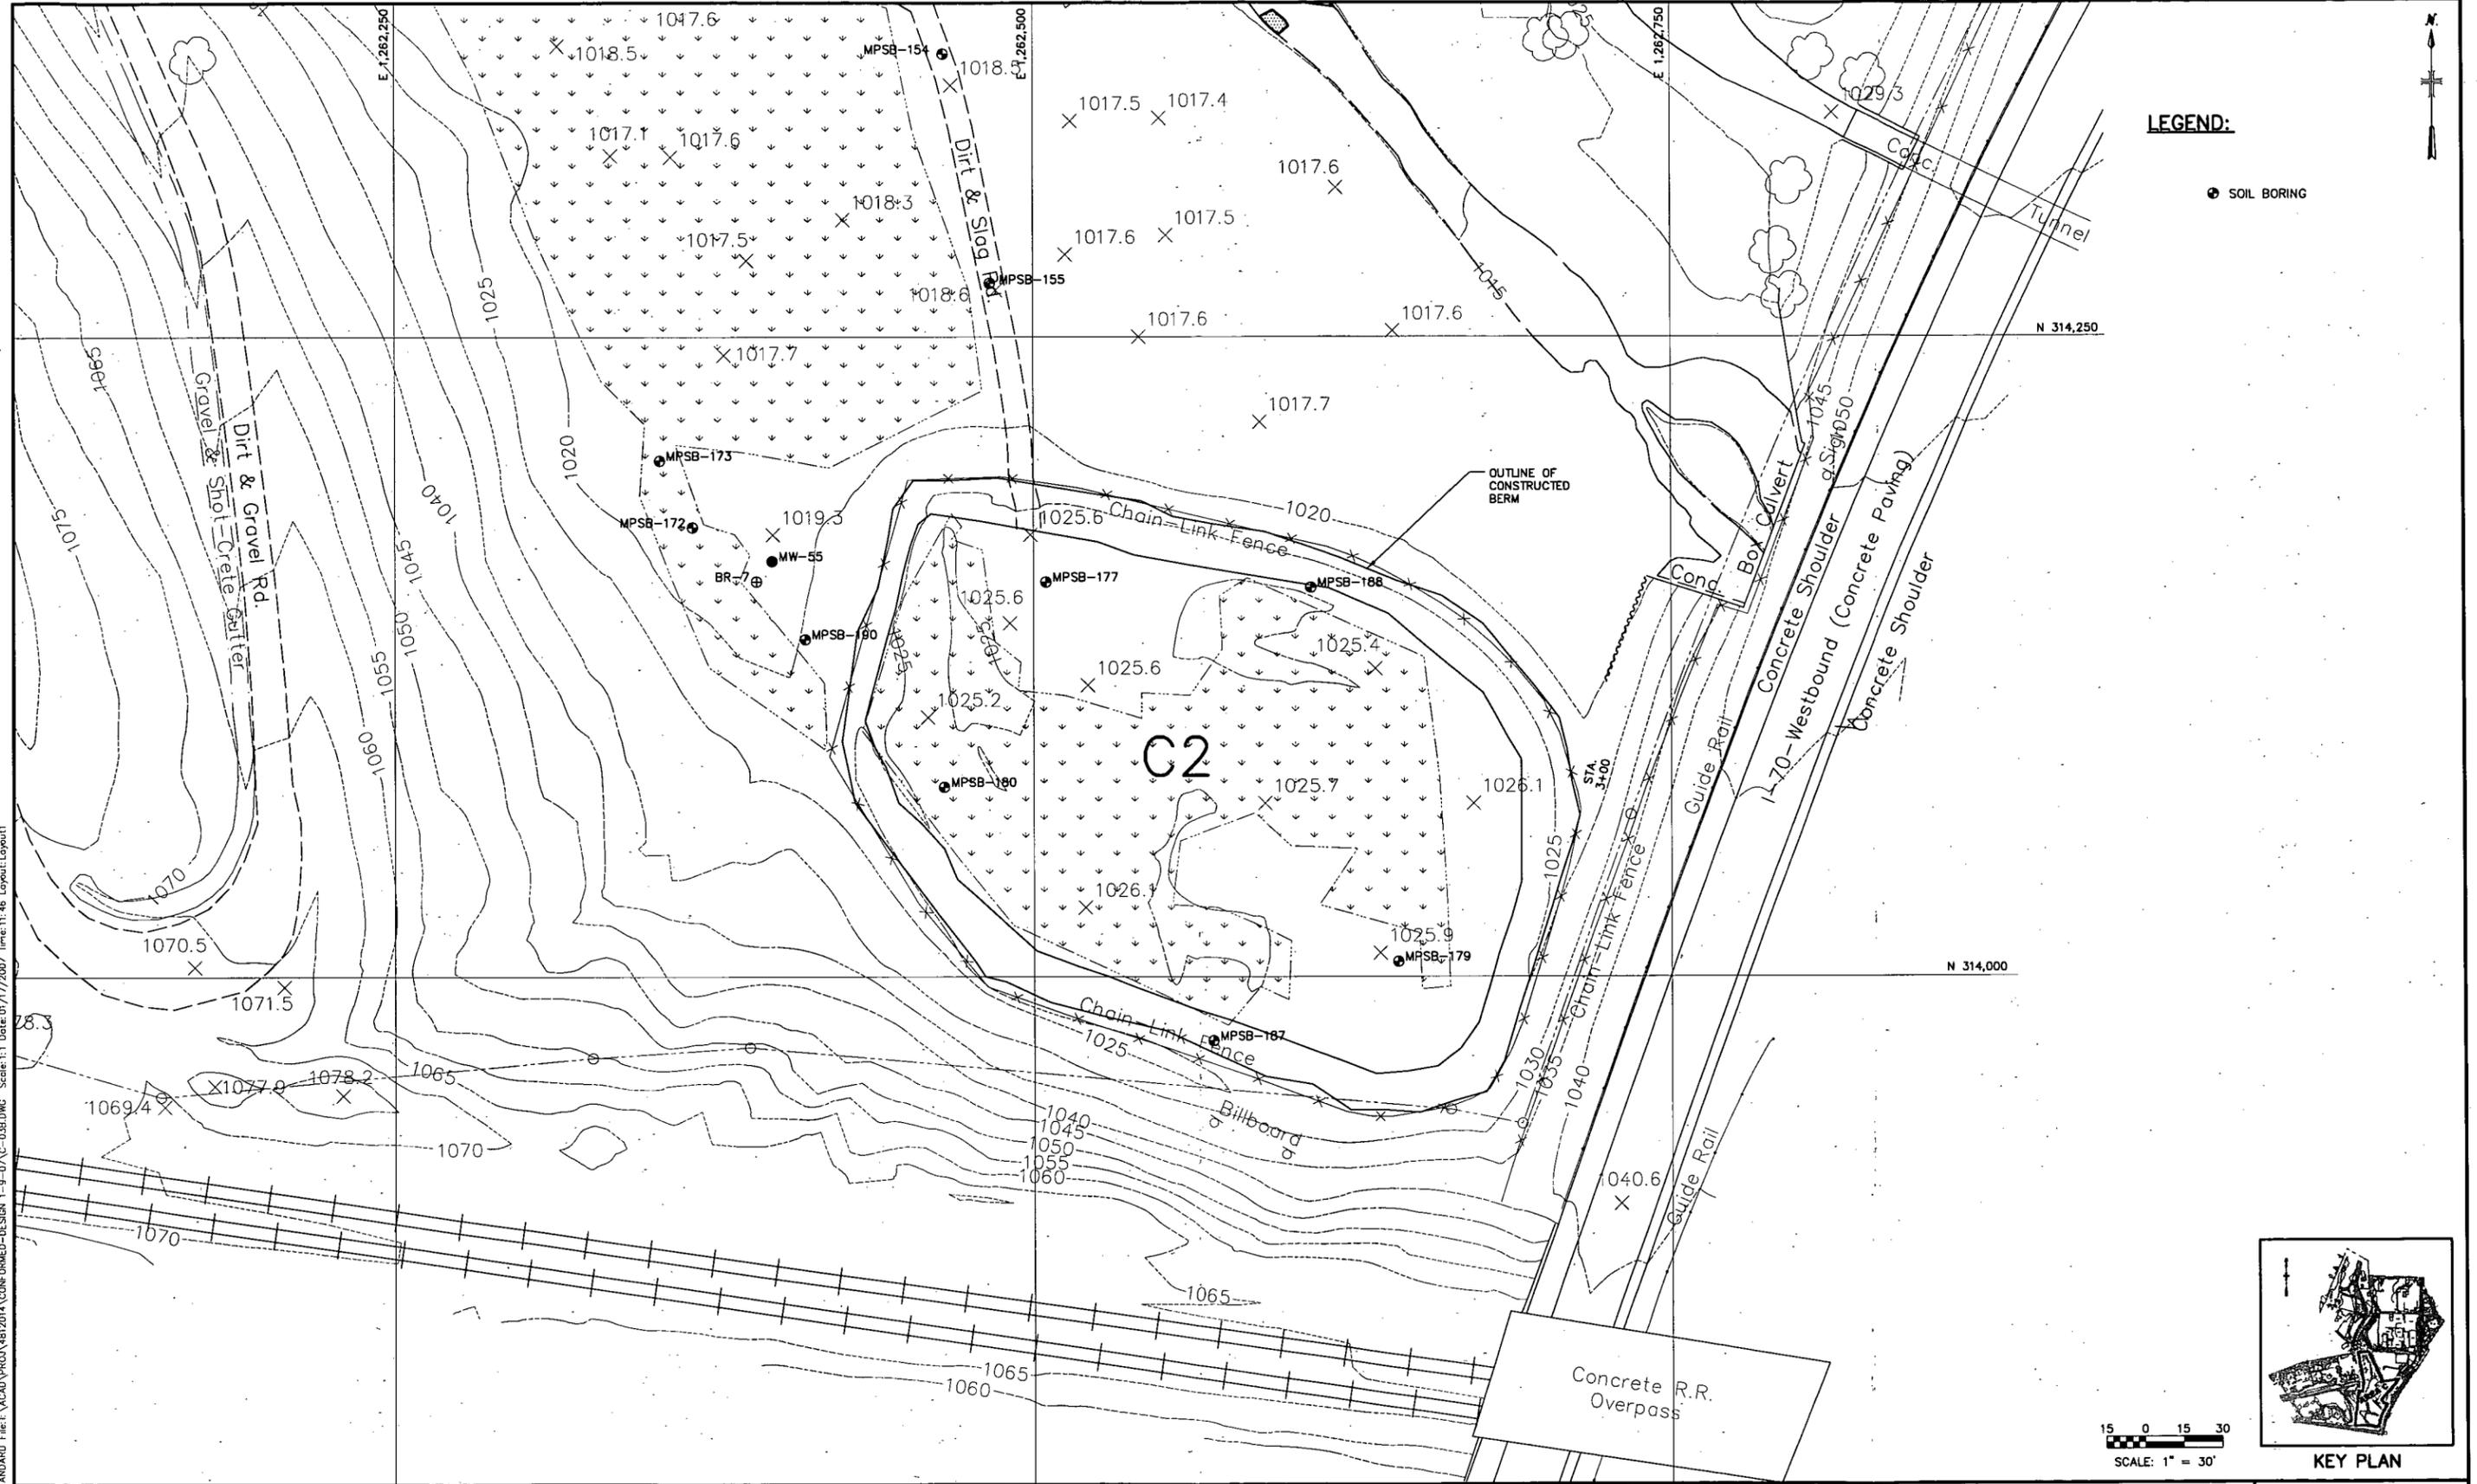
**FIGURE 1
 SOUTH TAR POND AREA
 BEFORE EXCAVATION**

Molycorp conducted a Supplemental Site Characterization Study in 2003-2004 to investigate both radiological and non-radiological conditions across the site. As part of this study, a 100% walkover survey of the slag access road leading to the South Tar Pond was performed. In addition, two borings were placed in the access road and core scans were conducted. No evidence of radiological contamination was detected.

Borings also were placed in the berm of the South Tar Pond and in the pond itself. No slag was detected in any of these borings.

Figure 1 shows the South Tar Pond (C2) area including the berm and the slag access road as they existed at the time of the characterization study.

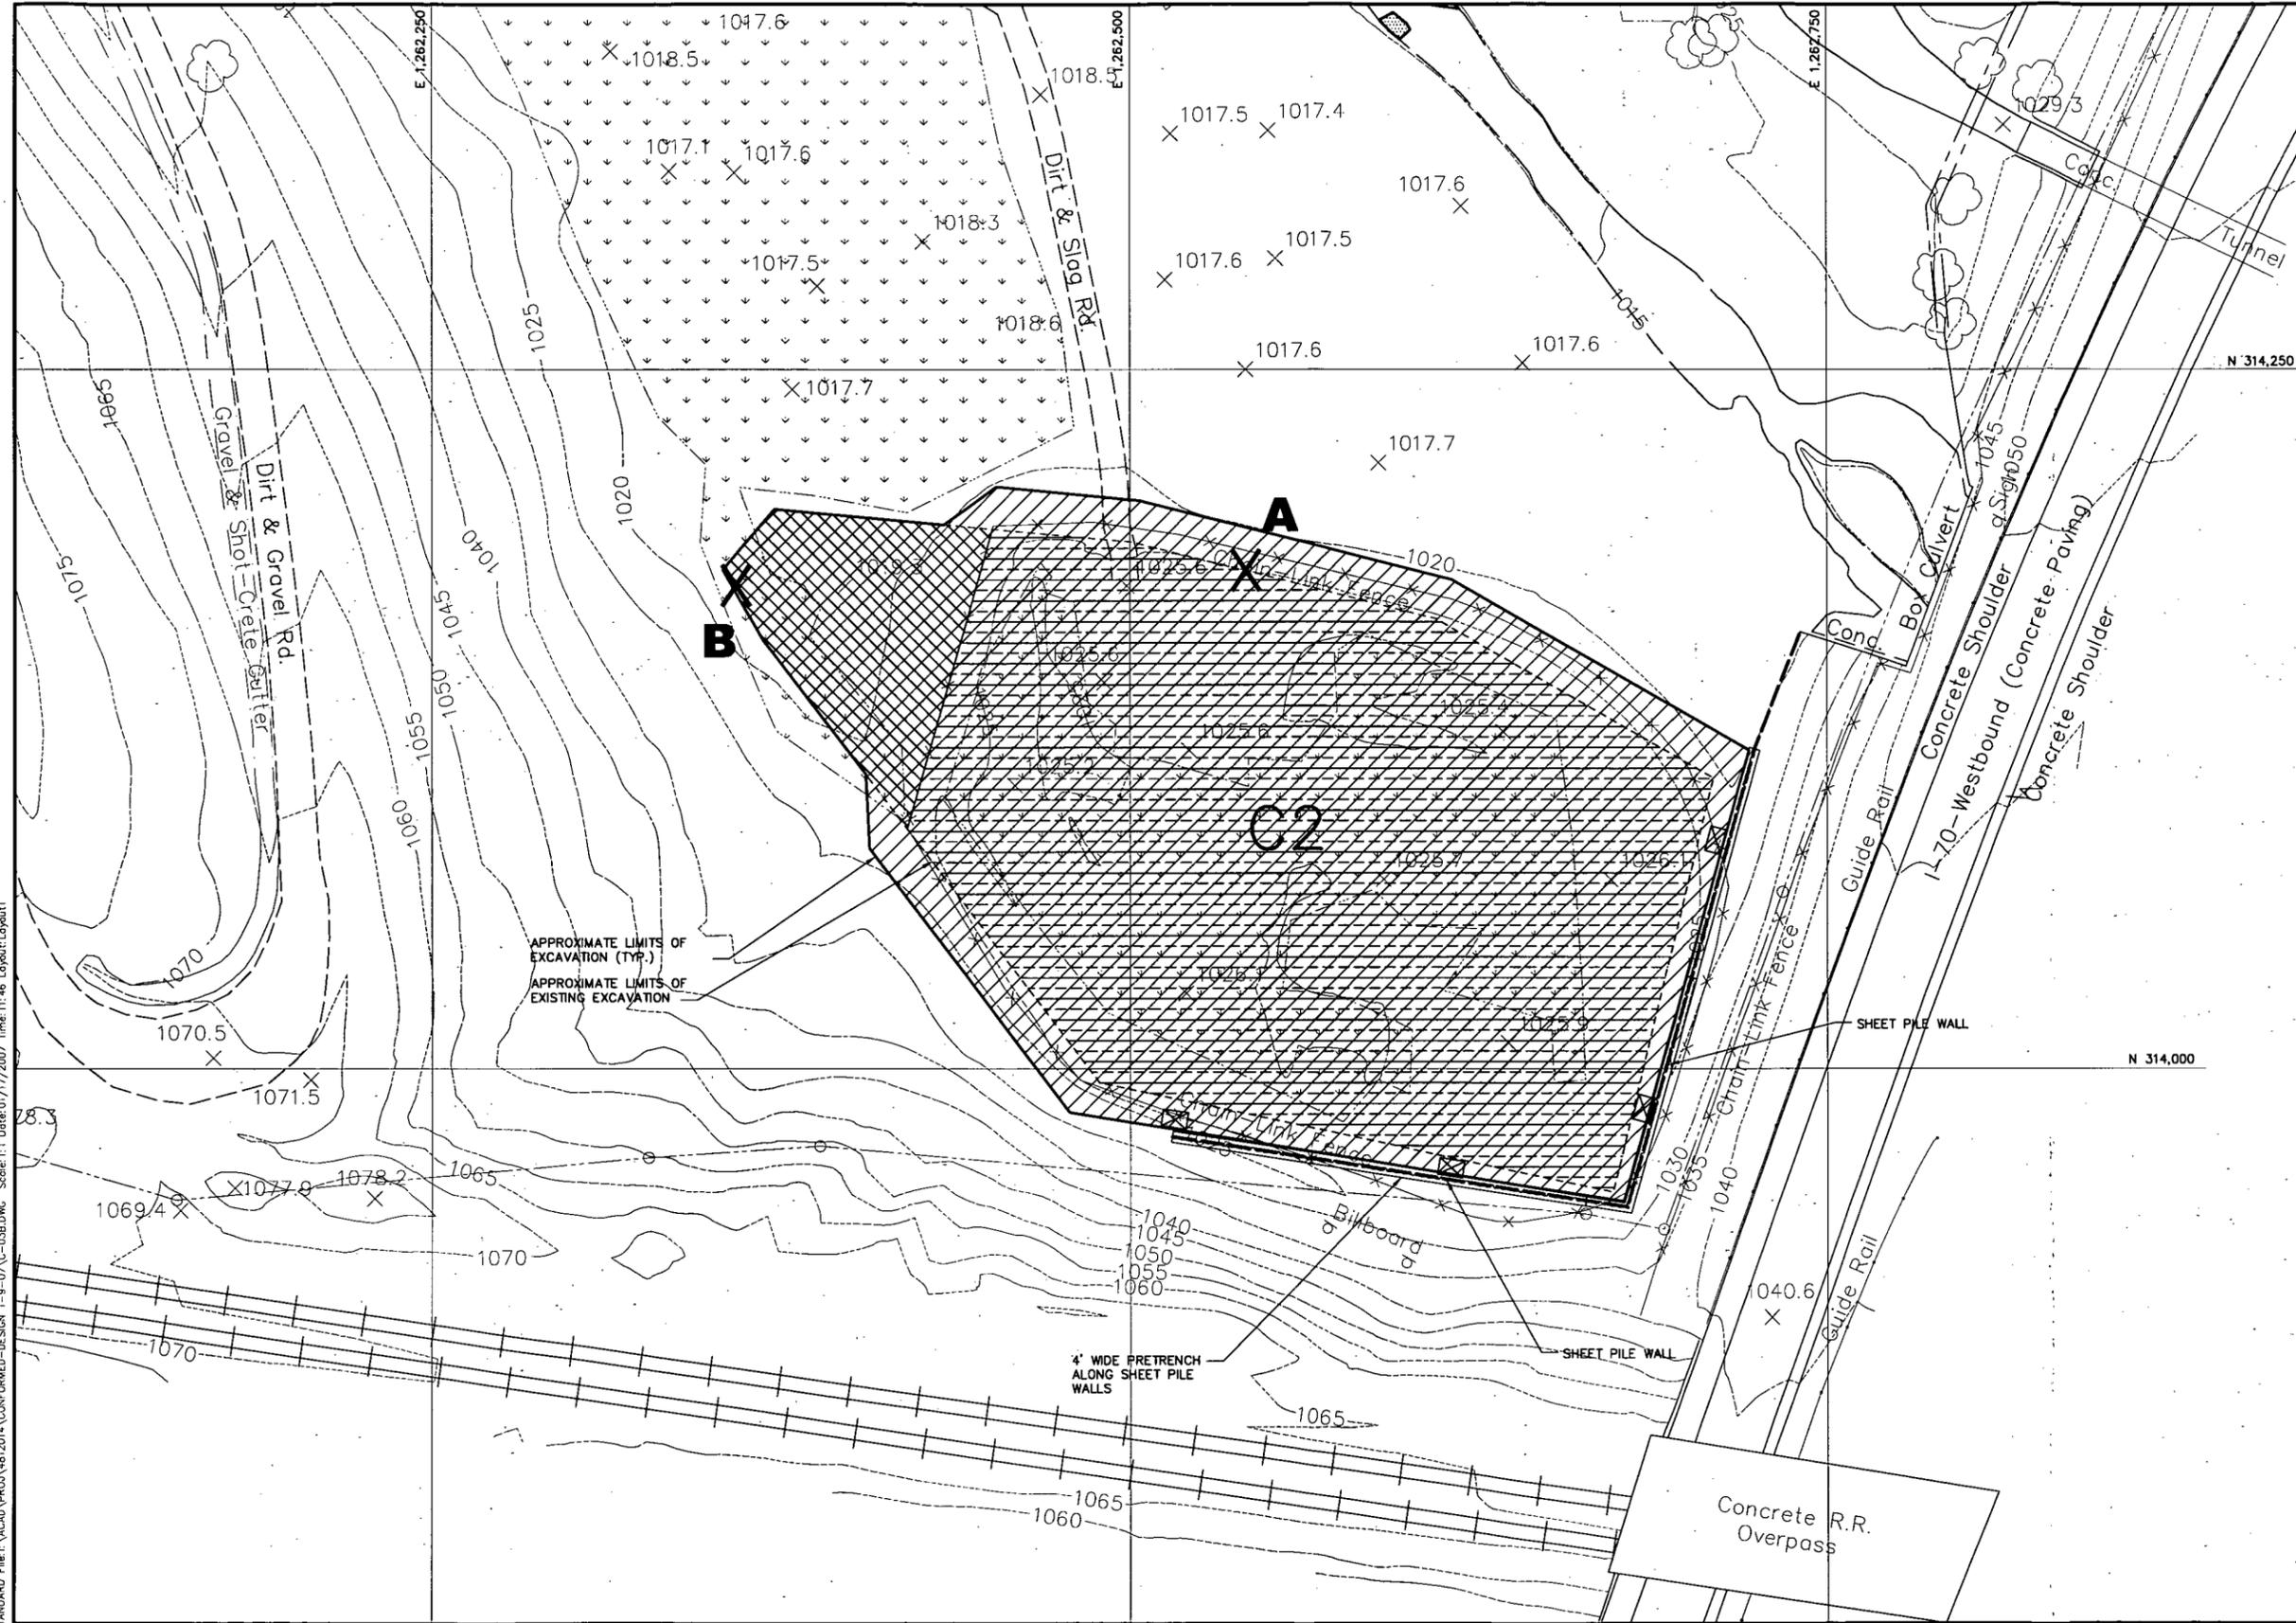
FIGURE 2
SOUTH TAR POND AREA
CONDITIONS, MAY 7, 2007

3. A small piece of slag-like material impregnated with a metallic substance which exhibited elevated activity was discovered in the western sidewall of the South Tar Pond excavation. A sample of this material was sent to the laboratory for gamma spectroscopy analysis. The location of this sample is shown on Figure 2.

Figure 2 depicts current conditions in the South Tar Pond excavation area. The eastern berm and a portion of the southern berm were completely removed during pretrenching activities prior to sheet pile installation. No slag was discovered during this activity.

The remainder of the southern berm and the western berm were completely removed during pond excavation activities. No slag was discovered during excavation in these areas.

The northern berm remains intact. A dewatering sump installed adjacent to the northern berm (point A on Figure 2) is believed to be the source area for the slag piece discovered in the truck and the slag piece found in the load-out area stockpile.

Point B on Figure 2 is the approximate location where the third piece of radioactive slag-like material was discovered in the face of the excavation. There appears to be a thin lens

of slag-like material about 2-4 feet below ground running along the south east face of the excavation from this point. This lens of material was scanned with a micro R meter and no additional zones of elevated activity were evident. This area is west of the South Tar Pond.

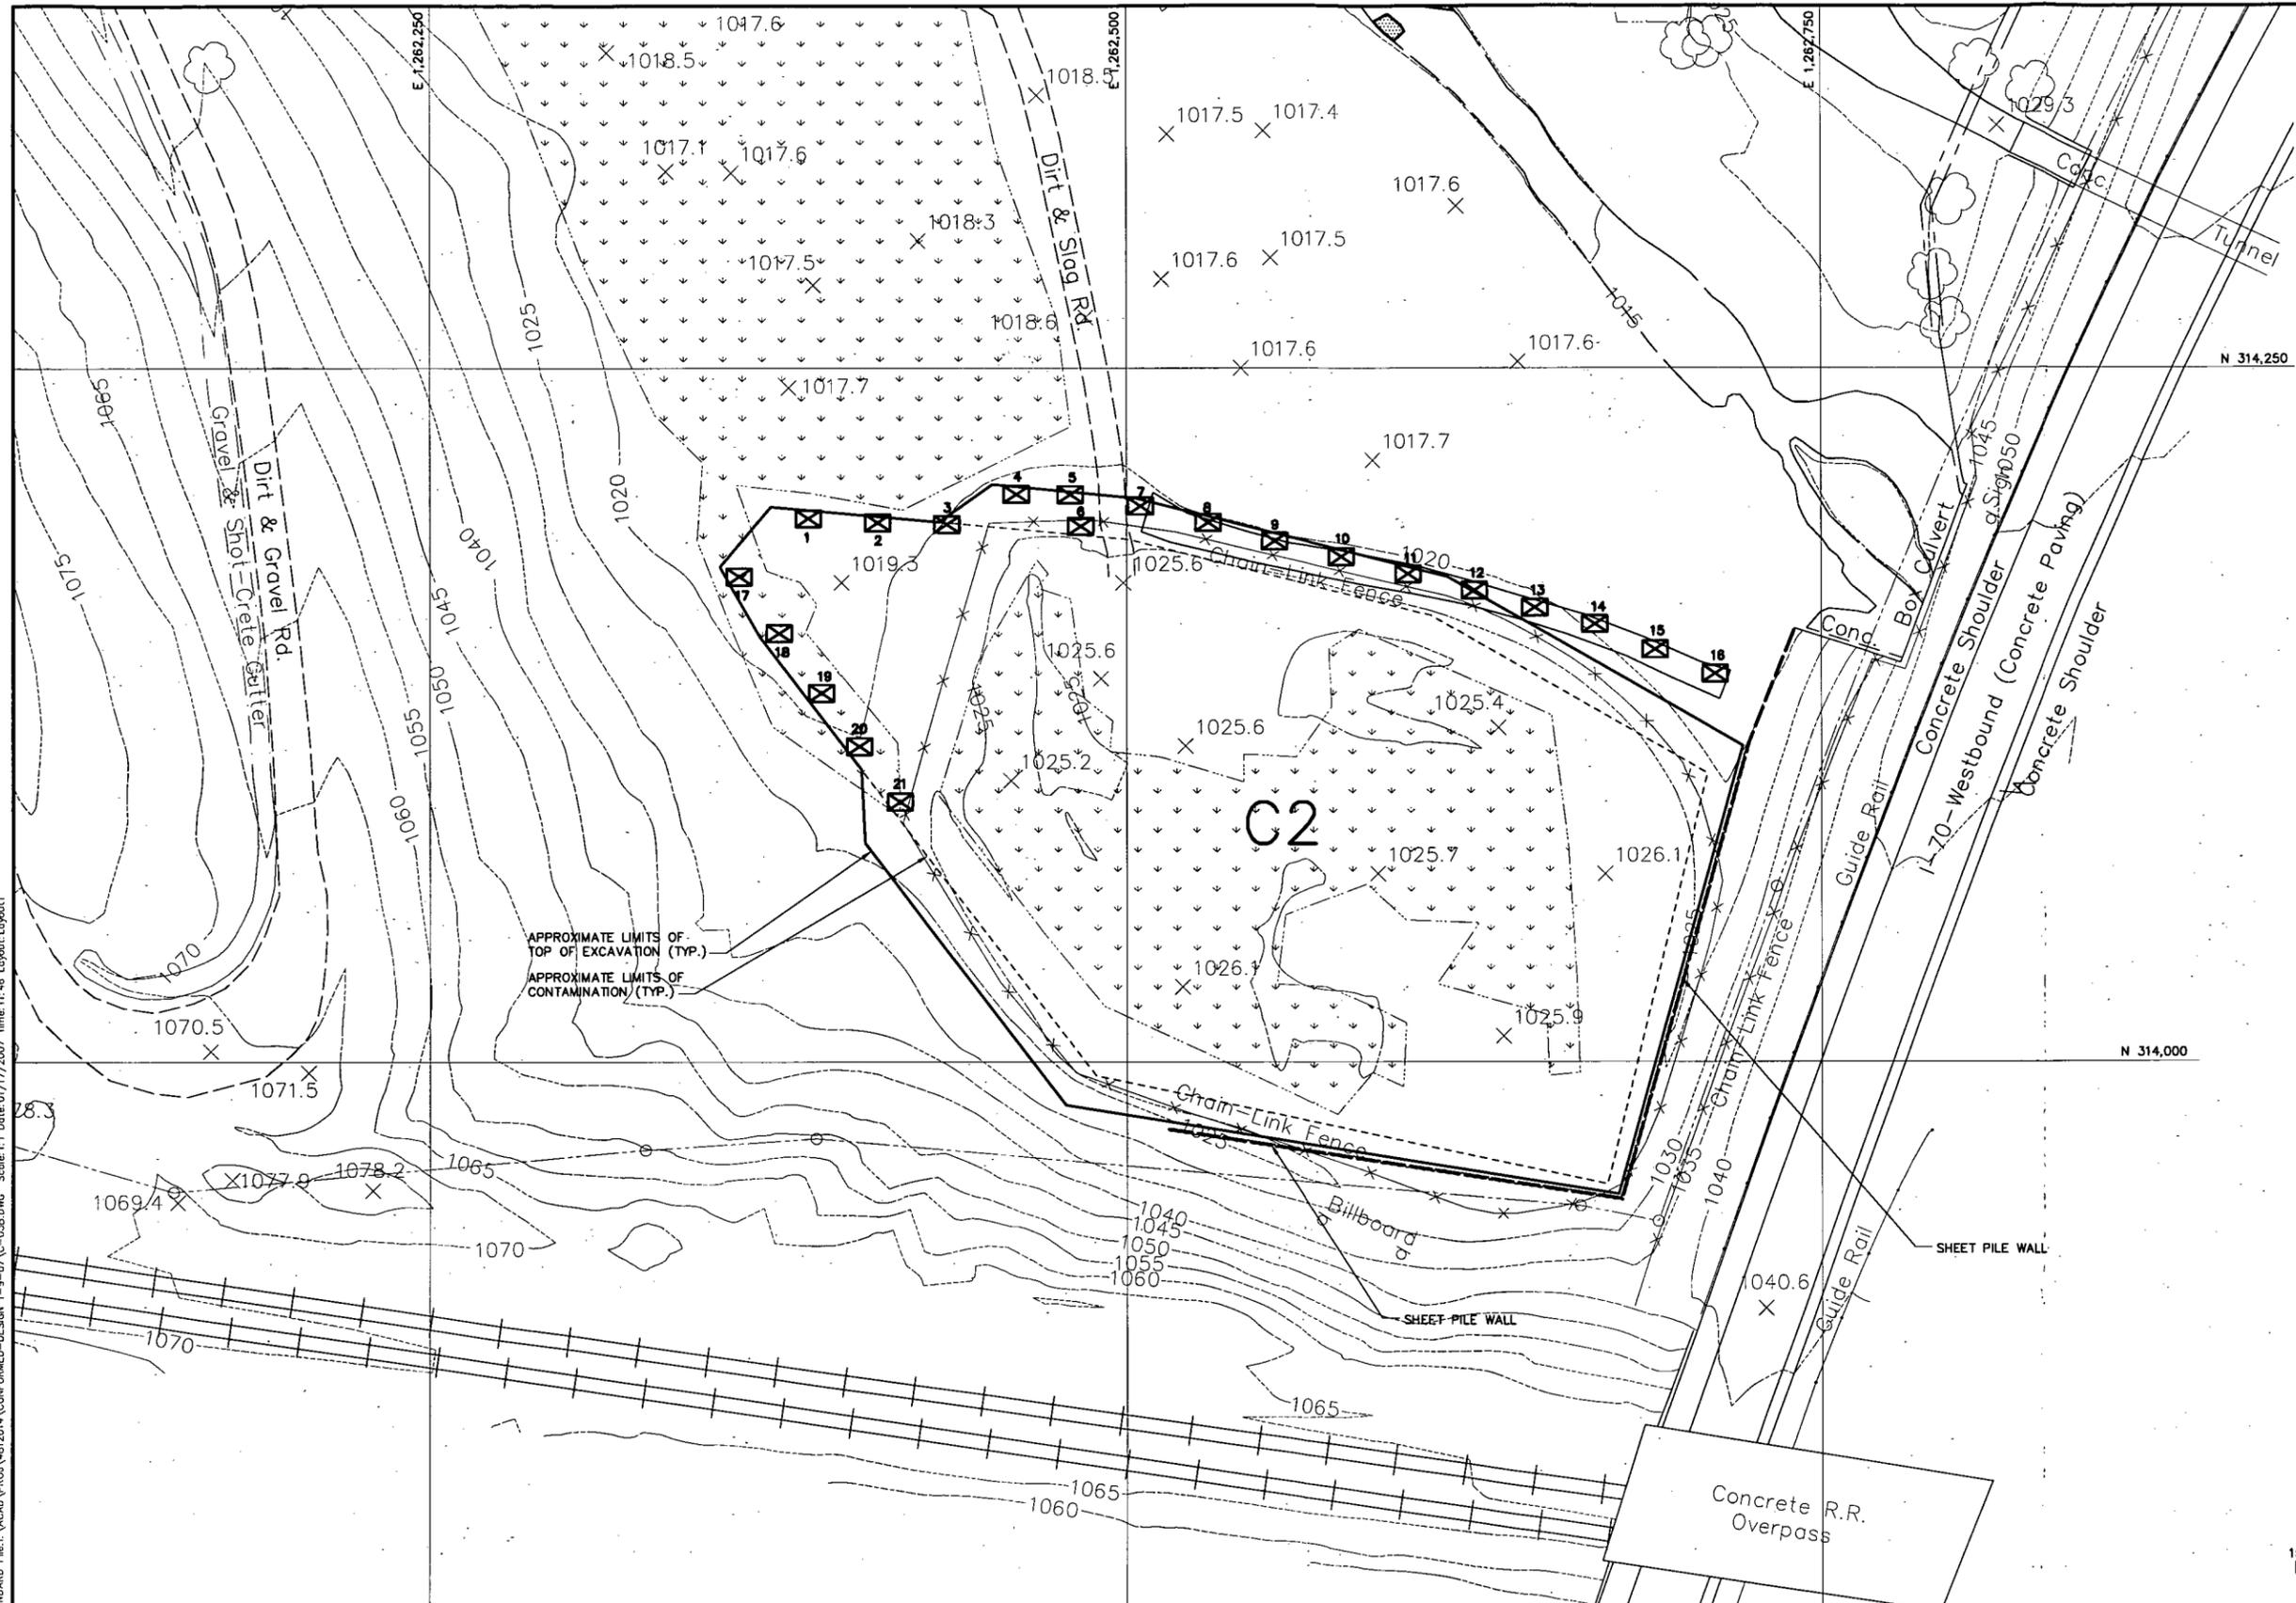
**FIGURE 3
SOUTH TAR POND AREA
RADIOLOGICAL INVESTIGATION PLAN**

During excavation of the South Tar Pond, the only slag that has been observed is associated with the northern berm area and with the western face of the excavation, west of the pond itself. Scanning in accessible areas has not detected any areas of elevated activity other than the three pieces of slag described above.

In order to further investigate the potential presence of radioactive slag in these areas, Molycorp plans to excavate 21 small test pits at the approximate locations shown on Figure 3. These test pits will be excavated using a small back-hoe. The depth of the test pits will vary from approximately four feet to six feet. Excavated material and the excavations will be scanned by a health physics technician using a Ludlum 2221 ratemeter with a 44-10 NaI detector. If scanning detects areas of elevated activity in the test pits, these areas will be sampled for gamma spectroscopy analysis. In any case, at least one sample will be obtained from each test pit and submitted for gamma spectroscopy analysis.

Test pit locations will be recorded by a GPS Surveyor and subsequently, the test pit excavations will be backfilled with excavated material.
