Appendix C1

SEM/EDS Data for Unused and Test #2, Day-30 Aluminum Coupons

Appendix C2

SEM/EDS Data for Unused and Test #2, Day-30 Copper Coupons

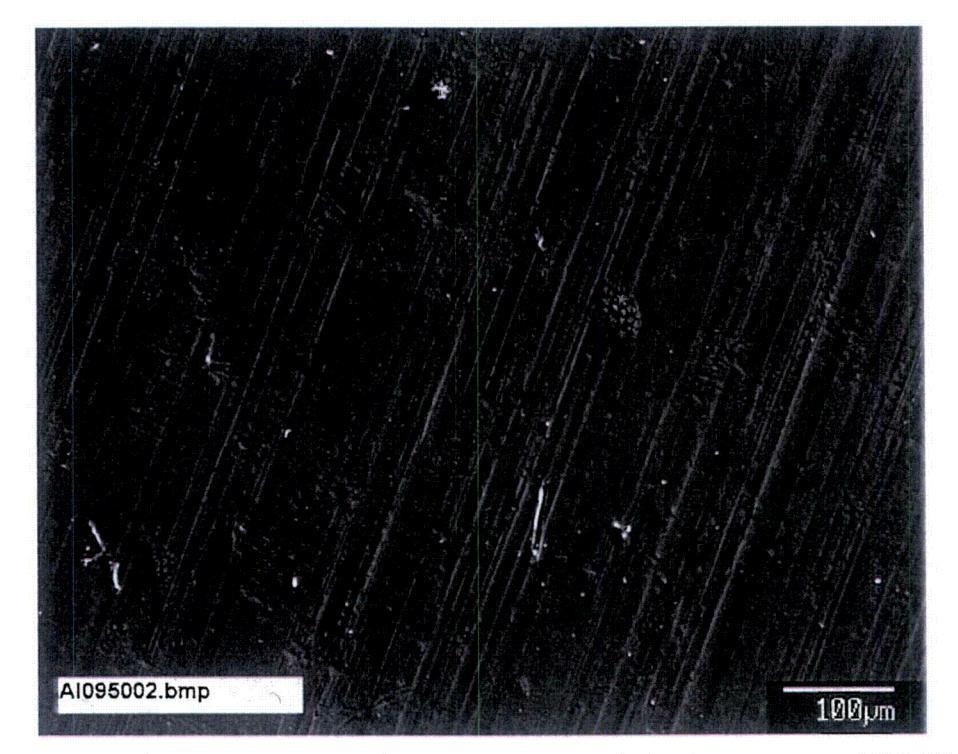
Figure C1-1. SEM image at 40× magnification for an unused aluminum coupon. (Al095001)

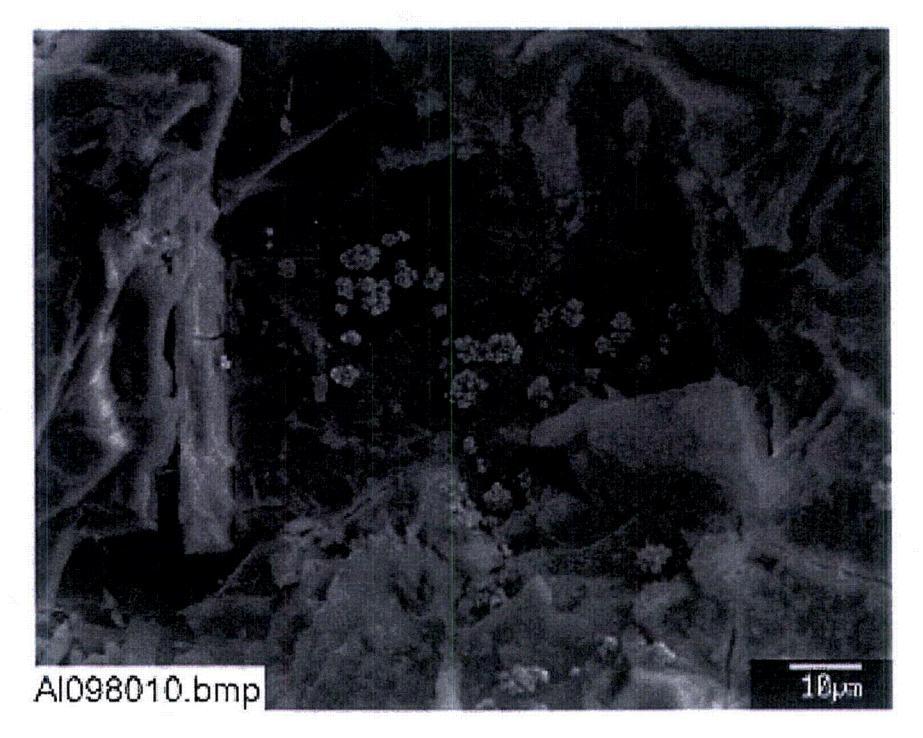
Figure C1-14. SEM image at higher magnification (1000×) for a Test #2, Day-30 submerged aluminum coupon. (Al098010)

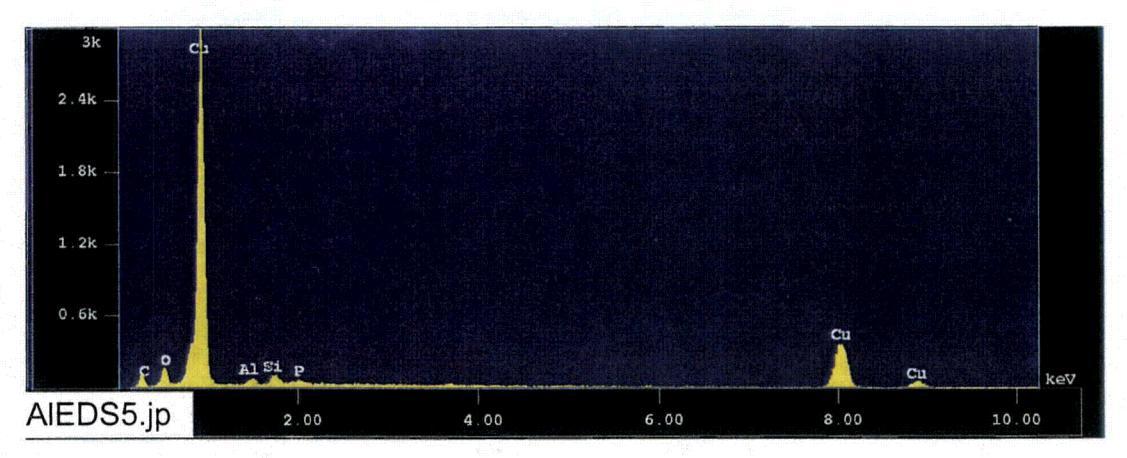
Figure C1-16. EDS counting spectrum for the crystal corrosion product, as shown as white granules in Figure C1-15. (AIEDS5)

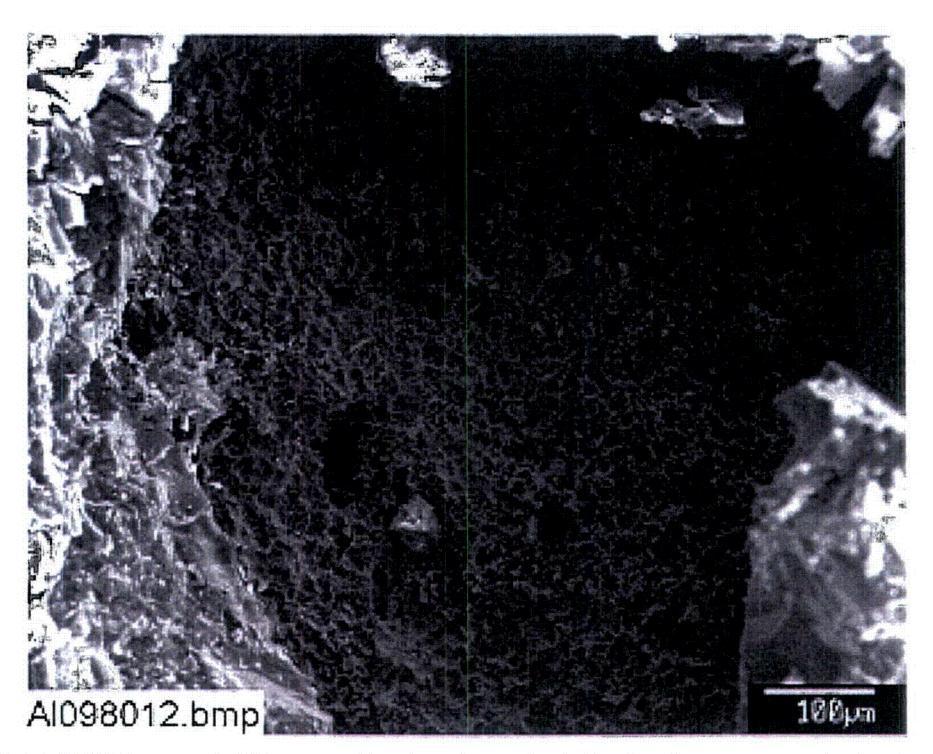
Figure C1-17. SEM image at 150× magnification for a Test #2, Day-30 submerged aluminum coupon showing a hole or defect in the corrosion layer. (Al098012)

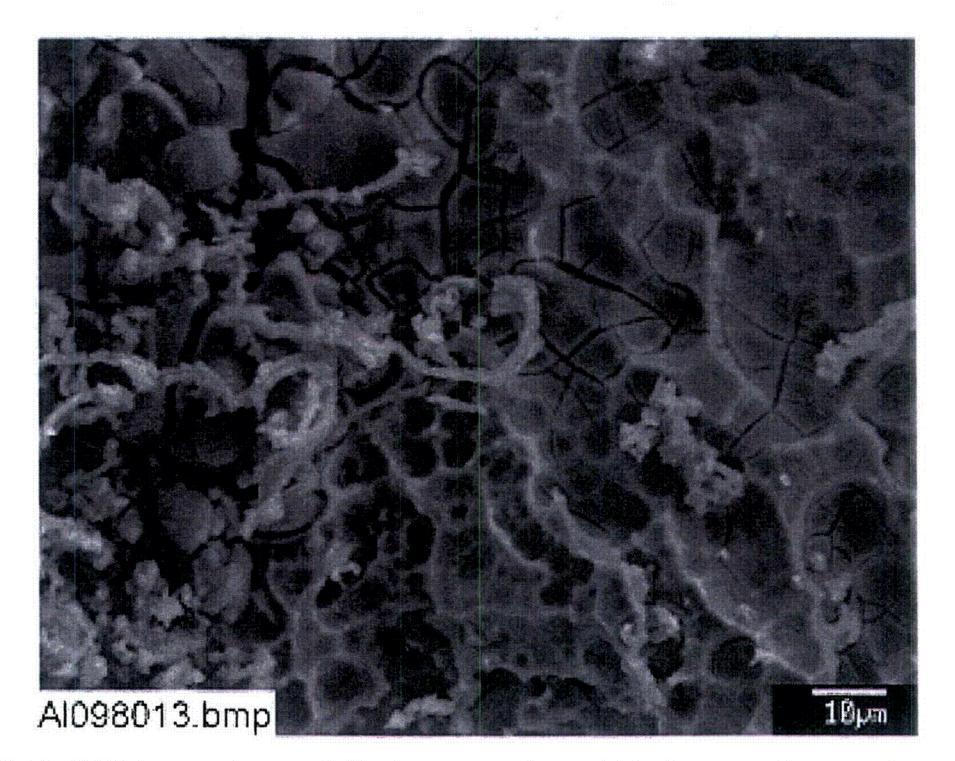
Figure C1-18. SEM image close-up (1000×) of the surface within the corrosion gap shown in Figure C1-17 on a submerged aluminum coupon. (Al098013)

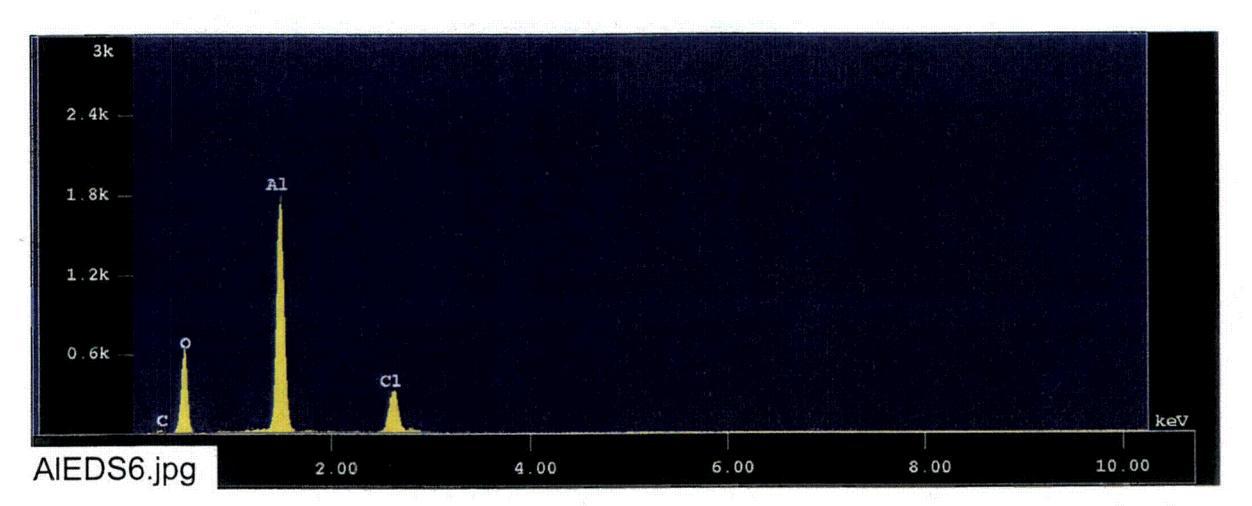
Figure C1-19. EDS counting spectrum for the wormlike corrosion product shown in Figure C1-18. (AIEDS6)

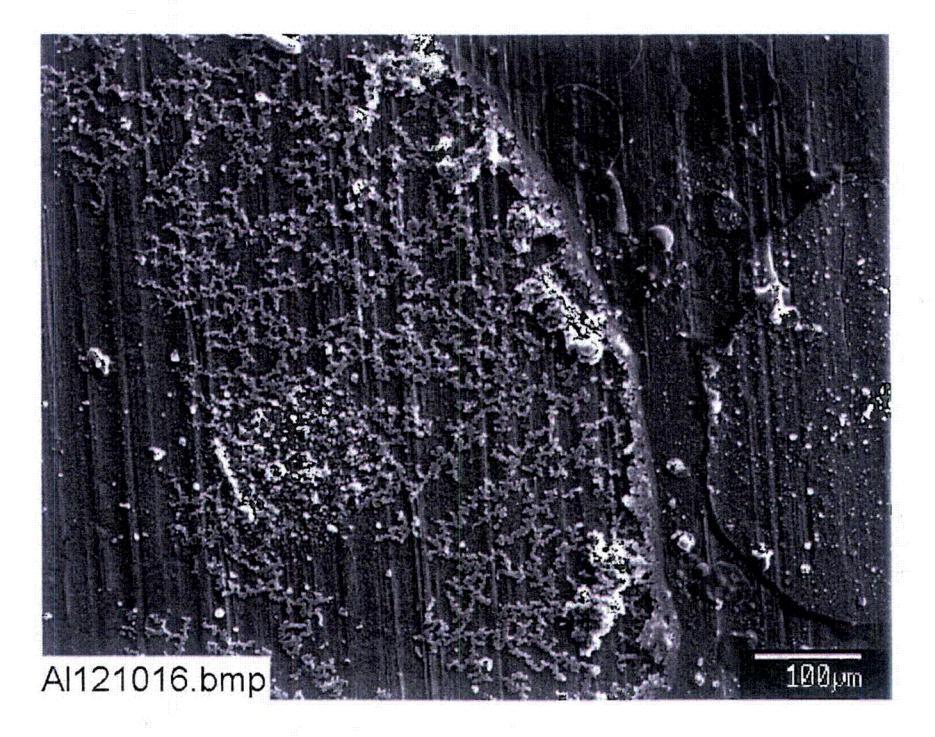
Figure C1-22. SEM image at 150× magnification for the circular corrosion patches shown in Figure C1-21 for a Test #2, Day-30 unsubmerged aluminum coupon. (Al121016)

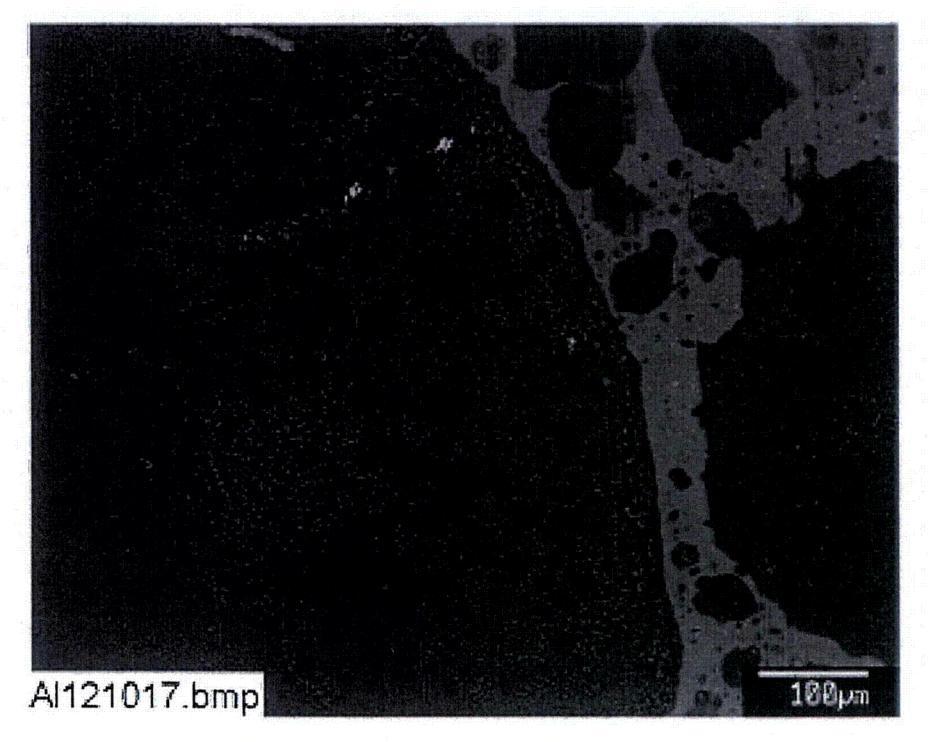
Figure C1-24. Backscattered SEM image at 150× magnification for the circular corrosion patches shown in Figure C1-21 for a Test #2, Day-30 unsubmerged aluminum coupon. (Al121017)

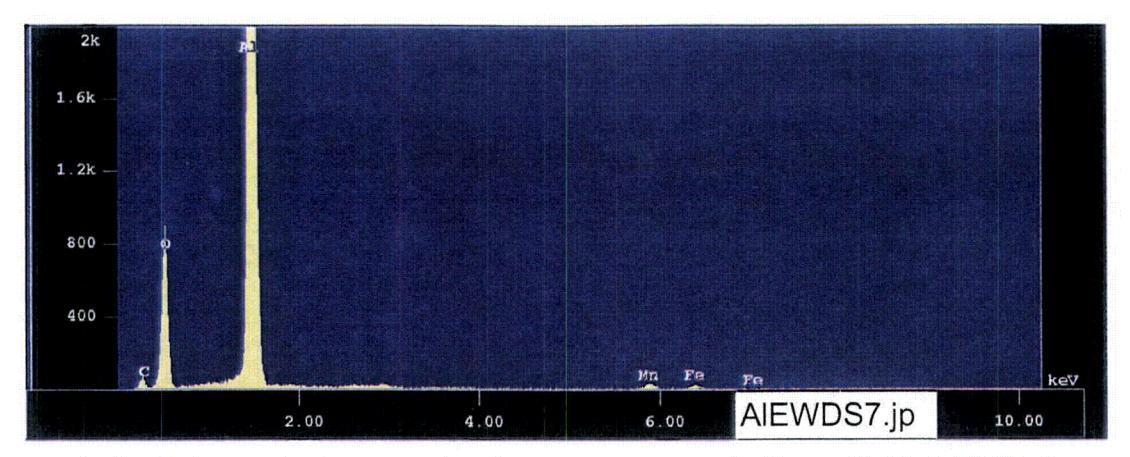
Figure C1-25. EDS counting spectrum for the dark patch shown in Figure C1-24. (AIEWDS7)

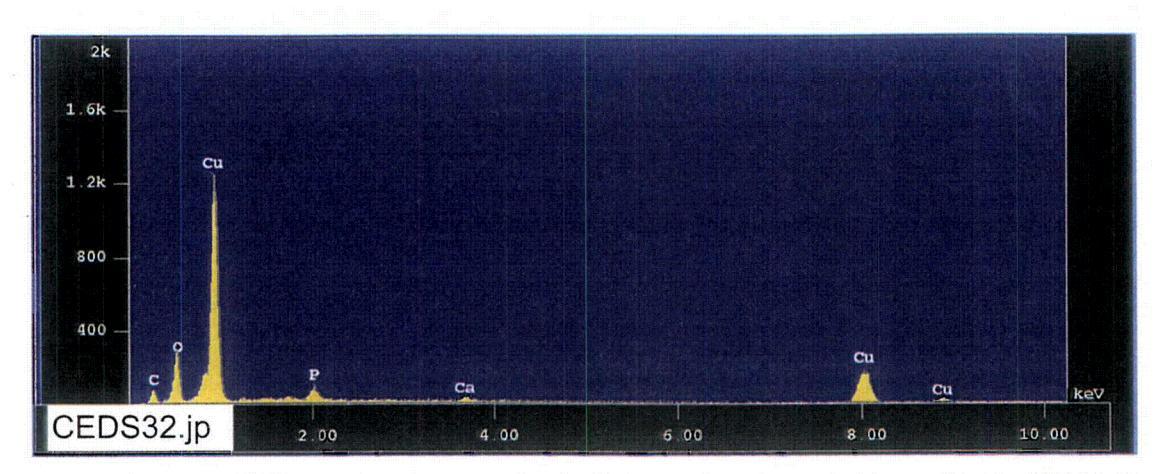
Figure C2-14. EDS counting spectrum for the light patches shown in Figure C2-11. (CEDS32)

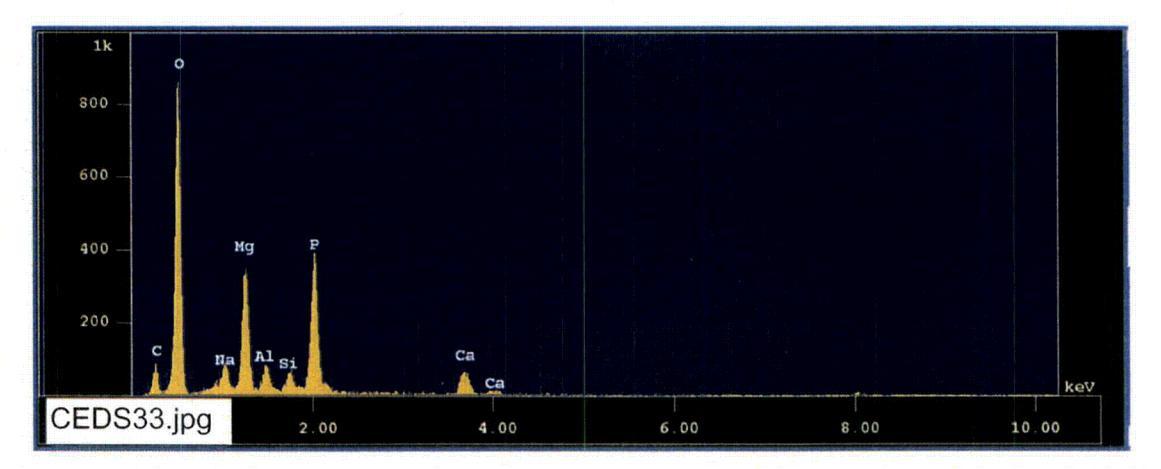
Figure C2-15. EDS counting spectrum for the lathlike crystals shown in Figure C2-12. (CEDS33)

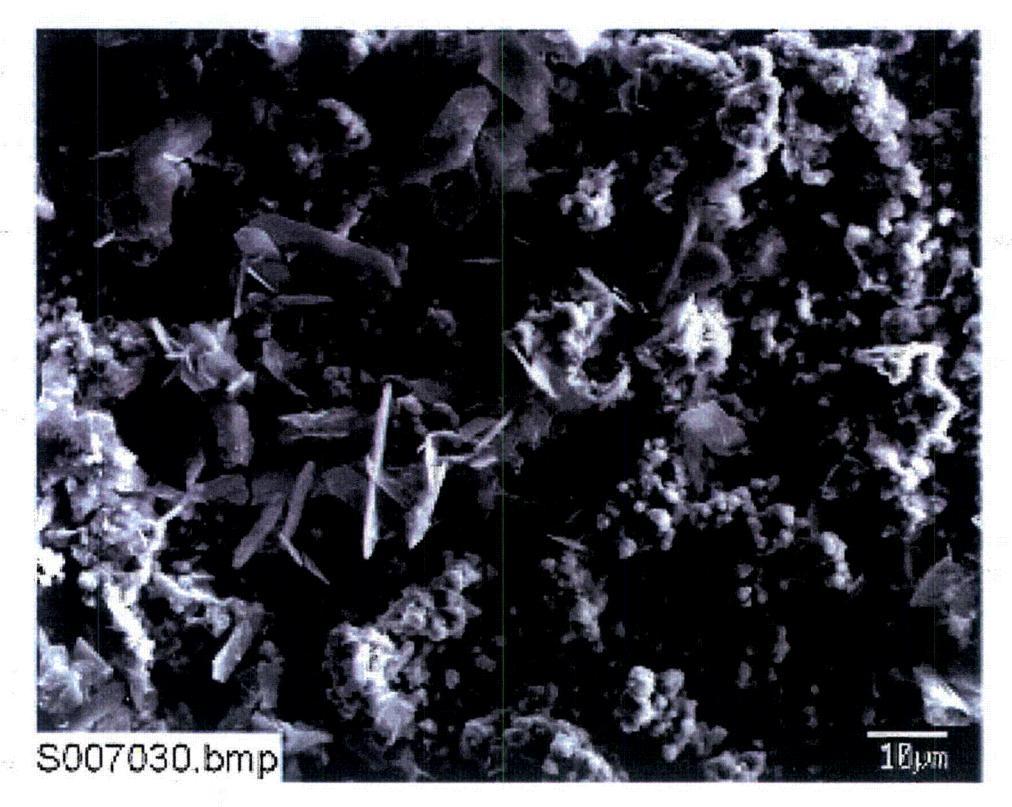
Figure C4-10. SEM image for the corrosion surface of a Test #2, Day-30 submerged steel coupon. (S007030)

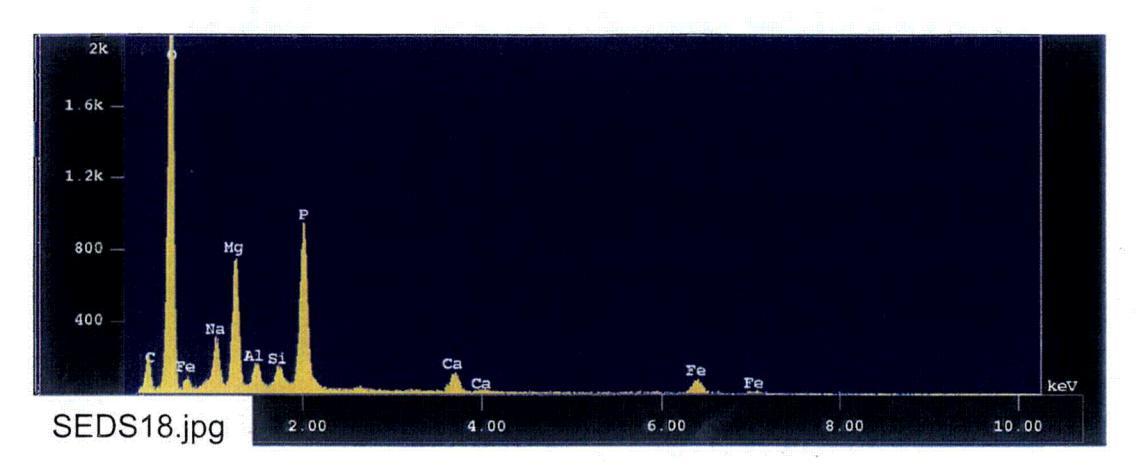
Figure C4-11. EDS counting spectrum for the thin crystals shown in Figure C4-10. (SEDS18)

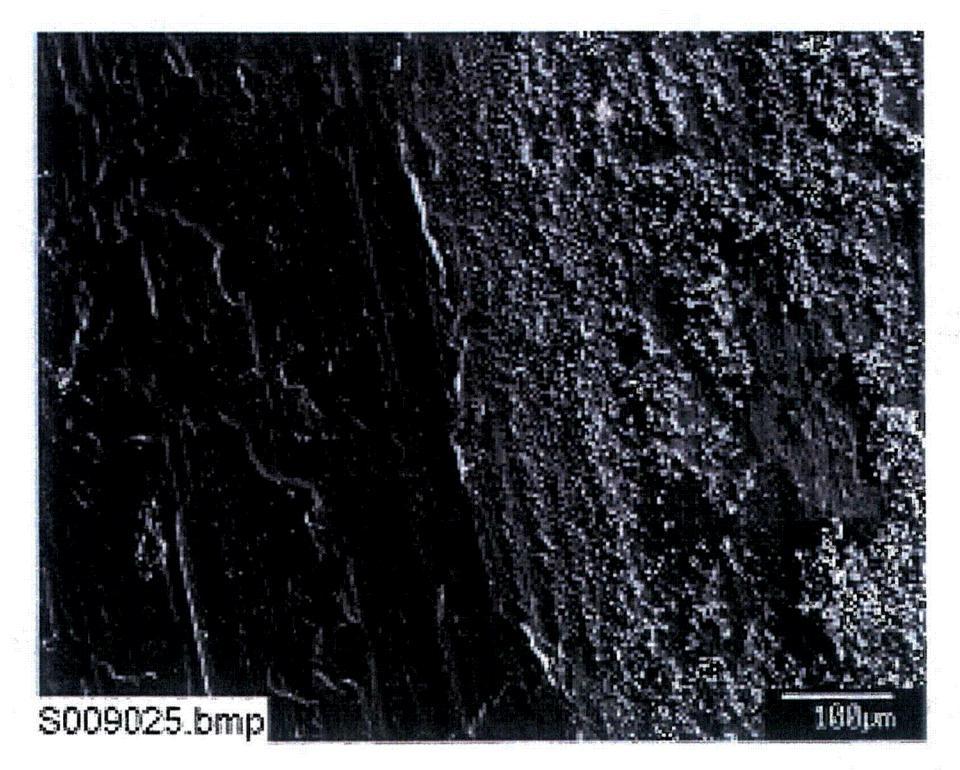
Figure C4-21. SEM image for a Test #2, Day-30 unsubmerged steel coupon (S009025). The image shows the interface between badly corroded (right) and less corroded surface (left).

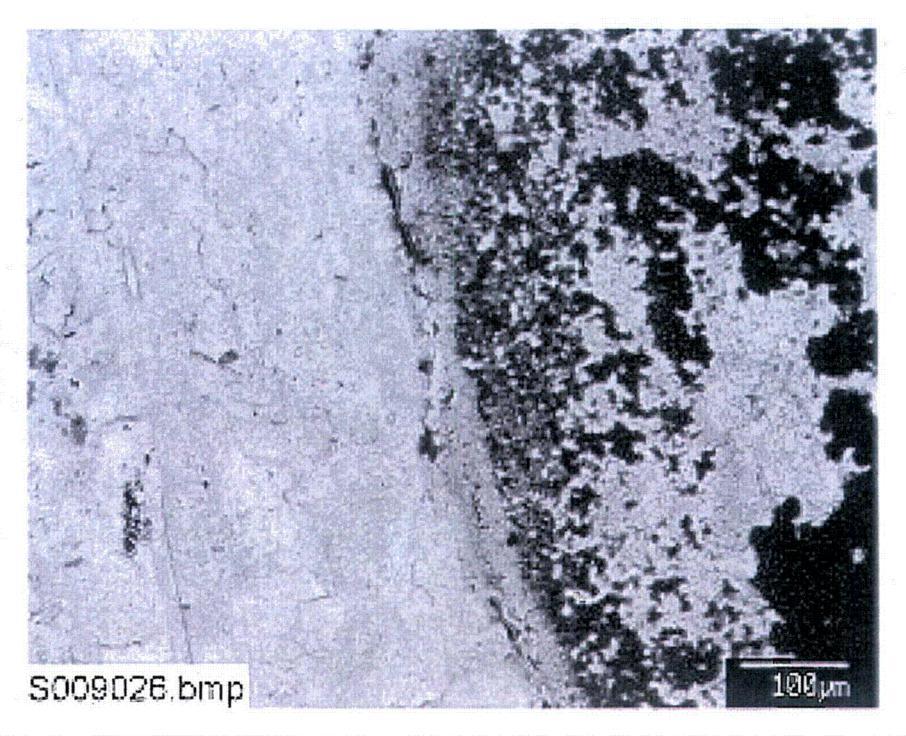
Figure C4-22. Backscattered SEM image for a Test #2, Day-30 unsubmerged steel coupon (S009026). It shows the same area as shown in Figure C4-21.

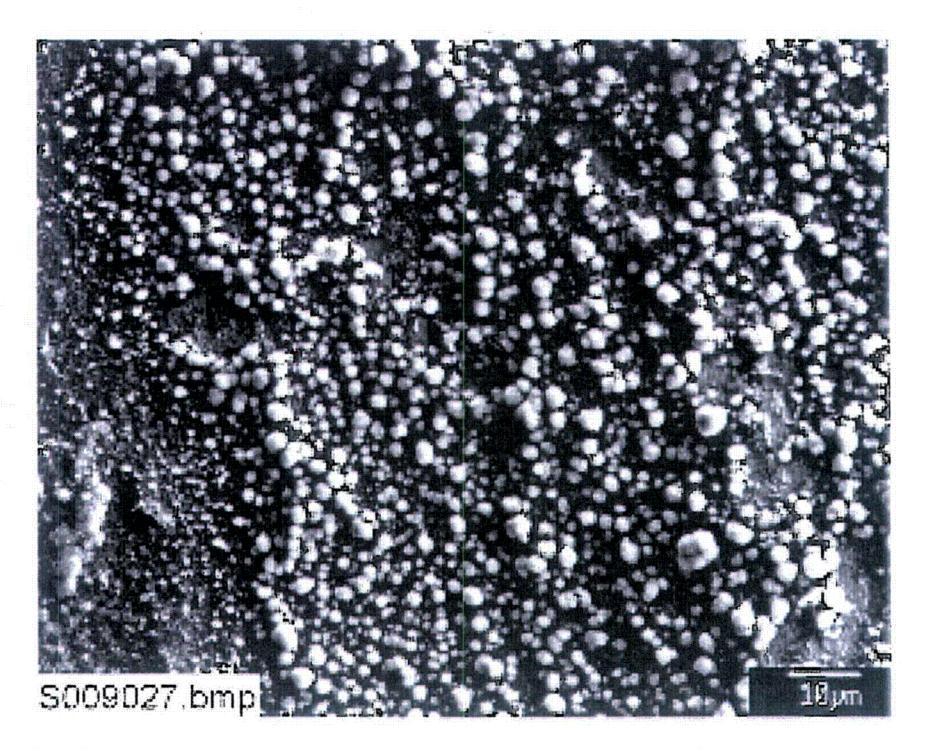
Figure C4-23. SEM image for a corroded area of a Test #2, Day-30 unsubmerged steel coupon. (S009027)

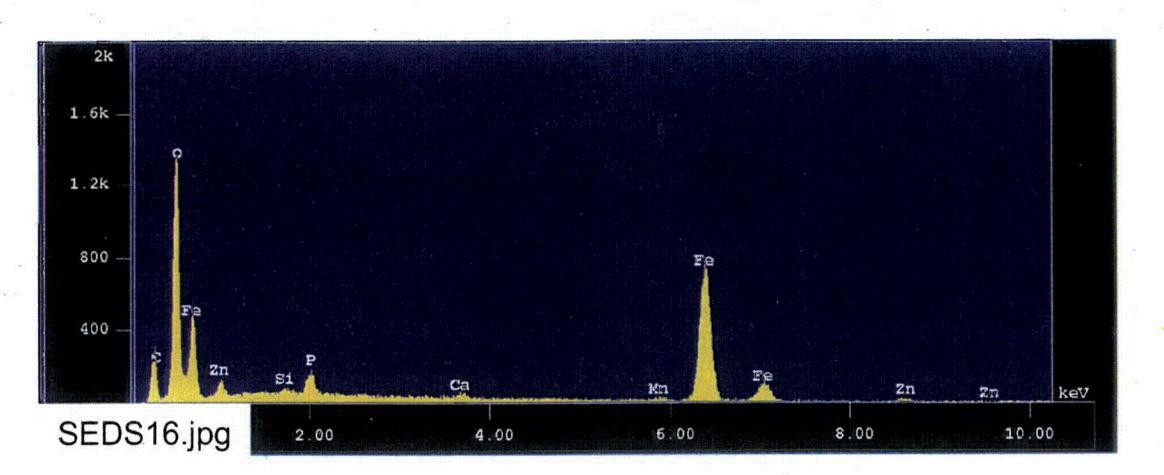
Figure C4-24. EDS counting spectrum for a clump of round corrosion crystals shown in Figure C4-23. (SEDS16)
Appendix D1

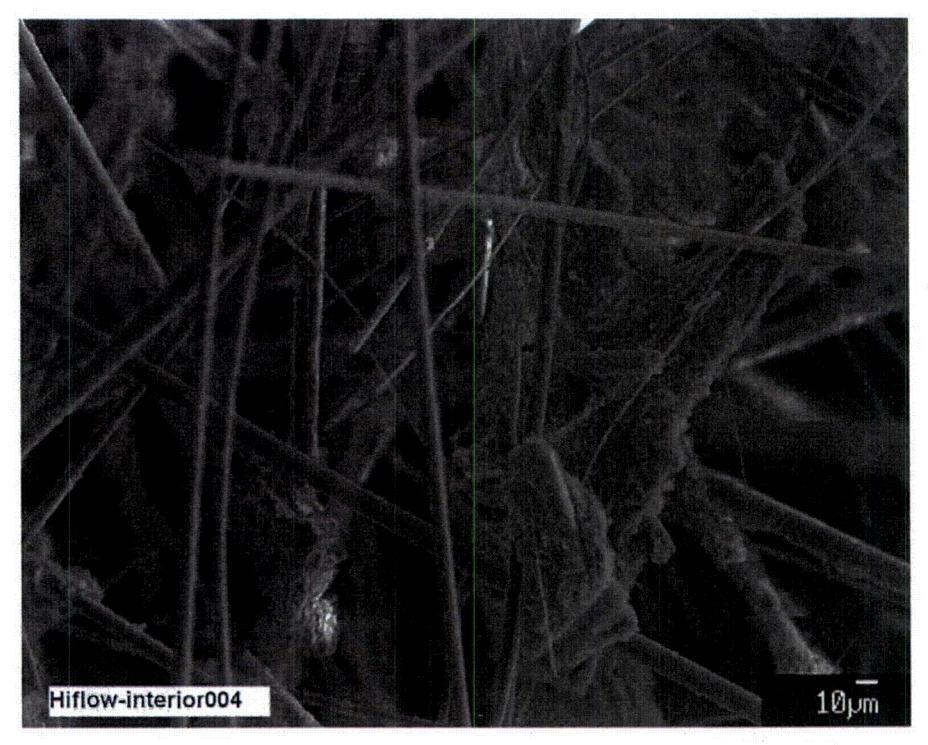
Figure D1-23. Test #2, Day-16 SEM image of deposits for high-flow interior. (Hiflow-interior004)

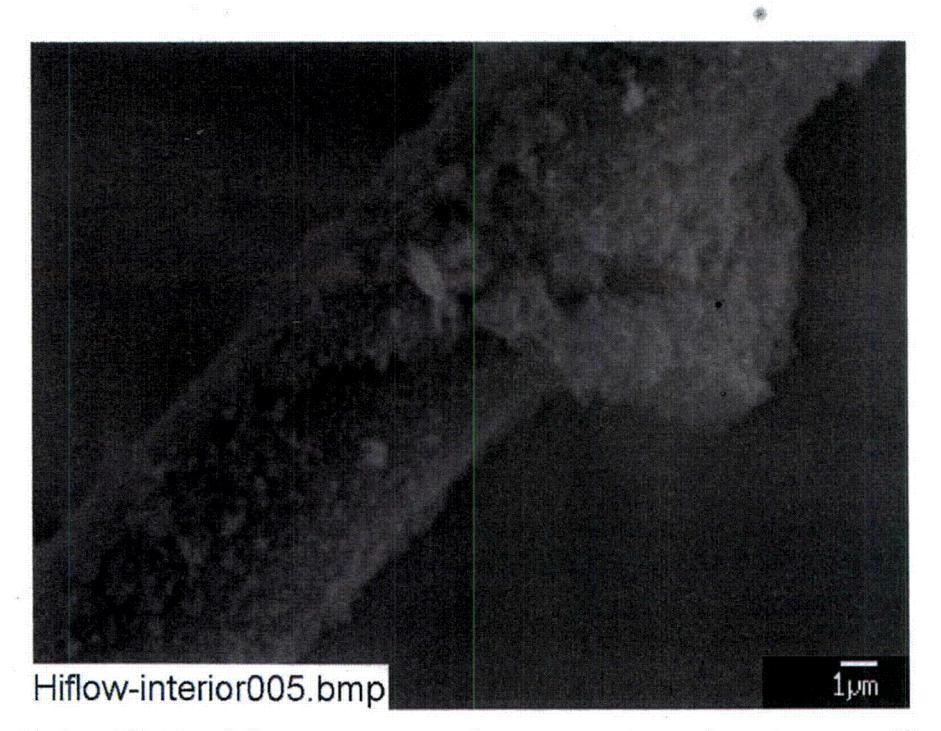
Figure D1-24. Test #2, Day-4 SEM image zoomed in on deposits on fiberglass, magnification 5000 times. (Hiflow-interior005)

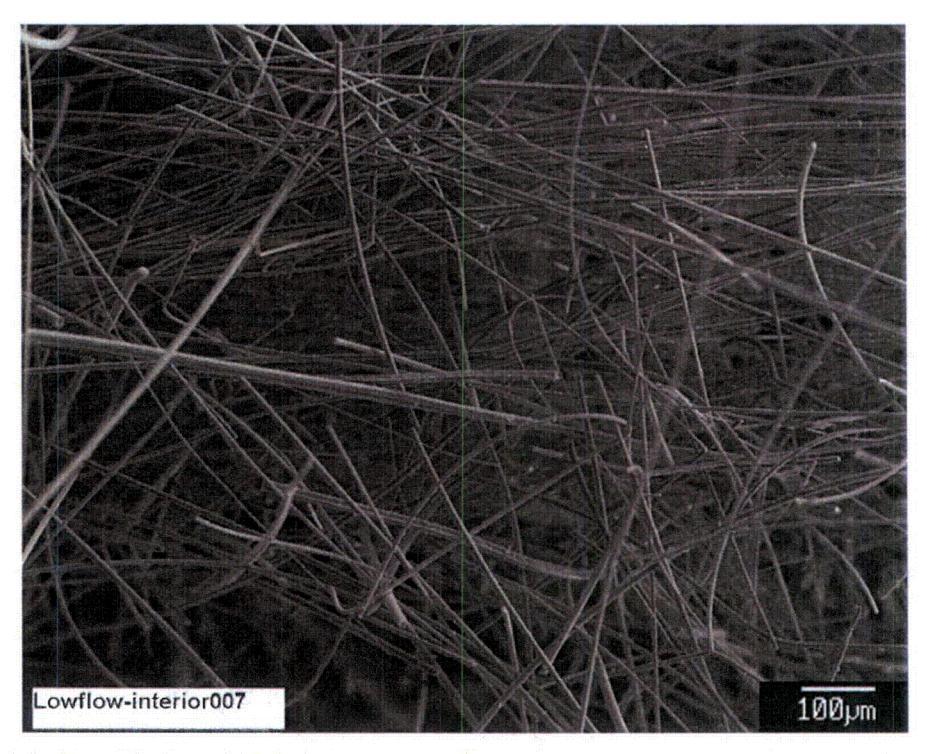
Figure D1-31. Test #2, Day-16 SEM image showing a cleaner appearance than seen in some high-flow interior samples. (Lowflow-interior007)

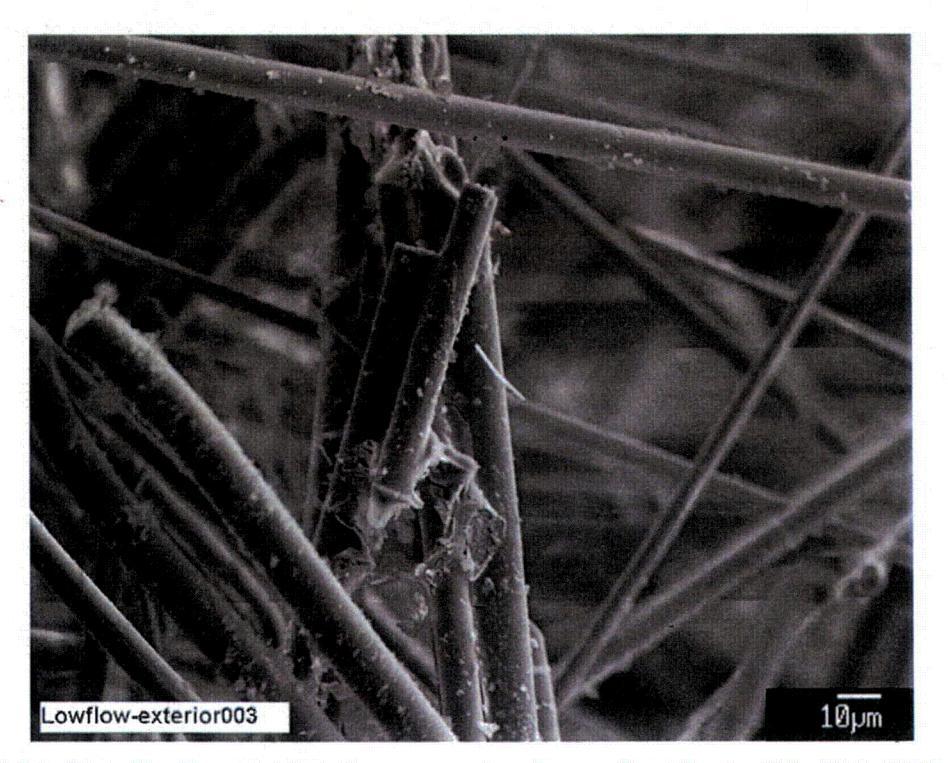
Figure D1-34. Test #2, Day-16 SEM image zooming in on deposits at 600 times magnification. (Lowflow-exterior003)

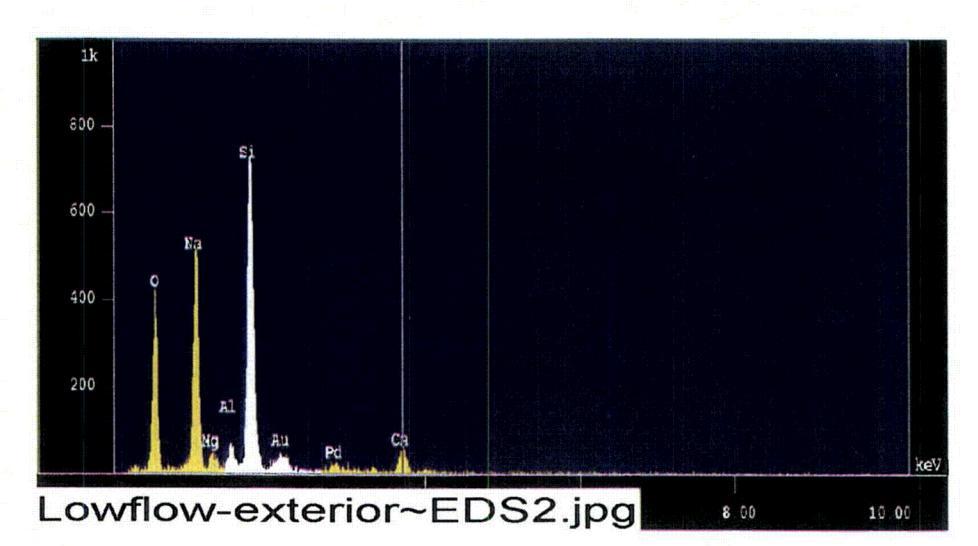
Figure D1-36. Test #2, Day-16 counting spectrum for a particle on the fiberglass shown in Figure D1-34. (Lowflow-exterior~EDS2)
