Appendix D2

ESEM and SEM/EDS Data for Test #2, Day-30 Fiberglass in High- and Low-Flow Zones

Appendix D3

ESEM and SEM/EDS Data for Test #2, Day-30 Drain Collar Fiberglass

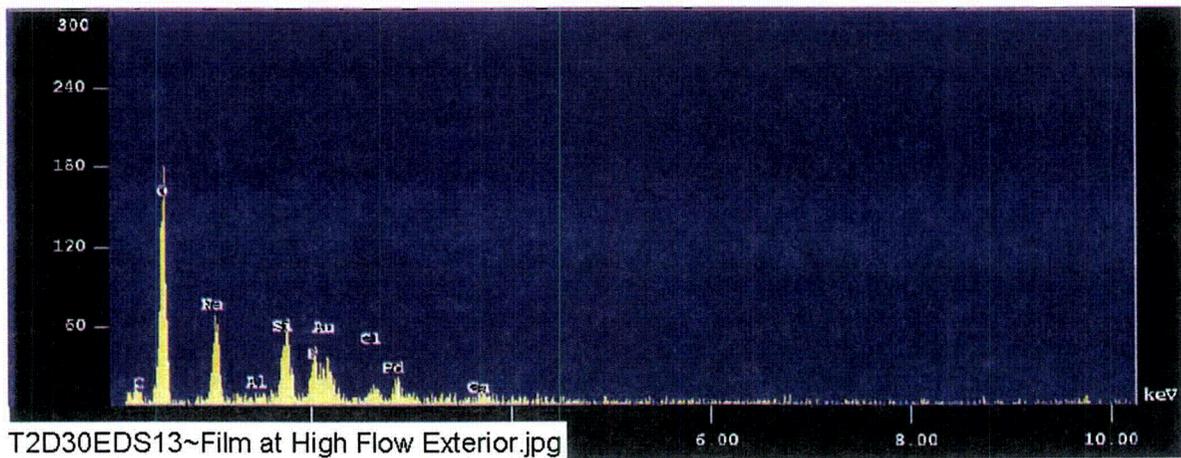
Figure D2-8. EDS counting spectrum for the film deposits or growth on fiberglass, as shown in Figure D2-7. (T2D30EDS13~Film at High Flow Exterior)

Group : NRC
 Sample : T2D30 ID# : 13
 Comment : film on HiFlow fiberglass
 Condition : Full Scale : 20KeV(10eV/ch,2Kch)
 Live Time : 60.000 sec Aperture # : 1
 Acc. Volt : 20.0 KV Probe Current : 3.247E-10 A
 Stage Point : X=48.137 Y=56.660 Z=10.558
 Acq. Date : Mon Mar 7 17:20:30 2005

Element	Mass%	Atomic%	ZAF	Z	A	F
C	0.000	0.0000	6.0057	1.0404	5.7730	0.9999
O	68.212	77.9670	0.7076	0.9928	0.7128	1.0000
Na	15.750	12.5283	1.5604	1.0448	1.4934	1.0001
Si	7.284	4.7427	1.3779	0.9953	1.3873	0.9980
P	4.750	2.8046	0.8298	1.1782	0.7048	0.9993
Cl	2.197	1.1335	1.1025	1.0478	1.0529	0.9993
Ca	1.806	0.8239	1.0120	1.0156	0.9965	1.0000

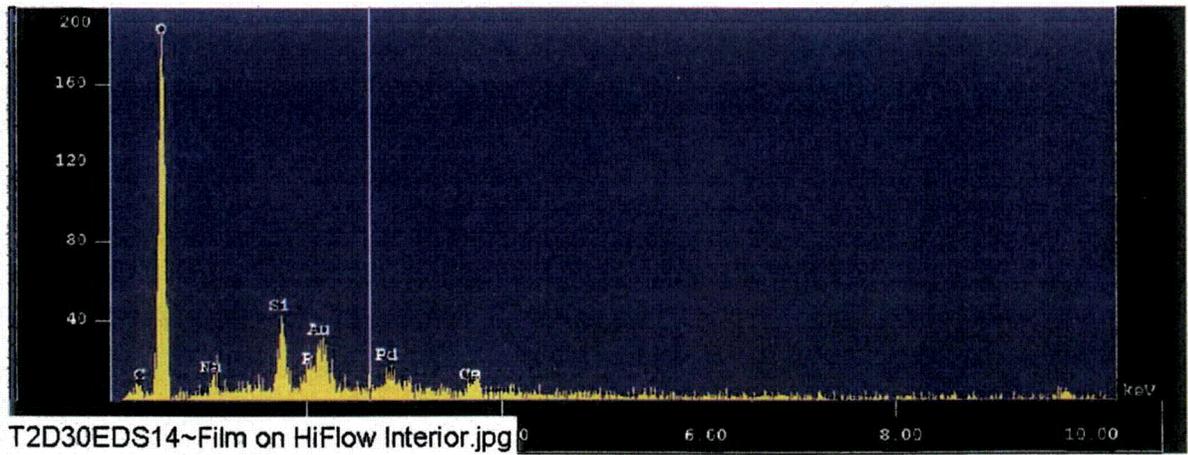
Figure D2-12. EDS counting spectrum for the film deposits or growth on fiberglass, as shown in Figure D2-11. (T2D30EDS14~Film on HiFlow Interior)

Group : NRC
 Sample : T2D30 ID# : 14
 Comment : film on hi flow fiberglass interior
 Condition : Full Scale : 20KeV(10eV/ch,2Kch)
 Live Time : 60.000 sec Aperture # : 1
 Acc. Volt : 20.0 KV Probe Current : 3.155E-10 A
 Stage Point : X=43.227 Y=69.357 Z=10.558
 Acq. Date : Mon Mar 7 17:34:53 2005

Element	Mass%	Atomic%	ZAF	Z	A	F
C	0.000	0.0000	3.8510	1.0451	3.6851	0.9999
O	85.150	90.8939	0.5770	0.9974	0.5785	1.0000
Na	4.620	3.4320	1.8017	1.0498	1.7160	1.0002
Si	6.368	3.8722	1.3235	1.0003	1.3239	0.9994
P	1.246	0.6870	0.7999	1.1842	0.6756	0.9999
Ca	2.616	1.1148	0.9886	1.0213	0.9680	1.0000

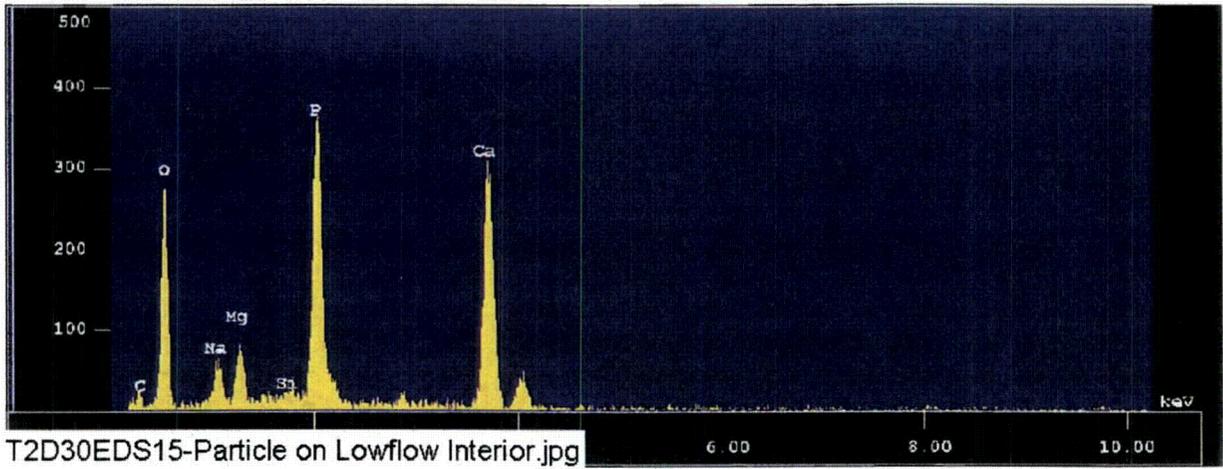
Figure D2-15. EDS counting spectrum for the particulate deposits or growth on fiberglass, as shown in Figure D2-14. (T2D30EDS15-Particle on Lowflow Interior)

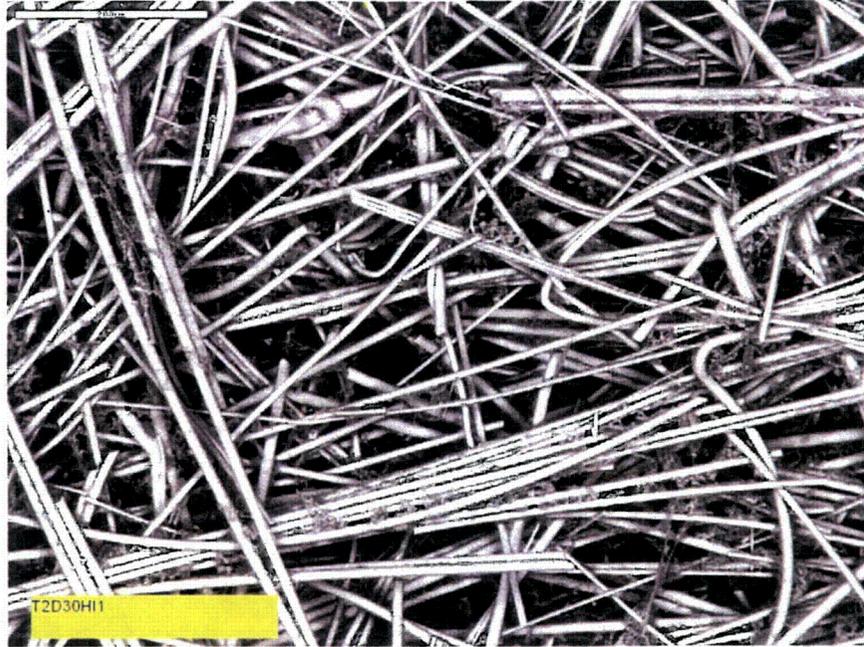
Figure D2-17. ESEM image for a Test #2, Day-30 high-flow interior fiberglass sample. It seems the interior fiberglass is cleaner than exterior fiberglass. (T2D30HI1)

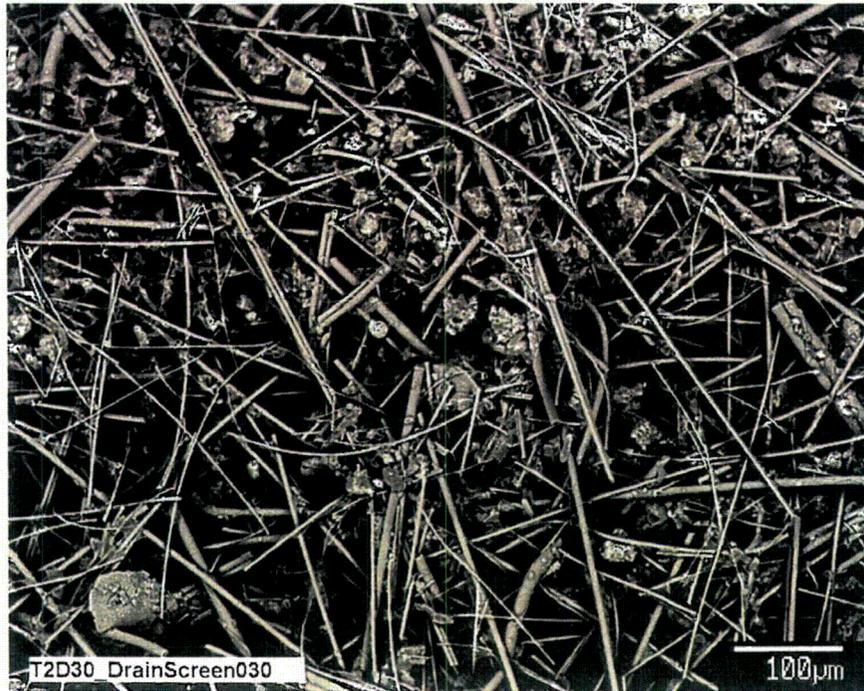
Figure D3-2. Backscattered SEM image for a Test #2, Day-30 fiberglass sample on the drain collar next to the drain screen, illustrating that deposits have a similar atomic number to fiberglass. (T2D30_DrainScreen030)

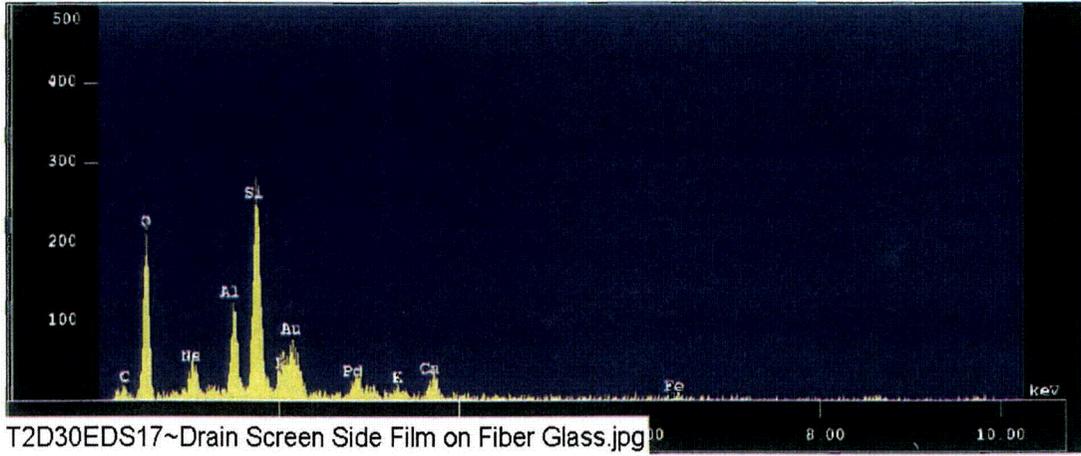
Figure D3-6. EDS counting spectrum for the film between fibers shown in Figure D3-4. The film is rich in silicon, oxygen, aluminum, sodium, and calcium. (T2D30EDS17~Drain Screen Side Film on Fiber Glass)

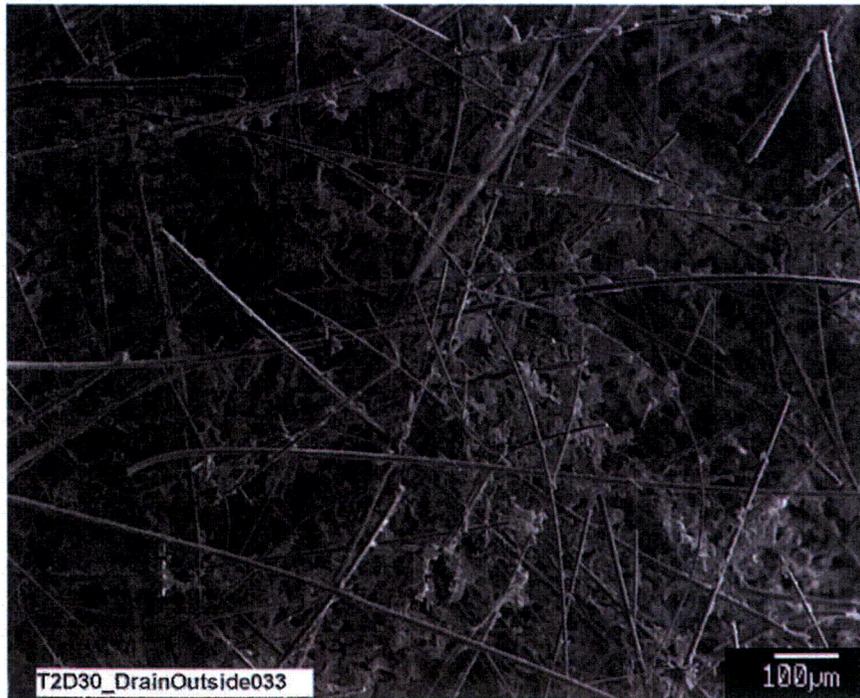
Figure D3-7. SEM image for a Test #2, Day-30 exterior fiberglass sample on the drain collar (away from the drain screen) showing deposits or growth on fiberglass. (T2D30_DrainOutside033)

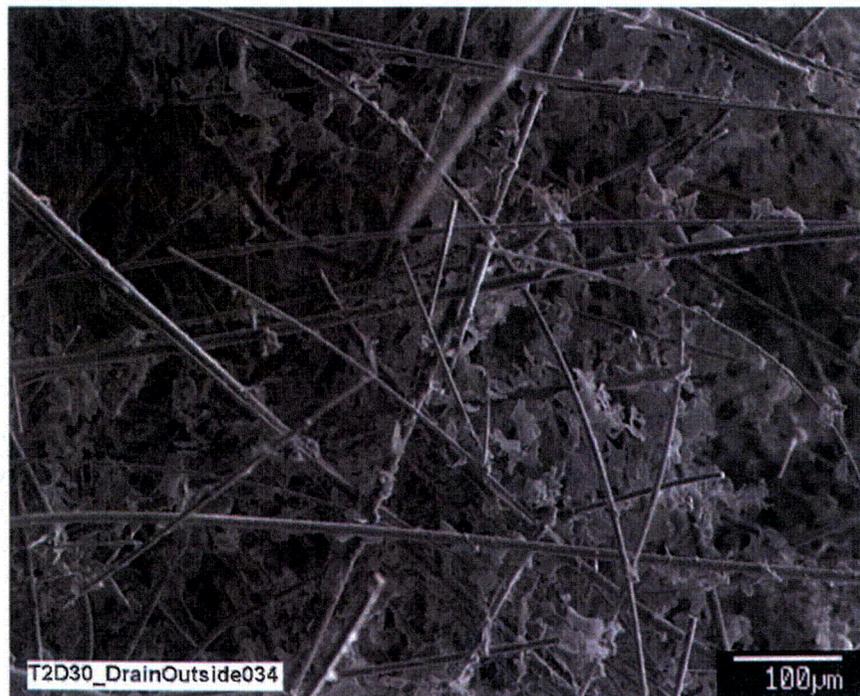
Figure D3-8. SEM image for a Test #2, Day-30 exterior fiberglass sample on the drain collar showing deposits or growth on fiberglass. (T2D30_DrainOutside034)

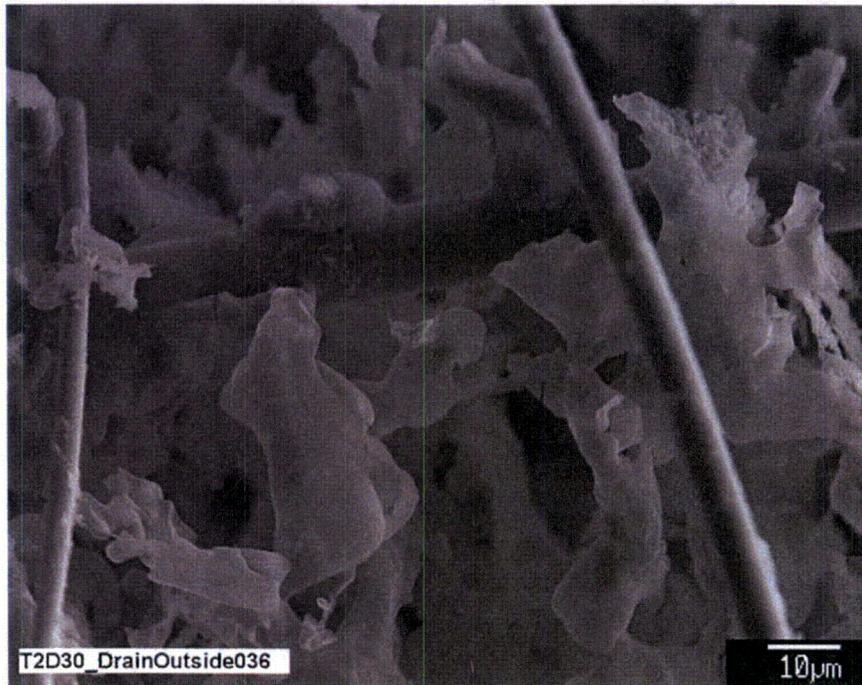
Figure D3-10. SEM image at a higher magnification for a Test #2, Day-30 exterior fiberglass sample on the drain collar showing deposits or growth on fiberglass. (T2D30_DrainOutside 036)

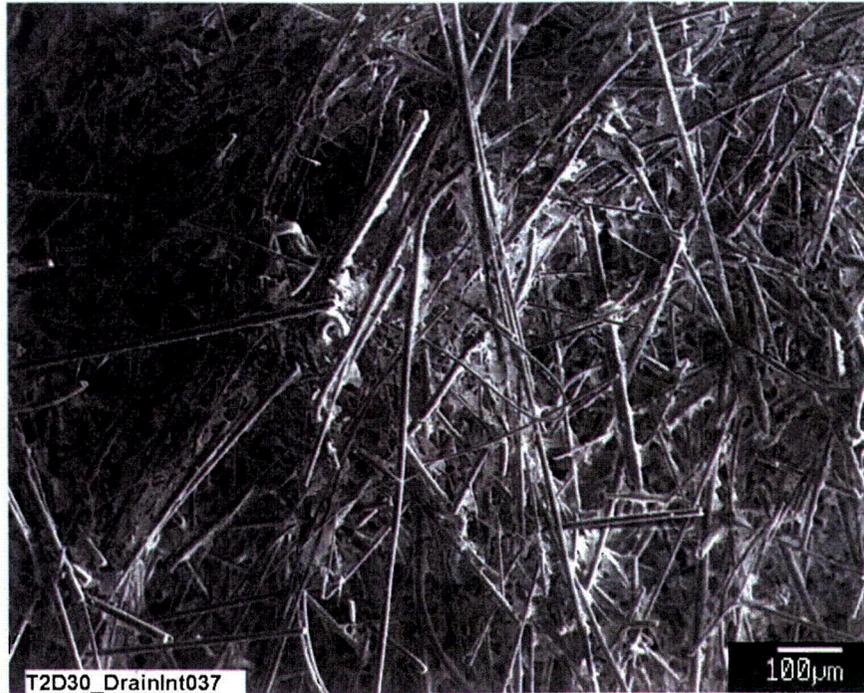
Figure D3-13. SEM image for a Test #2, Day-30 interior fiberglass sample on the drain collar. Image shows deposits or growth on fiberglass. (T2D30_DrainInt037)

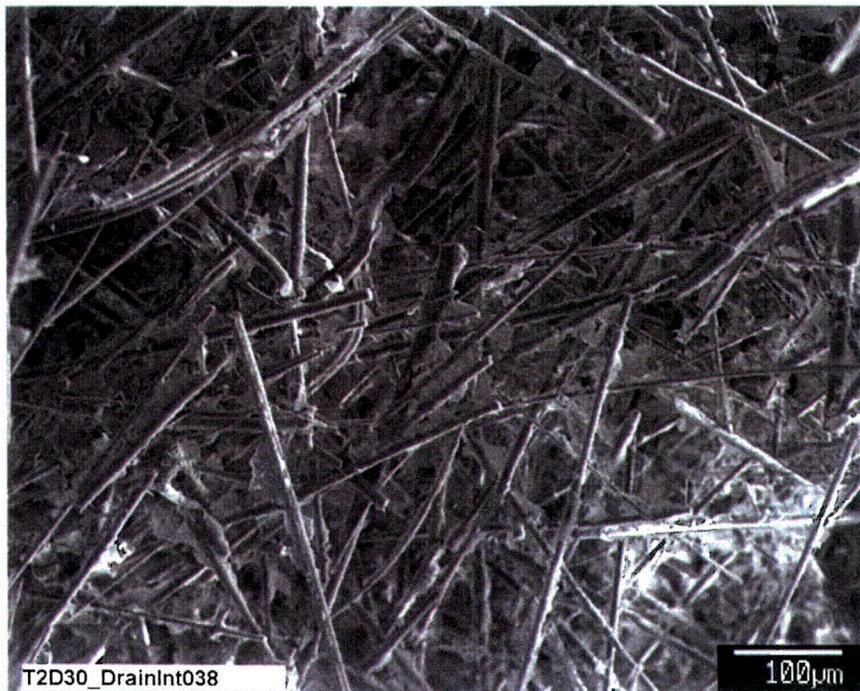
Figure D3-14. SEM image for a Test #2, Day-30 interior fiberglass sample on the drain collar. Image shows deposits or growth on fiberglass. (T2D30_DrainInt038)

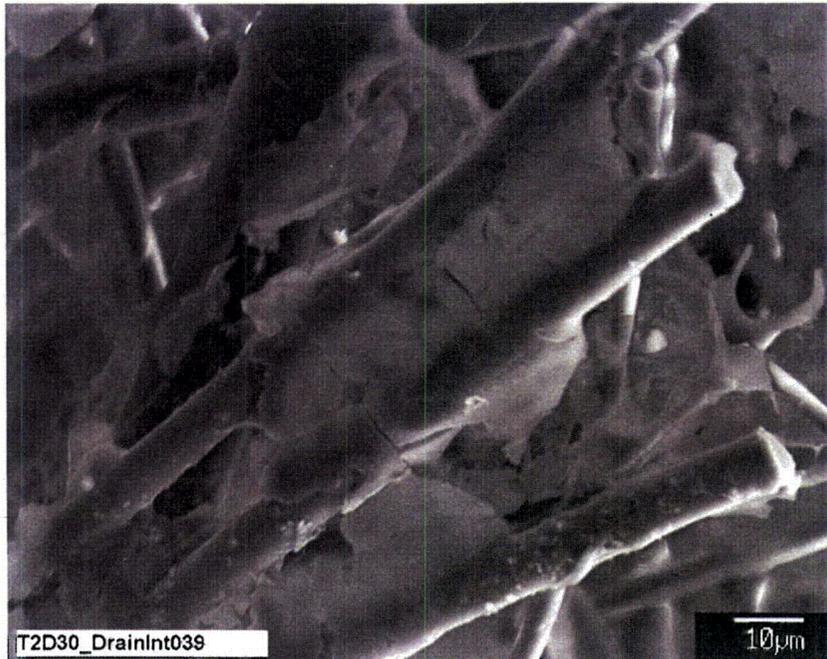
Figure D3-15. SEM image of a higher magnification for a Test #2, Day-30 interior fiberglass sample on the drain collar. The image shows deposits or growth on fiberglass. (T2D30_DrainInt039)

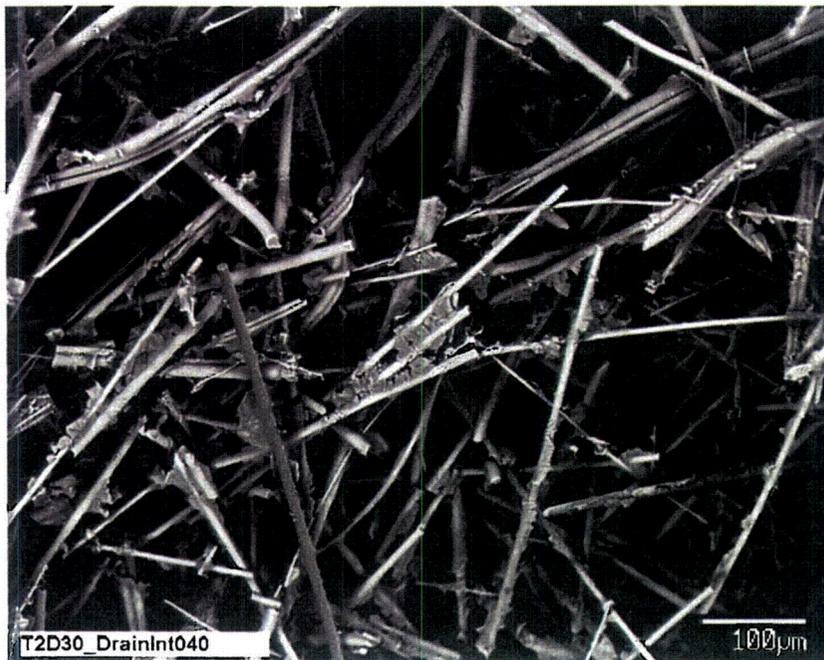
Figure D3-16. Backscattered SEM image for a Test #2, Day-30 interior fiberglass sample on the drain collar. Deposits appear to have a similar or lower atomic number as compared with fiberglass. (T2D30_DrainInt040)

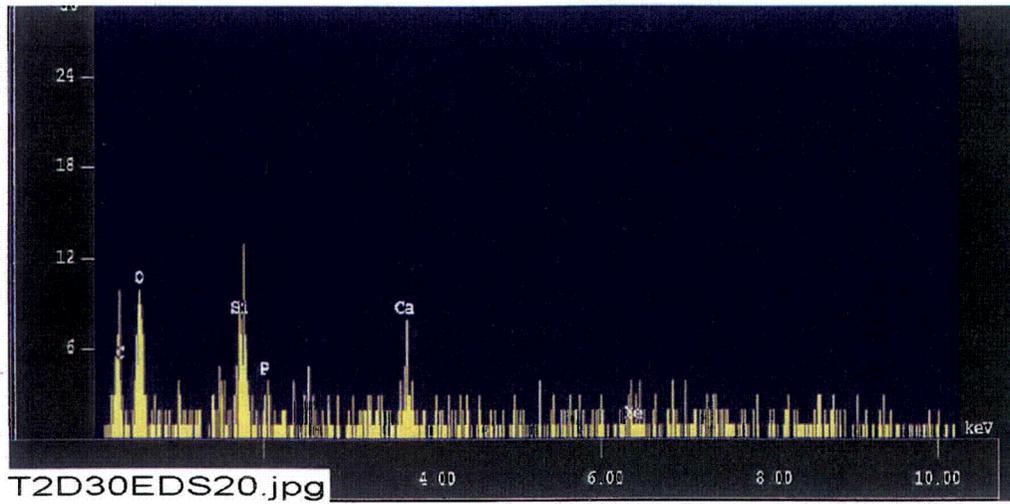
Figure D3-17. EDS counting spectrum for the deposits or growth on fiberglass. The deposits are rich in silicon, carbon, oxygen, and calcium. The deposits are very thin, and thus it was difficult to obtain high-quality EDS spectra. (T2D30EDS20)

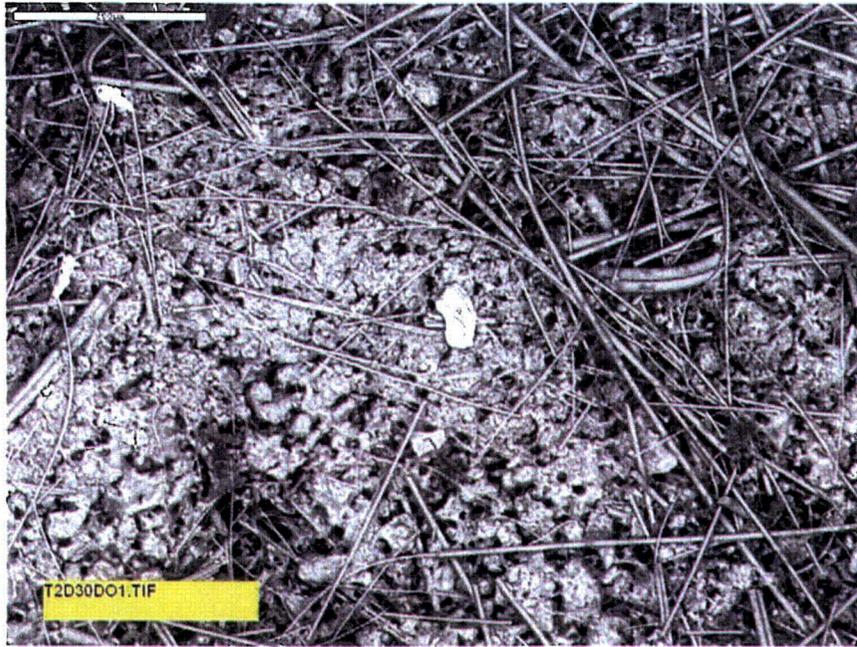
Figure D3-18. ESEM image for a Test #2, Day-30 exterior fiberglass sample on the drain collar. Image shows particulate deposits or growth on fiberglass. (T2D30DO1)

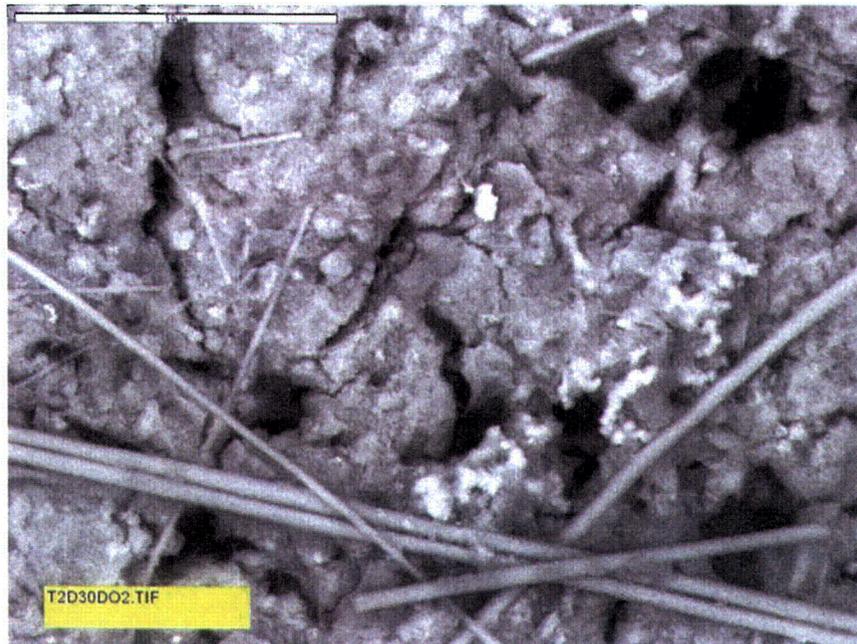
Figure D3-19. ESEM image of a higher magnification for a Test #2, Day-30 exterior fiberglass sample on the drain collar. The image shows particulate deposits or growth on fiberglass. (T2D30DO2)

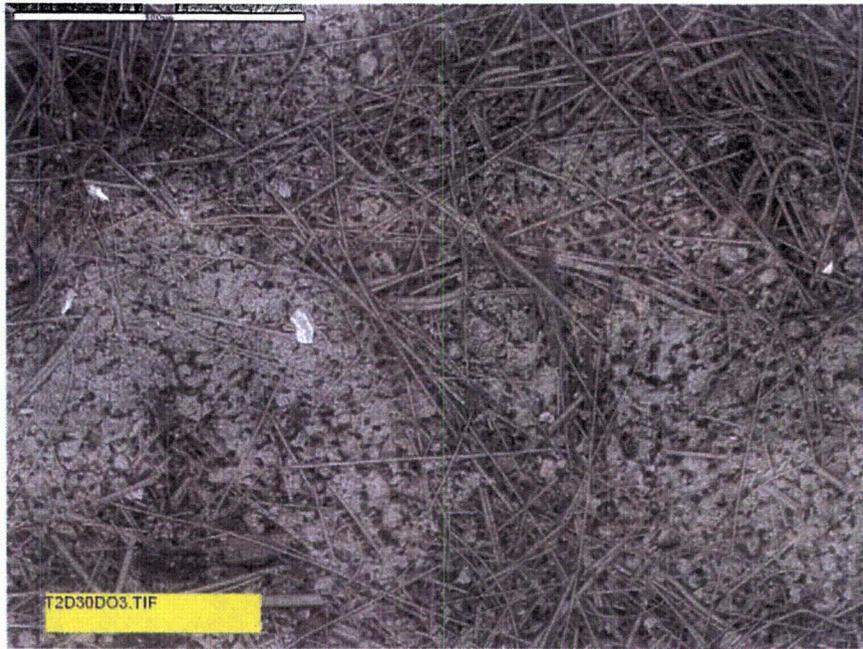
Figure D3-20. ESEM image for a Test #2, Day-30 exterior fiberglass sample on the drain collar. Image shows particulate deposits or growth on fiberglass. (T2D30DO3)

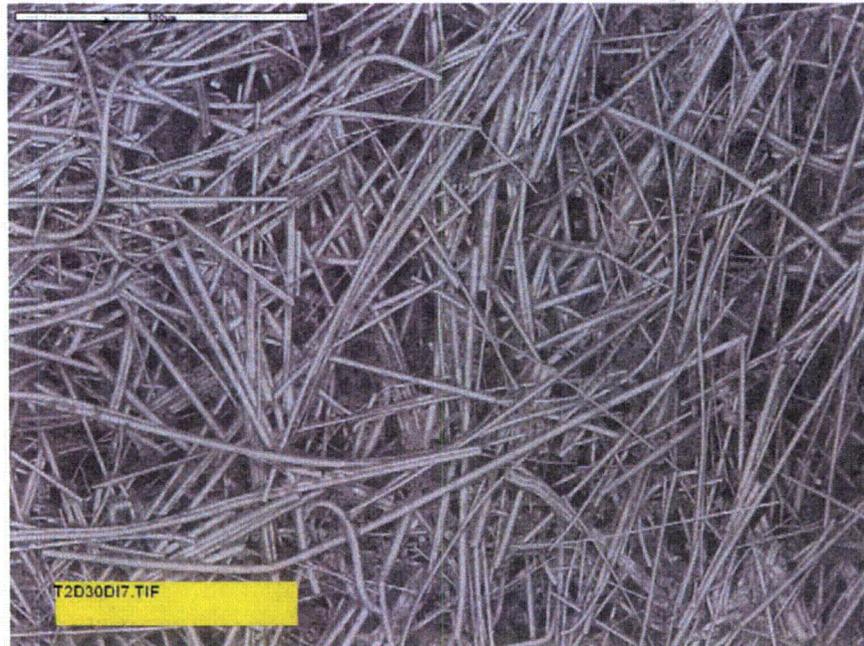
Figure D3-24. ESEM image for a Test #2, Day-30 interior fiberglass sample on the drain collar. Image suggests that interior fiberglass was relatively clean as compared with exterior. (T2D30D17)

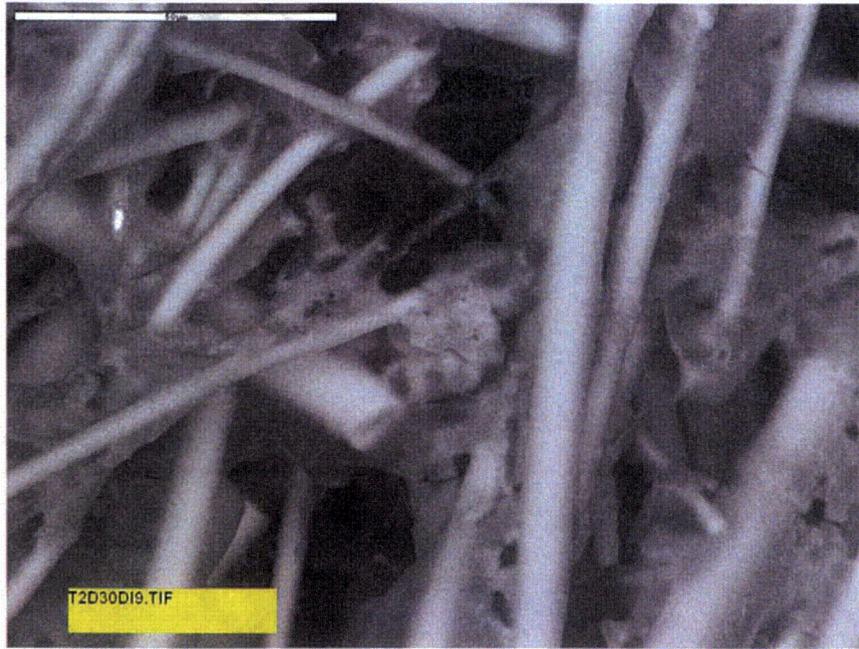
Figure D3-26. ESEM image of a higher magnification for a Test #2, Day-30 interior fiberglass sample on the drain collar. The image shows deposits or growth on the interior fiberglass, although the quantity was less than for exterior samples. (T2D30D19)

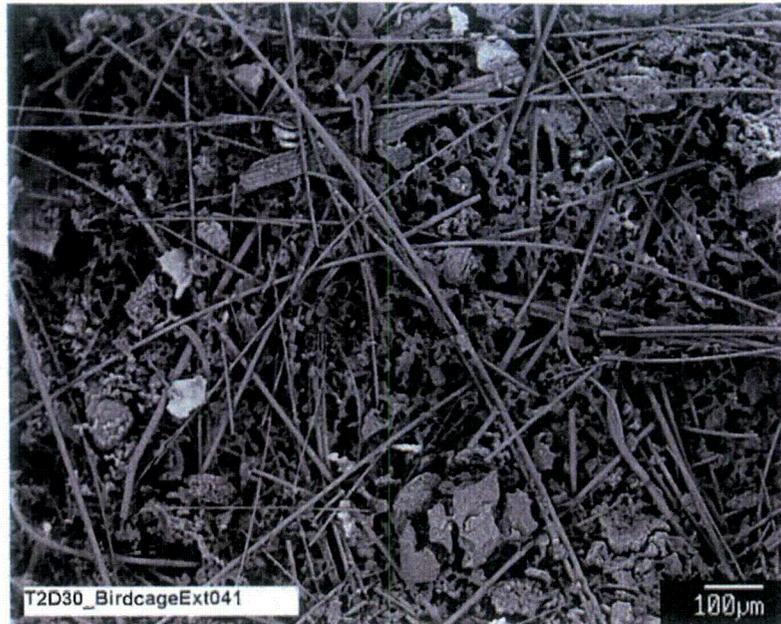
Figure D4-1. SEM image for a Test #2, Day-30 exterior fiberglass sample within the birdcage. The image shows particulate deposits or growth on fiberglass. (TD30_BirdcageExt041)

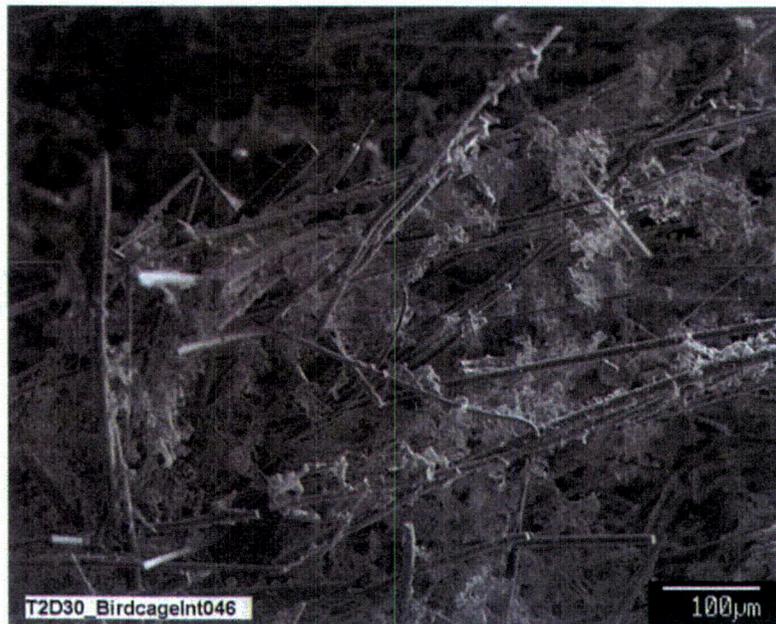
Figure D4-9. SEM image for a Test #2, Day-30 interior fiberglass sample within the birdcage. The image shows deposits or growth on the fiberglass. (T2D30_BirdcageInt046)

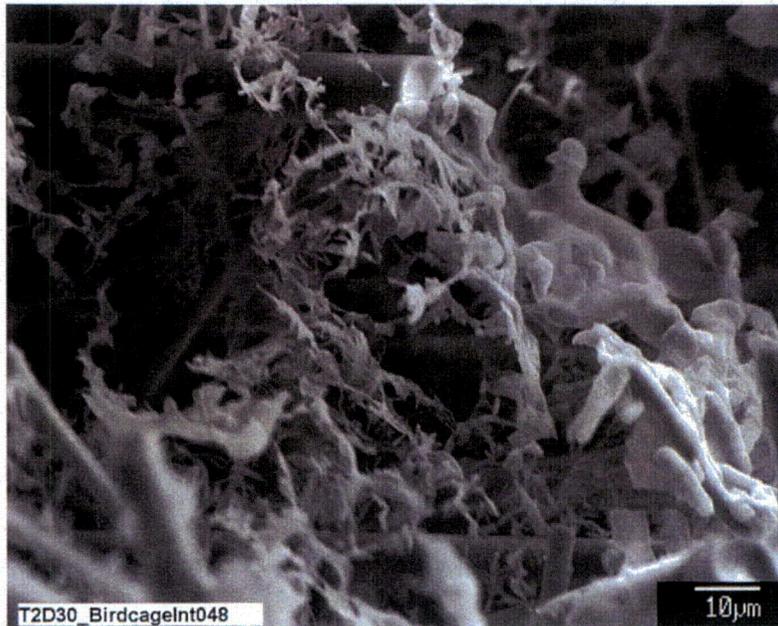
Figure D4-11. SEM image of a higher magnification for a Test #2, Day-30 interior fiberglass sample within the birdcage. The image shows deposits or growth on the fiberglass. (T2D30_BirdcageInt048)
