VIRGINIA ELECTRIC AND POWER COMPANY **SURRY POWER STATION UNITS 1 AND 2 RESPONSE TO REQUEST FOR ADDITIONAL INFORMATION** 2006 STEAM GENERATOR INSERVICE INSPECTION REPORTS

<u>Response to NRC Request for Additional Information Regarding</u> 2006 Steam Generator Inservice Inspection Reports

Surry Power Station Units 1 and 2

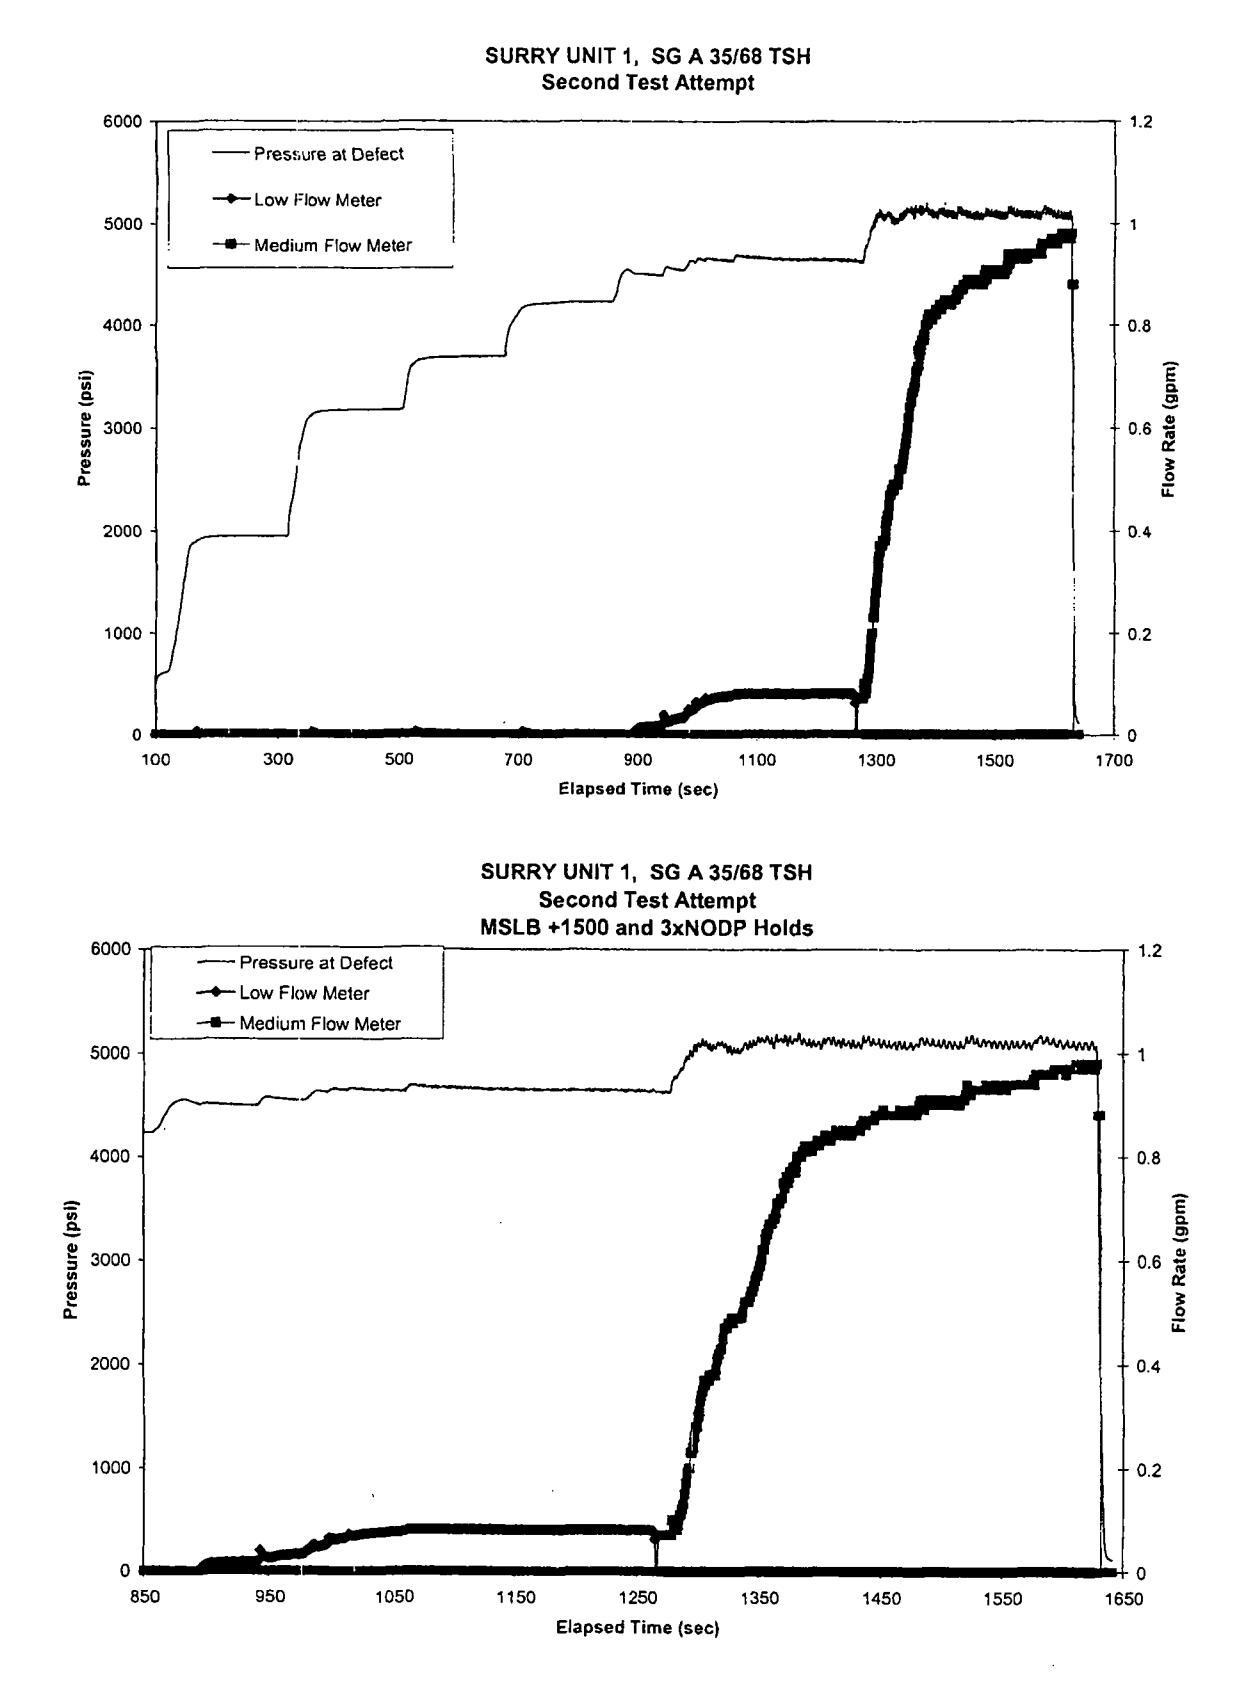
Leak Rate and Pressure versus Time Plot for the In-situ Pressure Test Performed on Tube Row 35 Column 68 in the "A" Steam Generator

3. During the Surry 1 outage, there was extensive discussion concerning the in-situ pressure test of Tube Row 35 Column 68 in SG A. Please provide a copy of the leak rate and pressure versus time plot for this in-situ pressure test (for historical reference).

A copy of the leak rate and pressure versus time plot for the in-situ pressure test performed on Tube Row 35 Column 68 in Surry Unit 1 SG A is provided in the attachment to this enclosure. As noted on the plot, the information provided is for the second in-situ test that was performed on the subject tube. The first in-situ test attempt was aborted due to a faulty medium flow meter that required replacement prior to completing the test.
