AmerGen Energy Company, LLC

(License Renewal for Oyster Creek Nuclear Generating Station) Docket No. 50-219

## AFFIDAVIT OF PETER TAMBURRO

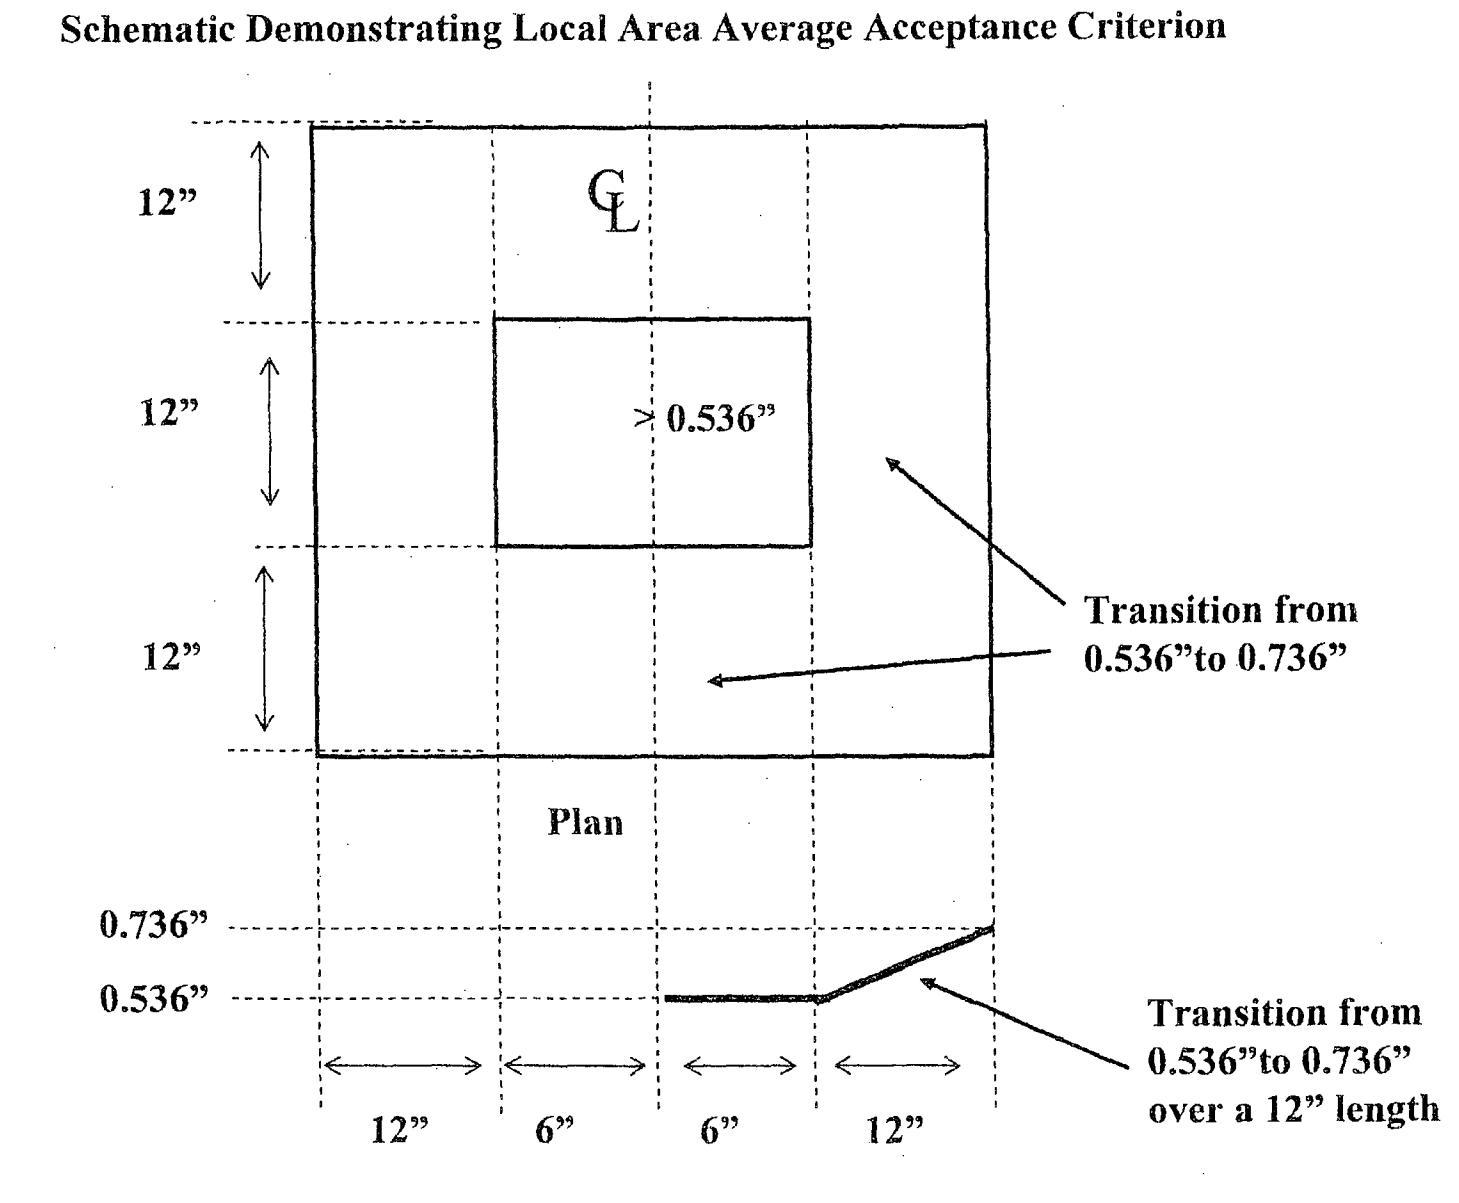
- 20. Thus, there are two criteria relevant to Citizens' argument. The first criterion is a *general* average thickness of 0.736". An area of average thickness less than 0.736" remains adequate if it meets the second criterion, which is the 0.536" *local area* average thickness, and other factors such as location, configuration, etc. This local

area criterion includes a one-foot *transition area* to 0.736" on all four sides of the 0.536" area, such that the total allowable contiguous area with thickness below 0.736 is *nine square feet*. This is clearly shown on Figure 1 which I created, and which is based on the GE Nuclear report that was attached to the AmerGen submittal to the ACRS on December 8, 2006, as Reference 22.

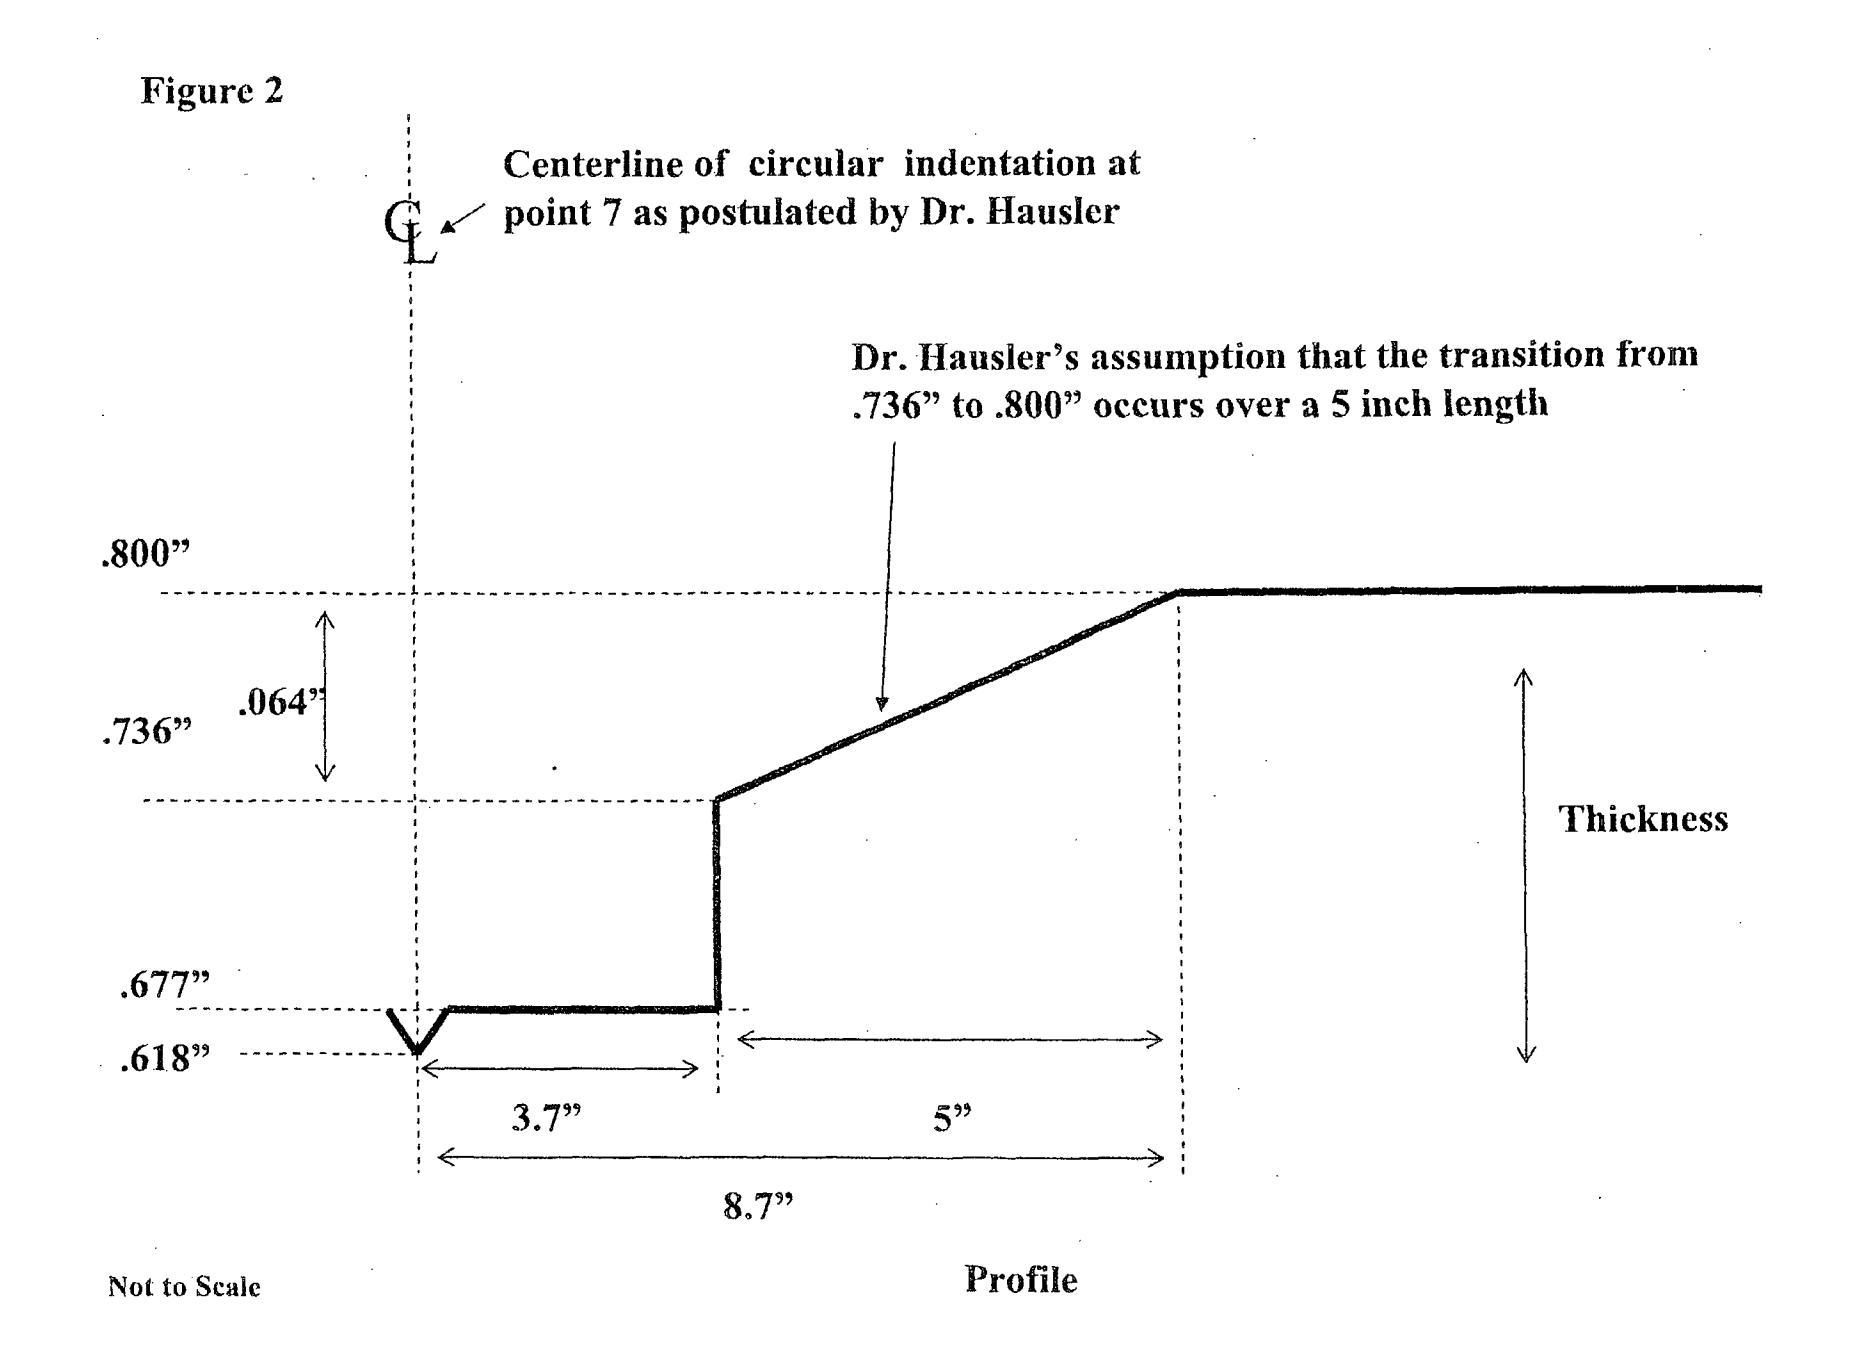
- 22. Dr. Hausler's misunderstanding seems to stem from his belief that the local area acceptance criterion is configured with an abrupt step-change (like a cliff) on all sides of the one square foot area that averages 0.536", such that the thickness increases to 0.736" with no transition. See Figure 2.

- 30. On page 7 of his June 23, 2006 memorandum, Dr. Hausler states that the total area less than 0.736" at "point 7", referring to the area which averages 0.677", is 0.3 square feet. Although the 1992 Oyster Creek reports describe this area as a 6" by 6" square area, Dr. Hausler elects to convert this area into a circular area. The corresponding radius of the circular area, which is 0.3 feet square, is 3.7 inches. I have created Figure 2 to show a profile representing these measurements.

- 31. Dr. Hausler's next statement is an assumption that is not supported by the data. Dr. Hausler states on page 7 of his June 23, 2006 memorandum that "this area is very sensitive to corrosion because in a length of around 5 inches, the thickness changed from around 0.736 inches to 0.800 inches. Assuming the edge of the hole is a straight line, this means that a change of 0.064 inches in depth occurs over about 5 inches in length." Dr. Hausler assumes that the transition from the thinner area less than 0.736" to areas that are 0.800" or thicker is 5" long (radially). As I said, this assumption is not supported by the data. However, if you construct a model of a hypothetical indentation as described in this unsupported assumption using the 5" transition zone and the corresponding inner radius of the 3.7", the total radius of the model is 8.7" or 17.4" in diameter. Figure 2 also shows this configuration.

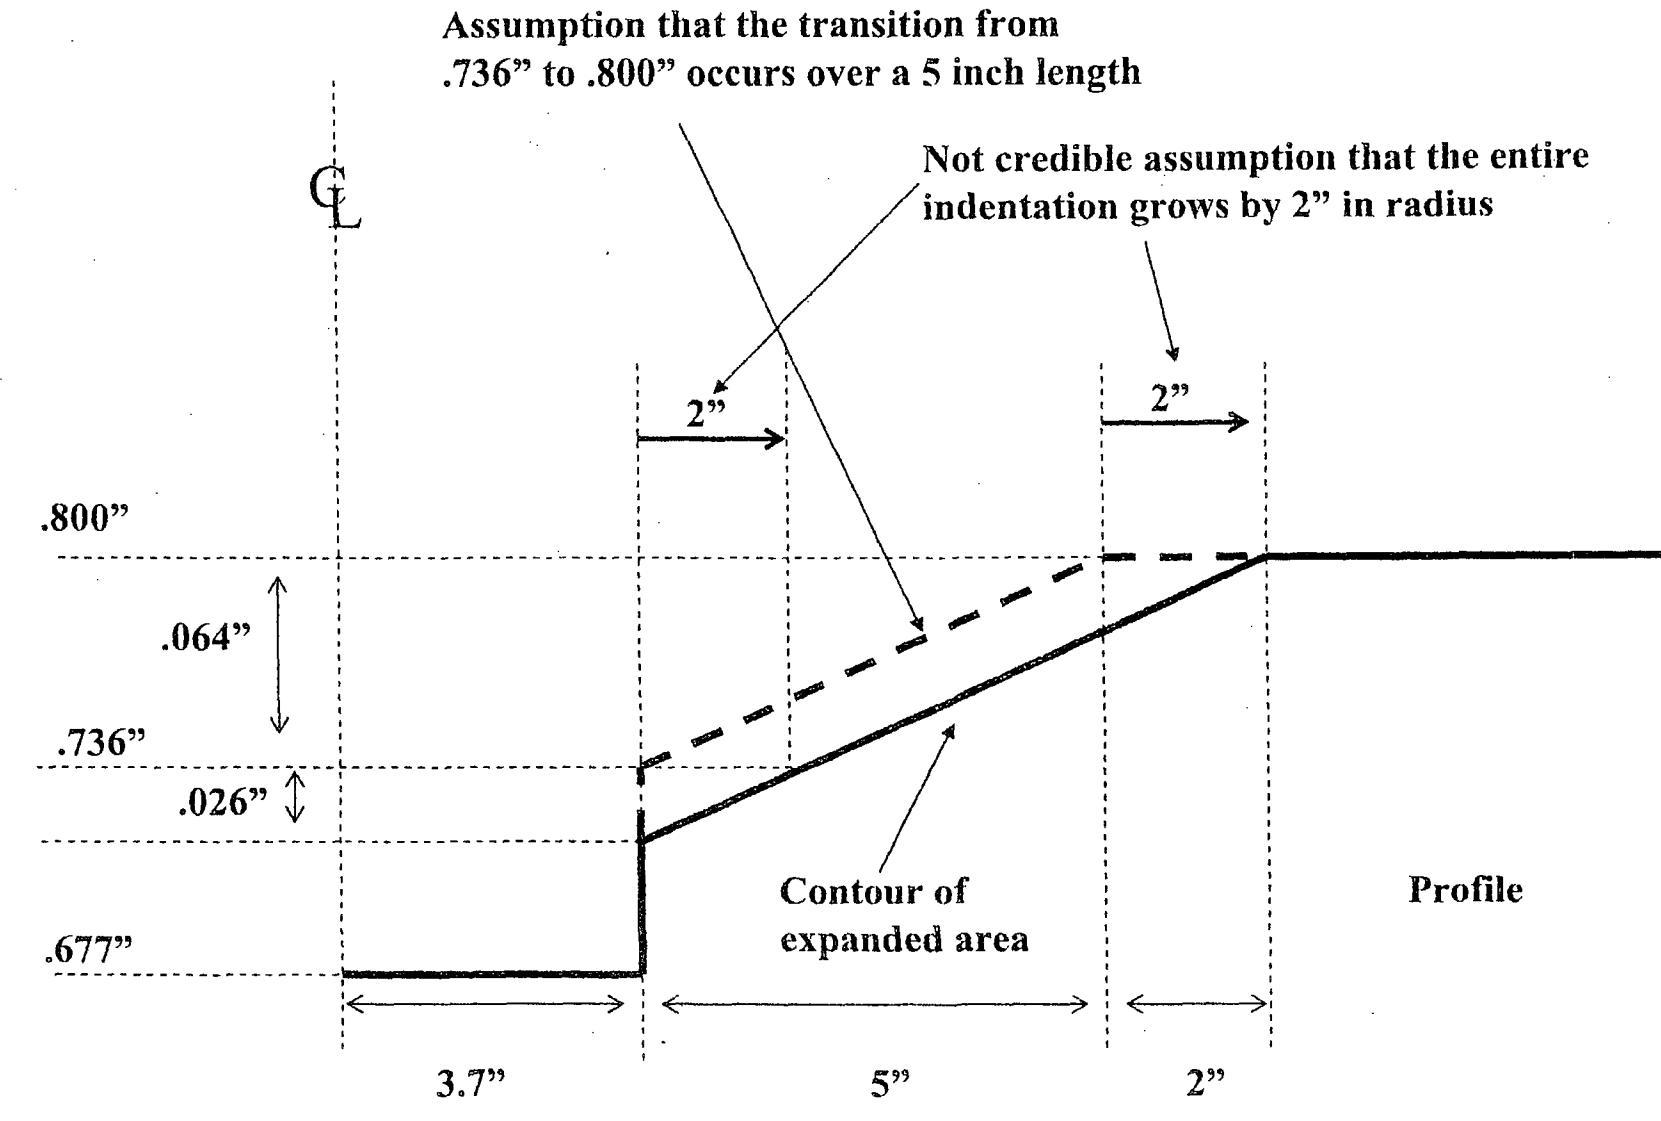
Regardless, by expanding the radius of the indentation by 2", the diameter of the indentation would increase by 4", for a total diameter of 21.7" (this is larger than Dr. Haulser's memo which mentions 17.4" diameter). I have created Figure 3 to show the increase of the radius of the hypothetical indentation by 2".

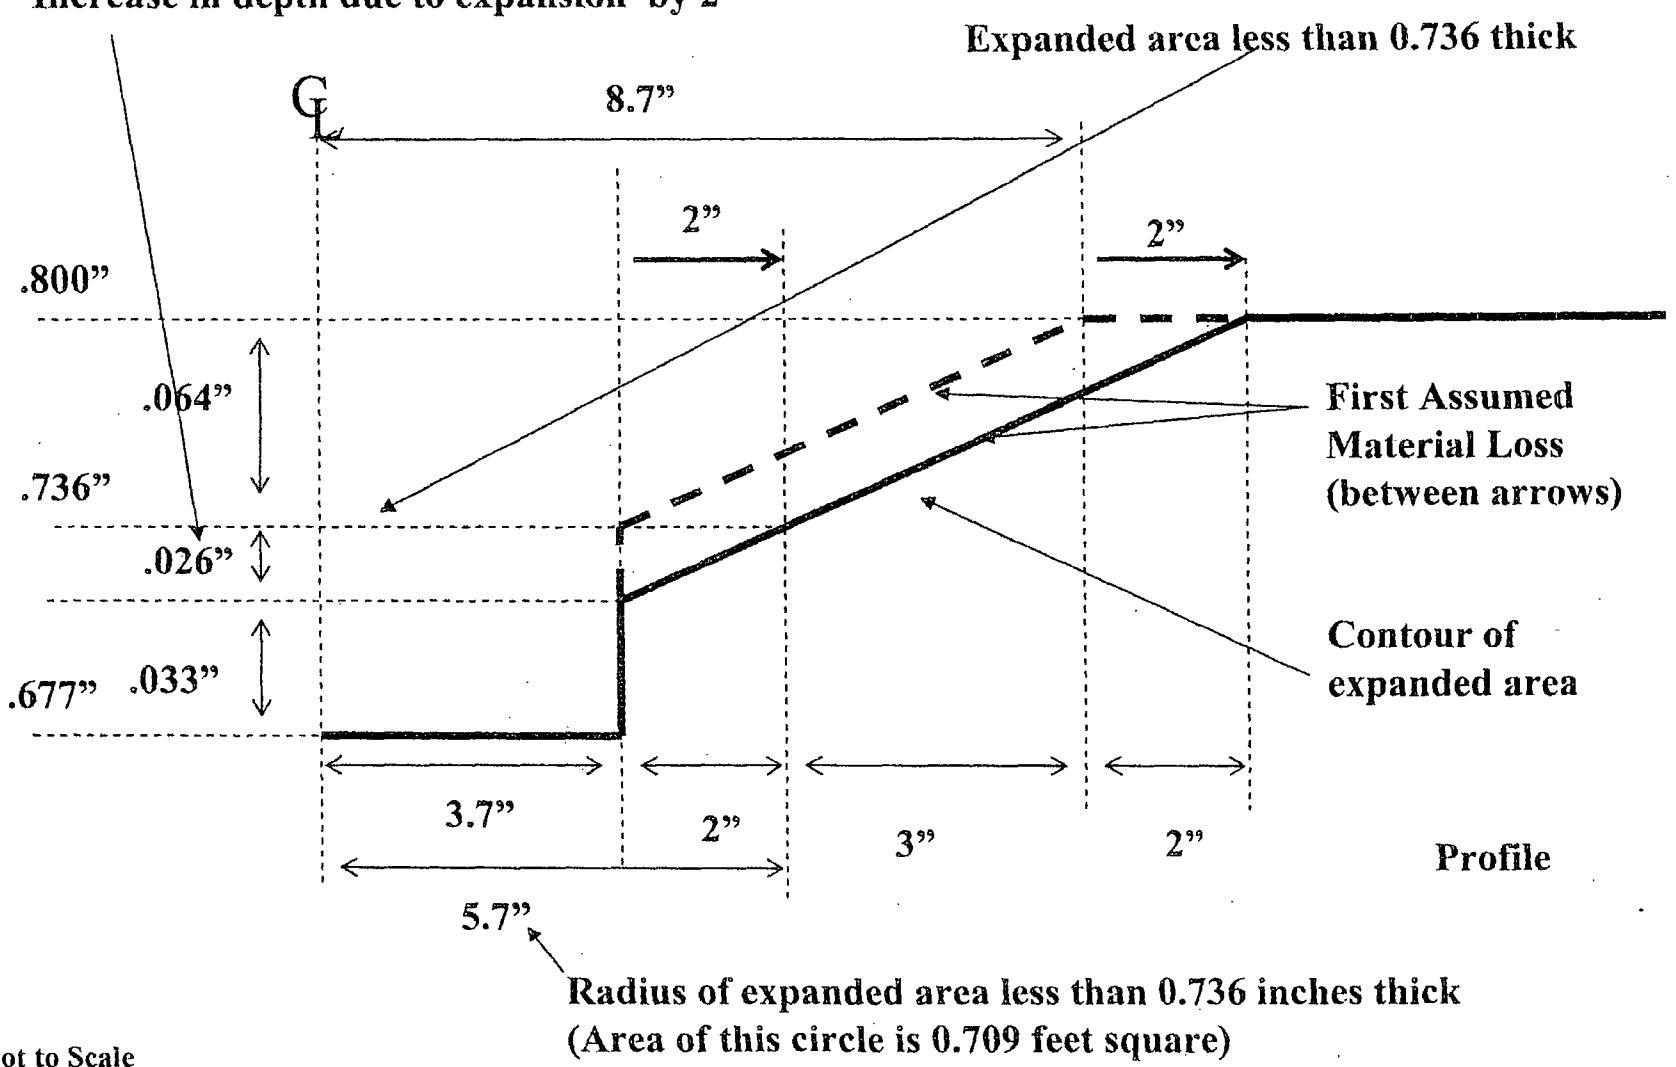
- 34. First, this conclusion is proved false by Dr. Hausler's own model. The radius of the expanded area less than 0.736" (shown on Figure 4) is 5.7". Simply calculating the area of a 5.7" radius circle results in 0.709 square feet. This value is significantly less than the 1.6 square foot value that Dr. Hausler offers.

Increase in depth due to expansion by 2"

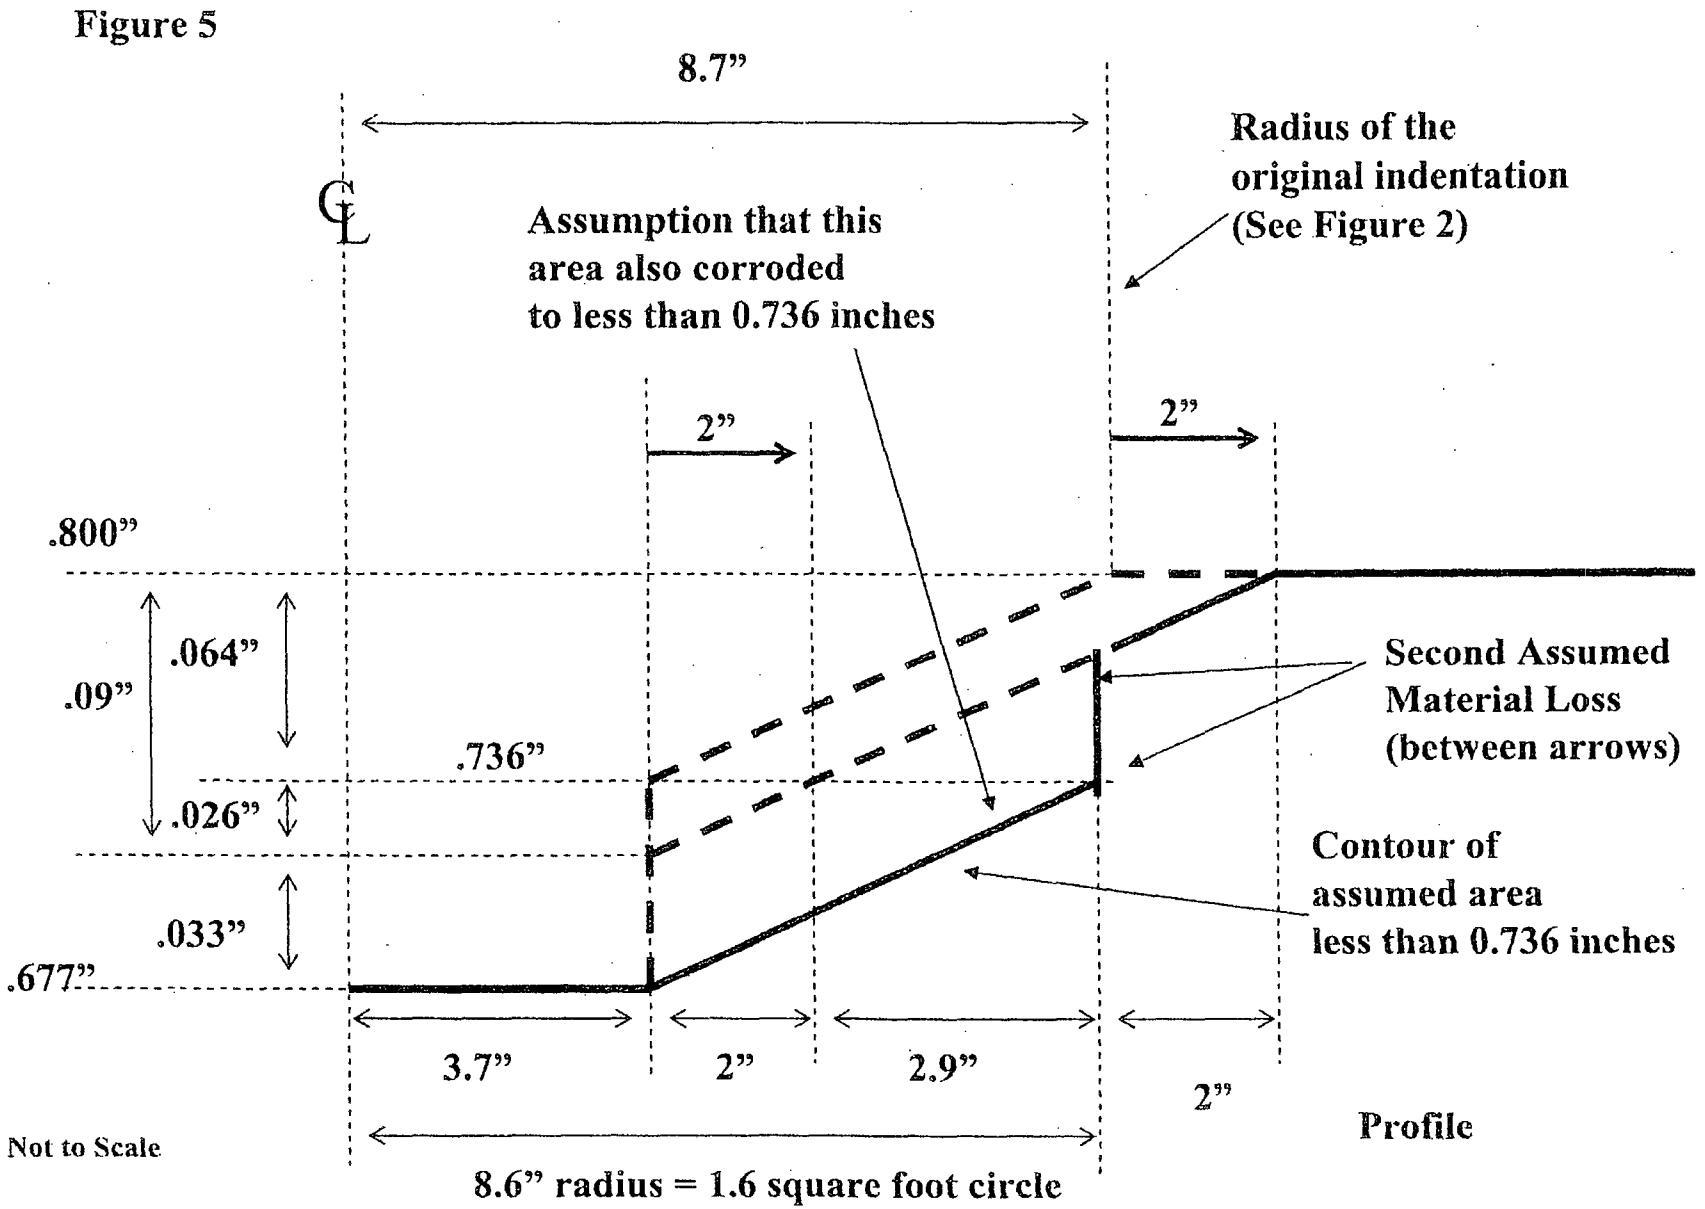
- 35. Second, Dr. Hausler underestimates how much metal needs to corrode to meet his (incorrect) definition of the local area acceptance criterion. The radius of a 1.6 square foot circle is approximately 8.6". As I explain in ¶31 above, Dr. Hausler uses 8.7" for this value rather than 8.6". See Figure 2. In my opinion, by arriving at his conclusion that a 1.6 square feet area is less than 0.736", Dr. Hausler has made another assumption that the entire original 17.4" diameter indentation is less than 0.736". This assumption would require an additional section of material, 0.033" deep to simply disappear (see Figure 5). Assuming this metal disappeared through corrosion, this corrosion would be in addition to the 0.026" of corrosion that Dr. Hausler hypothesizes. I have created Figure 5 to show the material that would need to disappear (see area designated as "Second Assumed Material Loss").

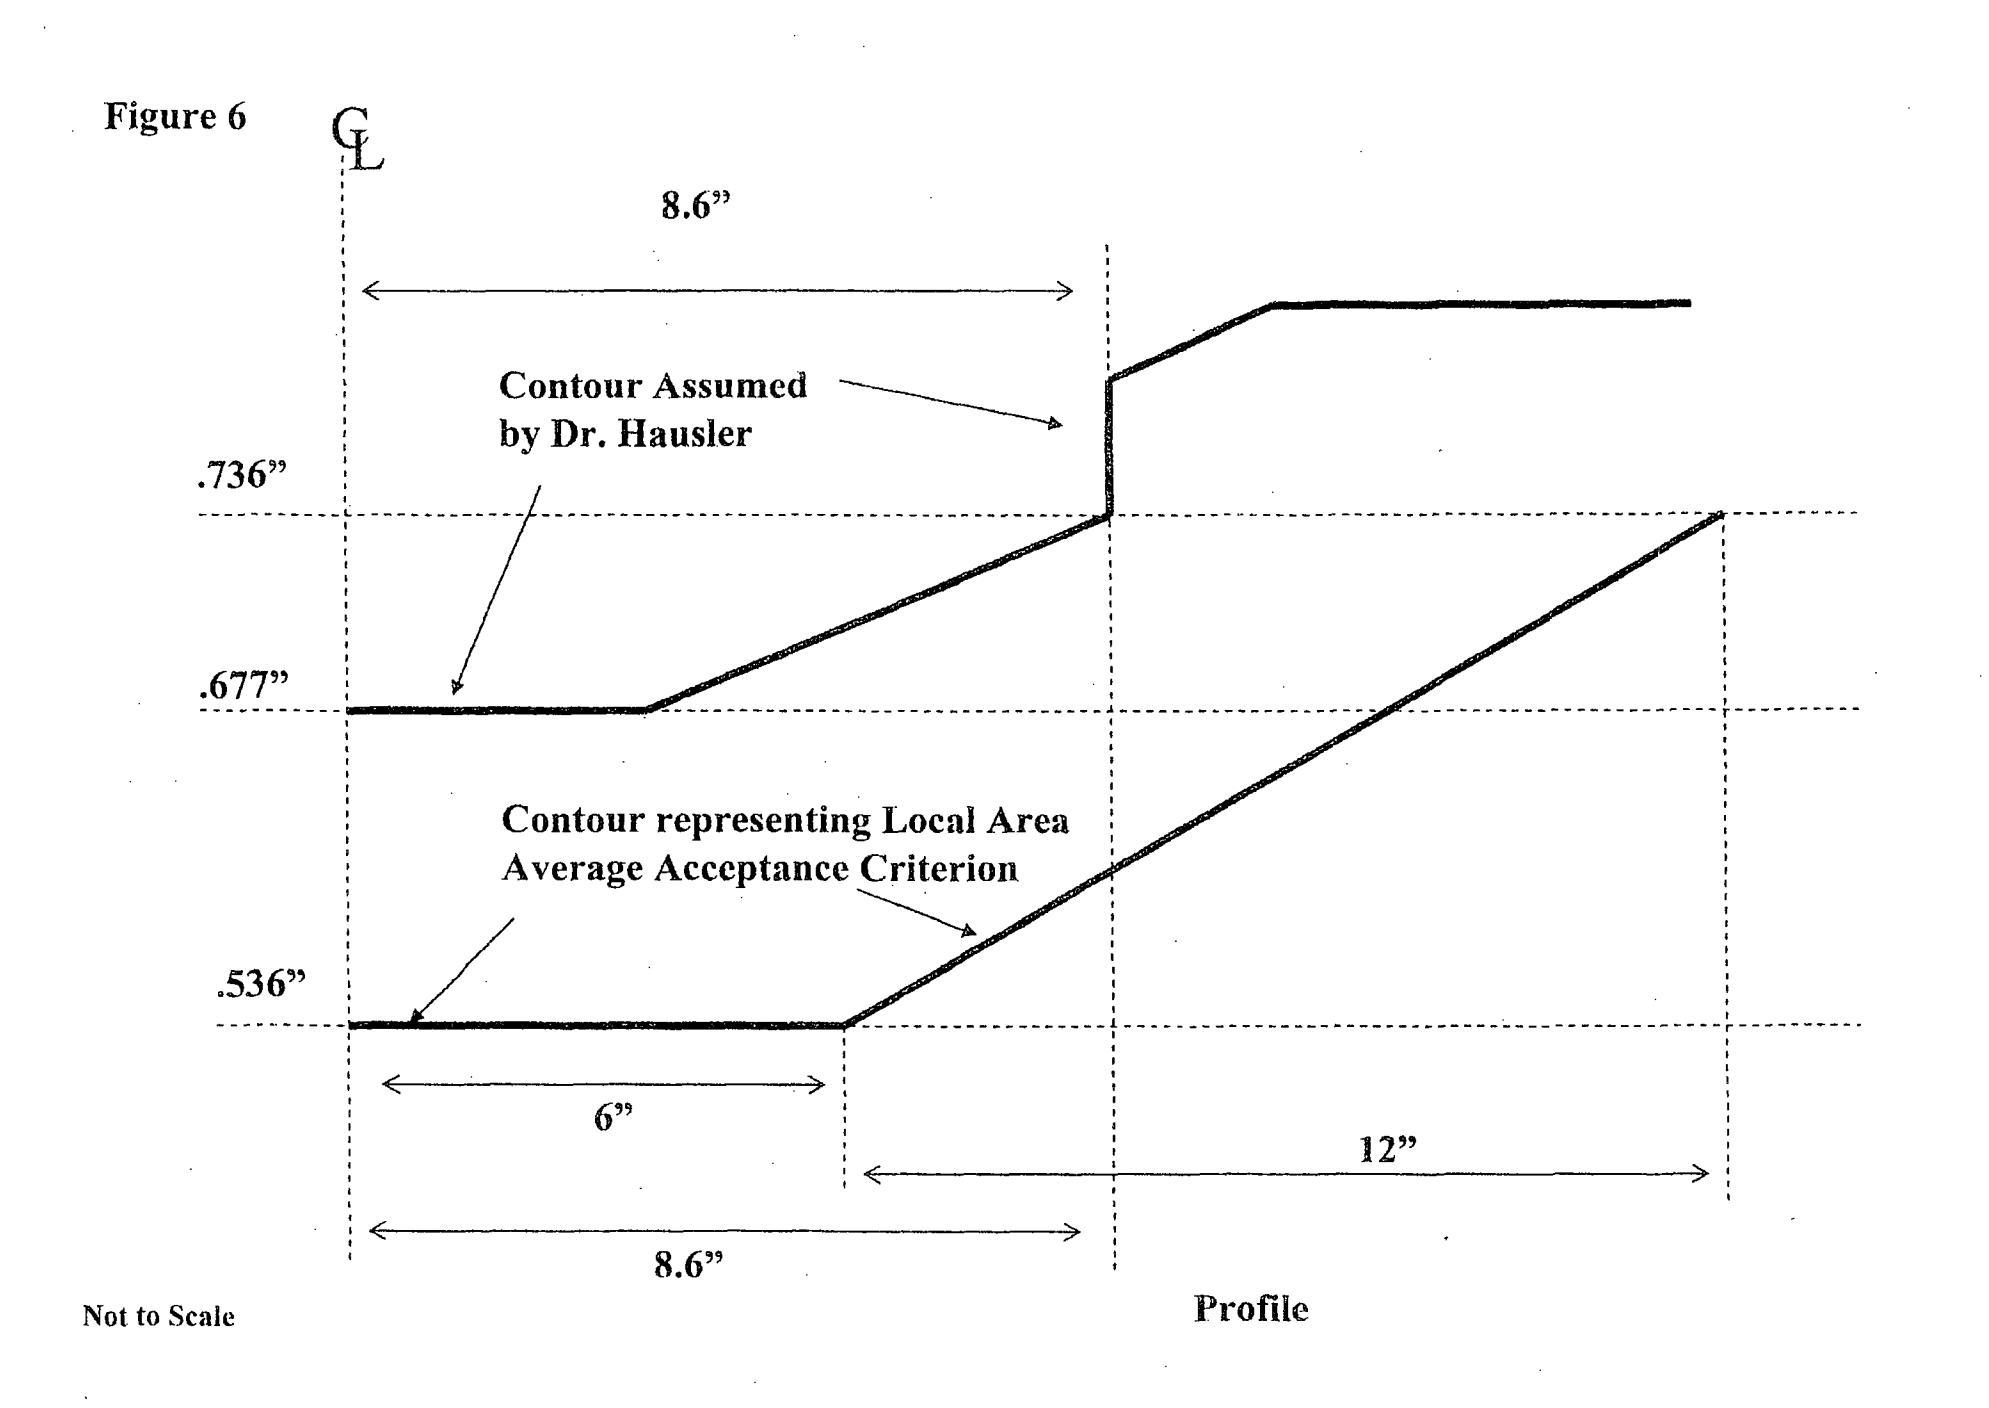
36. Finally, as I state above, Dr. Hausler then misinterprets the local area acceptance criterion by assuming that an area of one square foot that is thinner than 0.736" exceeds that criterion. He is wrong and I have created Figure 6 to show how the additional corrosion that Dr. Hausler postulates would not exceed the local area
thickness criterion. In Figure 6, I have reproduced the acceptance criteria profile from Figure 1, and overlaid Dr. Hausler's assumed contour from Figure 5. The new Figure clearly shows that the acceptance criterion is not exceeded.
