From: "Stillwell, Daniel" <dwstillwell@STPEGS.COM>
To: "Mark Tonacci" <MET@nrc.gov>
Date: 11/15/2007 3:54:28 PM
Subject: Additional Information on Main Cooling Reservoir Breach
cc: "David Dujka" <dldujka@STPEGS.COM>,"Gregory T Gibson" <gtgibson@STPEGS.COM>,"John T Conly" <jtconly@STPEGS.COM>,"Steven Thomas" <sethomas@STPEGS.COM>,"William Mookhoek" <wemookhoek@STPEGS.COM>

The attached files contain additional information on the main cooling reservoir breach from the licensing of Units 1 and 2. Sediment deposit following a nonmechanistic breach of the main cooling reservoir was not considered during the licensing of Units 1 and 2, however, scour and erosion were the subject of several NRC meetings and much correspondence starting in 1983 when HL&P notified the NRC of a potentially reportable condition concerning erosion and scour associated with failure of the MCR embankment that had the potential to affect the structural backfill supporting the foundations of Seismic Category I structures (ST-AE-HL-1011, 9-28-83). This issue was the result of a revision to RG 1.59 to Rev. 2 that required consideration of erosion and scour for Design Basis Flood events. After discussion, the NRC ind

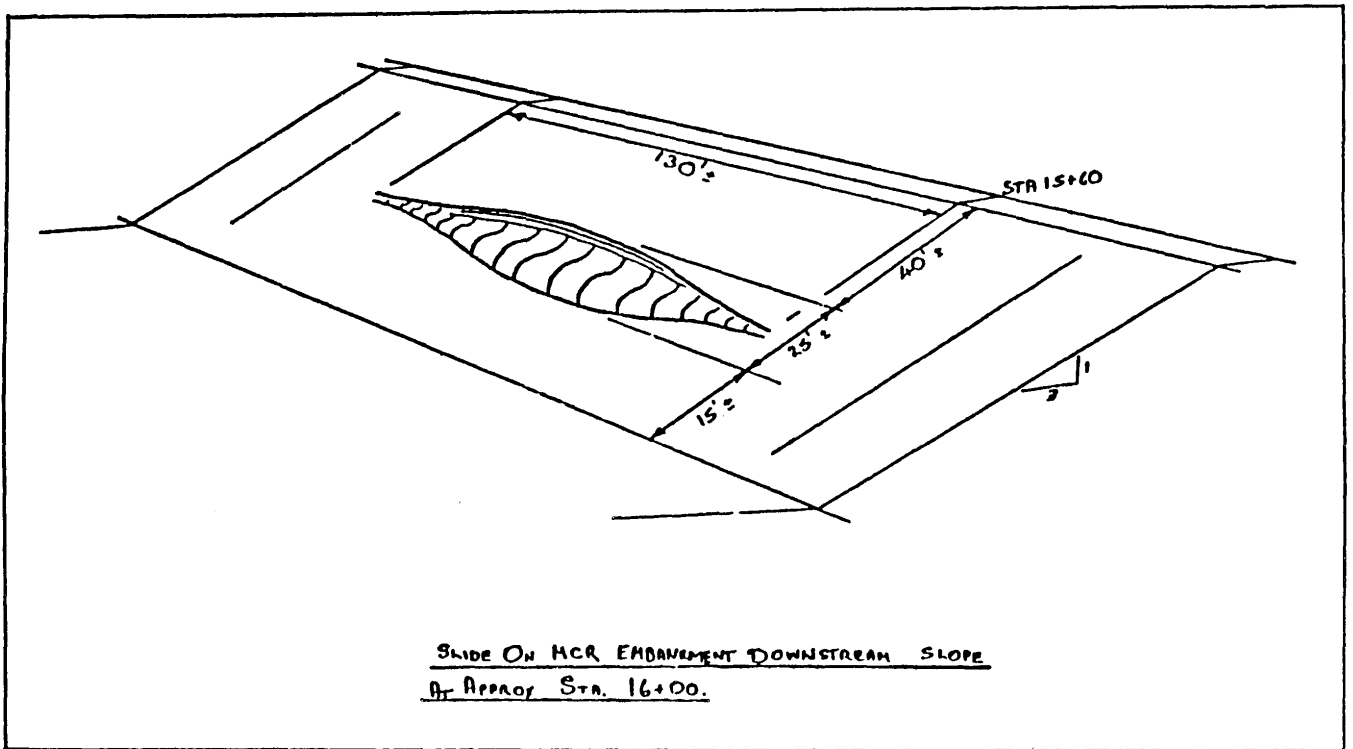
Figure 6 Surface slide
Source: HL&P

Embankment Slope Failures: Except for three incidents of shallow slides on the outer slope (embankment stations 16, 20, and 435), inclinometer measurements and observation over the entire embankment reveal no significant deformations. All three slides were repaired soon after they appeared. The slides are most likely a result of weakened surface soils caused by cyclic changes in moisture content and associated soil volume changes. As the soil dries, cracks are formed that inevitably fill to some extent with loose material. When the soil is rehydrated it expands and the cracks close. If the cracks are partially filled, the expanding soil block will move laterally creating a weakened zone at the base of the block.

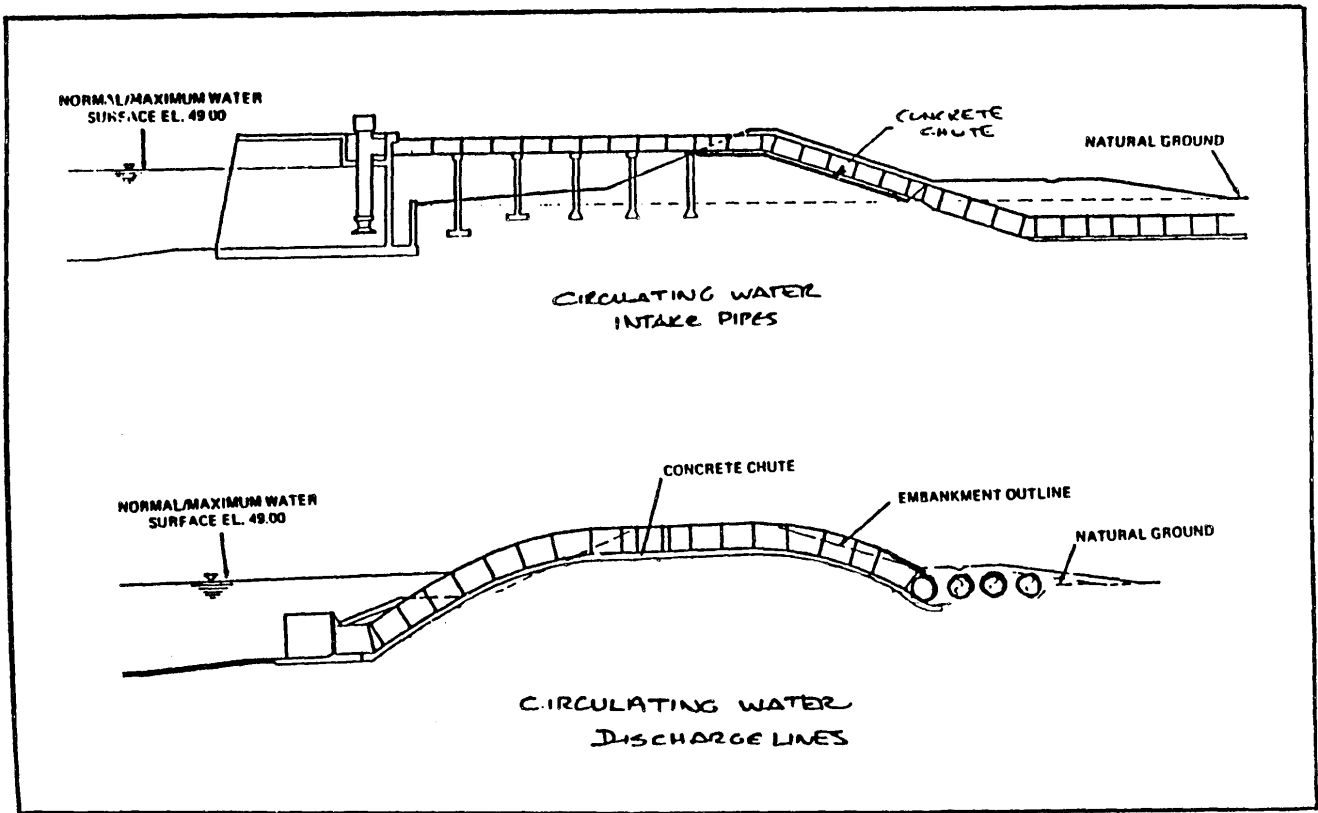
Figure 9 Circulating water intake and discharge pipes before modifications
Source: Provided at meeting between NRC and applicant, Bethesda, Maryland, April 2, 1985

+28 Foot Pool Elevation: Filling began in July, 1983 and stopped November, 1984 at a reservoir pool elevation of +28 feet MSL. The most significant modification at this pool elevation was the change in the circulating pipe penetrations through the embankment. The original design and construction was to bury the pipes in the embankment. However, leaks in the circulating pipes could have degraded the stability of the embankment through underground erosion and by locally elevating the water table. Therefore, instead of penetrating the embankment, the circulating water pipes are now exposed and run over the embankment in concrete saddles. Other work included relief well repairs and replacement.
