Electrical Insulation Research Center Institute of Materials Science, U-136 University of Connecticut Storrs, CT 06269-3136

> Performed for Tennessee Valley Authority contract TV-79850T

ANALYSIS OF DAMAGE TO INSTRUMENTATION CABLES REMOVED FROM WATTS BAR NUCLEAR PLANT

December 11, 1989

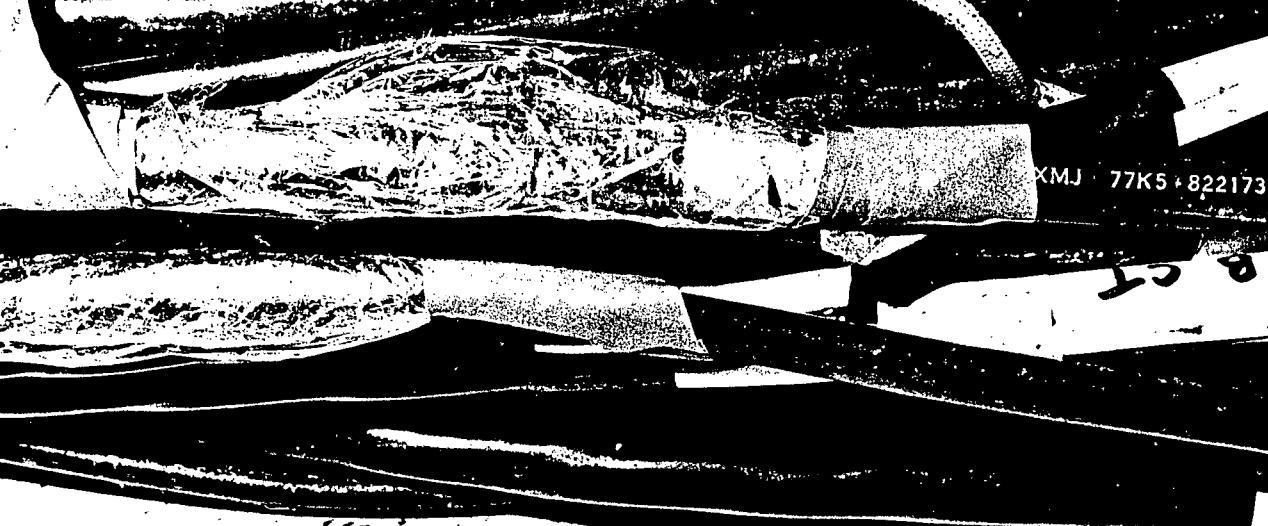
CONDUIT MC 400B

> Figure 4 Damaged Sites On Cables from Conduit MC 400B, Showing Protective Wrapping Applied by TVA Prior To Shipment

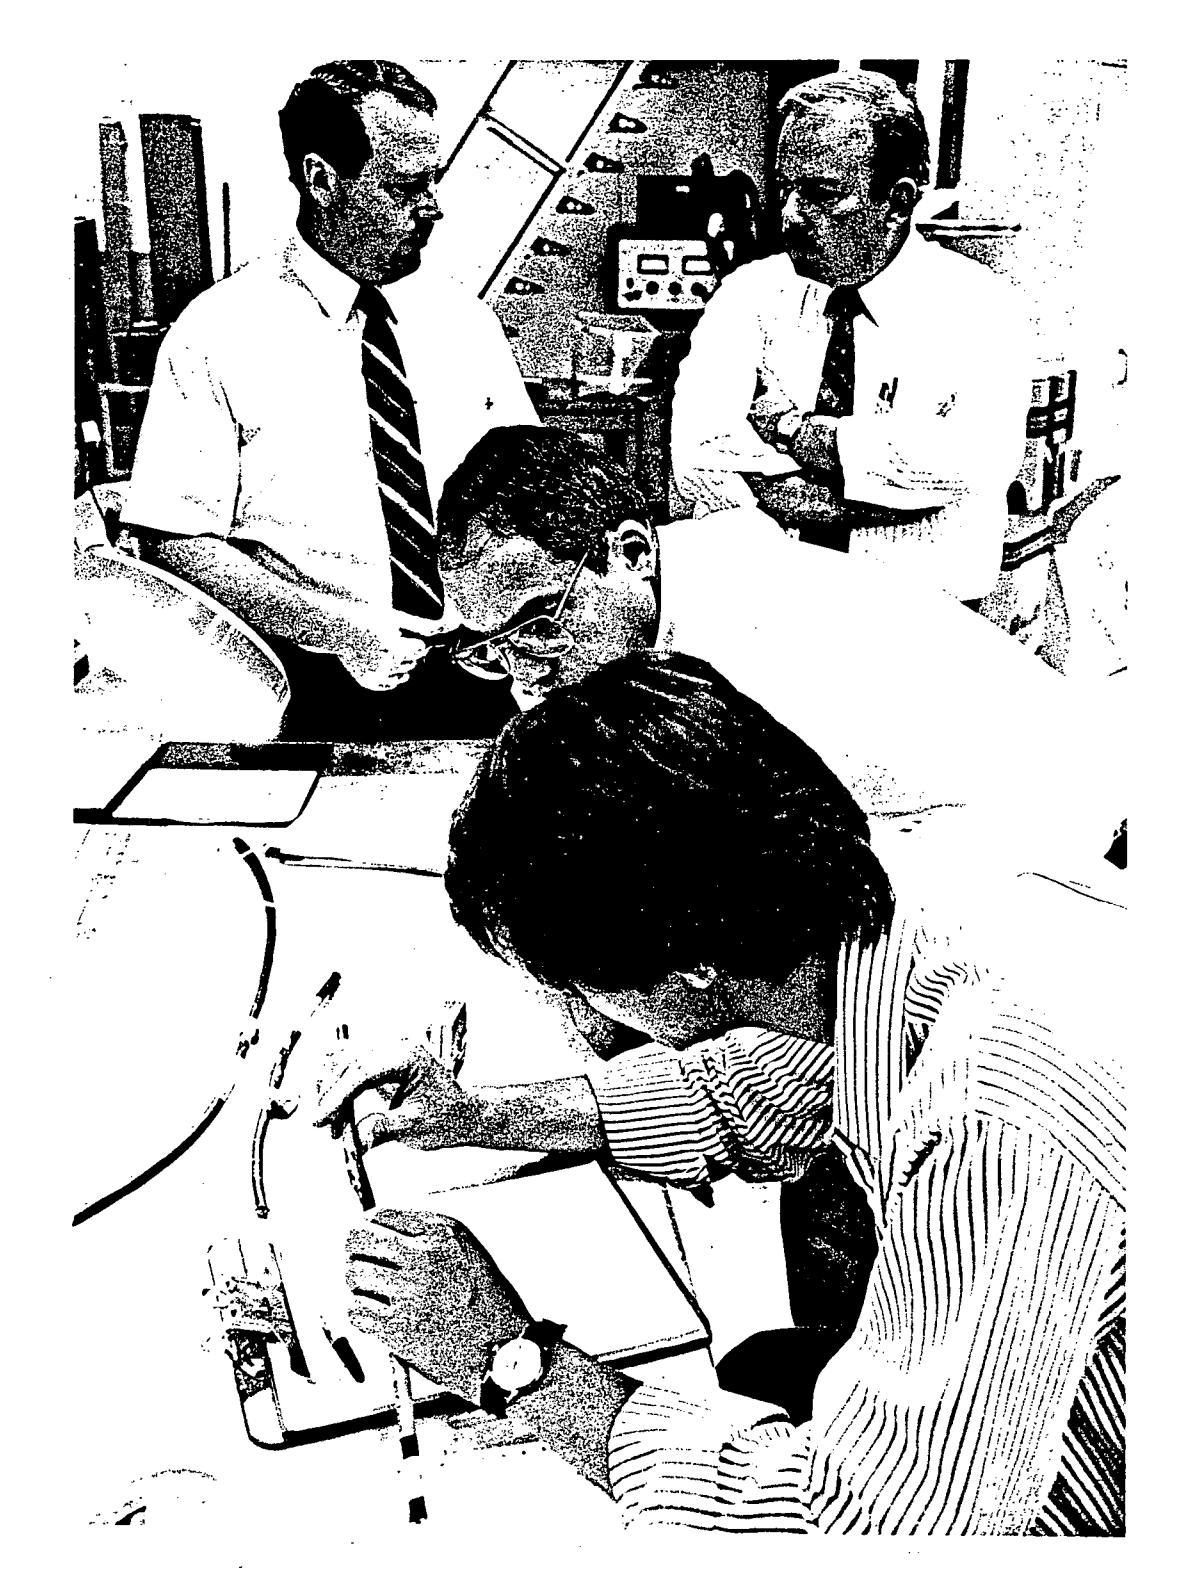
Figure 5 Visual Examination of Damaged Sites Removed from Instrumentation Cables Listed In Table 1

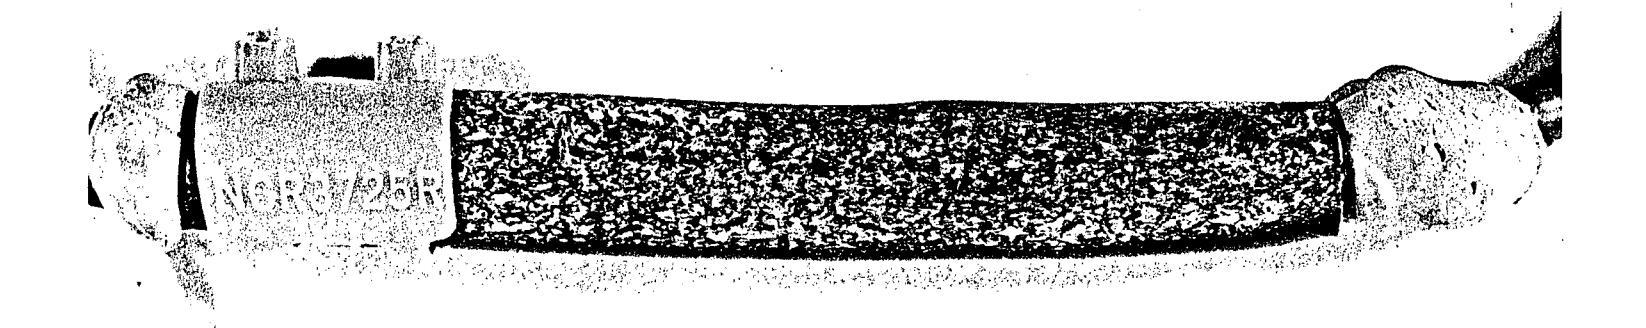
1-2P5-68-283-D From Conduit 1P5-702D

The suspected repair splice, 1-2PS-68-283-D was verified as such. This was applied to cover a cut that was limited to the jacket of this cable. Inspection of the cable following removal of the repair sleeve showed that no damage had been done to the primary insulation or conductors of this cable.

Figure 18 Cable Repair Sleeve 1-2PS-68-283-D Shown In **Its As-Received Condition**

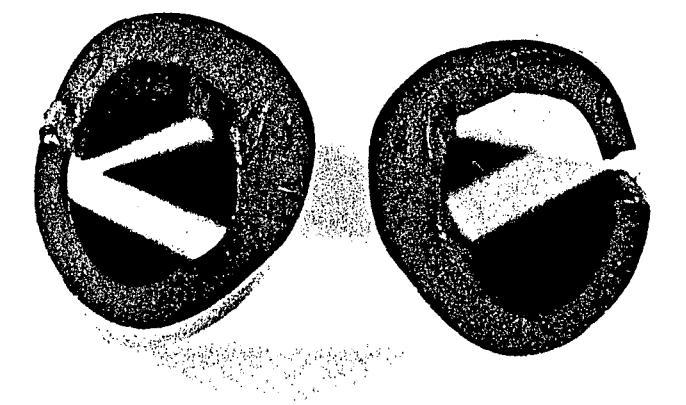
1-2FM-3-3990A

Figure 26 Cross-Section Through "Bump" On Surface of Jacket, Cable 1-2PM-3-3990A. Note Small Particle Embedded In Jacket

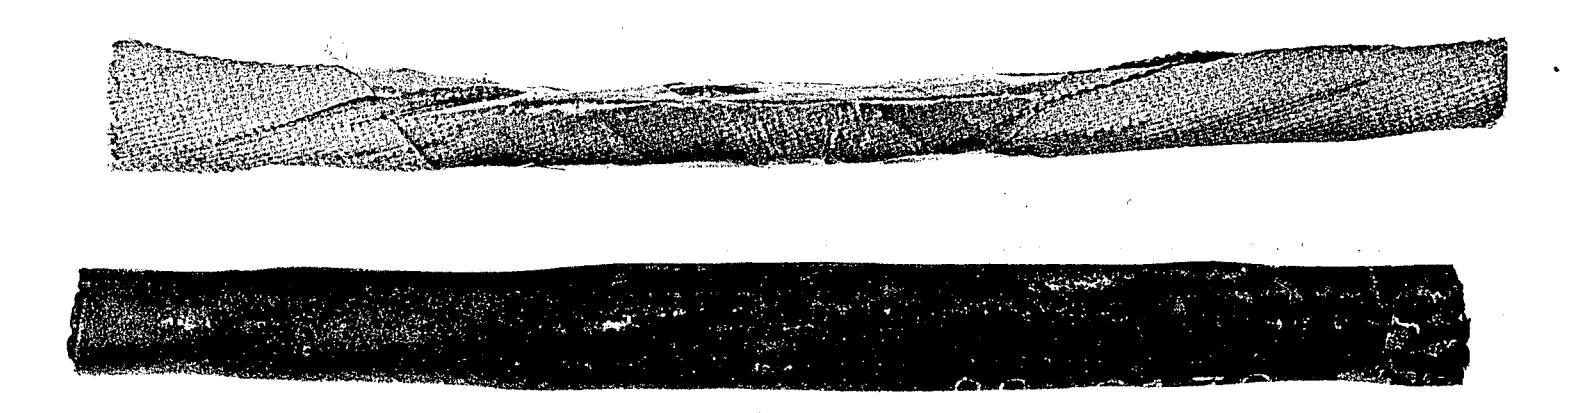
Figure 29 Representative "Bulge" On Surface of Cable 2PM-1041-D (bottom) with Corresponding Assembly Wrap Splice Shown Above · - (11) 1041 11 . 4

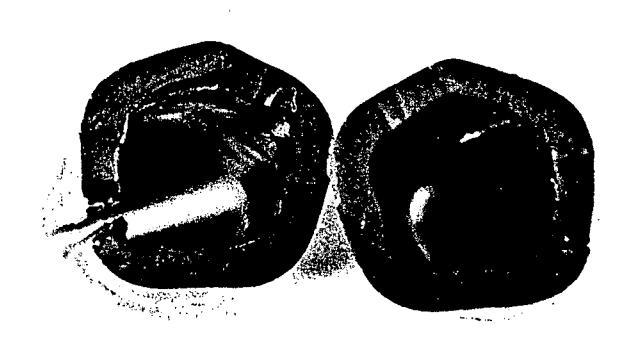
Figure 30 Jacket Cross-Section Through "Bulge" On Surface of Cable 2PM-1041-D

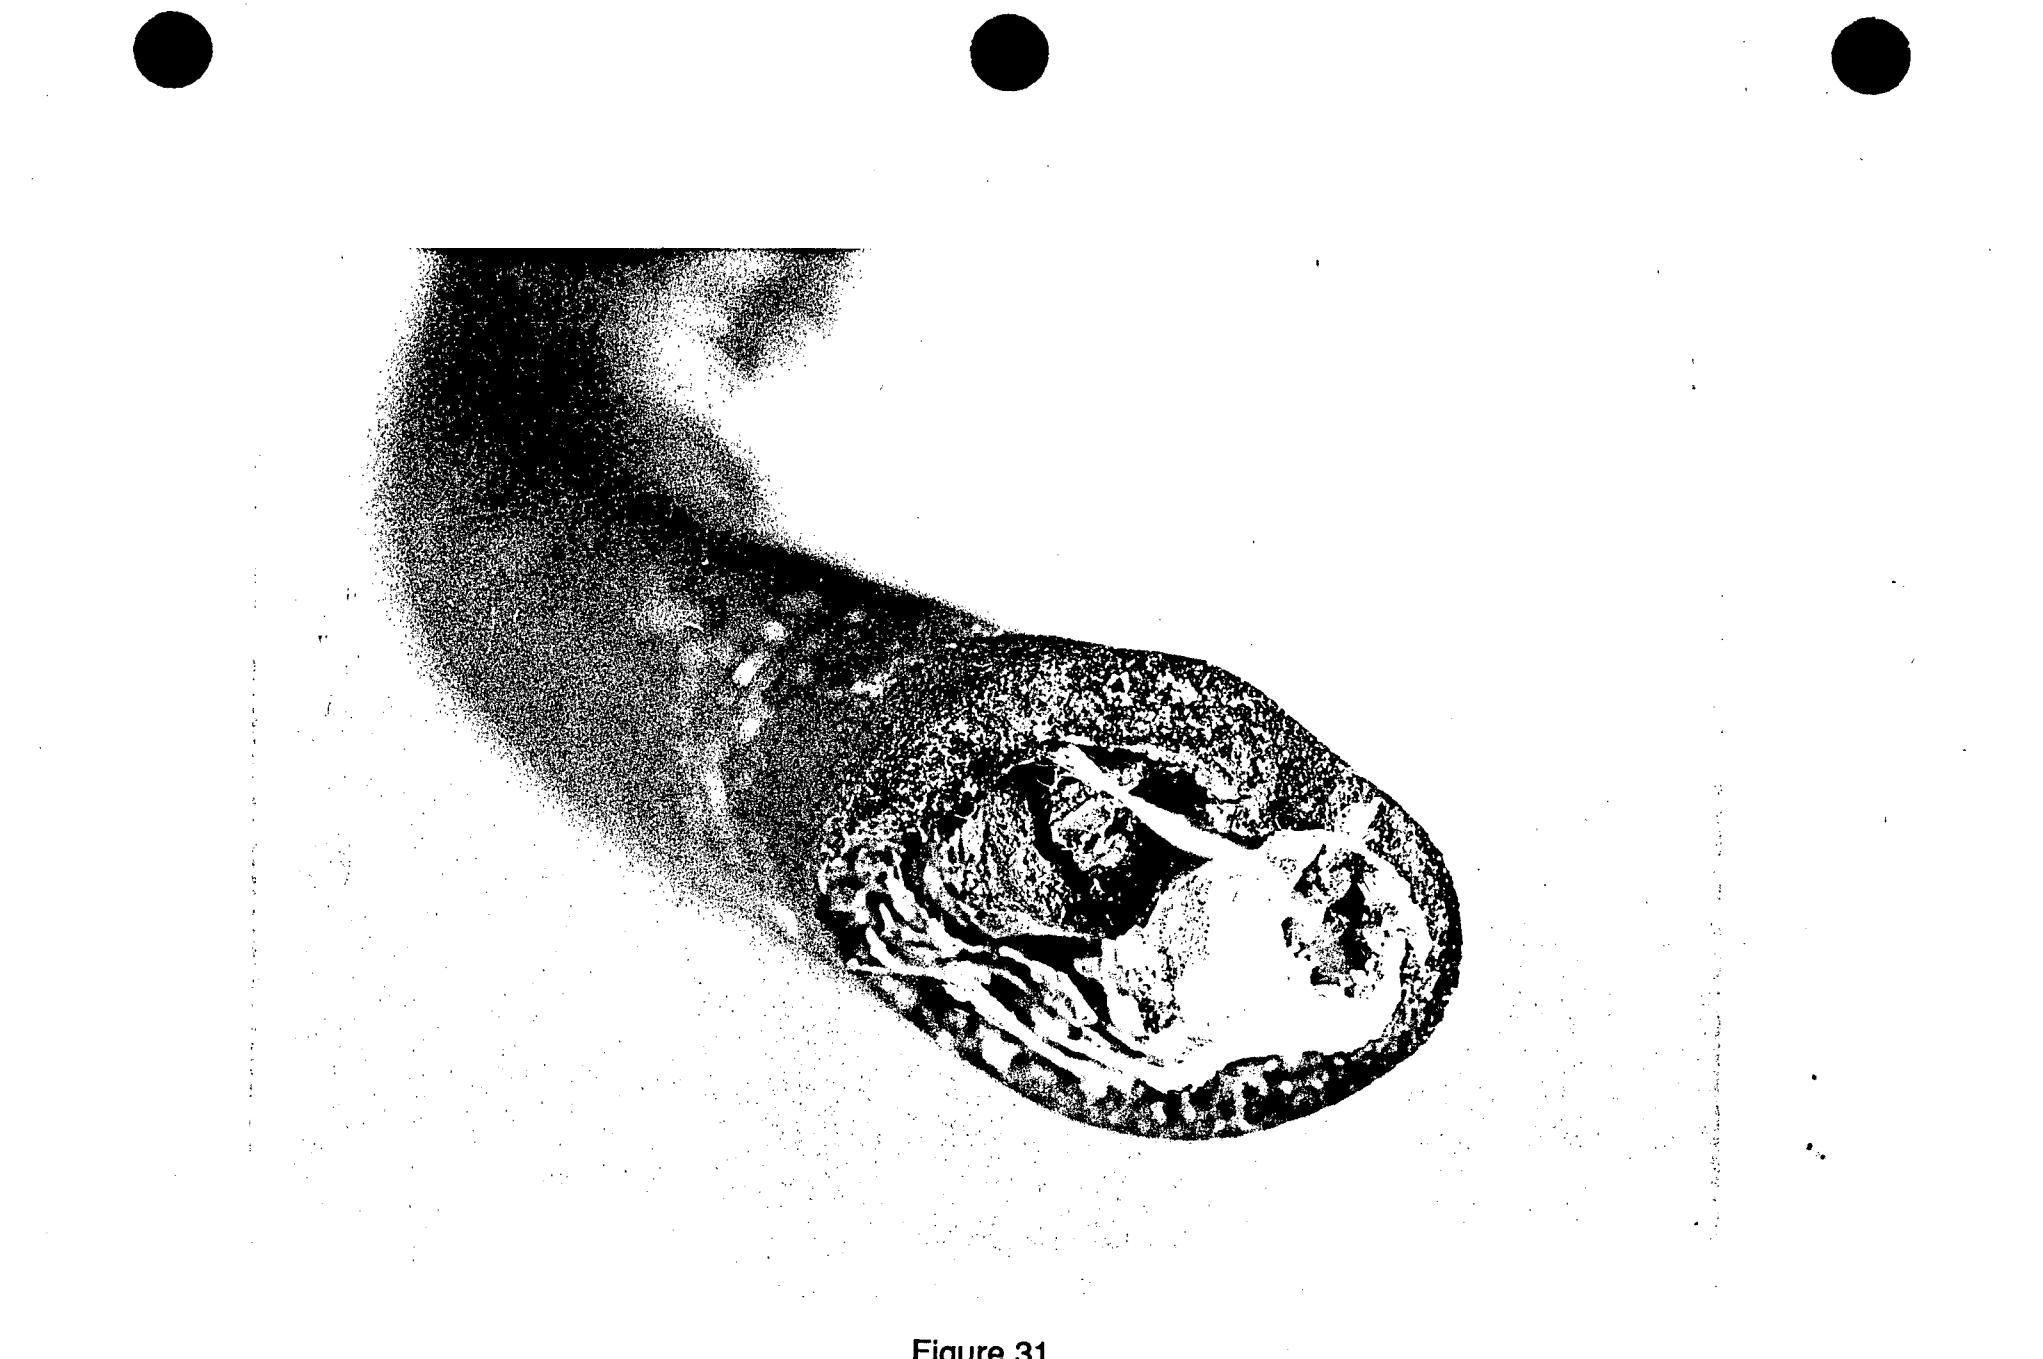
Cable 2PS5281D had been found as a short section that had been abandoned in the WBN Unit 2 conduit in which it had been installed. The ends of this cable were examined in order to determine how it had failed, specifically whether it had broken or had been cut. Figure 31 is an overall view of the end of this cable. In Figure 32, more details of the ends of the conductors are shown. These were found to be elongated and tapered which is consistent with a tensile overload fracture [5].

The 2-conductor #12 AWG cable (2PS281D) manufactured by AIW and found abandoned in a conduit, had broken due to a tensile overload.

Figure 31 End of Cable 2PS281D Abandoned In Conduit, WBN Unit 2

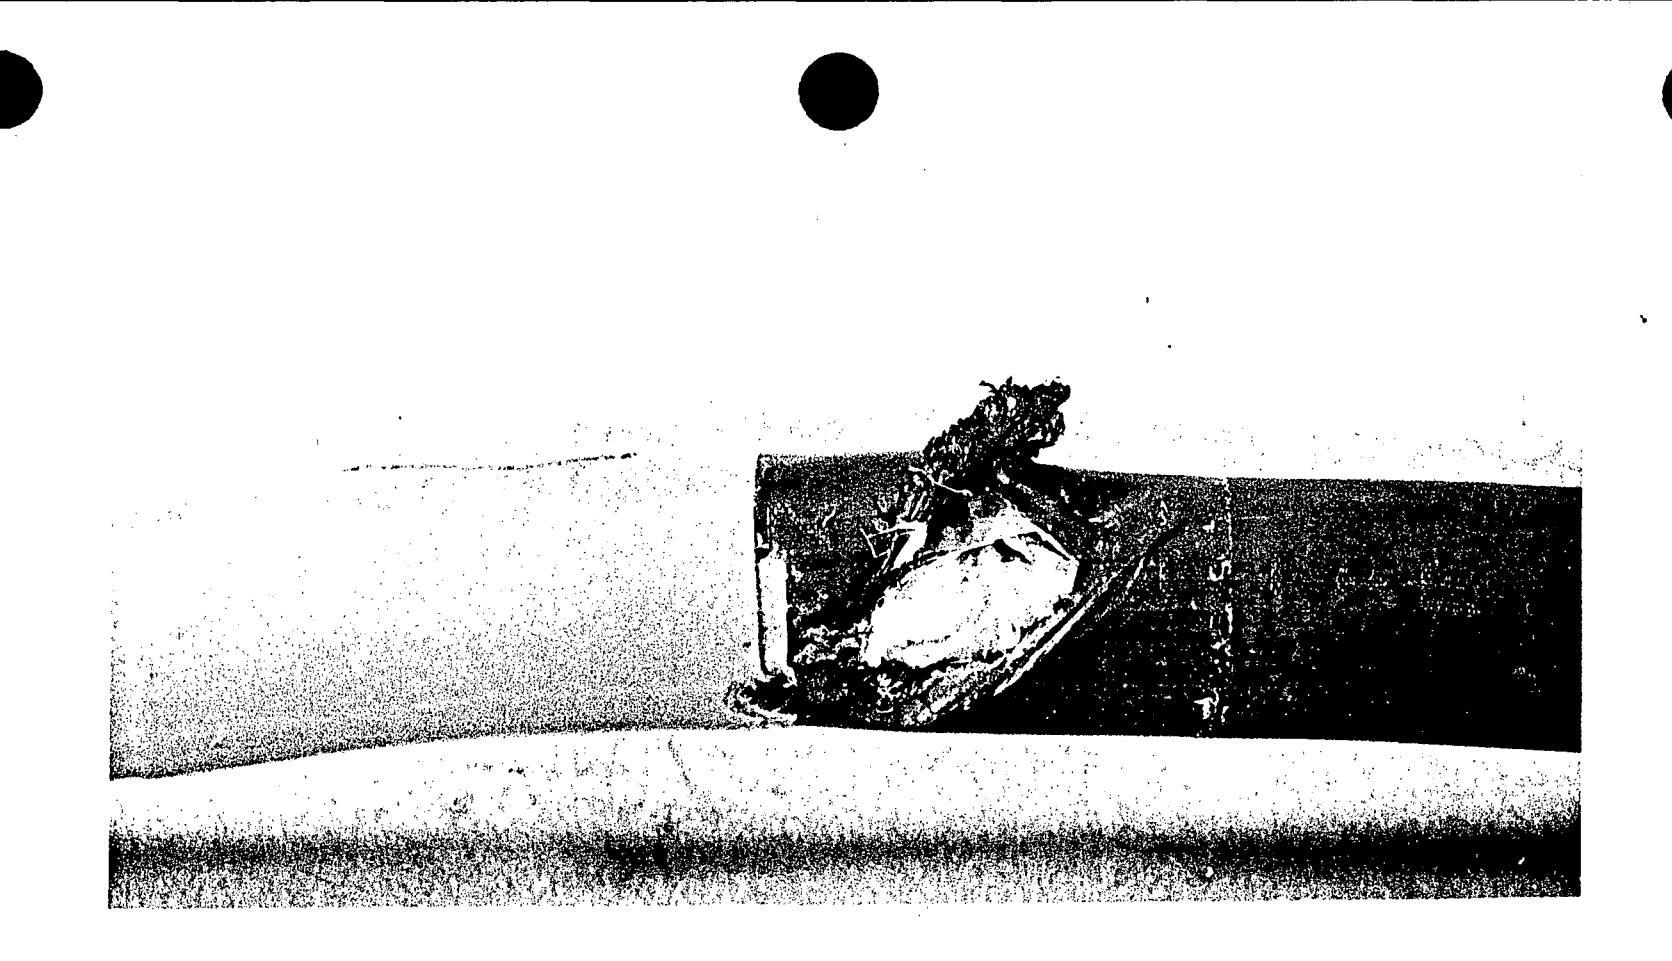
1-PM - 778-D

Figure 33 Groove In Jacket of Cable 1-PM-778-D Caused by Cut-Off Wheel Contact

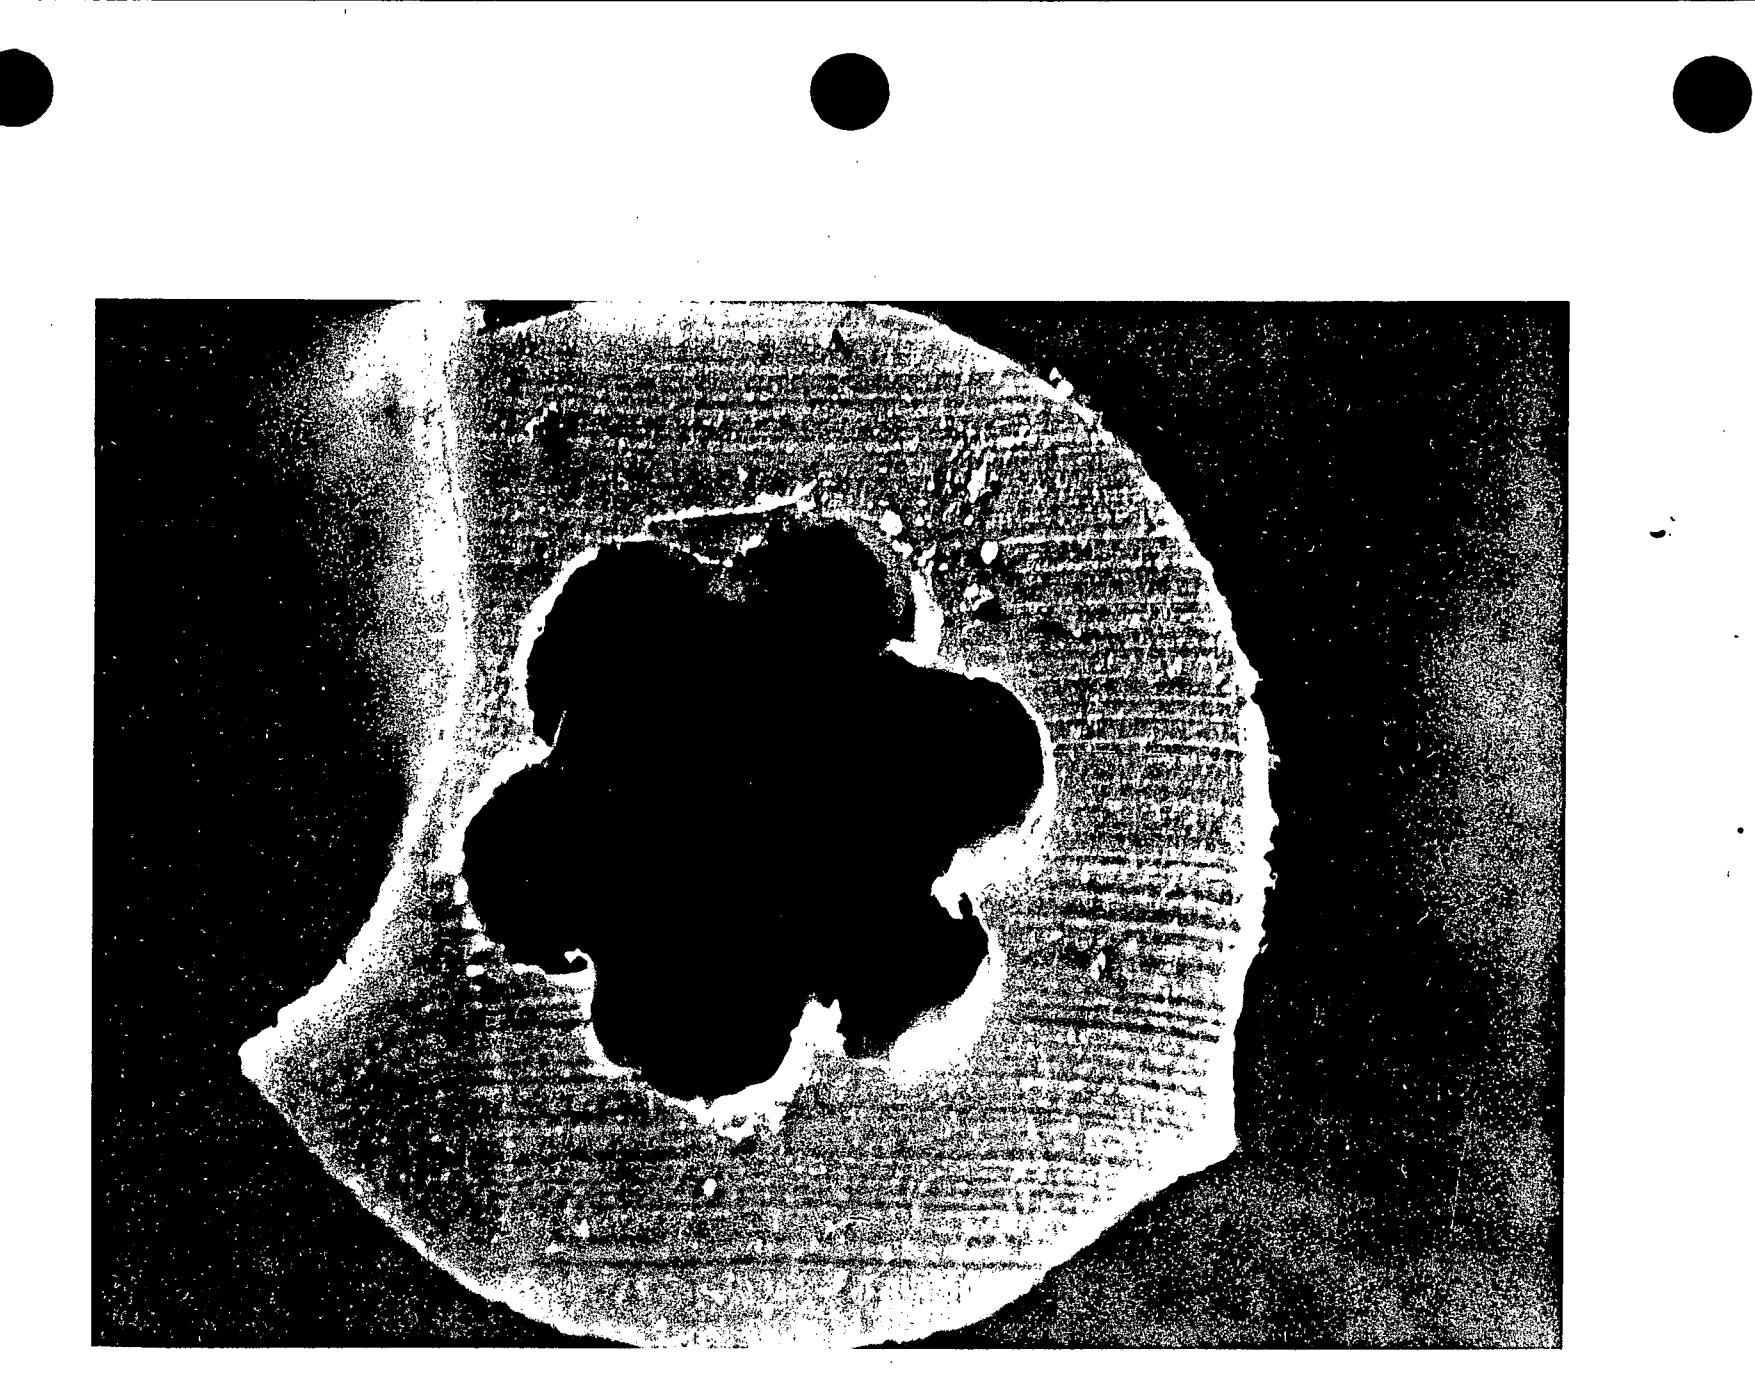
Figure 38 Cross-Section Through Damaged Site of Cable 1M-2450-B

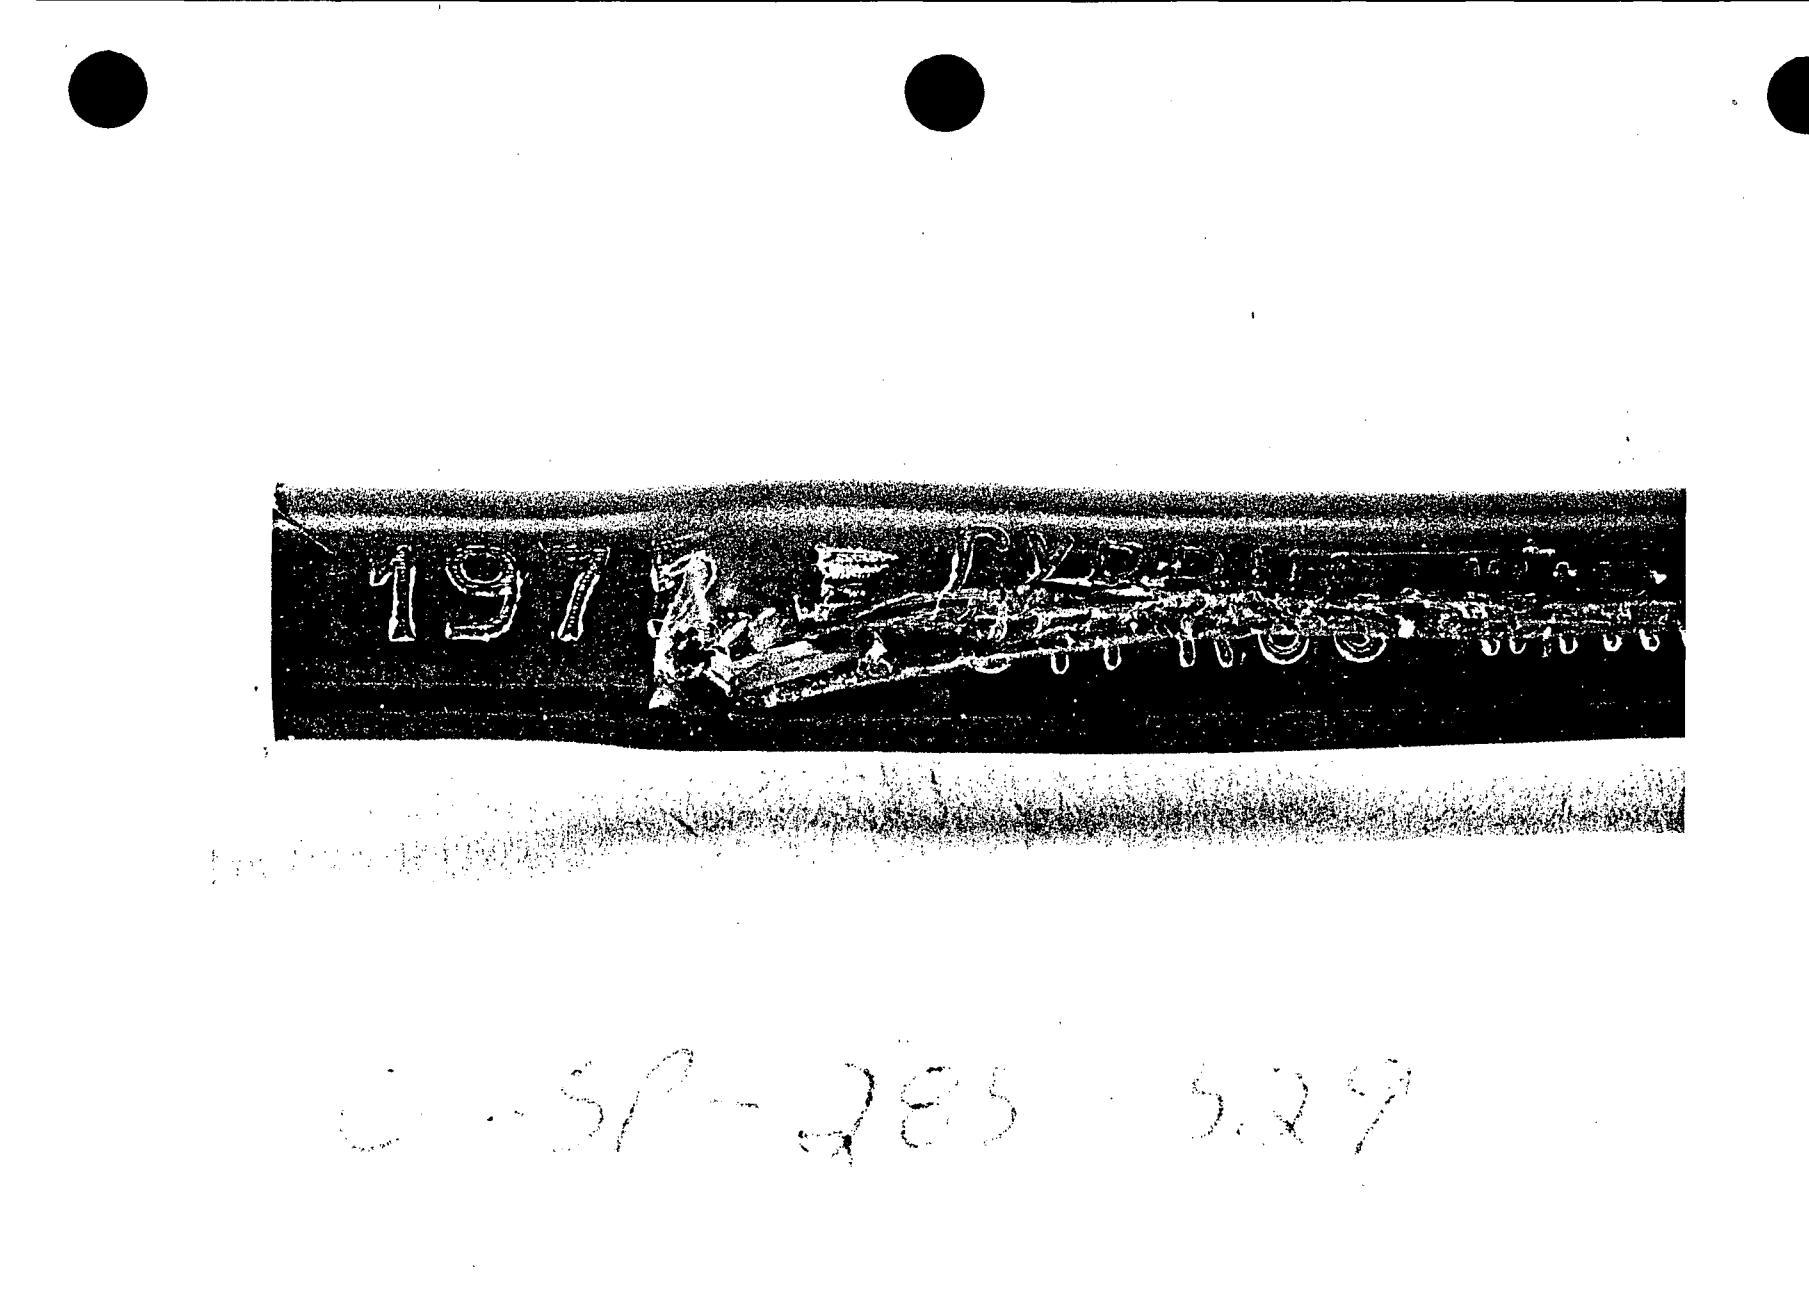
Figure 39 Sharp, Deep Cut In Surface of Cable O-SP-255-529 (Conductors Exposed)

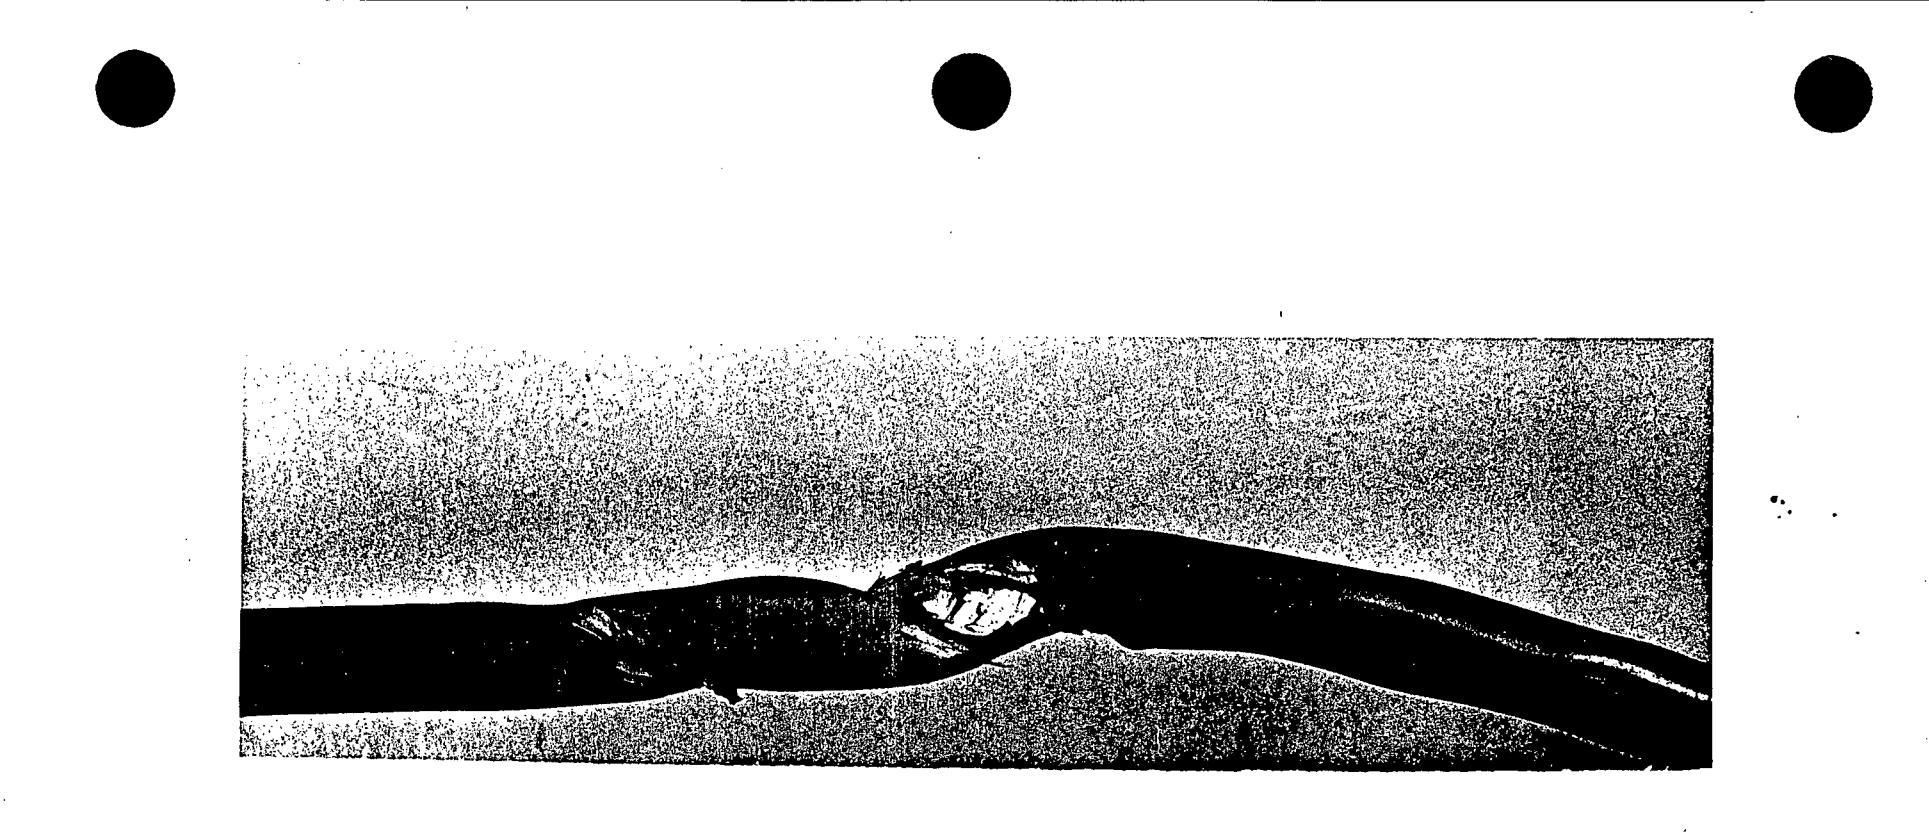
The surface of the CPE jacket was severely damaged by the parachute cord during the pull-by simulations with a contact load of 75 lb. This produced a narrow groove that nearly penetrated the jacket thickness. With a load of 100 lb., the jacket was fully penetrated by the parachute cord, as shown in Figure 39. The groove was measured and found to have a width of approximately 0.13 The edges of the groove were found to be smooth, with a great in. deal of feathering at the edges with "stringers" present. The latter term is used to describe the strings of elongated jacket material extending past the end of the groove cut by the parachute These result from plastic flow of the polymer, caused by cord. high contact forces and high temperature produced by interfacial friction.

Figure 40 Pull-By Simulation Damage To Surface of CPE Jacket from Contact with Parachute Cord
