UNITED STATES NUCLEAR REGULATORY COMMISSION OFFICE OF INSPECTION AND ENFORCEMENT WASHINGTON, D.C. 20555

IE Bulletin No. 79-05

NUCLEAR INCIDENT AT THREE MILE ISLAND

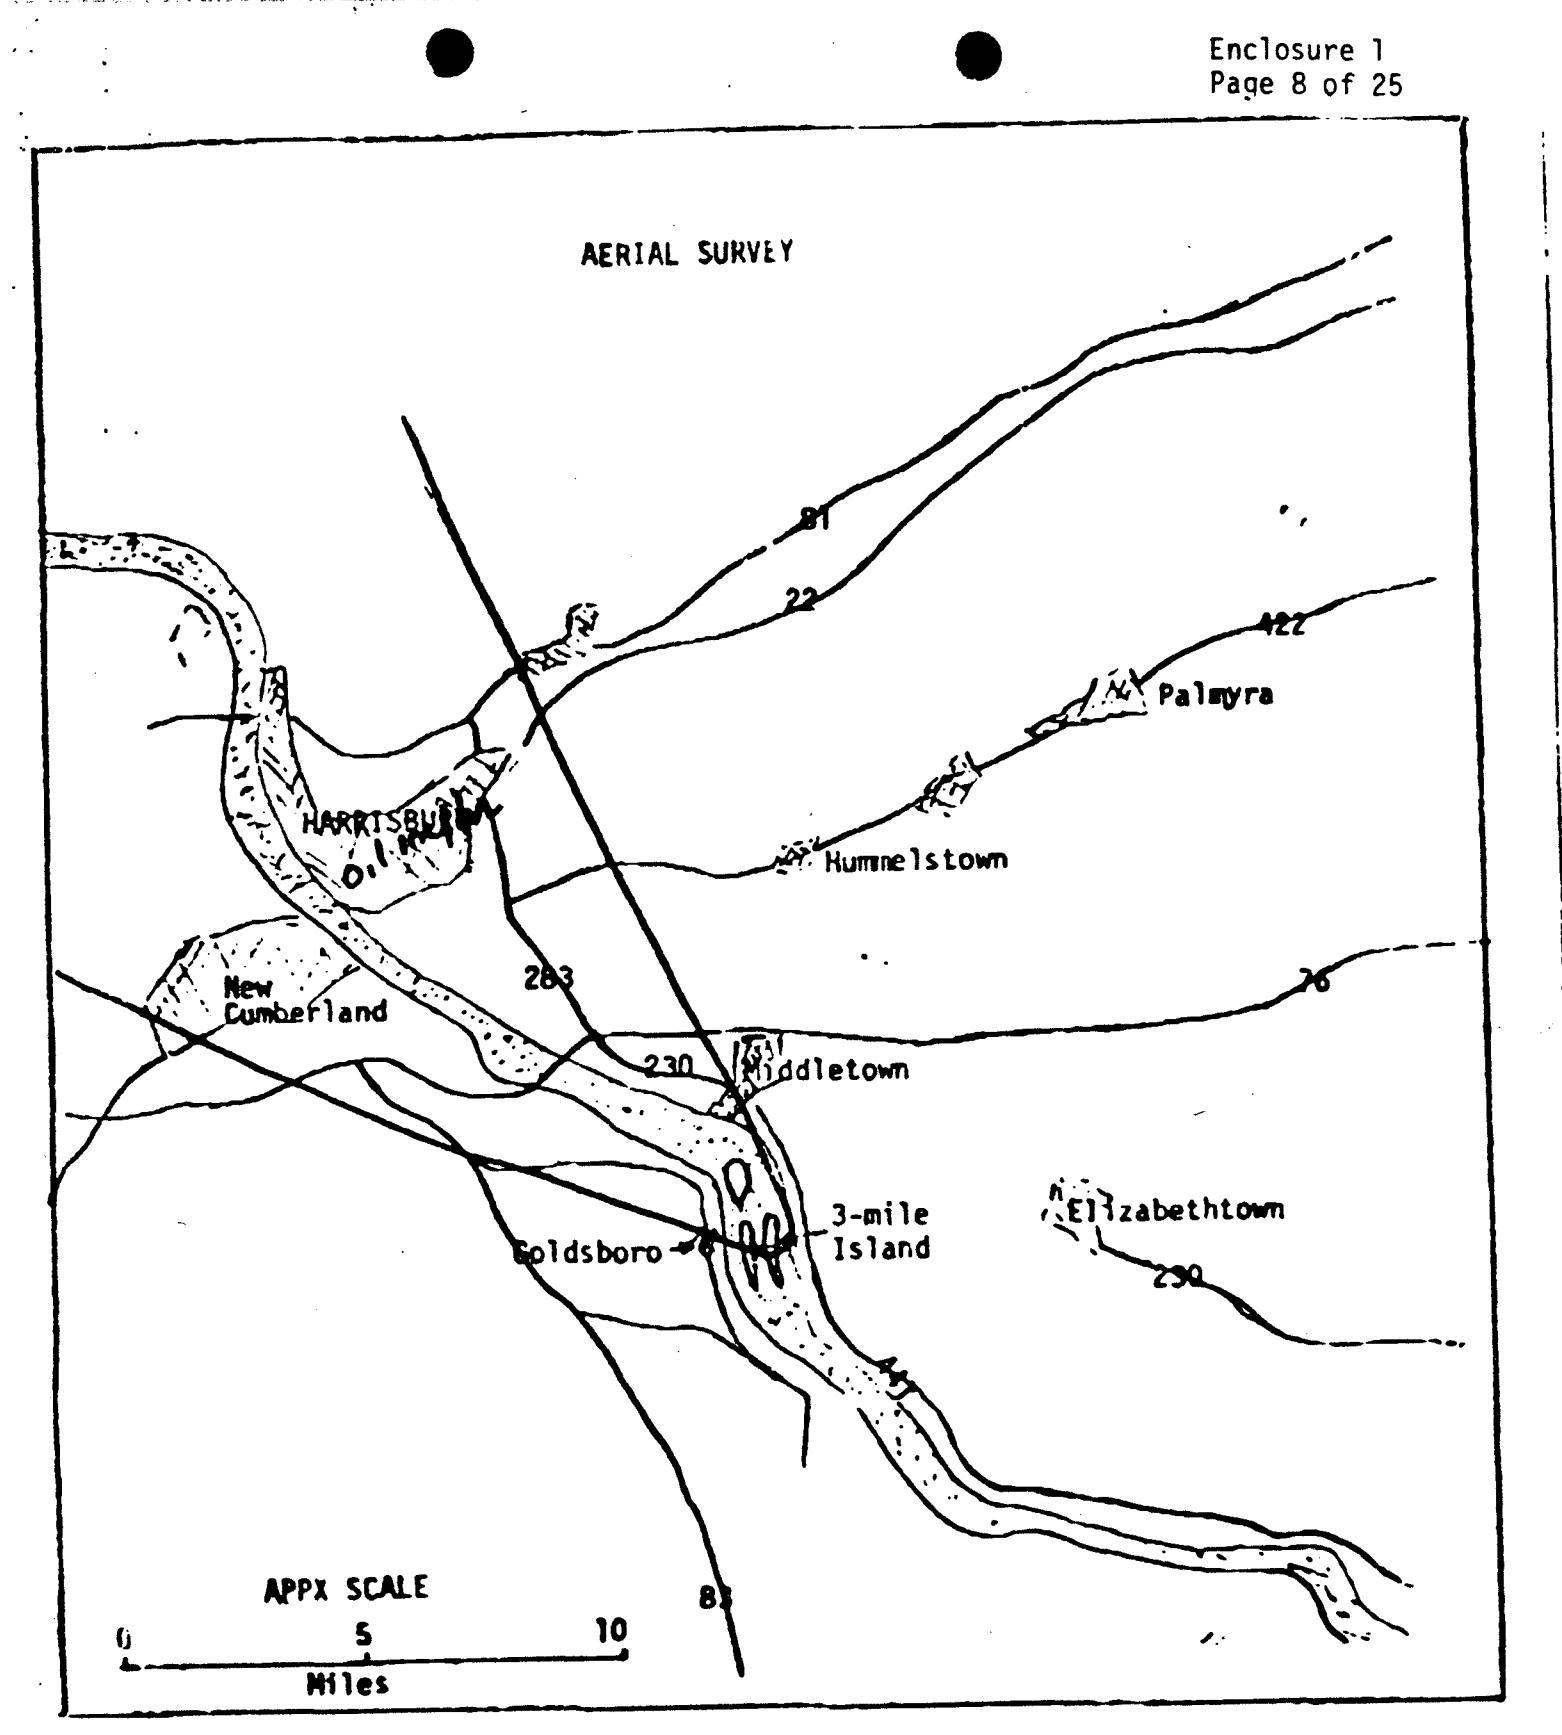
March 28, 1979 8;00 p.m.

Plume in a N to NW direction. Primarily Xe-133. Over Harrisburg, radiation measurements in the plume showed about 0.1 mr/hr. At 10 miles from the site, the plume was about 4-5 miles wide; top of plume at about 3000 feet.

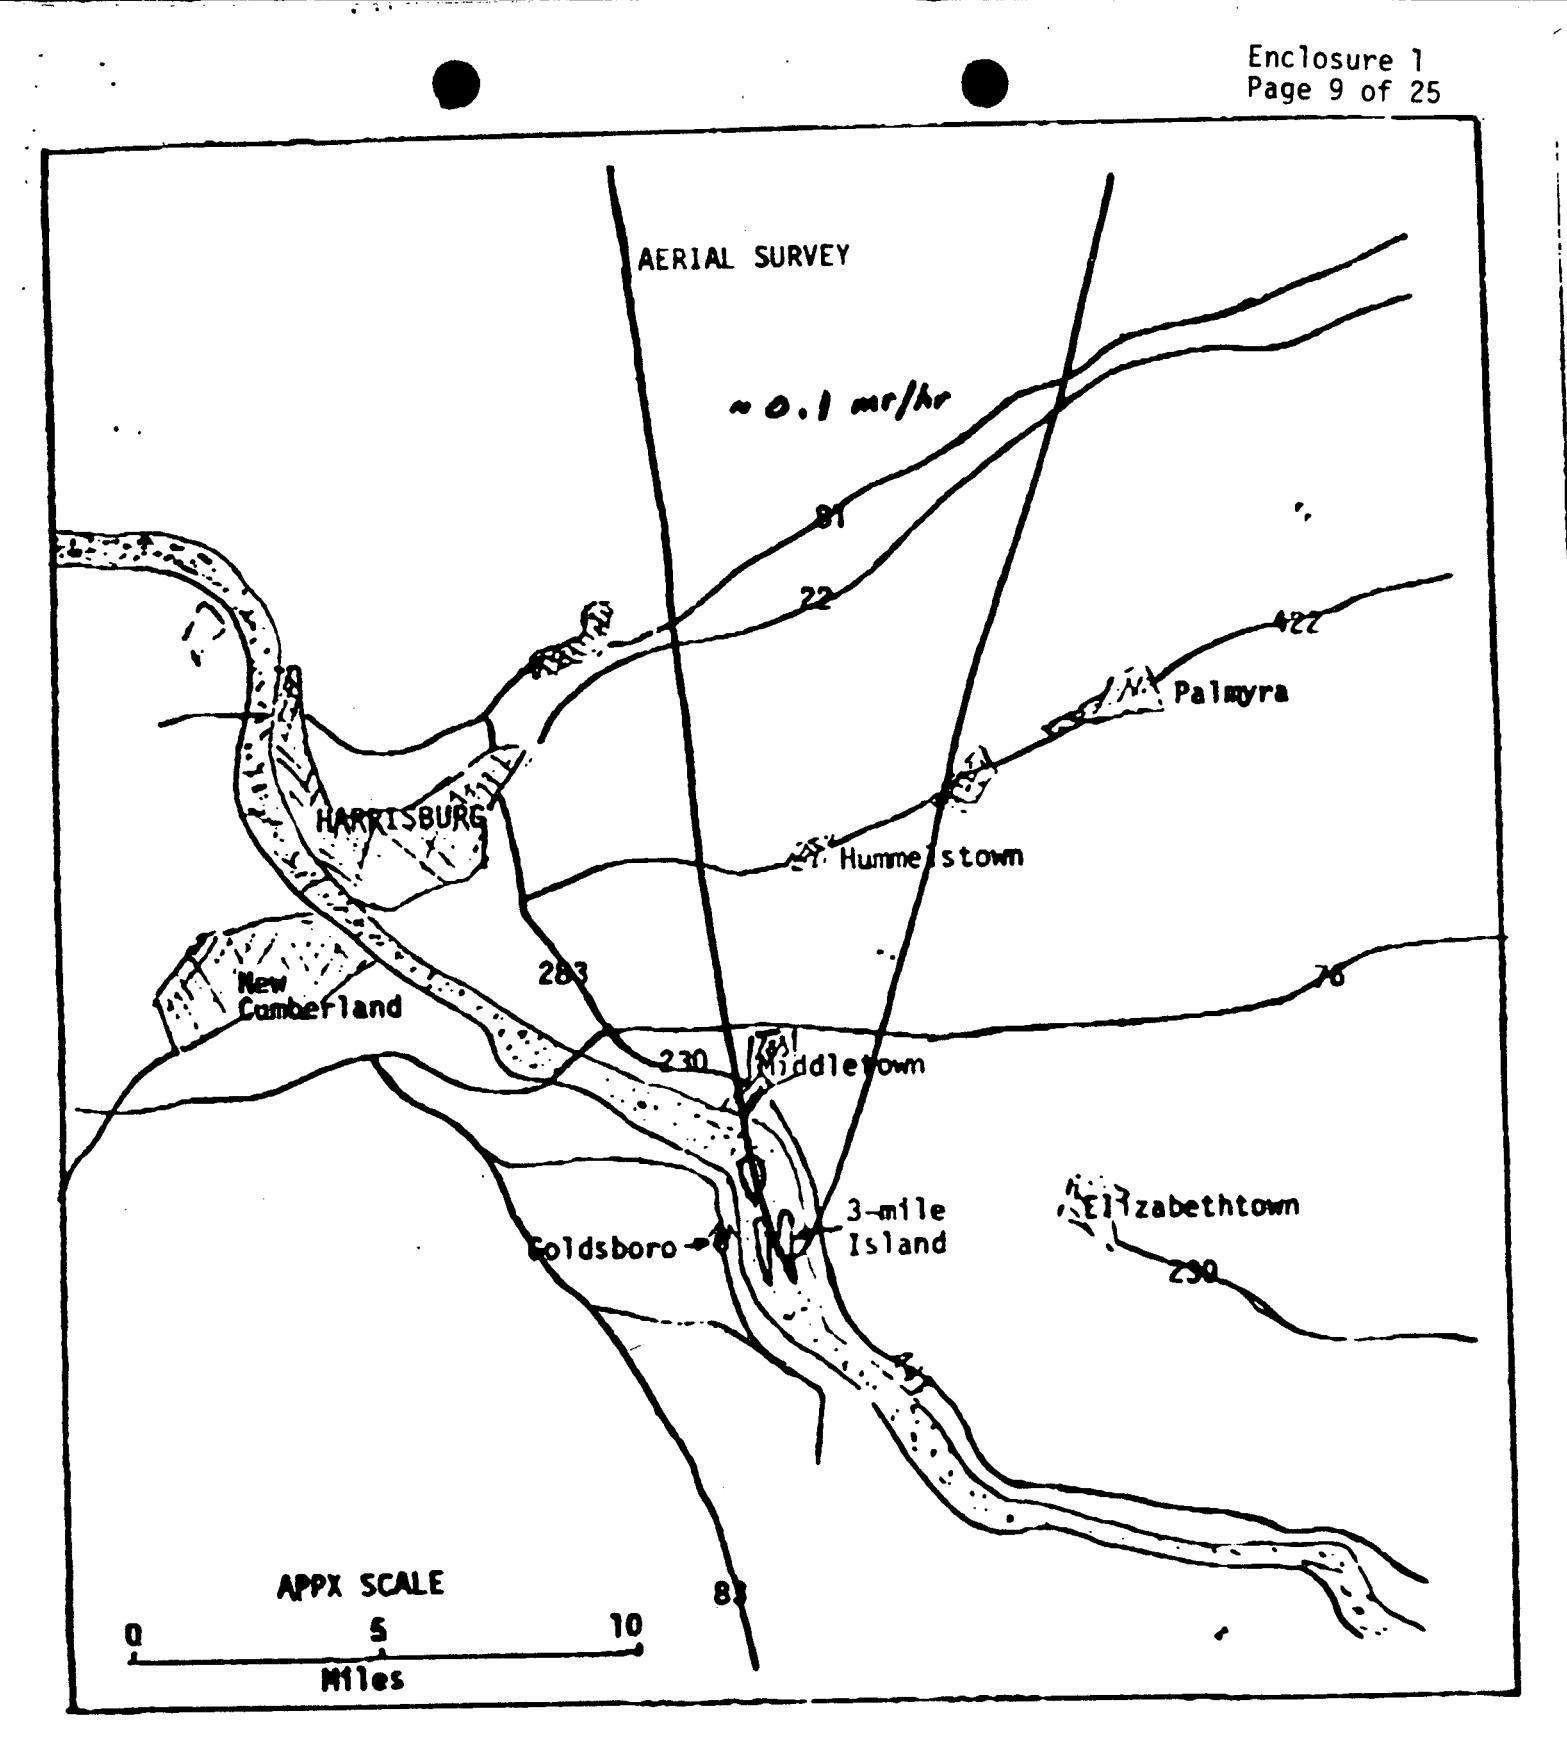
March 28, 1979 4:30 p.m.

Plume in a N to NE direction, about 30° sector. Primarily Xe-133. At distance of about 16 miles, radiation measurements in the plume were about 0.1 mr/hr.

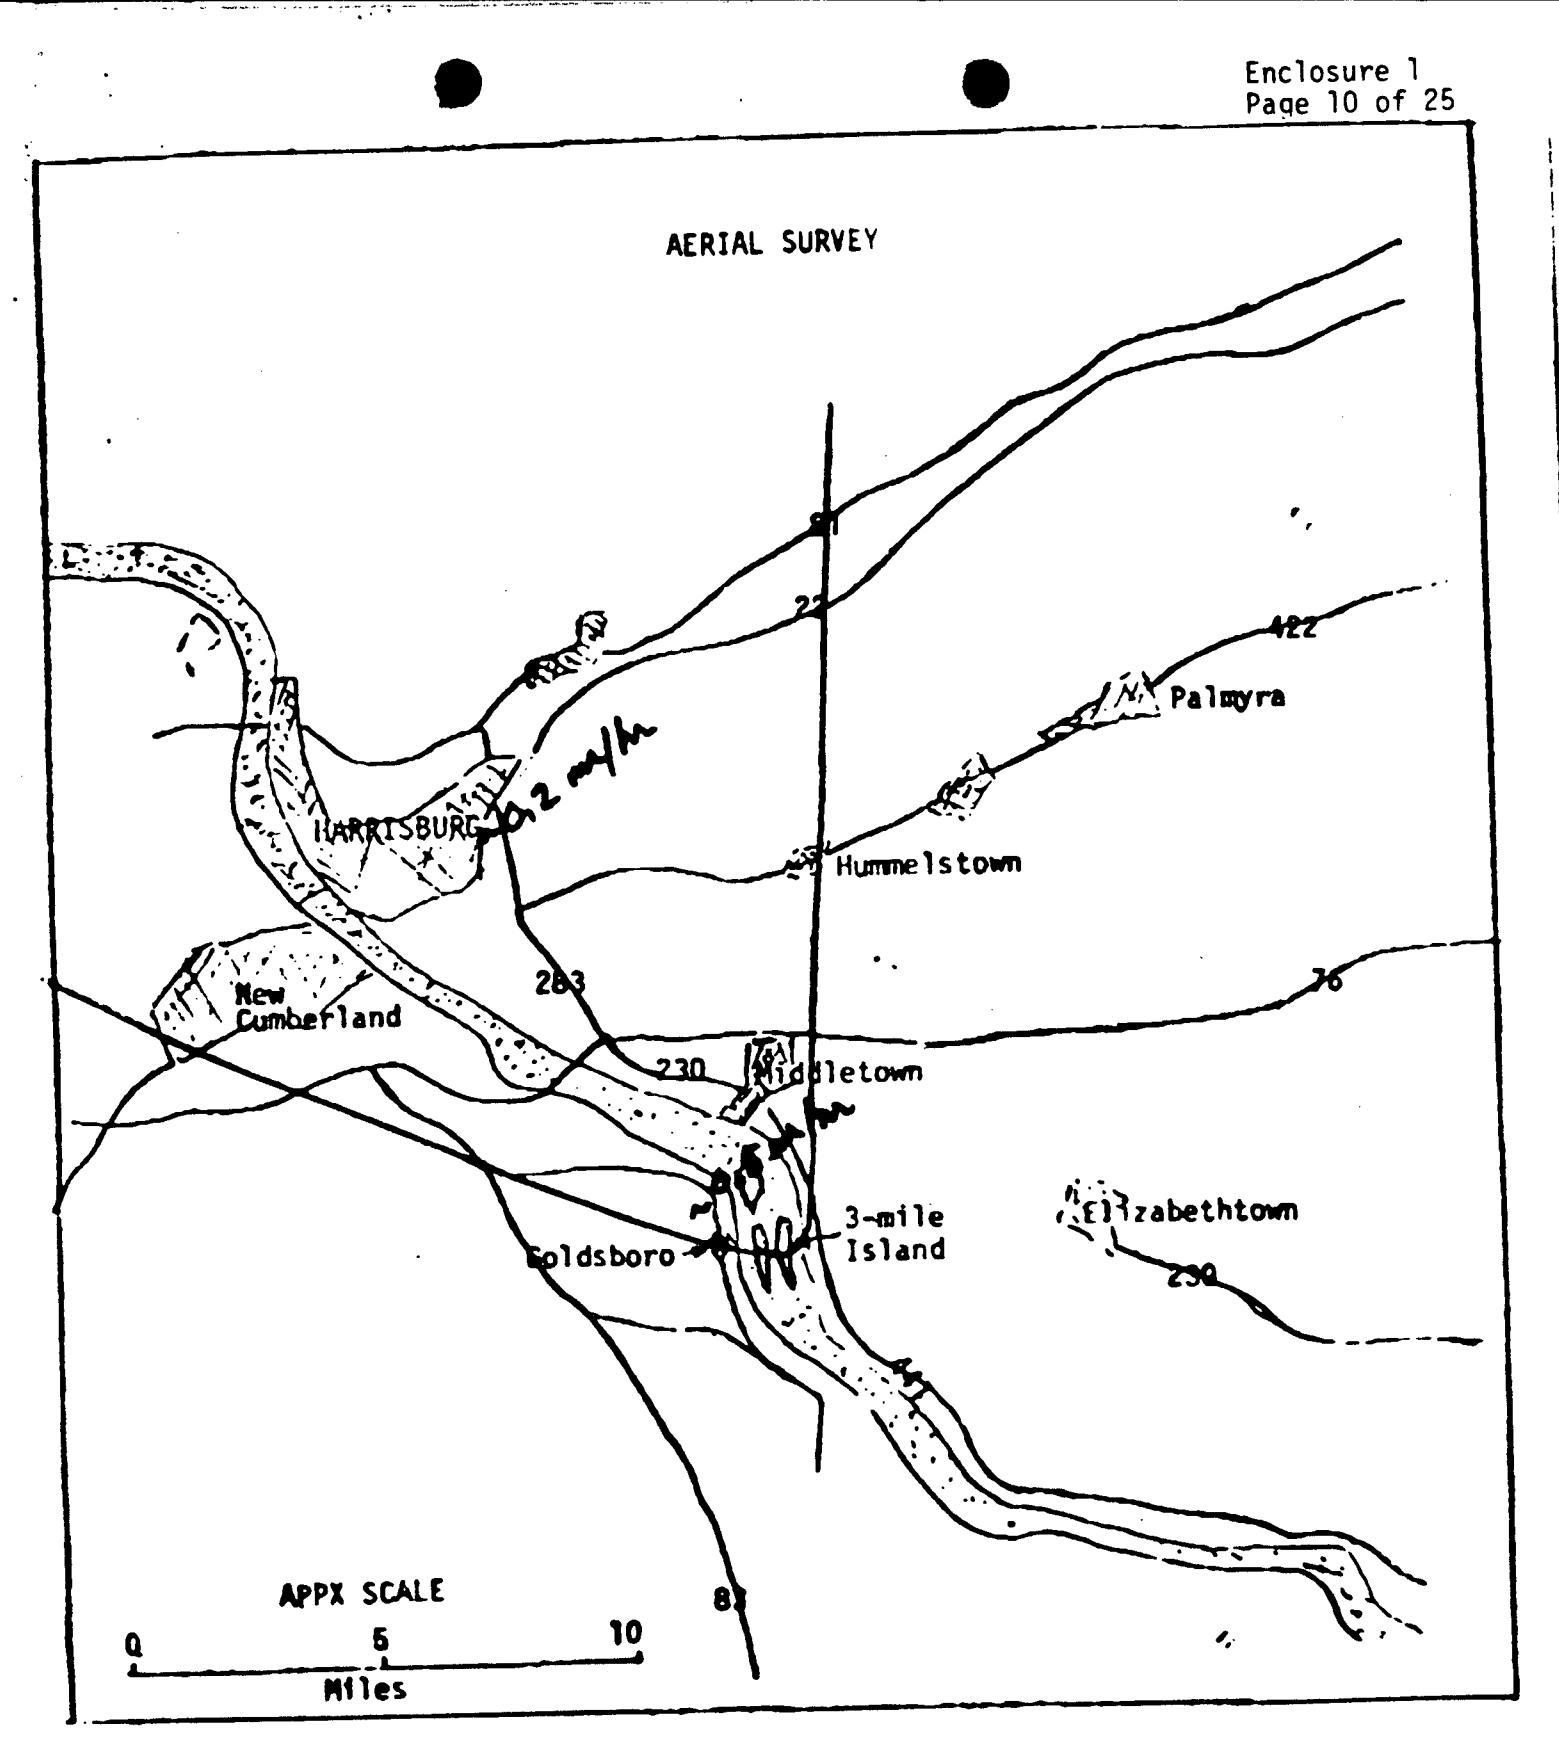
March 29, 1979 10:45 a.m.

Plume in a N to NW direction. Primarily Xe-133. Radiation measurements in the plume at about 10 miles from plant in centerline of plume were 0.2 mr/hr; at 1 mile from plant, about 0.5 mr/hr maximum.

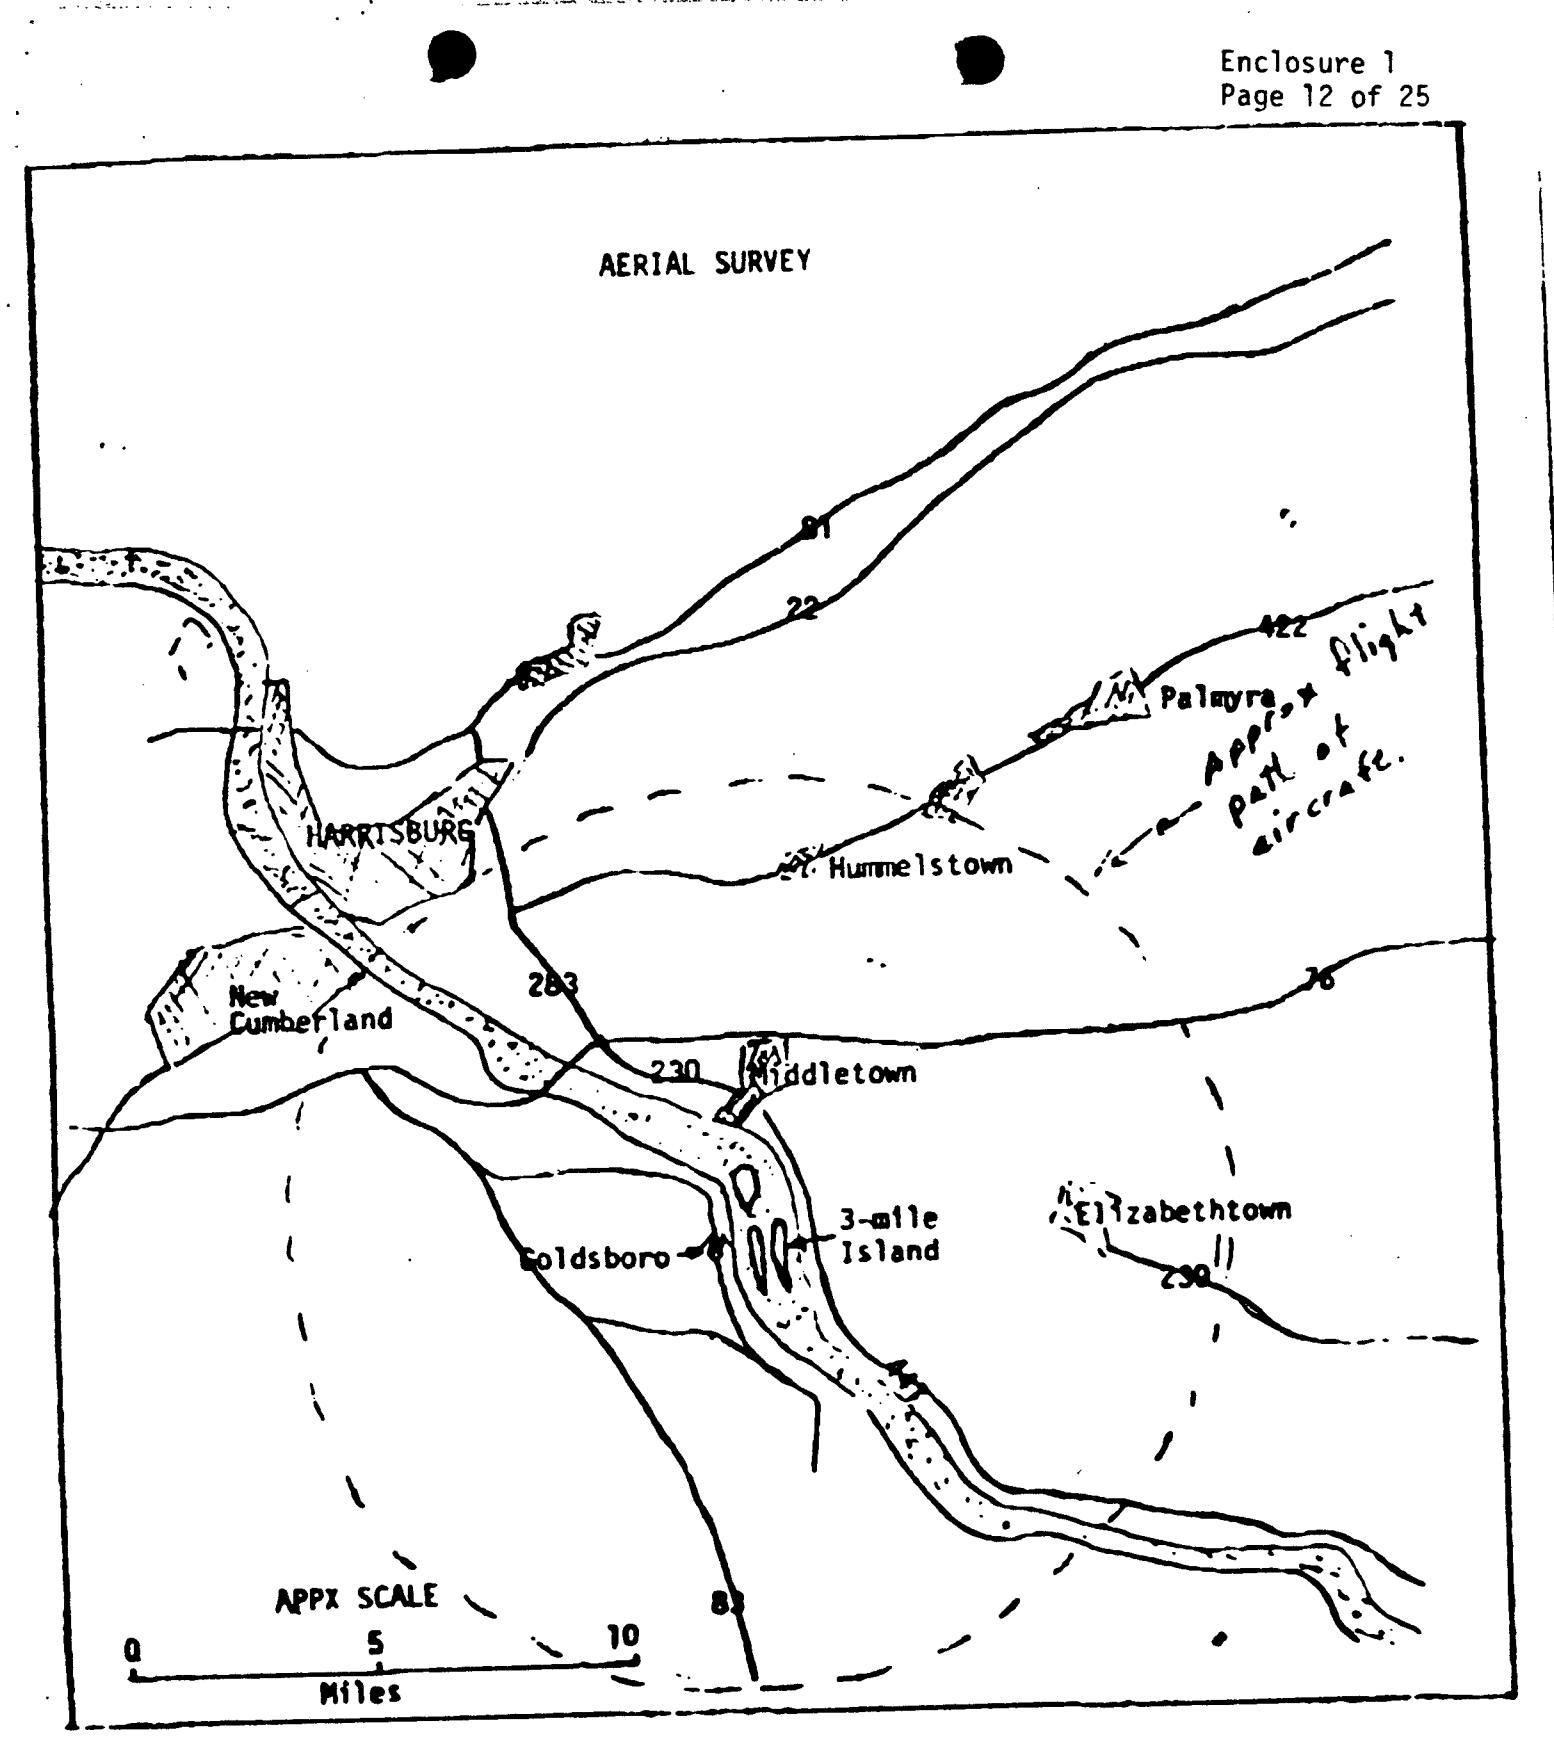
March 29, 1979 8:00 p.m.

Survey aircraft circled the site at distance of about 8 miles at allitude of 1000 feet. No detectable plume: "pockets" of residual radioactivity were detected with radiation readings in the range of of 25 - 50 microroentgens/hour.

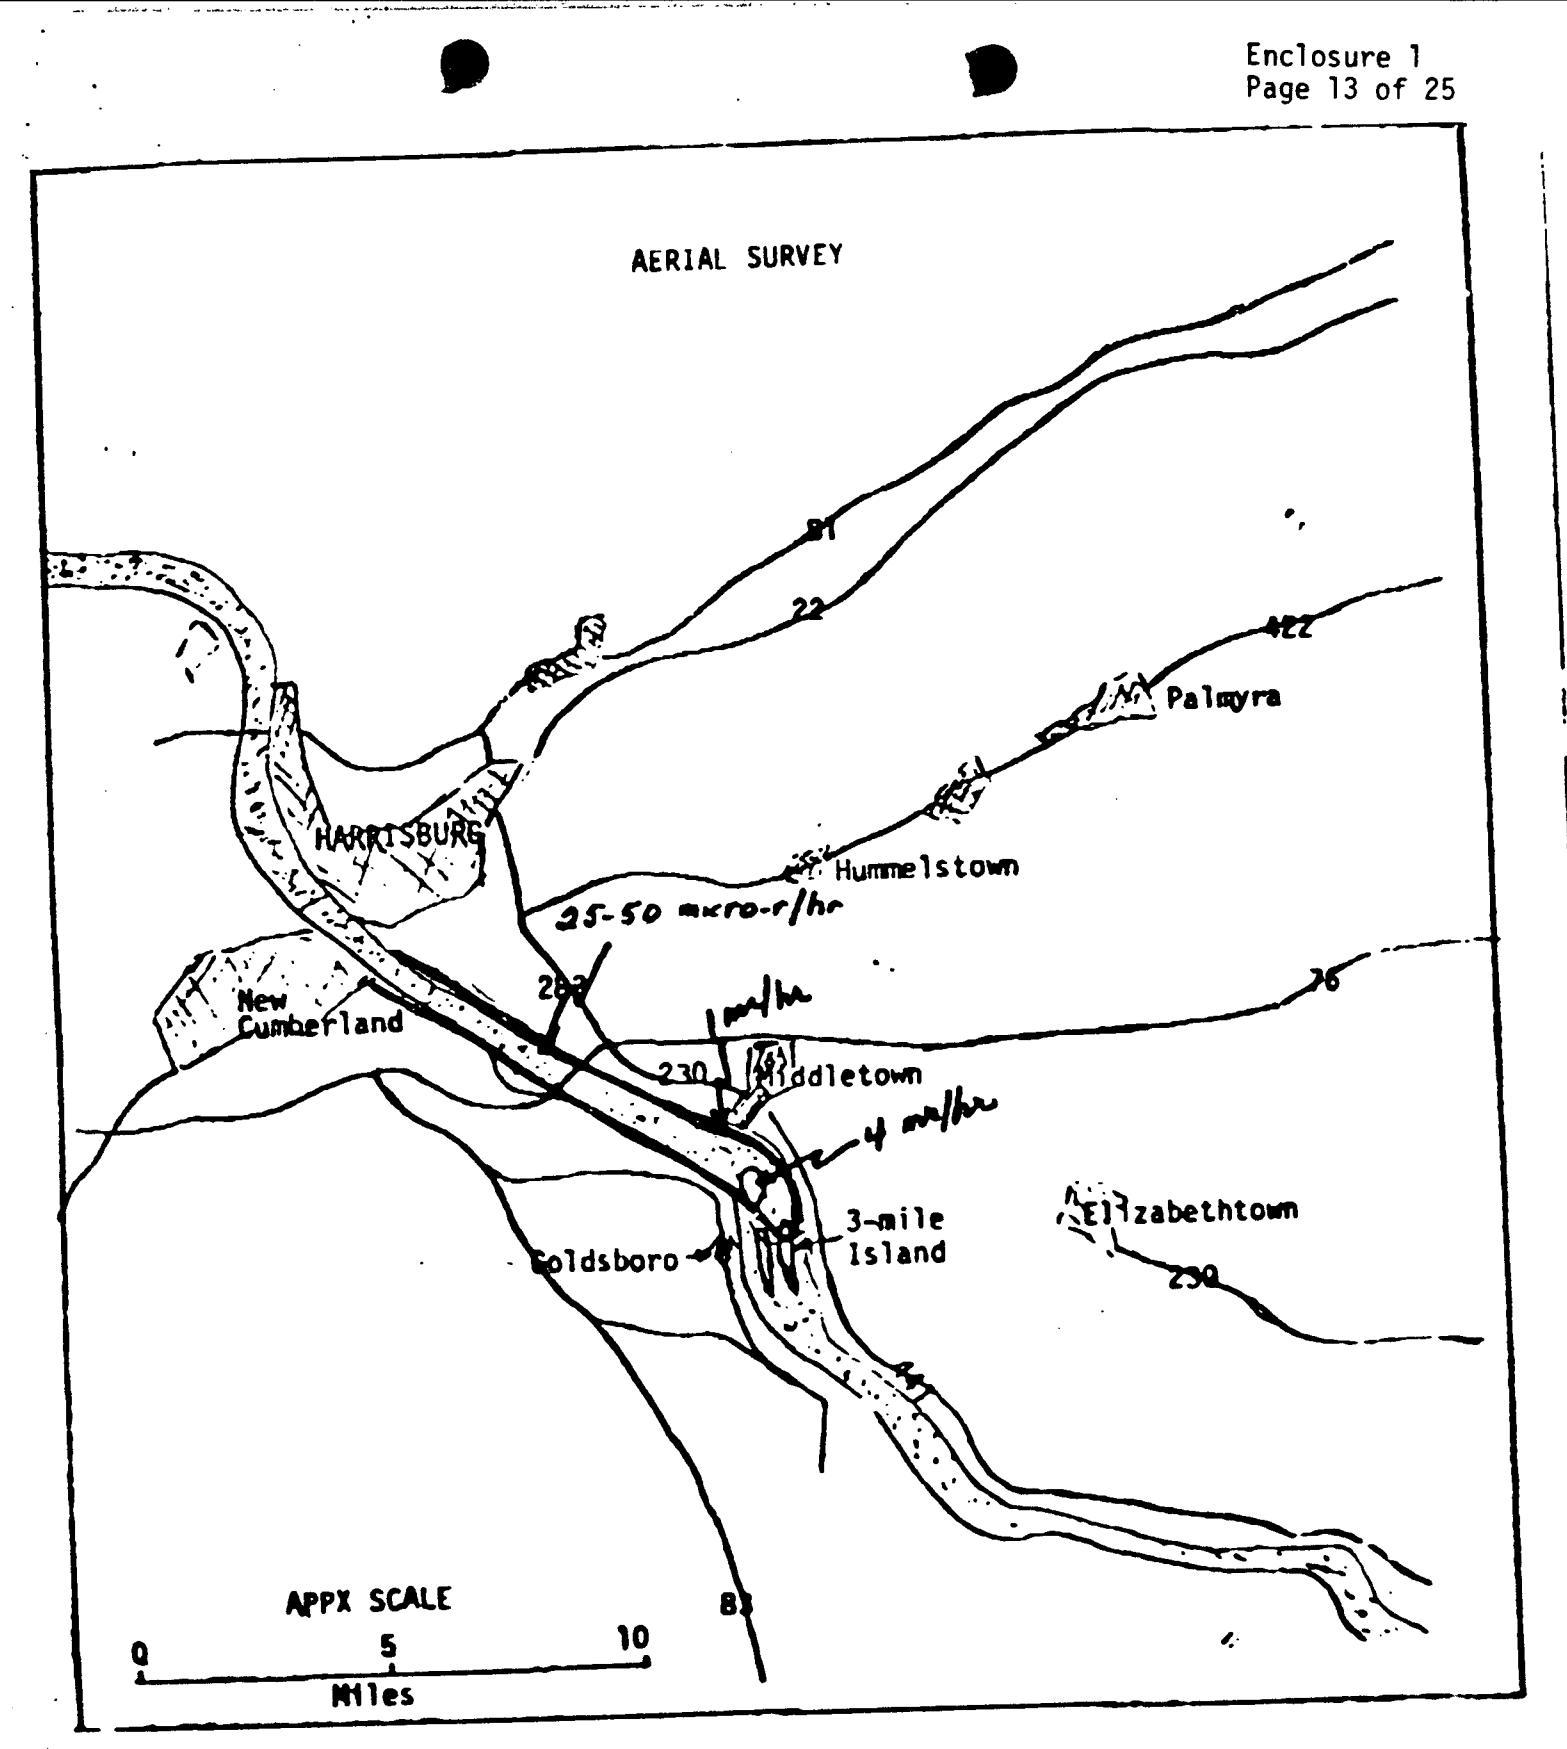
March 29, 1979 10:30 p.m.

Plume in a NW direction, width about equal to width of river. Plume touches down about 1 mile from plant at Hill Island. Radiation measurements at east shore line at Hill Island, $\frac{4 \text{ mr/hr}}{1 \text{ one mile north of Hill}}$.

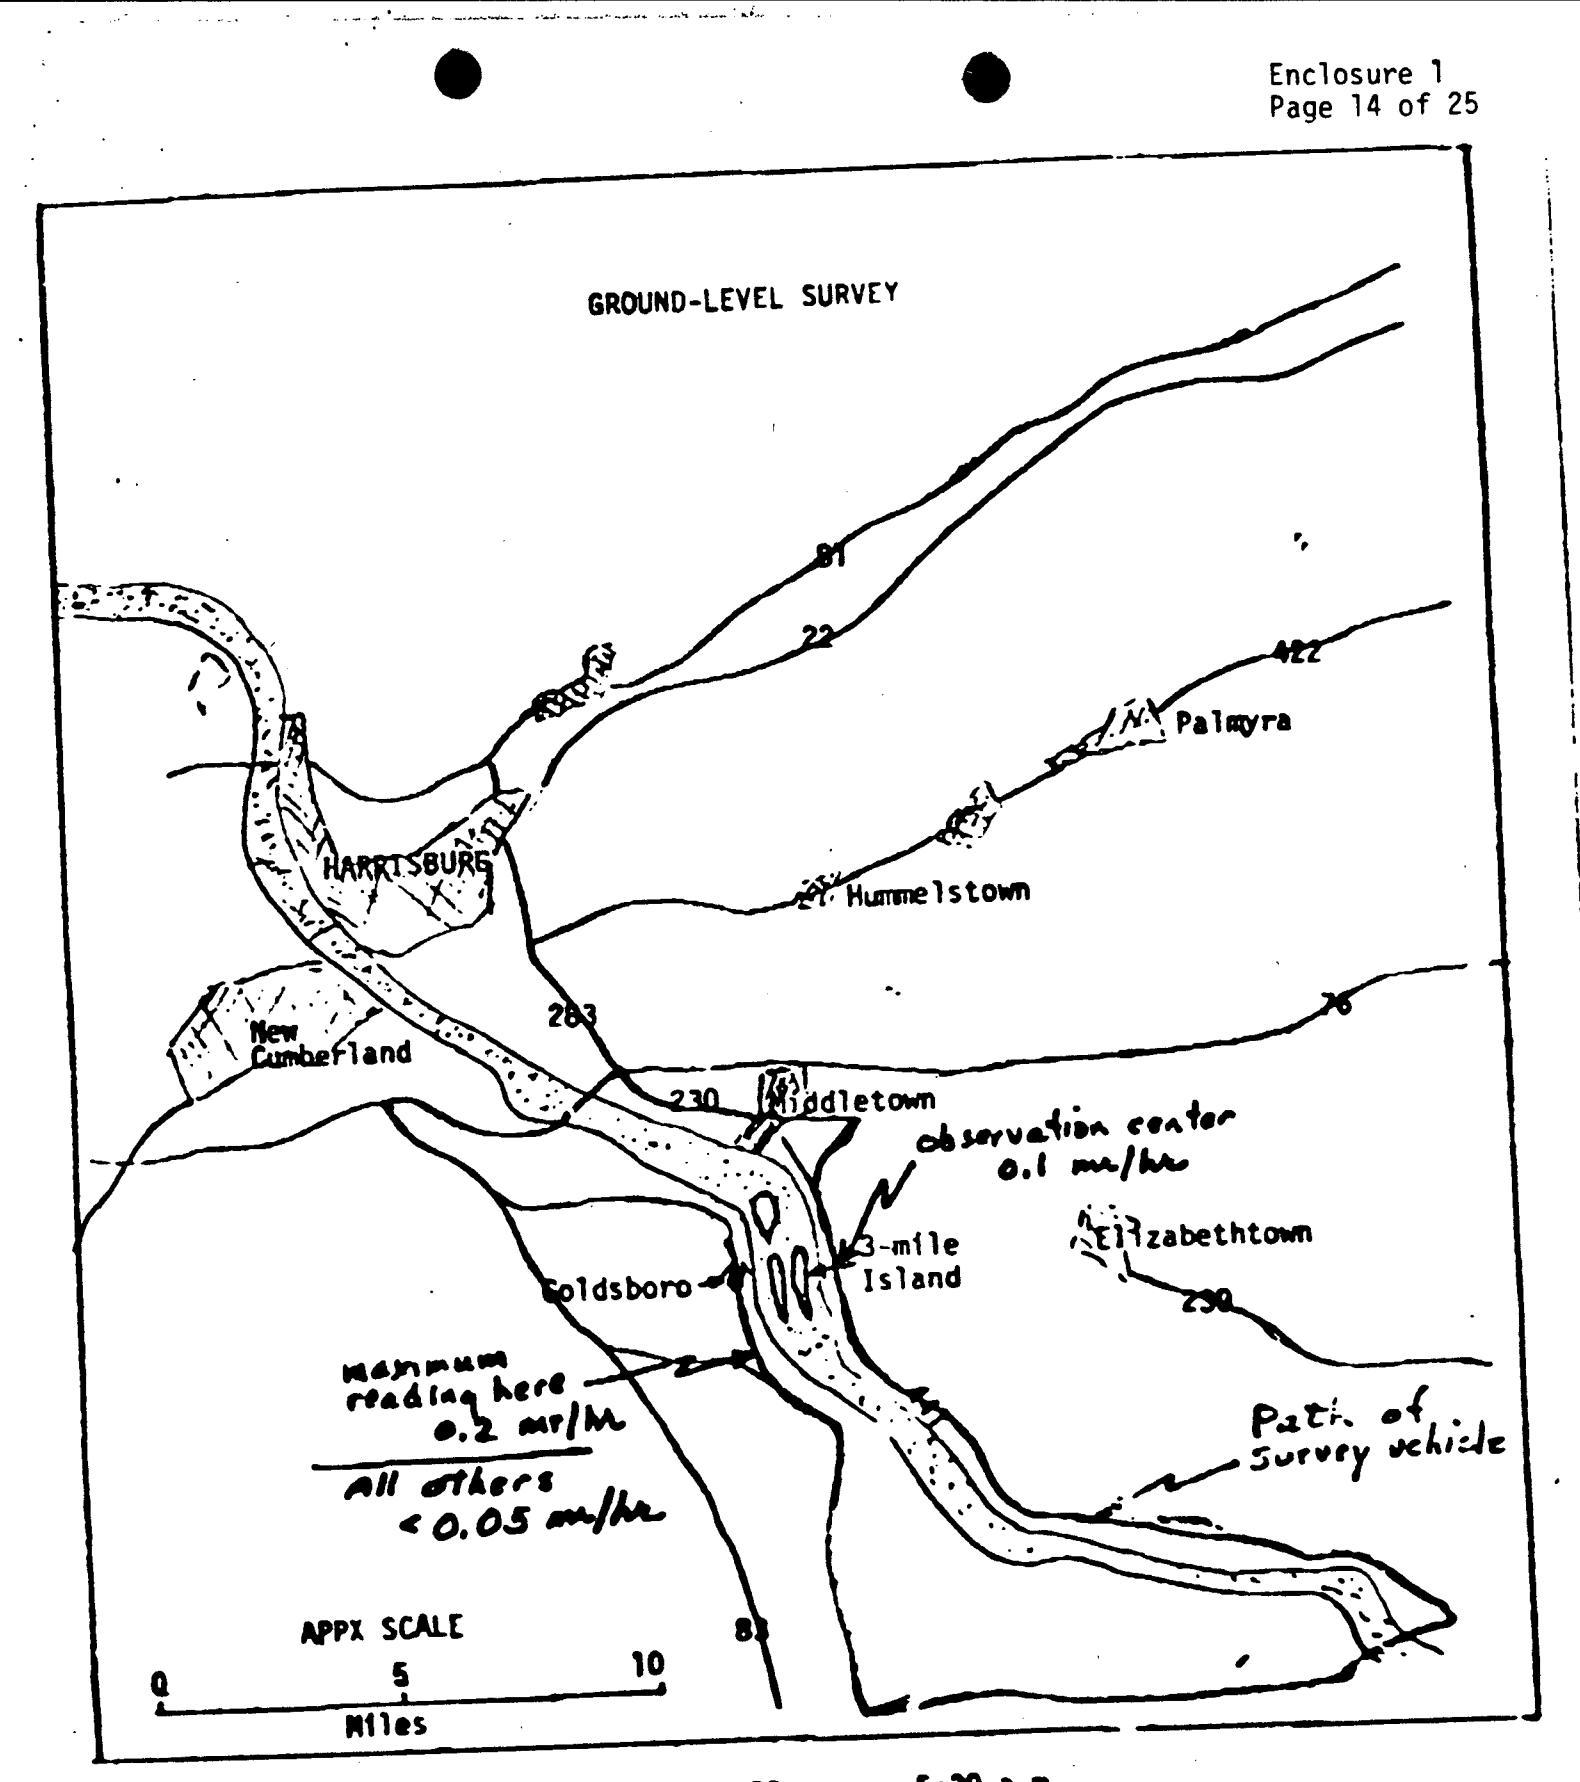
An NRC survey team took radiation measurements from a vehicle traveling both sides of the Susquehanna River.

Radiation levels were highest near Cly, a community just south of the plant on the west side of the river. The level at Cly was about 0.2 mr/hr. With the exception of the reading of 0.1 mr/hr at the Observation Center, the remainder of the readings on the route were less than 0.05 mr/hr. PRELIMINARY NOTIFICATION

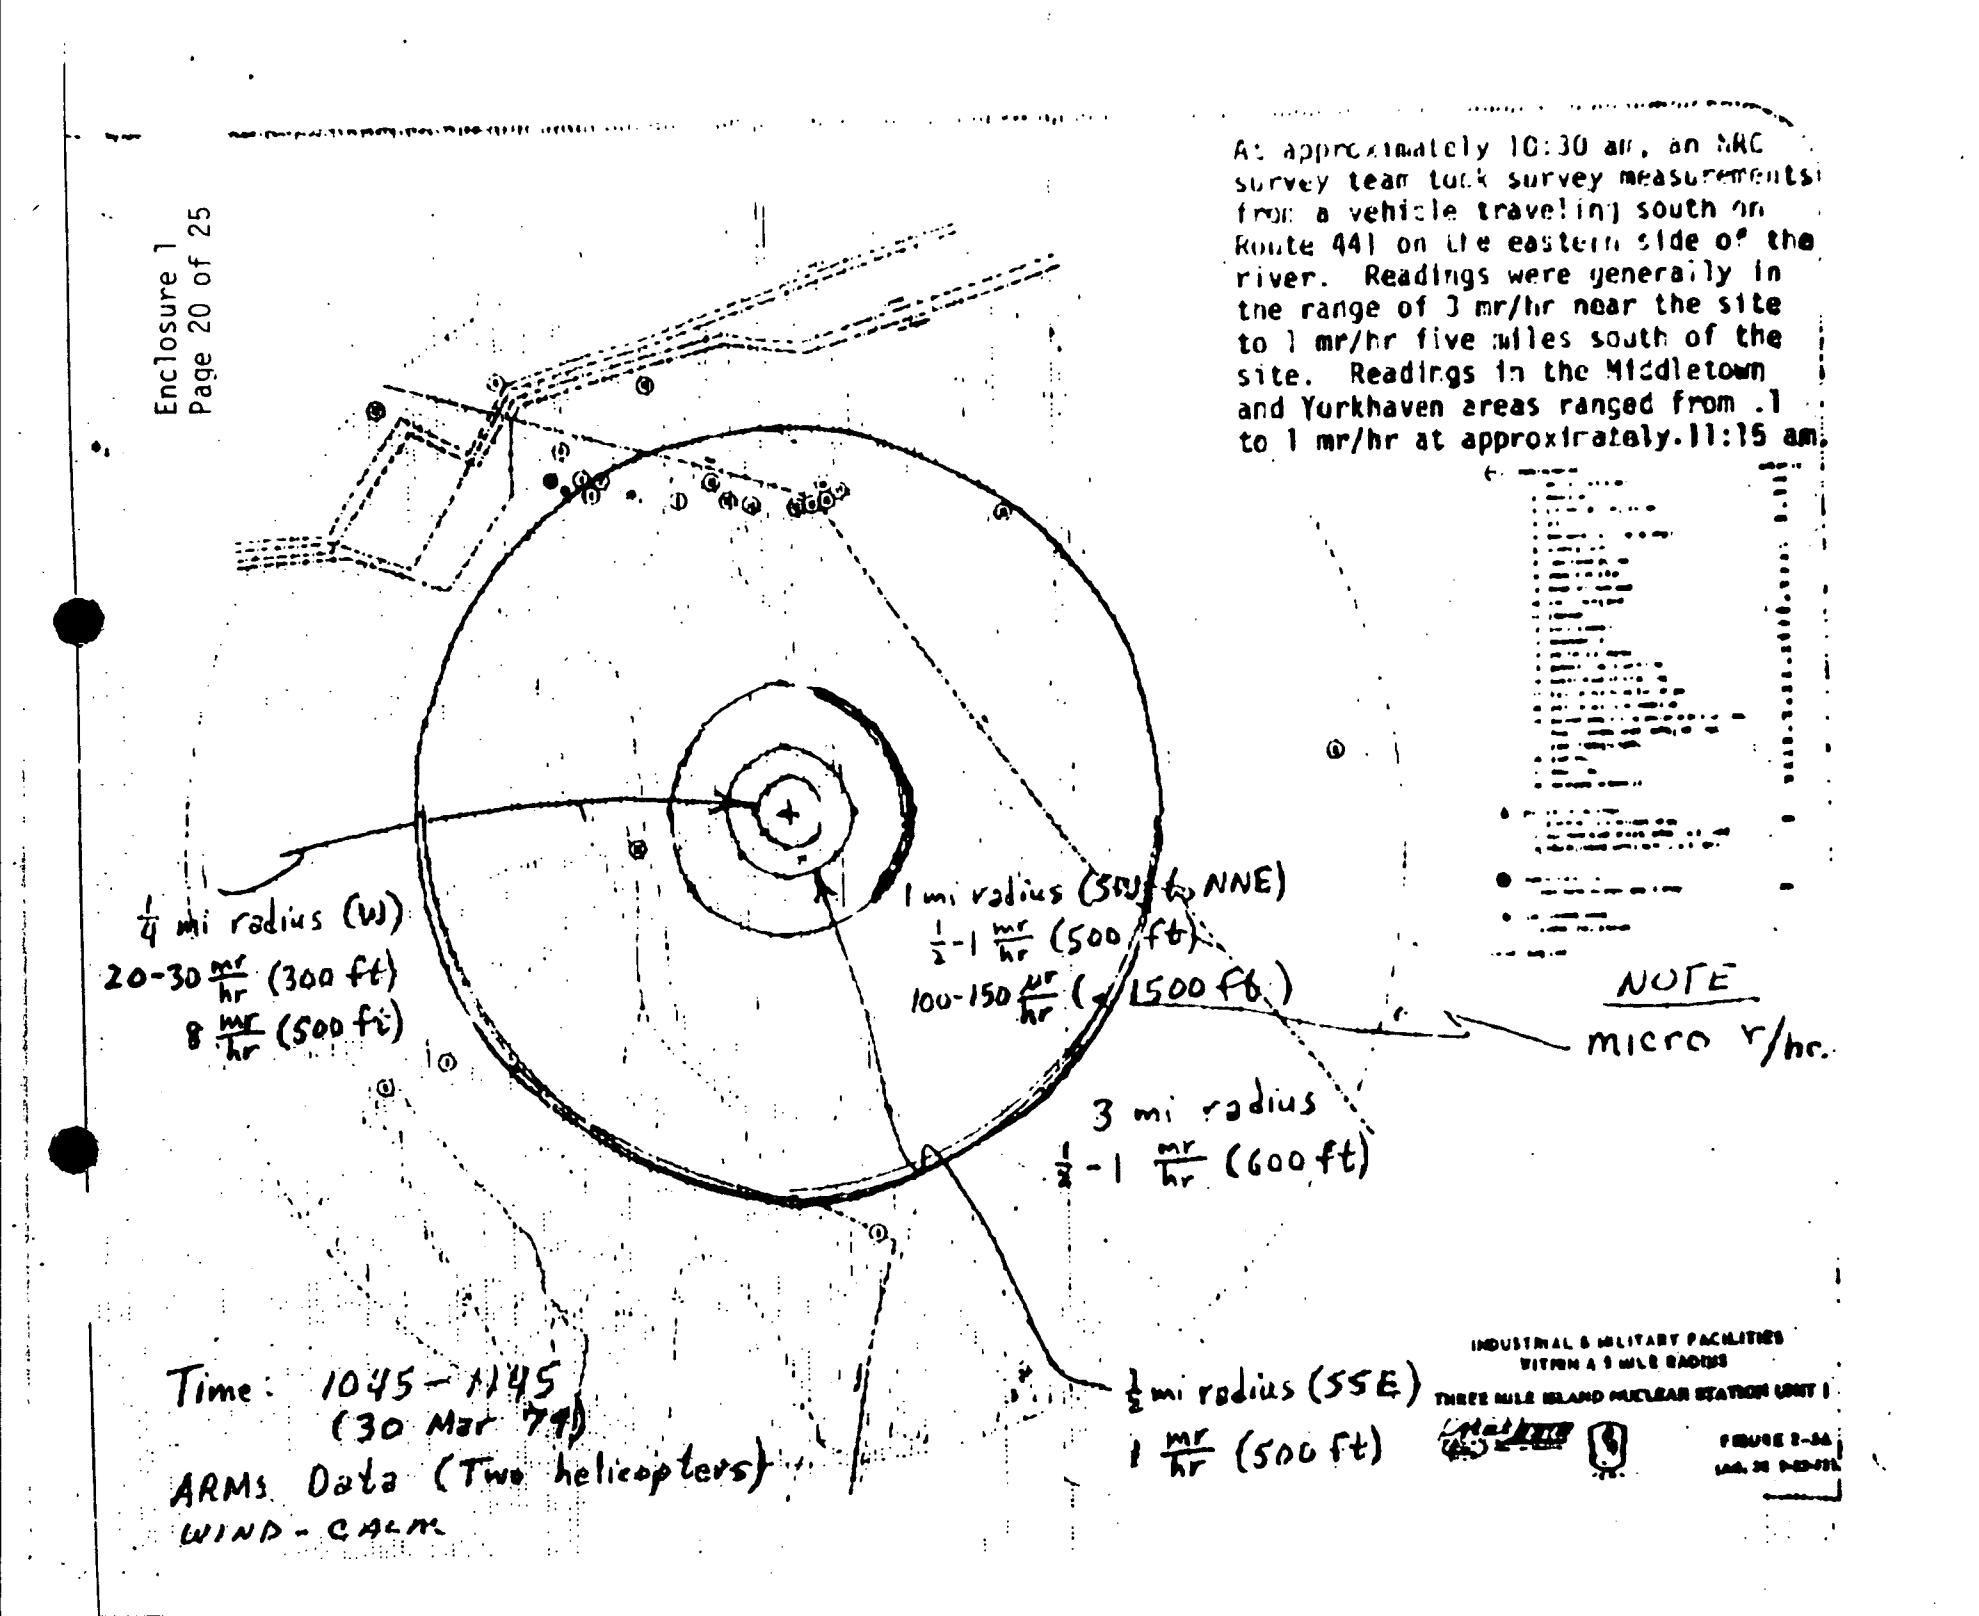
Attachment (1) Radiation Survey Map

Offsite ground level gamma surveys in the Middletown and Goldsboro areas between 3:00 and 6:00 P.M. on March 30, ranged from .01 to 1 milliroentoens per hour. An aerial survey was made by helicopter from 4:00 - 6:00 P.M. on March 30, the site was surveyed in concentric circles at approximately one mile intervals and at a height of 300 to 1,000 feet. The highest radiation readings were over the site and measured 8 to 10 milliroentgens per hour. In the plume the highest radiation readings were 6 to 8 milliroentgens per hour. The plume followed the river in a northwesterly direction and was not detectable beyond five to six miles from the site. Site ground level surveys conducted between 7:30 - 8:00 P.M. ranged from .01 to 1.8 milliroentgens per hour.

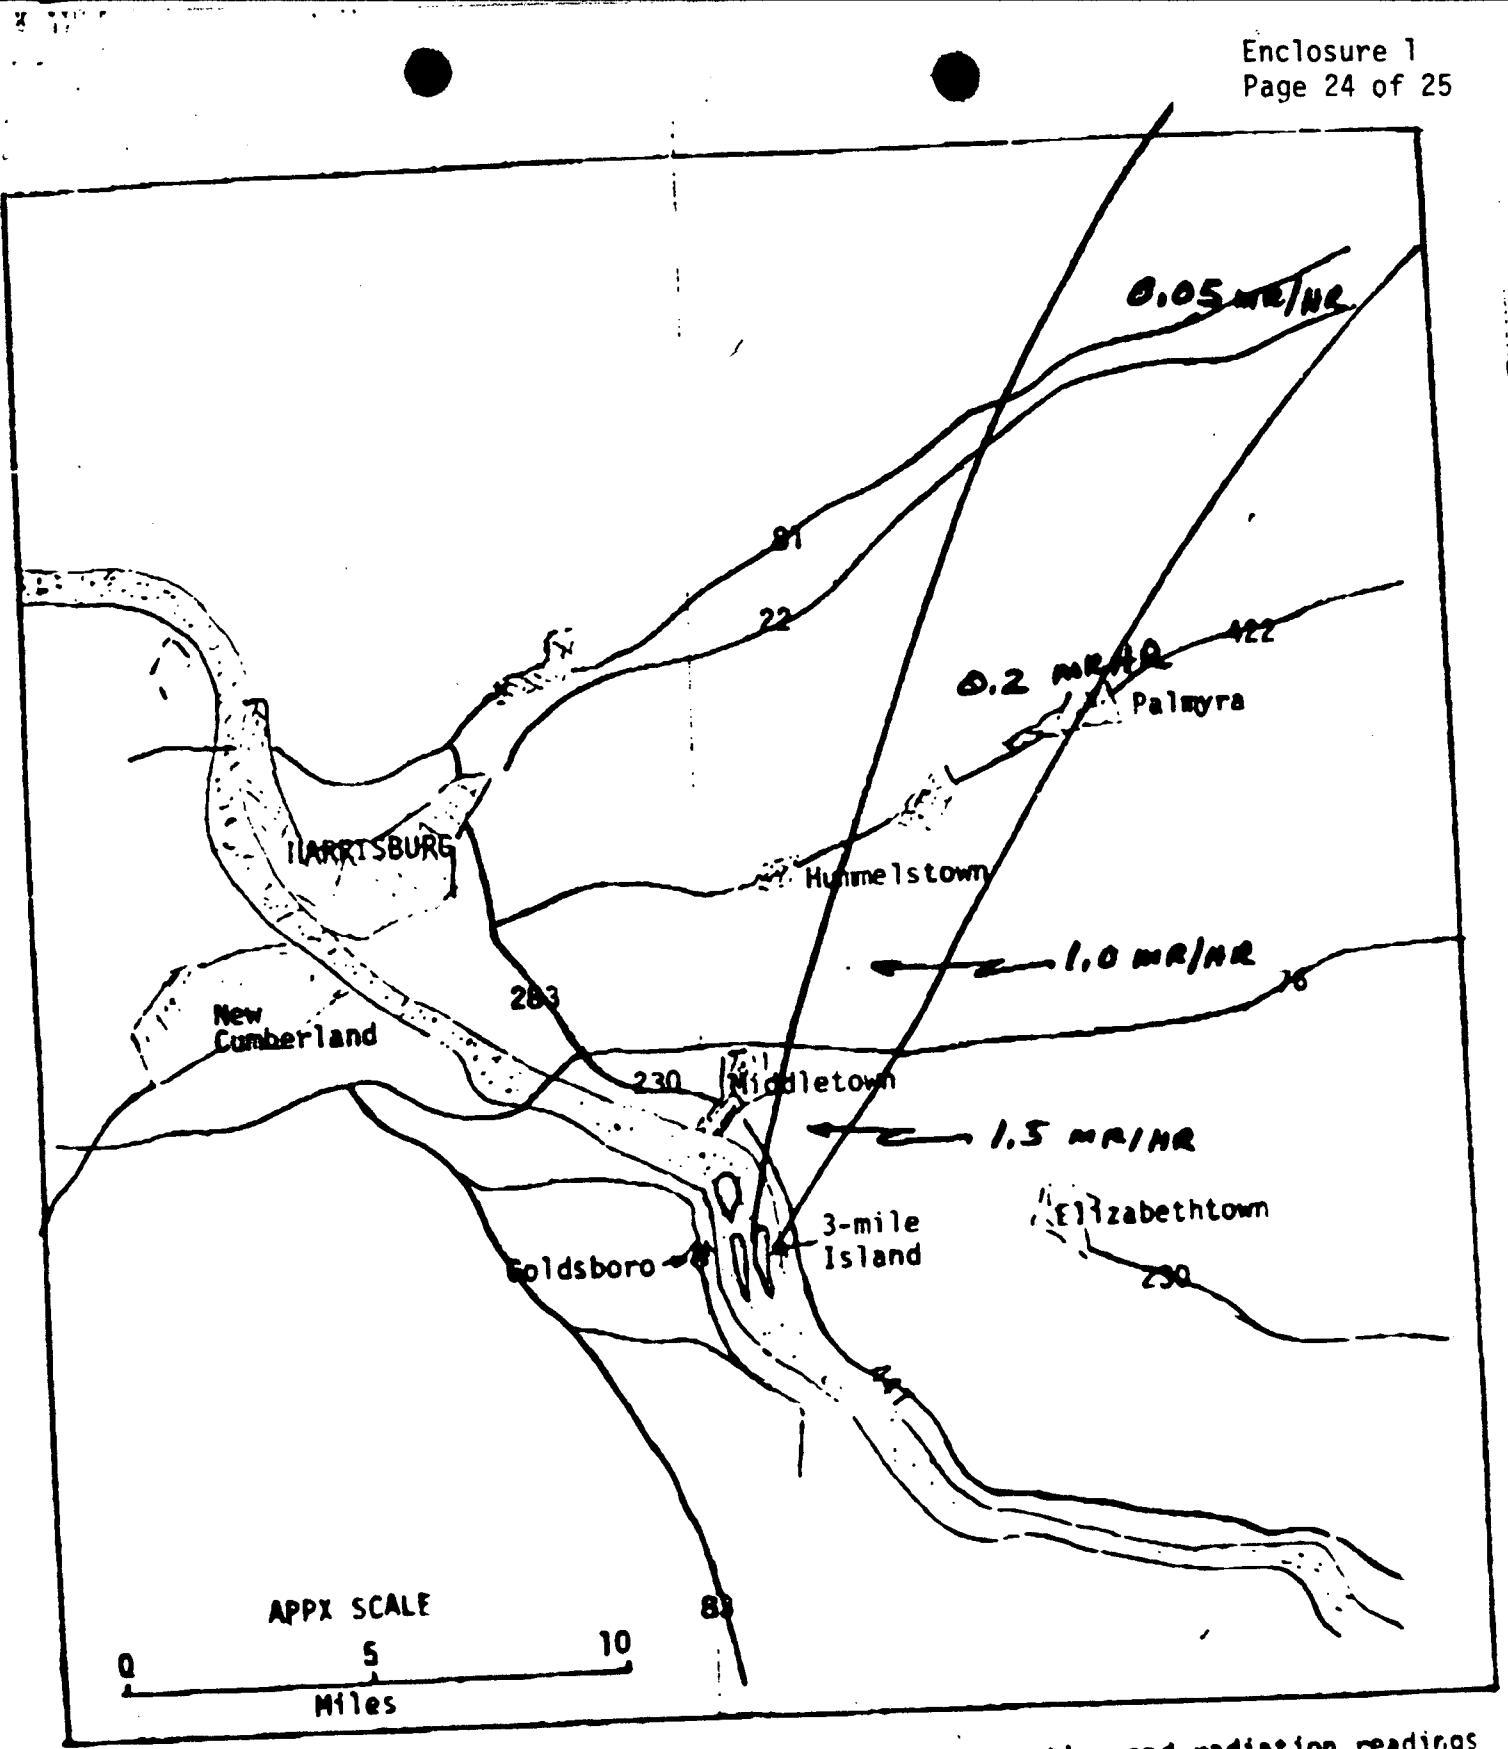
March 31, 1979 -4:00 a.m.

Three ARMS flights were conducted at about 6:00 a.m., 9:00 a.m., and 12:00noon on March 31. All flights reflected a rather stable situation. Maximum readings in the plume were from 1.5 to 2.5 milliroentgens per hour (mr/hr) at a distance of one mile from the plant, from 0.5 to 1.0 mr/hr out to 7 miles, and 0.1 to 0.2 mr/hr beyond 10 miles. The plume width is about 1-1/2 to 2 miles. No radioiodines have been detected in the plume. Offsite ground level gamma surveys performed in the predominant wind direction indicated maximum levels of about 2 mr/hr at about 1/2 mile from the site in the direction of the plume. The wind was from the SSW at the time of the
