# **Exelon Nuclear Pre-Submittal Meeting**

Proposed Relaxation Request  
from  
First Revised Order EA-03-009  
Byron Station Unit 2

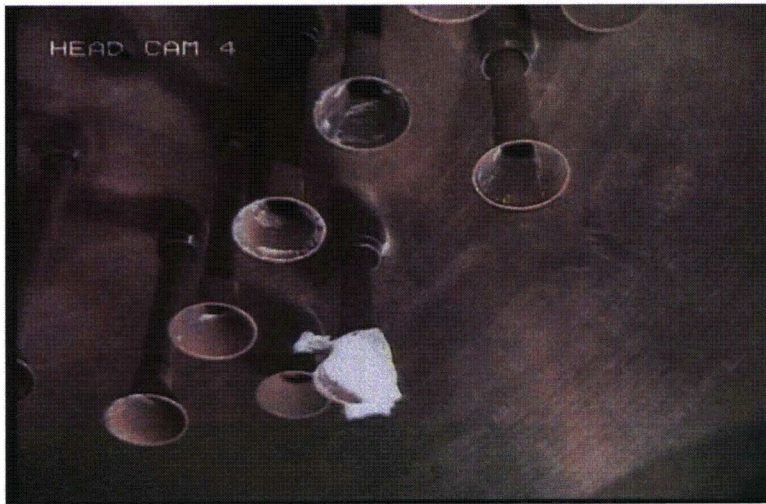
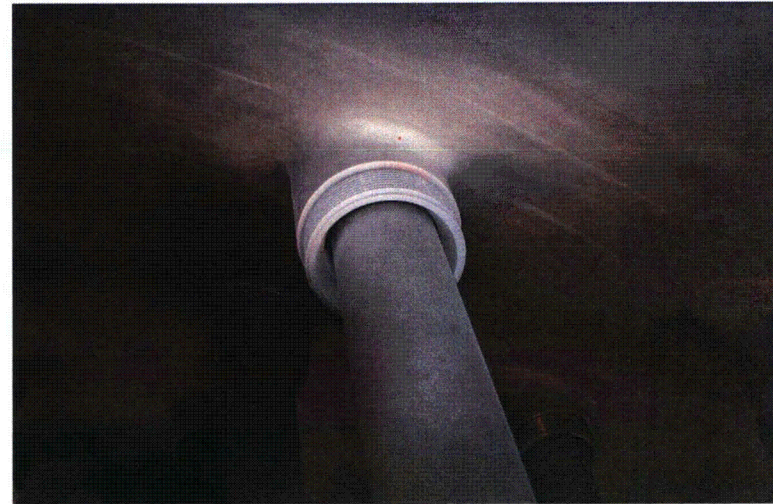
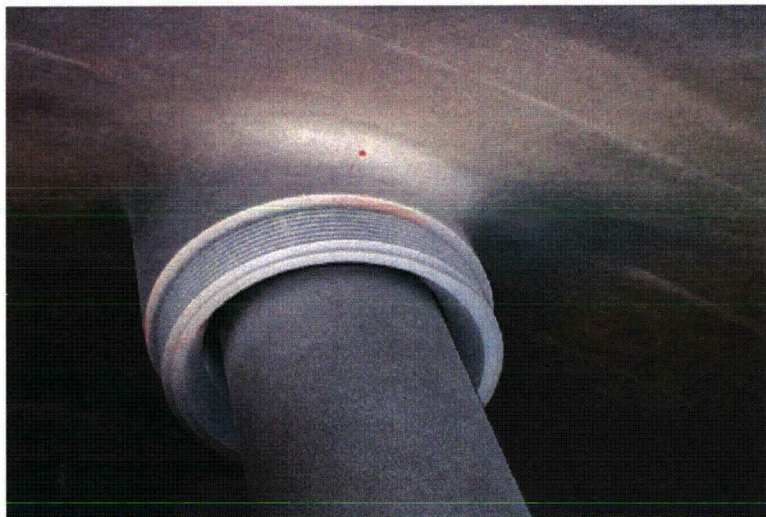
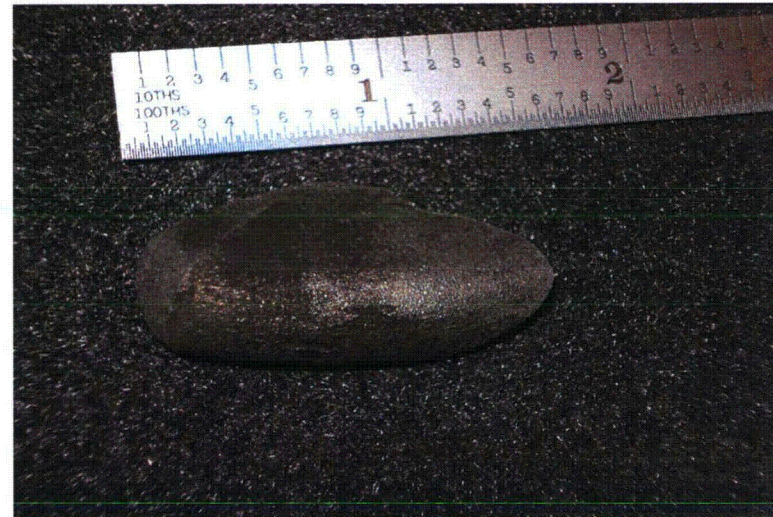
# Boat Sample Results

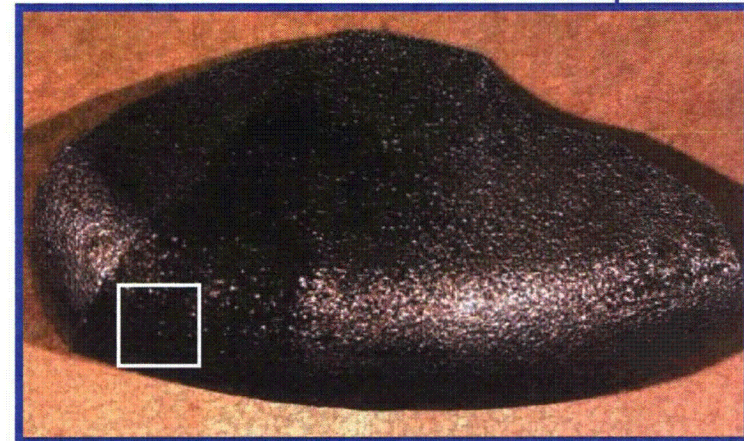
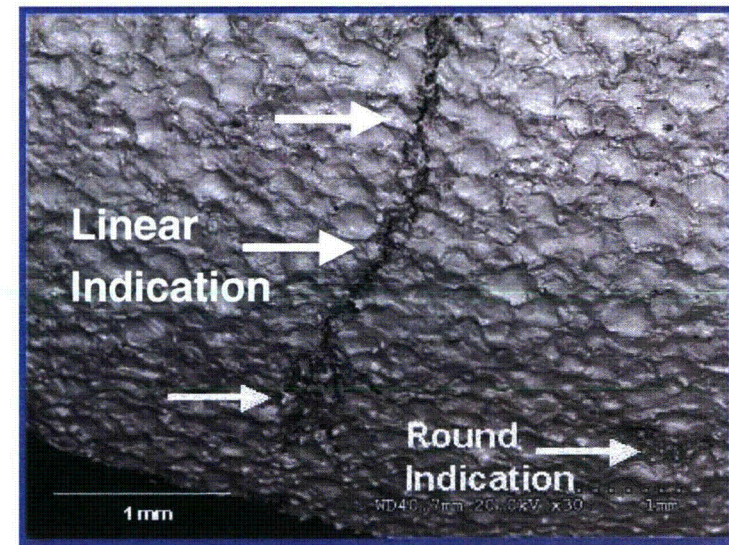
SEM Image of inset area above

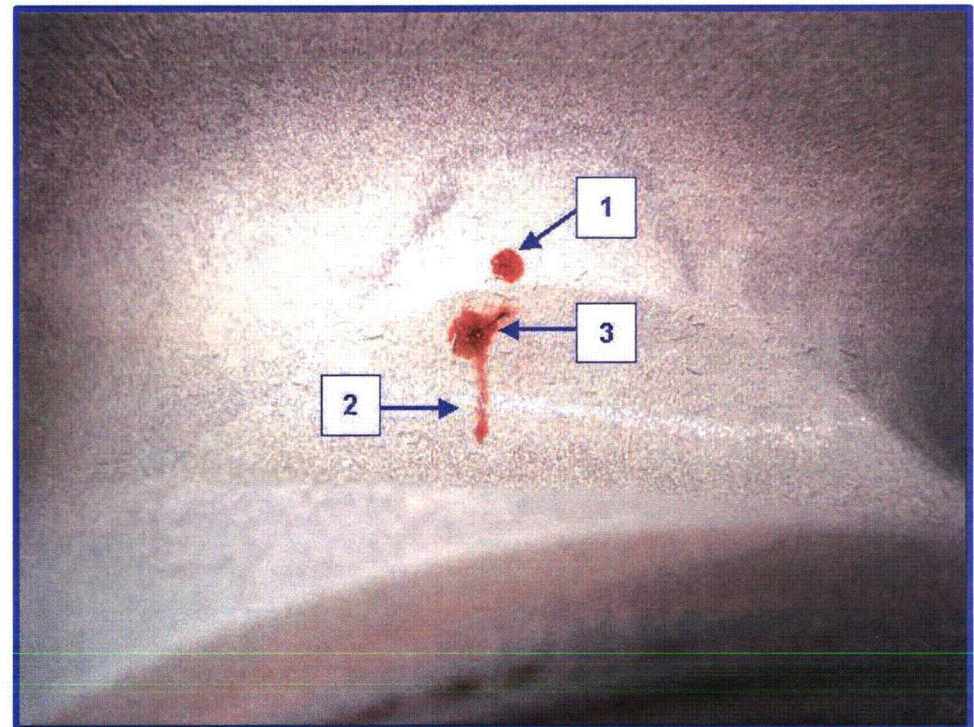
1. Rounded PT indication
2. Subsurface portion of axial indication
3. Subsurface linear defect connected to lack of fusion

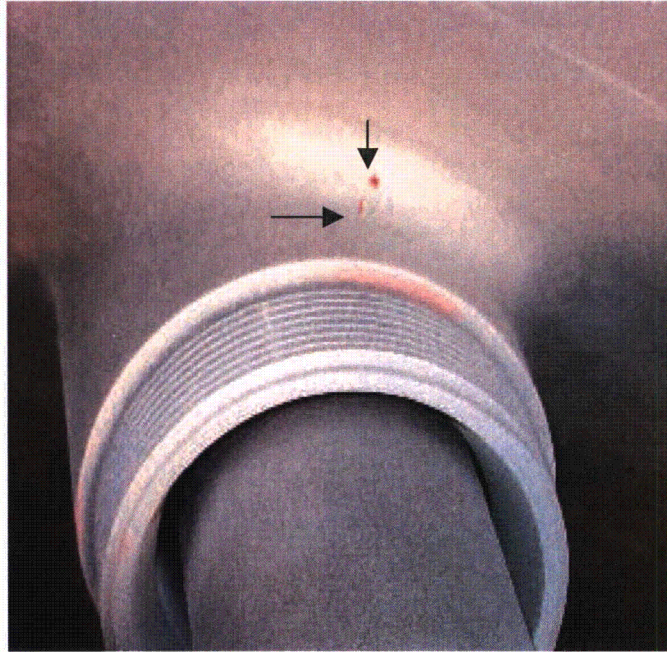
**Figure 3-1:** A photograph of the two dye penetrant indications on the surface of the J-groove weld on CRDM 68.

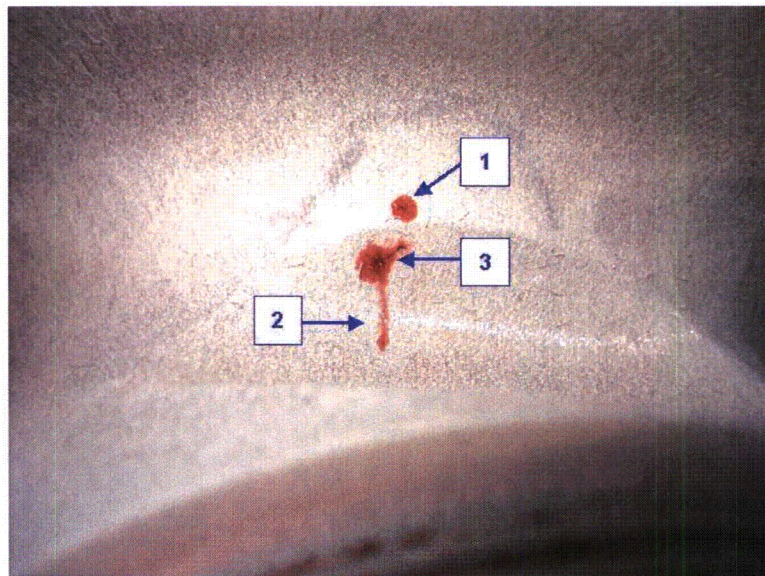
**Figure 3-2:** A photograph of the field dye penetrant results of the excavation site after the boat sample was removed. The excavation uncovered an angled, subsurface linear defect (#3) that intersected the subsurface portion of the original axial linear defect (#2). The original rounded indication (#1) remained in the penetration.

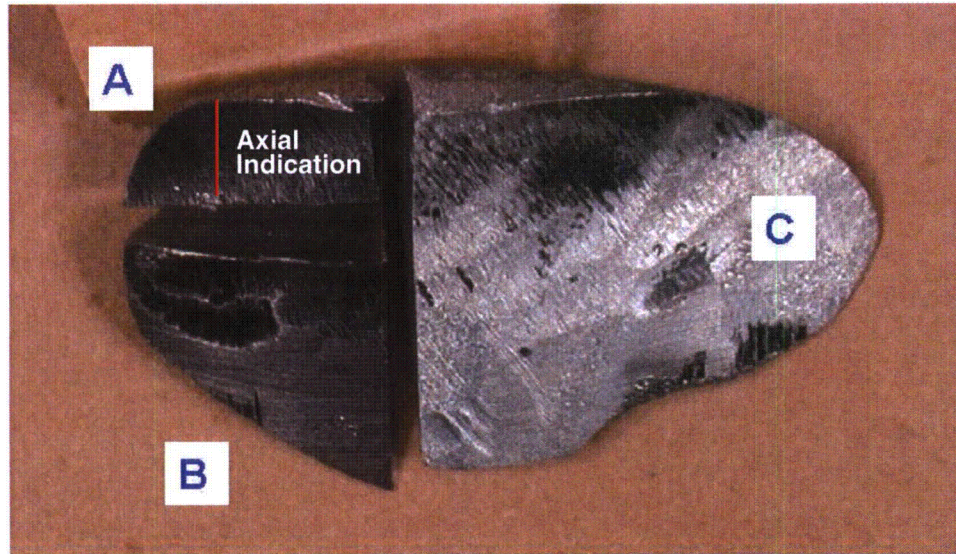
**Figure 3-3:** A photograph of the boat sample after initial sectioning in the laboratory. The front surface is the wetted surface of the J-groove weld; the back surface is the EDM cut surface.

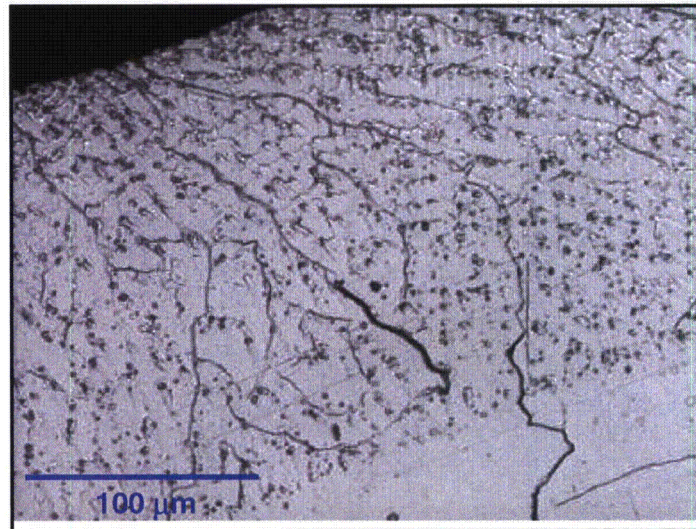
**Figure 3-4:** Photomicrograph of the metallurgical mount prepared from the horizontal cut face in Section B. The direction of crack growth is from the tube material into the weld. (Original magnification 375X; electrolytic phosphoric-nital dual etch)

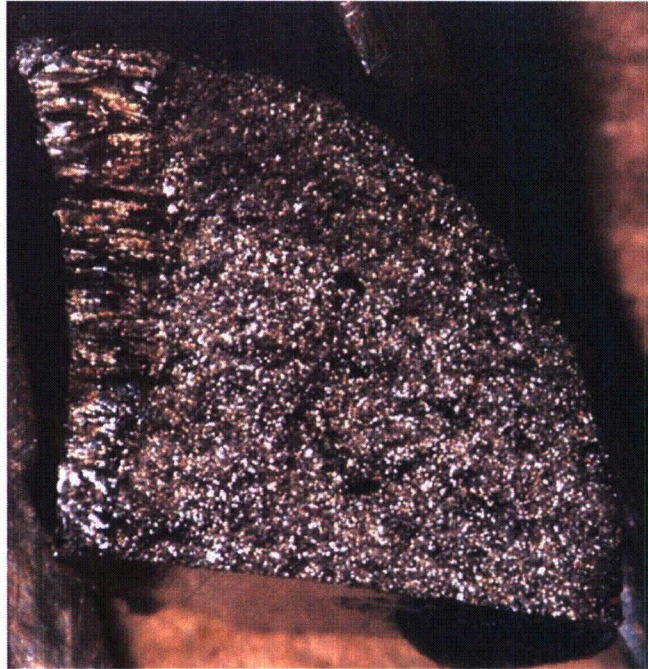
**Figure 3-5:** A stereoscope view of the exposed surface of the axial indication from Section A. The weld is toward the left side of the sample.

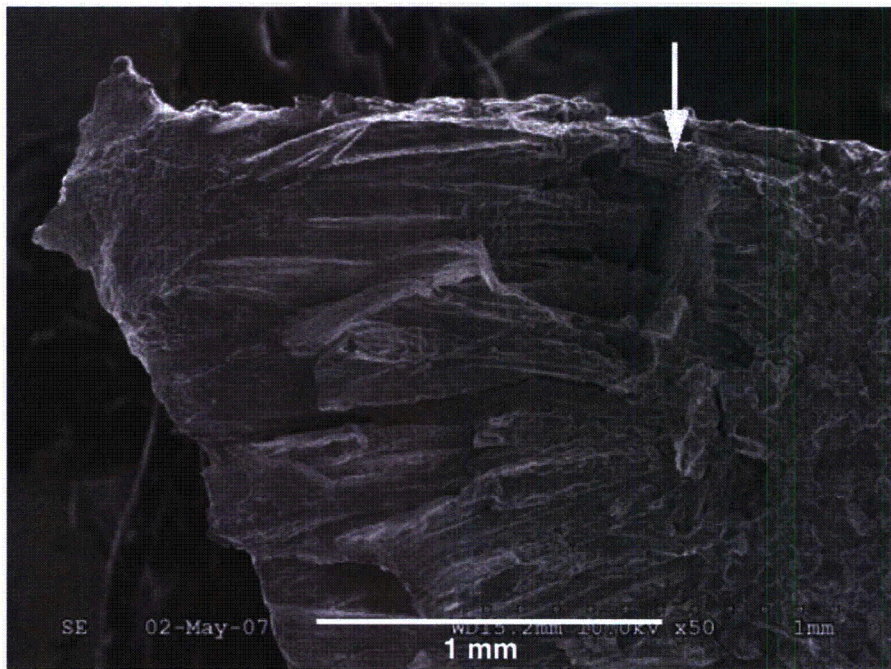
**Figure 3-6:** A scanning electron micrograph of the exposed surface of the axial indication from Section A. The arrow points to the lack of fusion between the weld passes. A ductile region can be seen in the upper left corner of the sample. (Original magnification 50X)

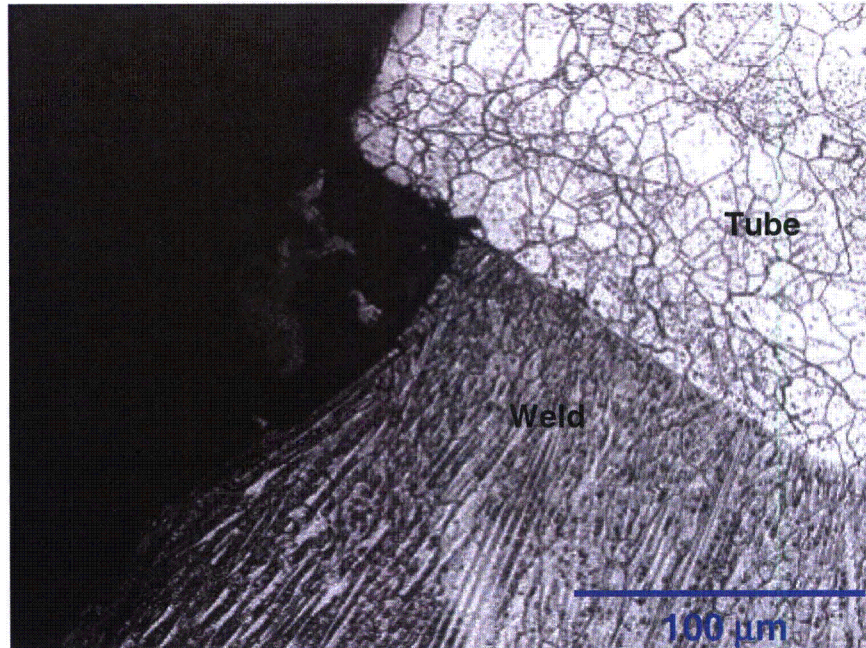
**Figure 3-7:** An etched view of the lack-of-fusion defect contained in Section A. Also note the flat interface at the fusion line, which indicates there was little penetration at this location. (Original magnification 190X, electrolytic phosphoric-nital dual etch)

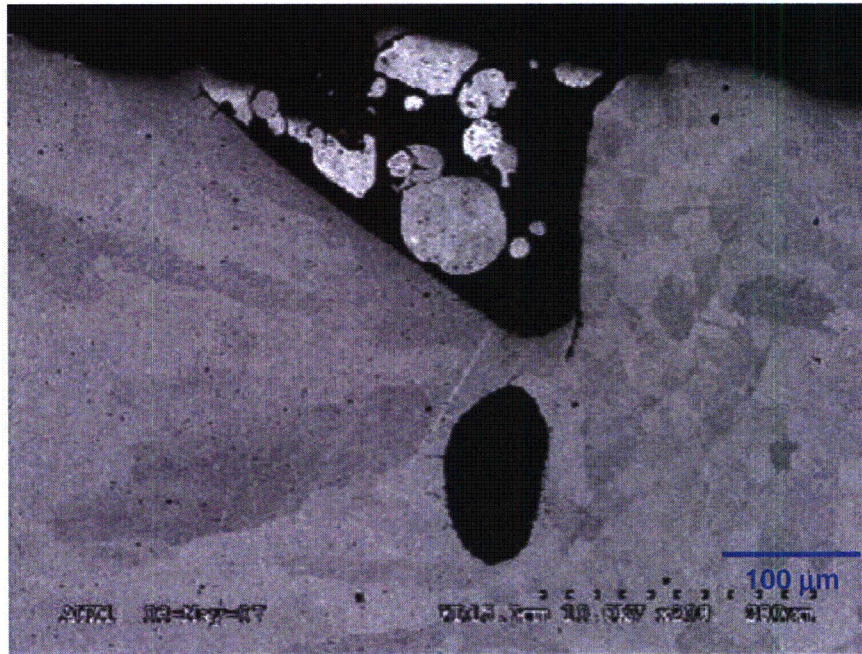
**Figure 3-8:** A scanning electron micrograph of the lack-of-fusion defect after repolishing, which revealed the large inclusion. (Original magnification 200X)

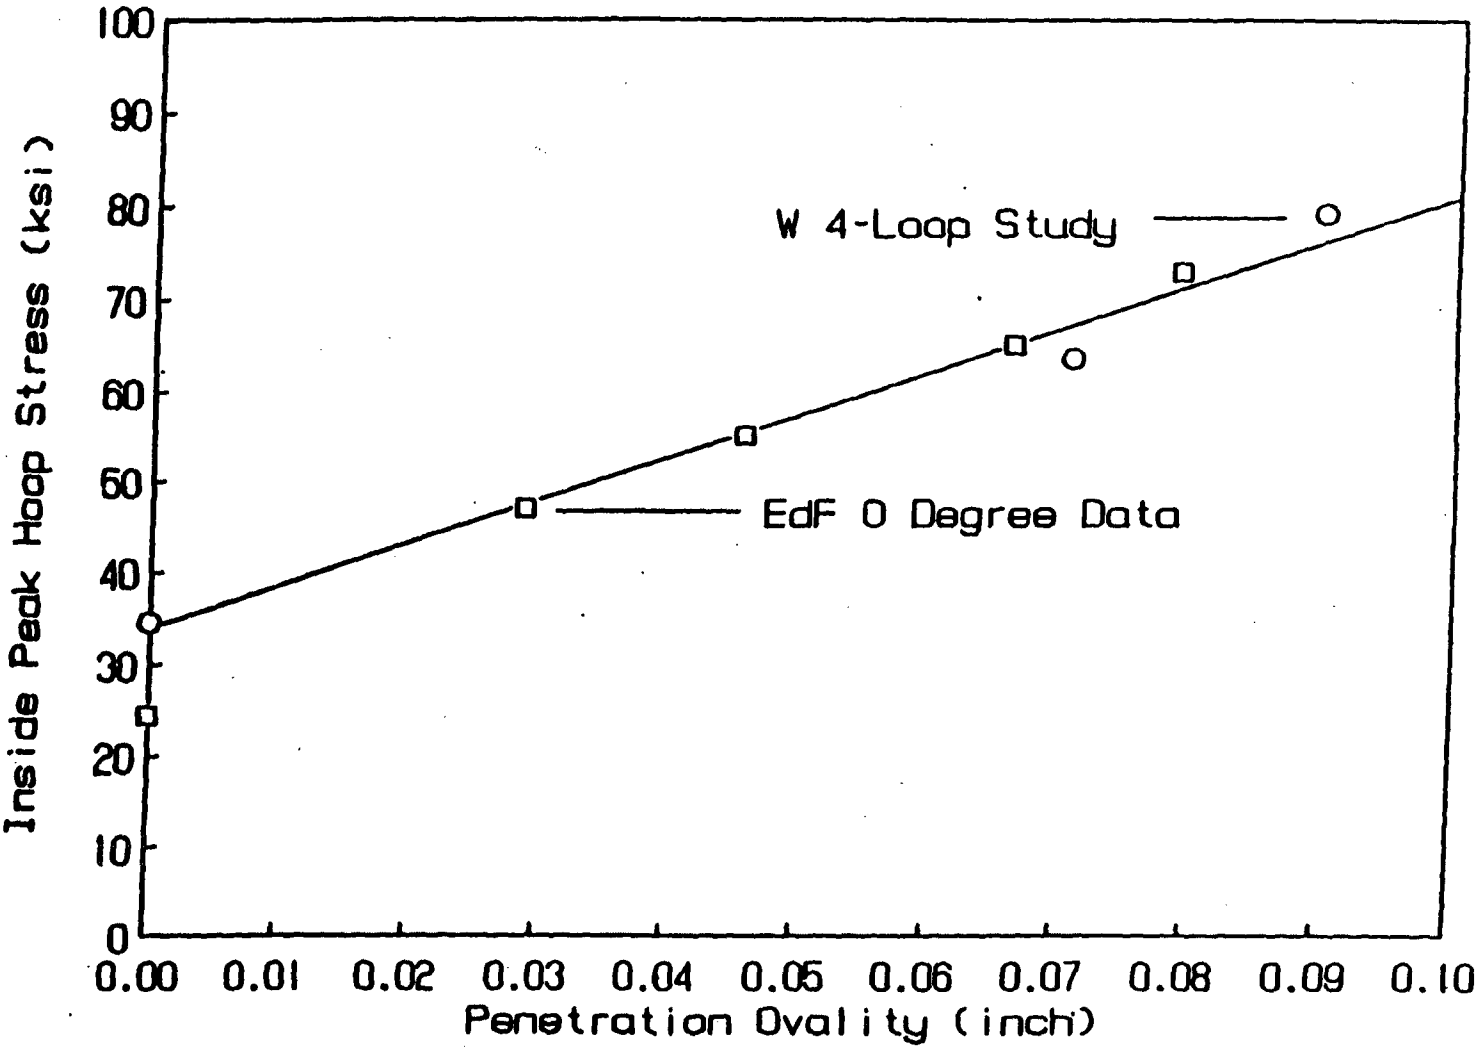
Figure 4-1: Vessel Head Penetration Stresses From WOG Four-Loop Plant Study [Ref. 21]

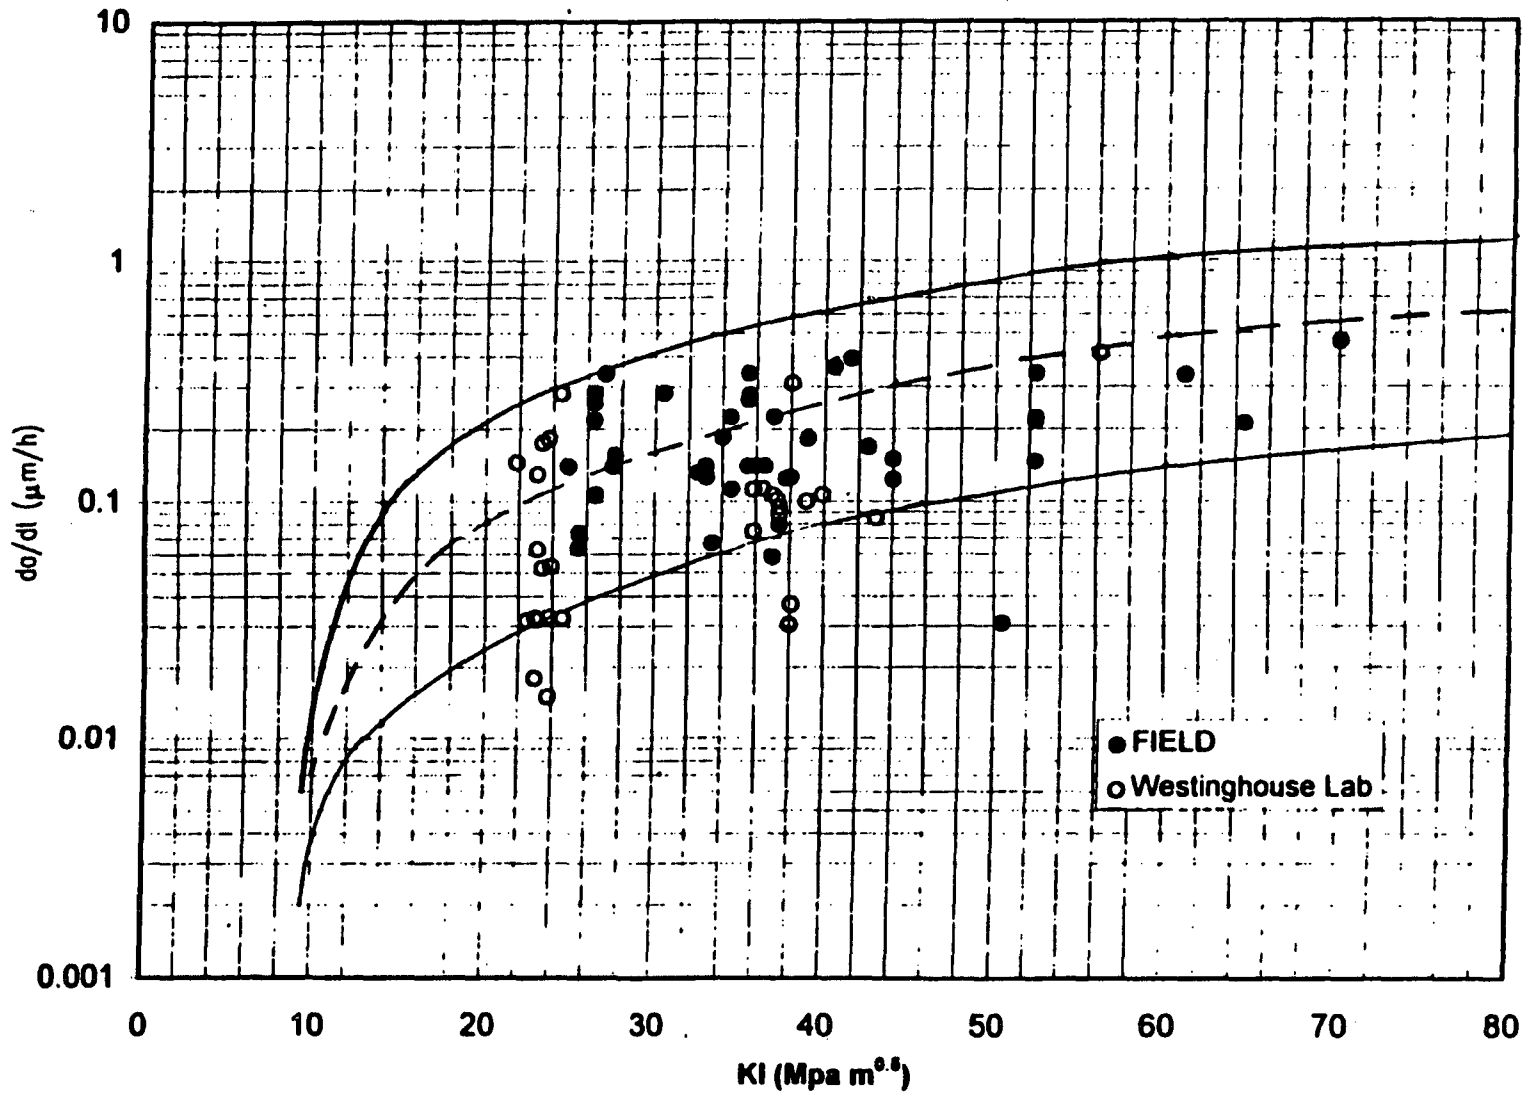
Figure 4-2: Comparison of Recent Alloy 600 Data With the Crack Growth Rate Model

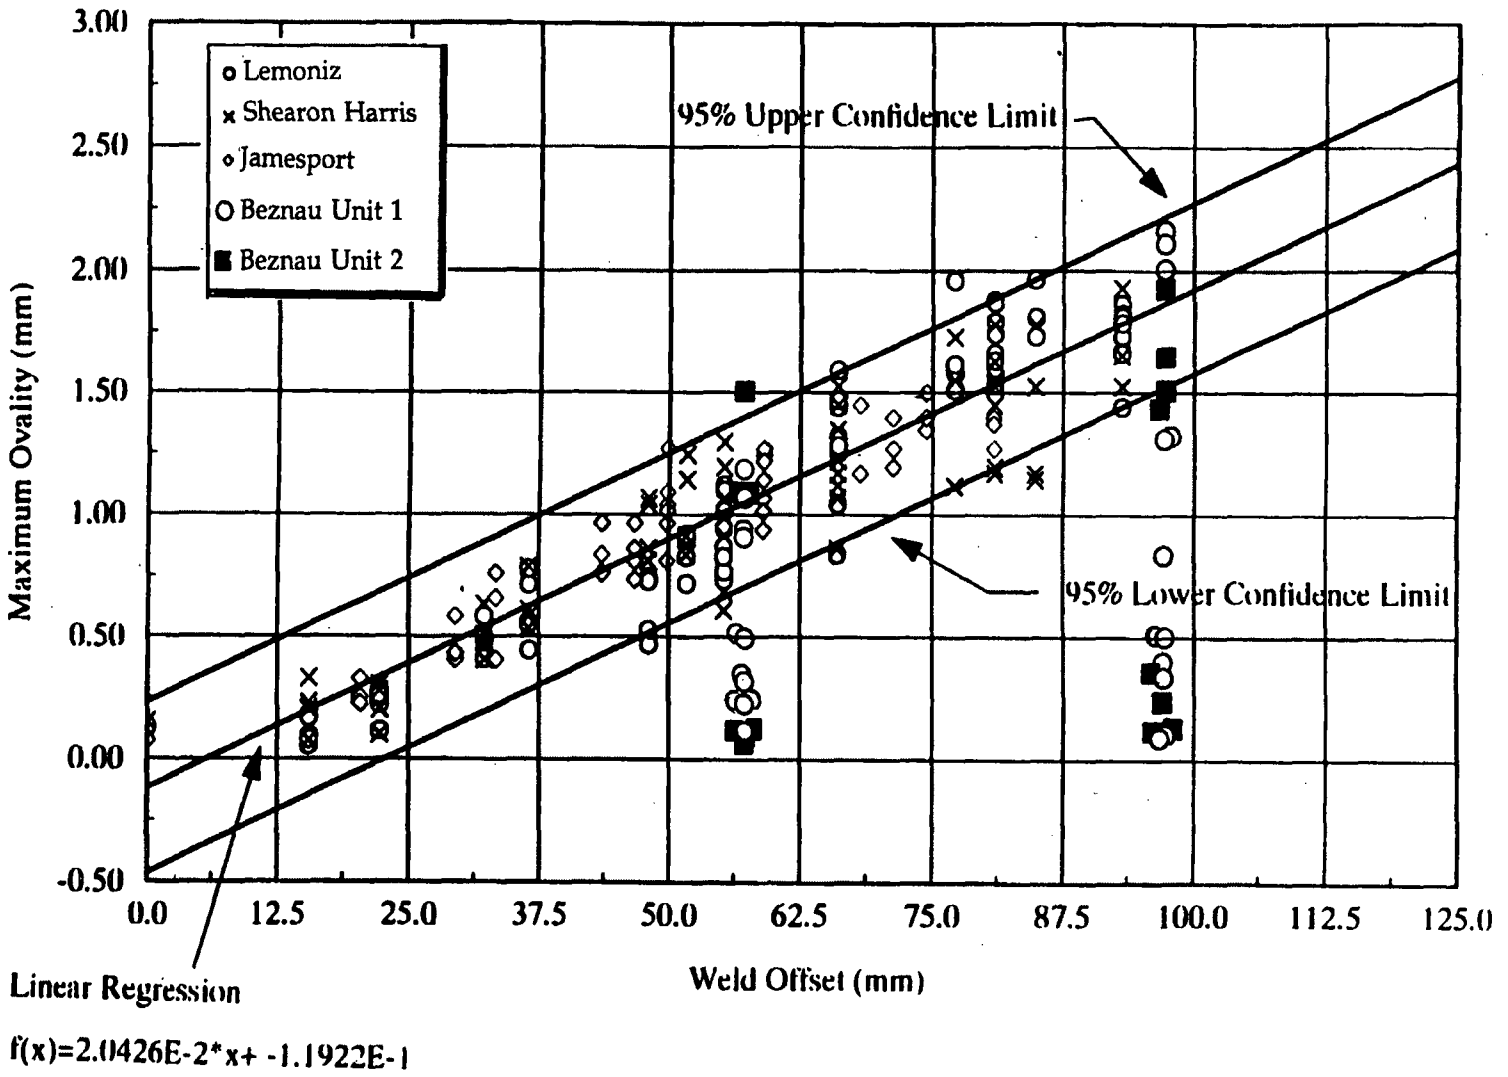
Figure 4-3: Measured Vessel Head Penetration Ovality Data and Regression Results [Ref. 22]

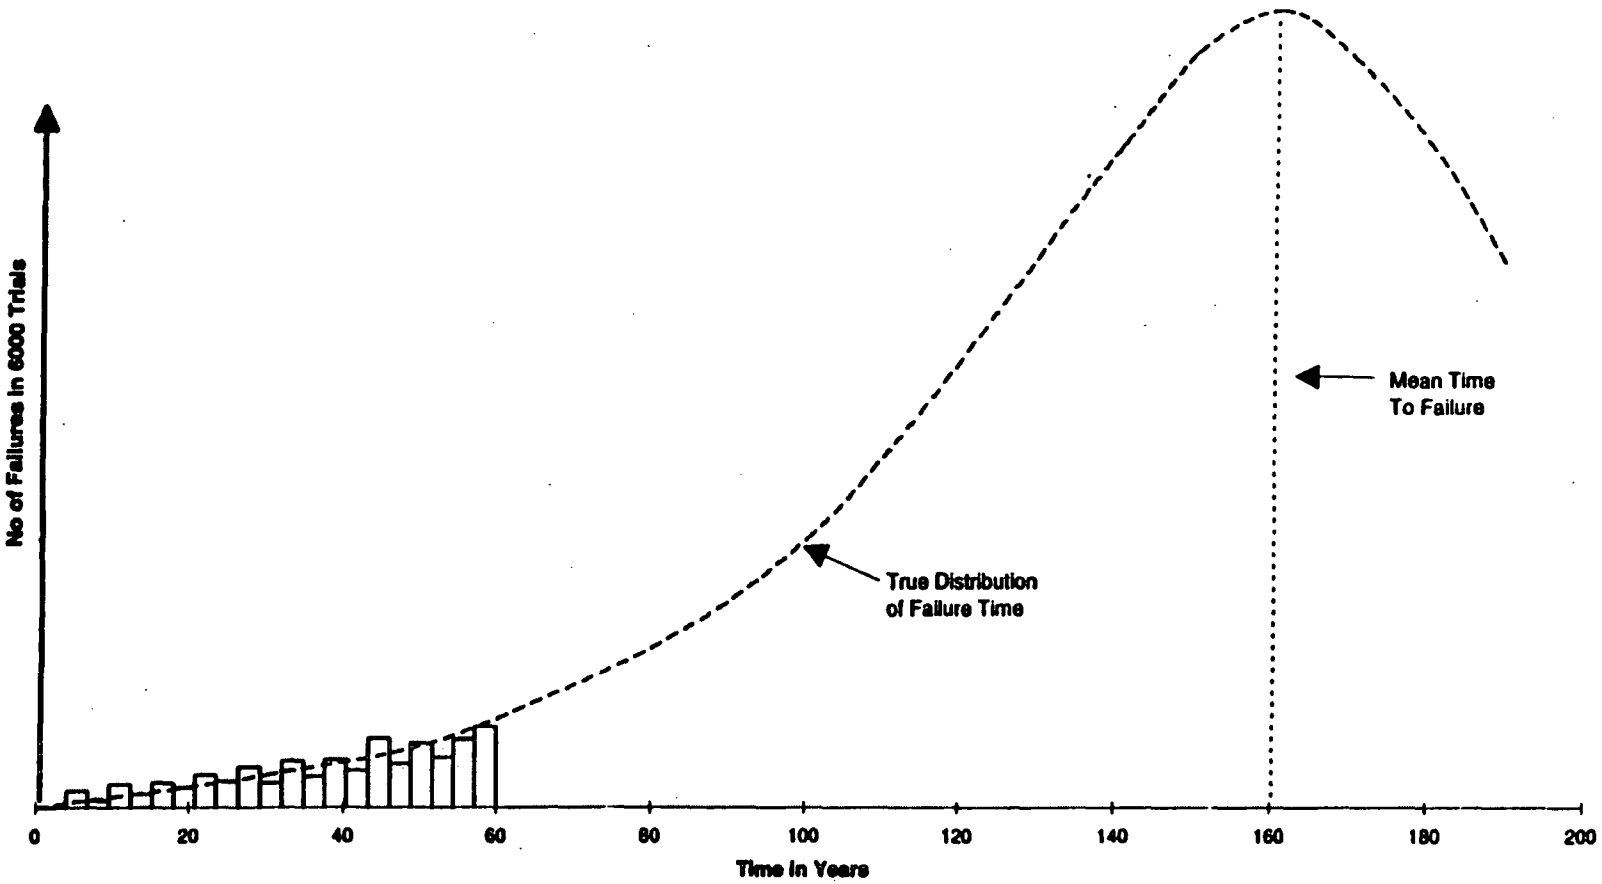
Figure 4-4: Example Histogram of Failures From Monte Carlo Simulation

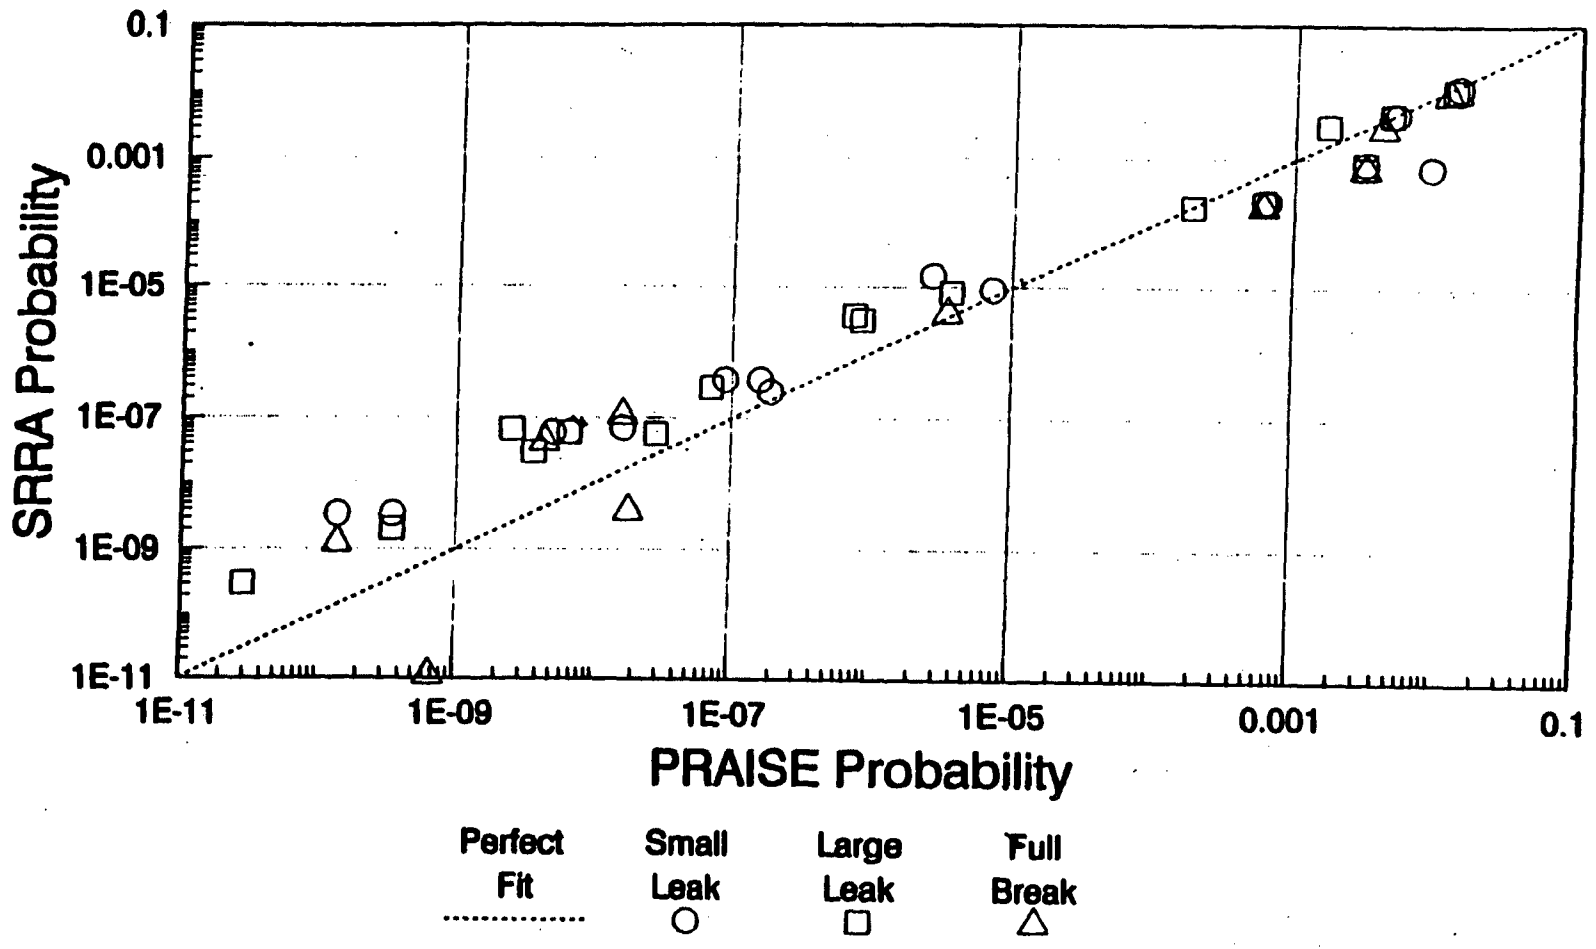
Figure 4-5: Comparison of Calculated Piping Probabilities

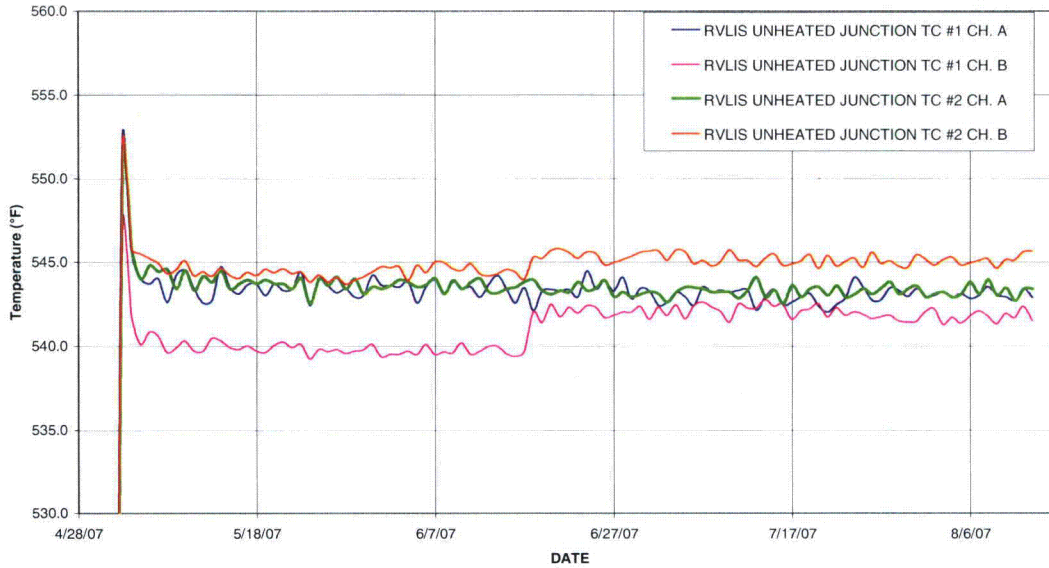
**Figure 5-1:** Byron Unit 2 Reactor Vessel Head Operating Temperature for Fuel Cycle 14

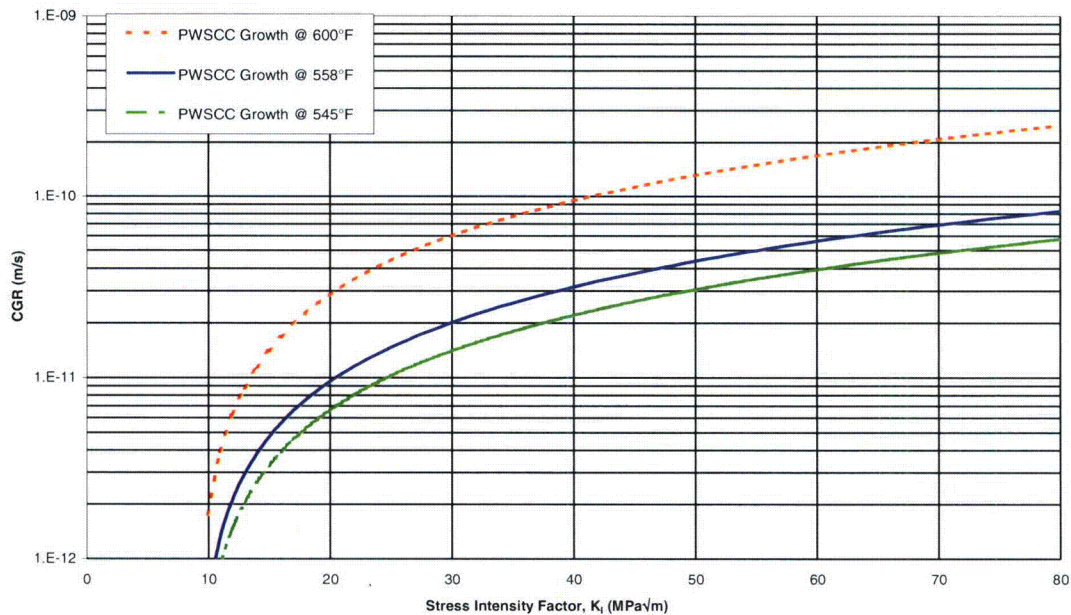
**Figure 5-2: PWSCC Growth Rate Comparison for Cold vs. Hot RPV Head Temperatures**

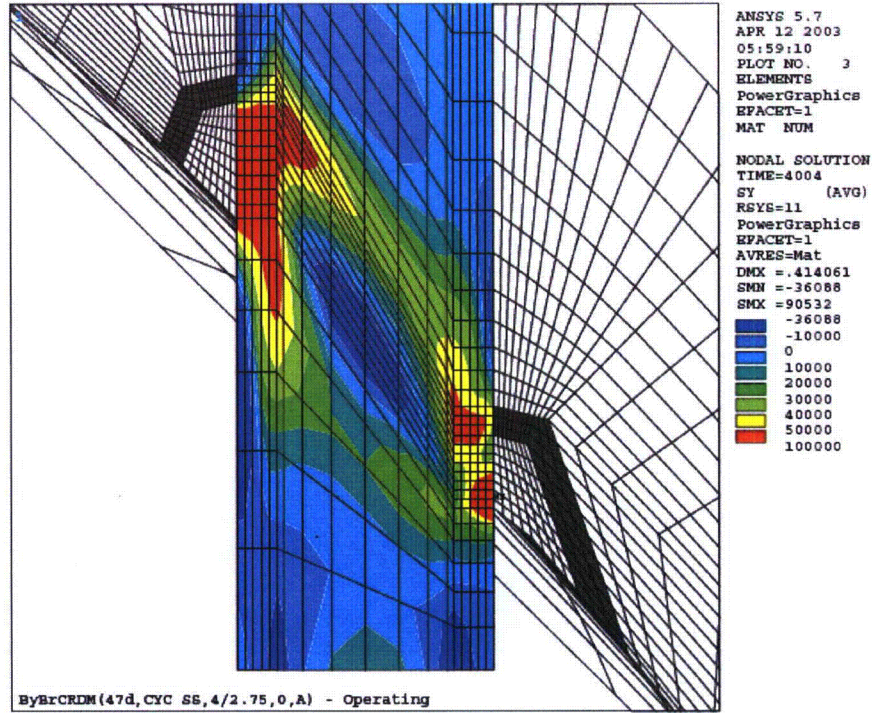
**Figure 5-3:** Typical Operating Plus Weld Residual Hoop Stress Field Used for Crack Growth – RPV Head 47° Nozzle (psi)

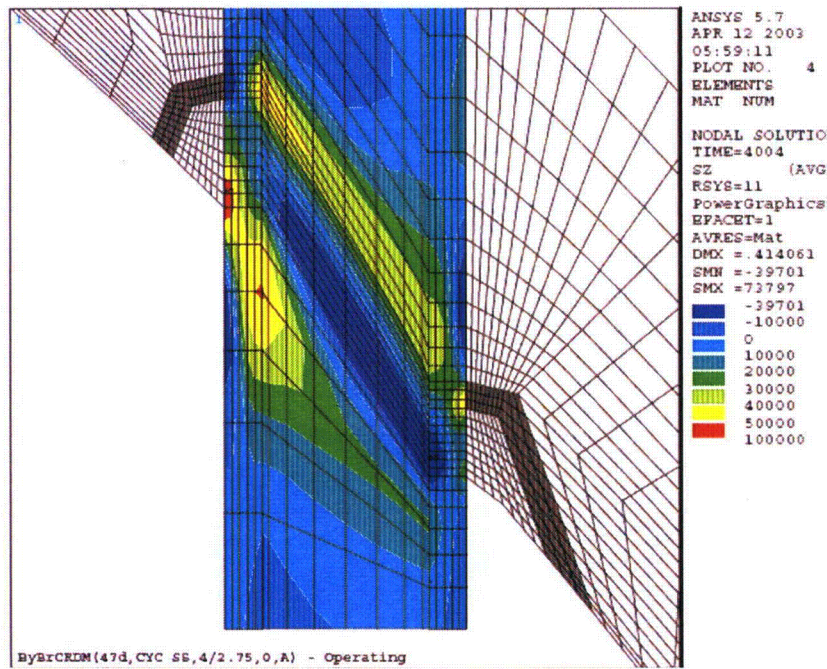
**Figure 5-4:** Typical Operating Plus Weld Residual Axial Stress Field Used for Crack Growth – RPV Head 47° Nozzle (psi)

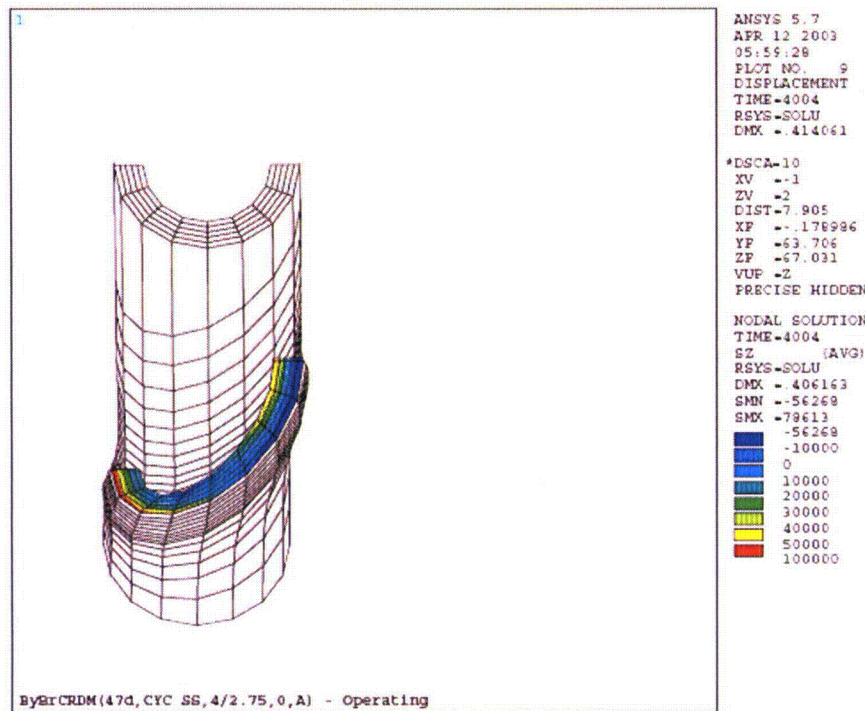
**Figure 5-5:** RPV Head 47° Nozzle Operating Plus Weld Residual Axial Stress Along the Top of the J-Groove Weld (psi)

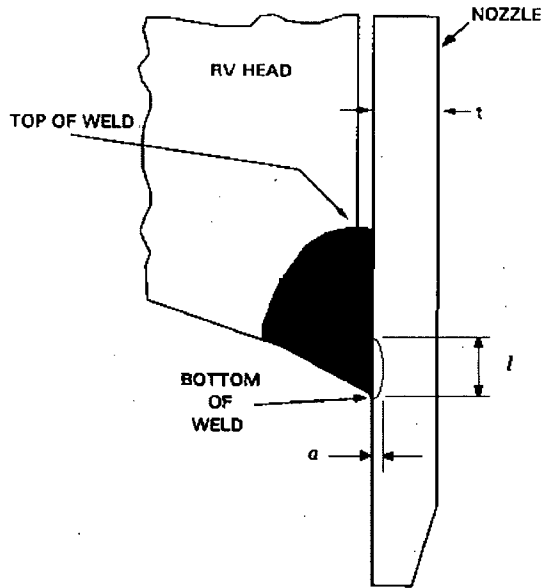
**Figure 5-6: RPV Head Nozzle Schematic with Postulated Flaw Location**

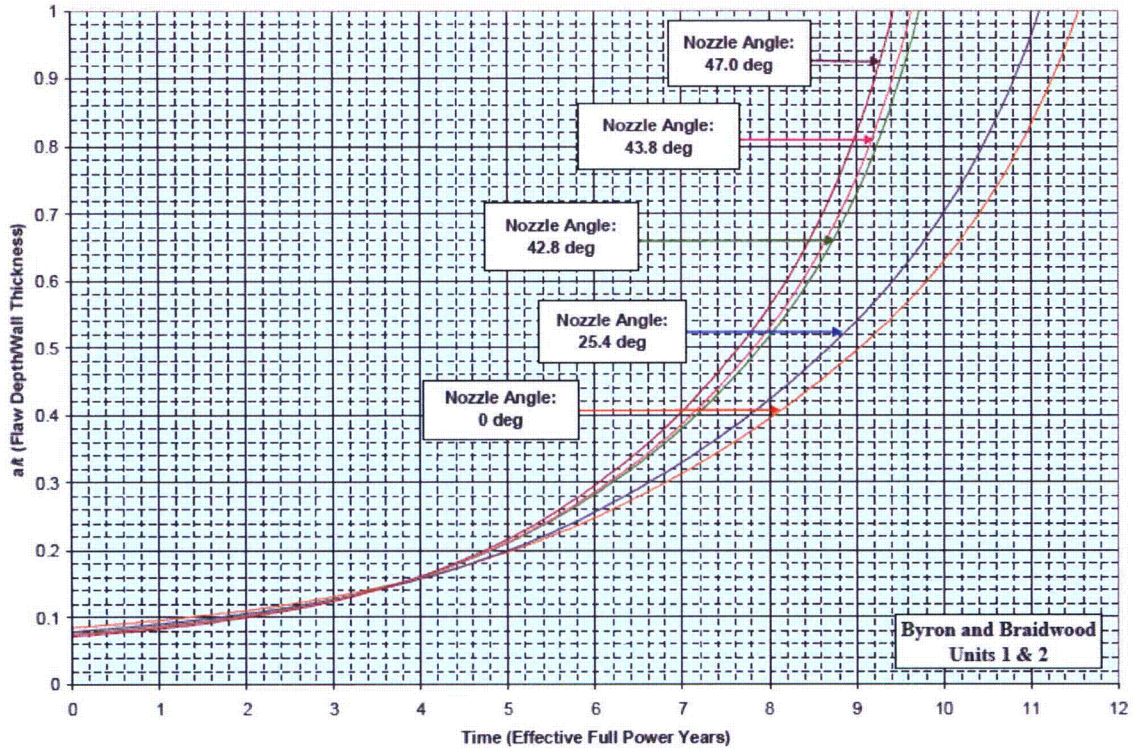
**Figure 5-7:** PWSCC Growth Projections for an Inside Surface, Axially Oriented Flaw on the Uphill Side at the J-groove Weld

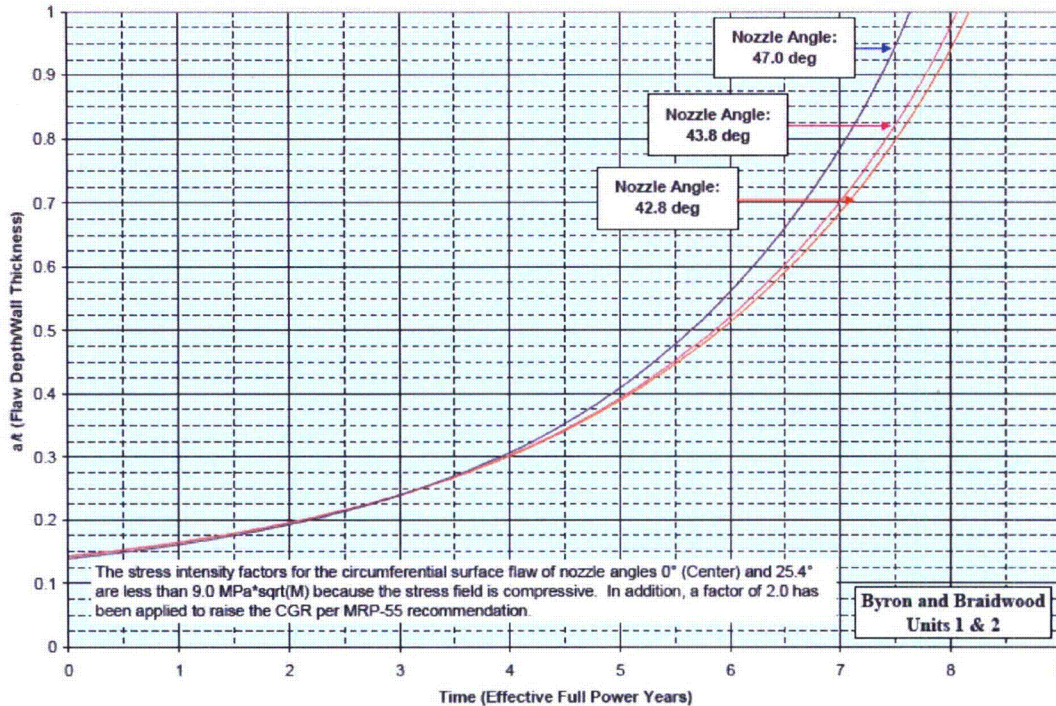
**Figure 5-8:** PWSCC Growth Projections for an Outside Surface, Circumferentially Oriented Flaw on the Downhill Side Above the J-groove Weld

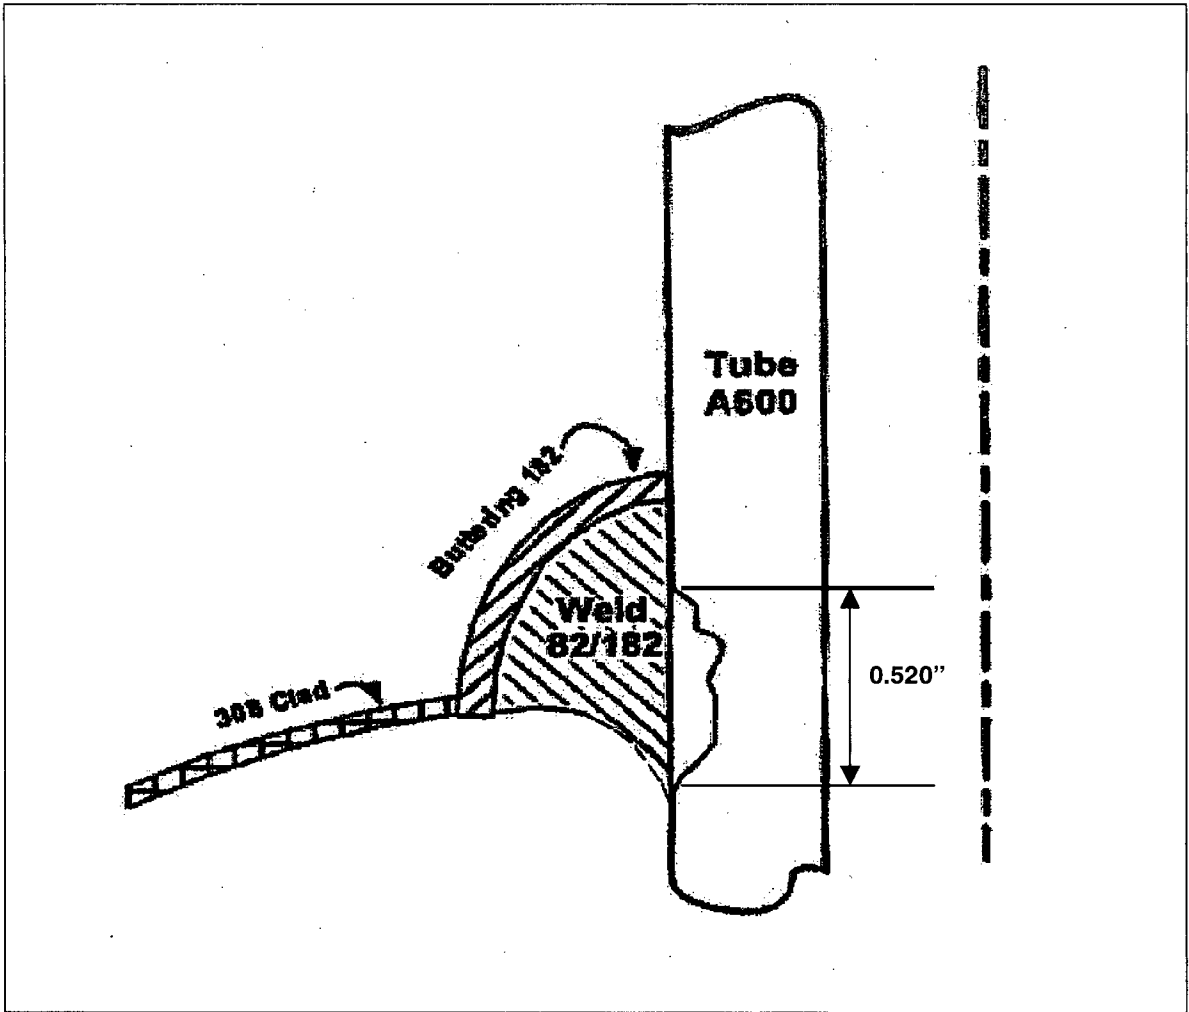
Figure 1 – A non-scale sketch of the ultrasonic indication identified in the Reference 1 report. The inspection identified a 0.520” long x 0.326” deep axial, external indication in the #68 CRDM penetration tube near the J-groove elevation. The 0.326” depth corresponds to approximately 52% of the 0.625” tube thickness. The maximum ultrasonic reflector was approximately 16.5 degrees counter clockwise from the zero reference (as looking upward). The zero reference was the downhill side of the periphery tube. A follow-up eddy current exam detected no relevant indications on the inner surface of the tube.

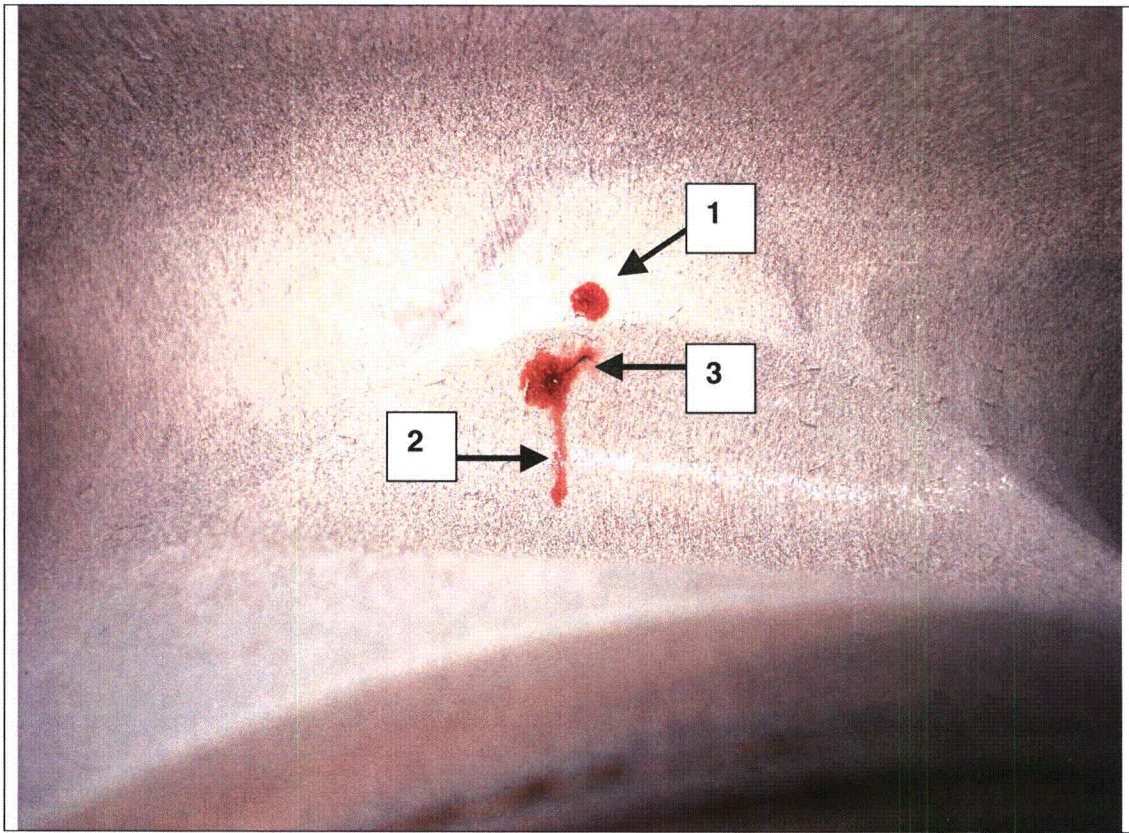
Figure 3 – A photo showing the field dye penetrant results for the excavation site after the boat sample was removed (Ref. 3). The boat sample did not capture the rounded indication (#1) or the deepest portion of the axial indication (#2). In addition, the excavation uncovered an angled, sub-surface linear defect (#3) that intersected the axial indication.
