# **Exelon Nuclear Pre-Submittal Meeting**

Proposed Relaxation Request  
from  
First Revised Order EA-03-009  
Byron Station Unit 2

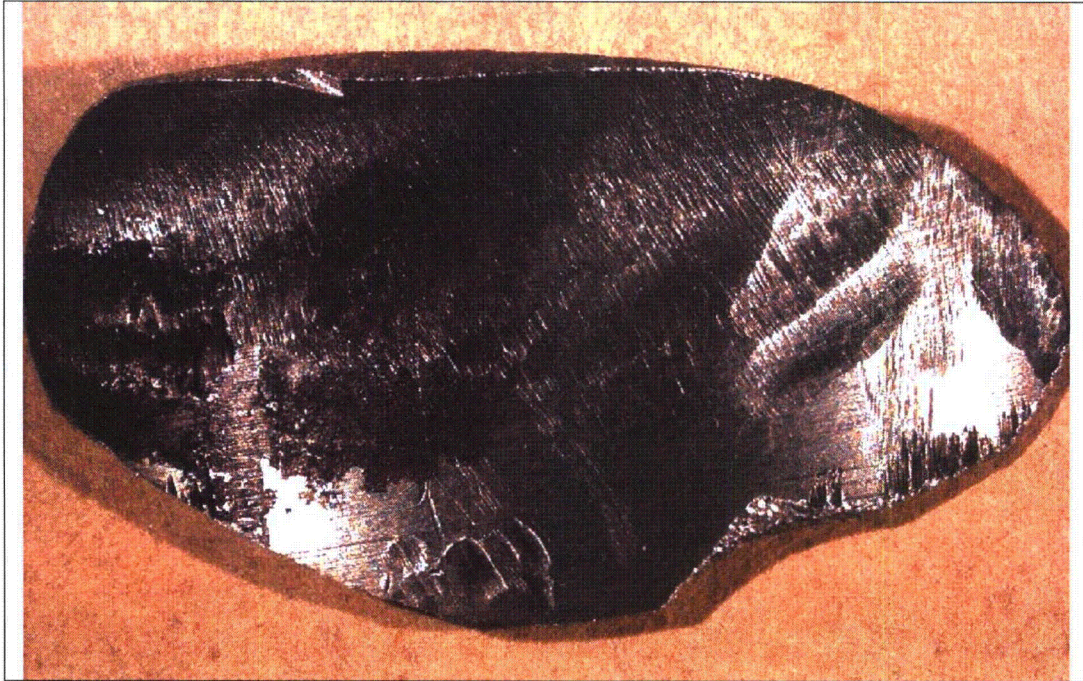
Figure 4 – The non-cut (i.e. wetted) surface of the boat sample. Note the relatively heavy grinding toward the upper half (weld side) of the sample. The sample measured 1.5” long x 0.75” wide. No crack-like indications were visible. (4x Magnification)

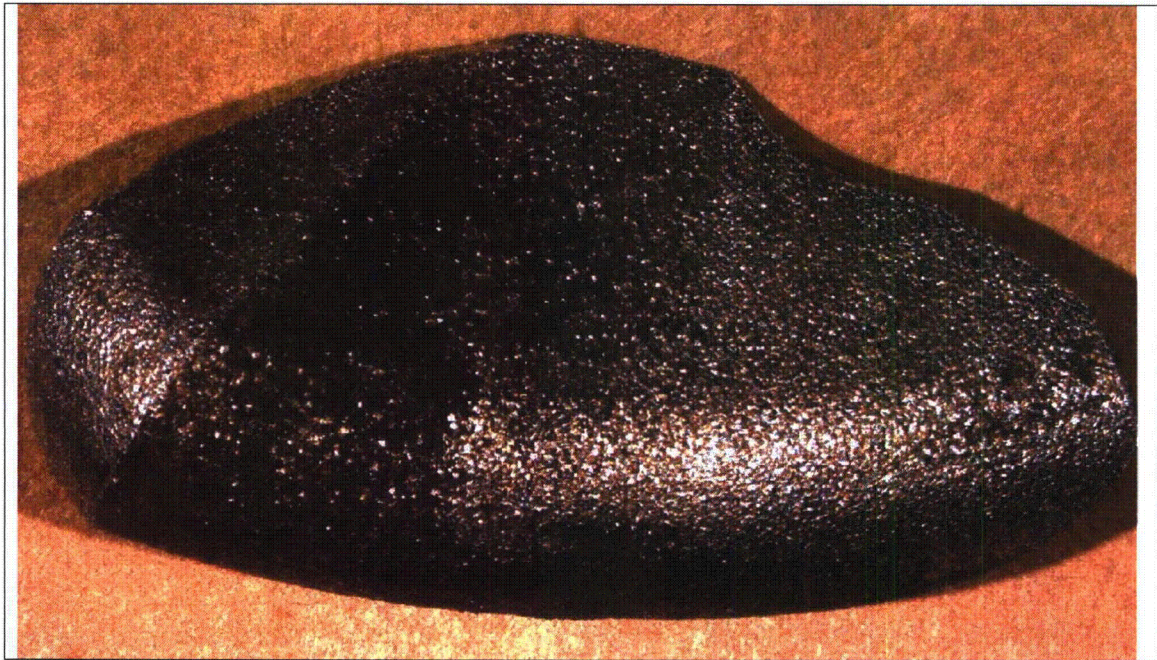
Figure 5 – The EDM cut surface. No cracking was visible. (4x Magnification)

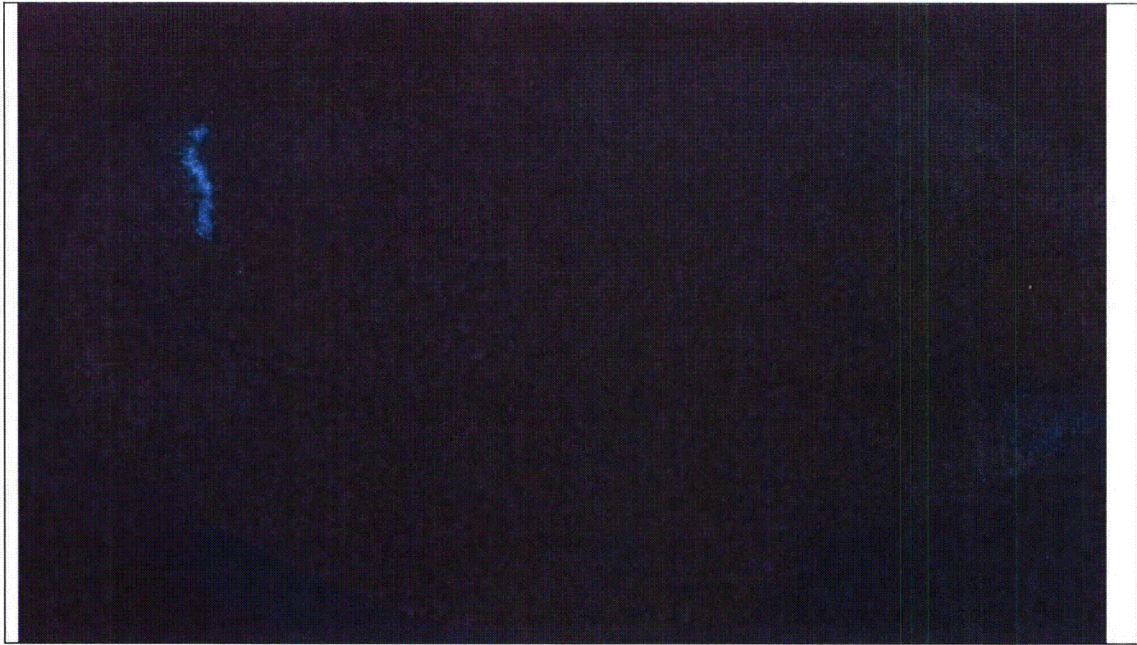
Figure 6 – A photo showing the fluorescent dye penetrant indication on the non-cut surface of the boat sample. The indication measured 0.18” long and followed an irregular path.

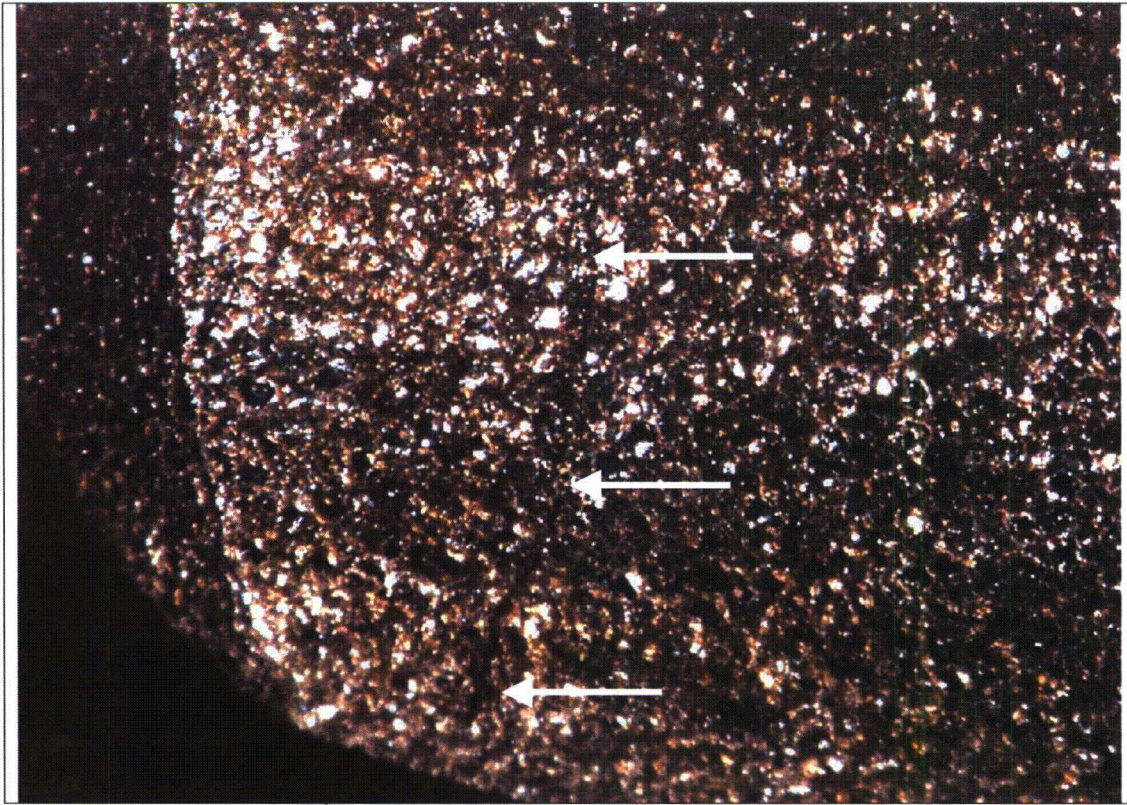
Figure 10 – A stereoscope photo showing the axial crack on the EDM cut surface. (17x Magnification)

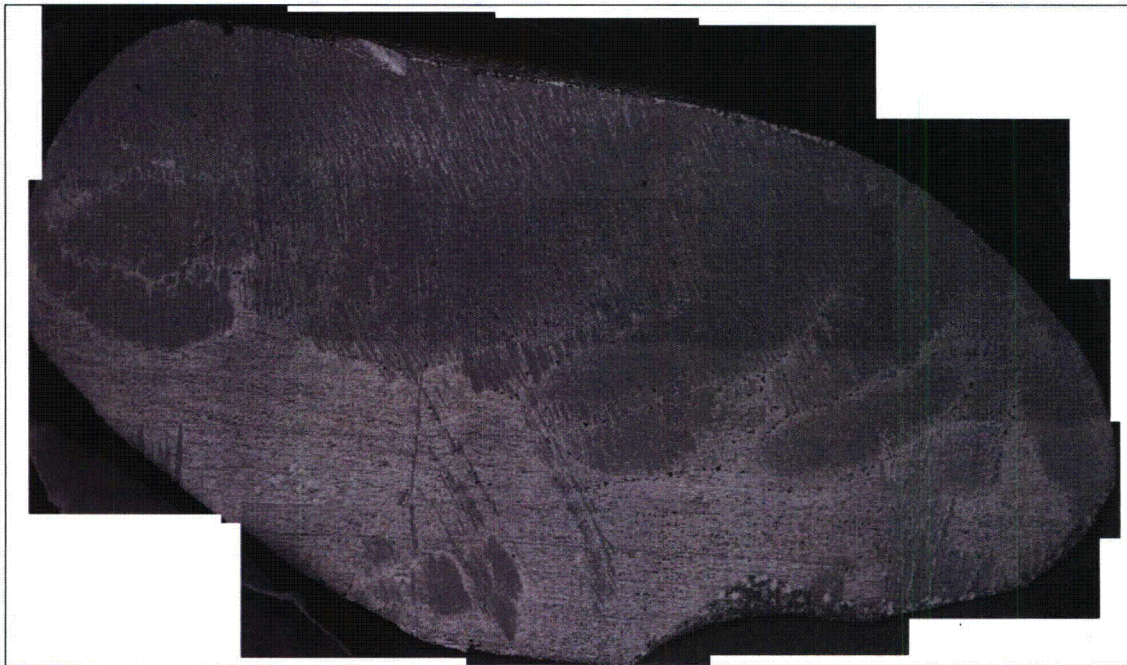
Figure 11 – A low magnification SEM photo of the non-cut surface. (4x Magnification)

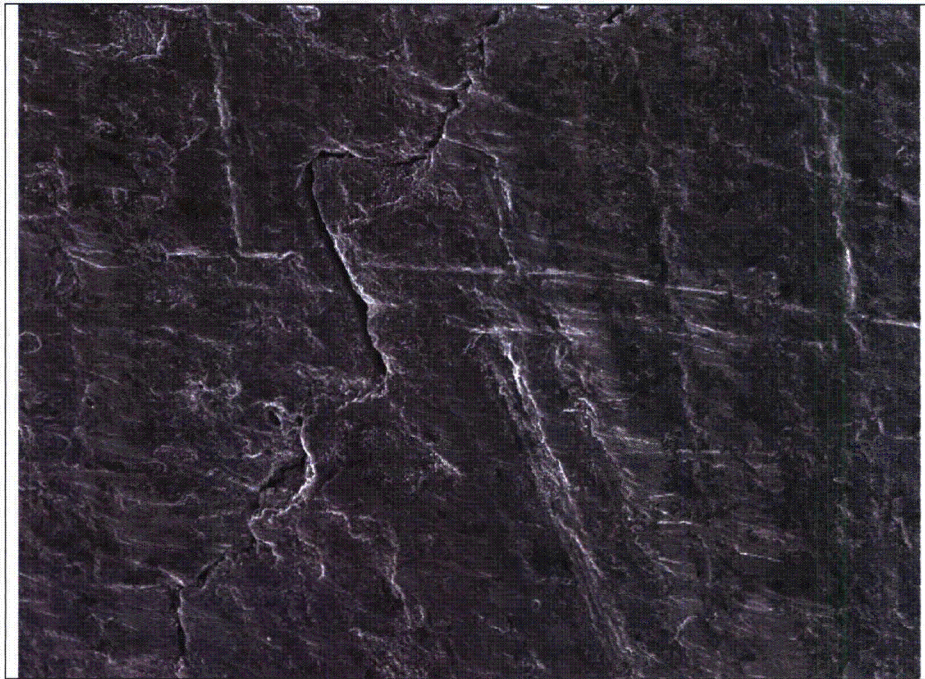
Figure 13 – An SEM photo of the axial crack on the non-cut surface. The crack followed an irregular path and was non-branching. In this area, the crack did not follow the local grinding marks. (500x Magnification)

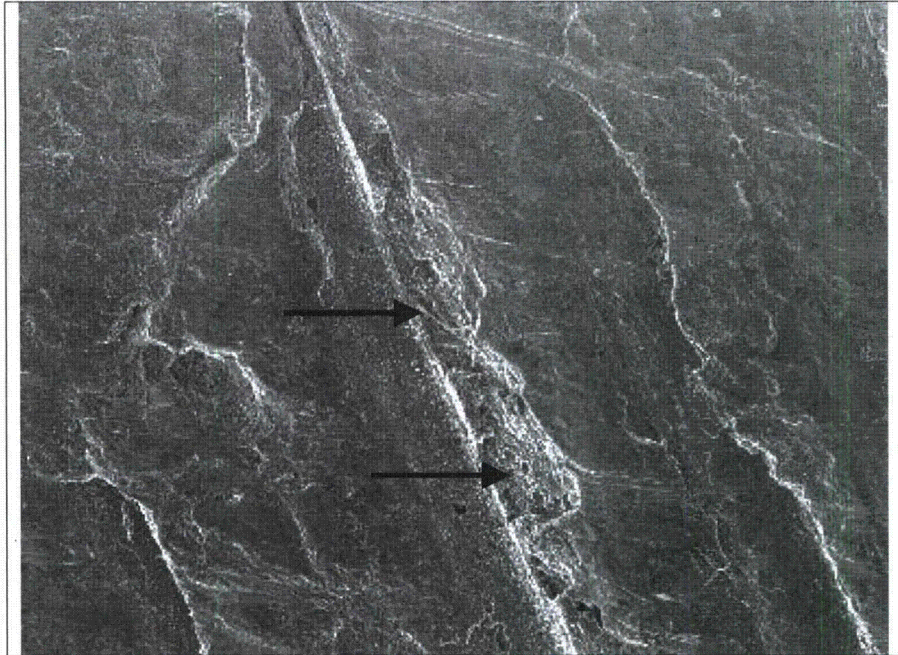
Figure 14 – A local patch of ductile appearing dimples (arrows) in the axial indication on the non-cut surface. The dimples were likely related to the surface grinding. In this area the indication followed the grinding direction. (500x Magnification)

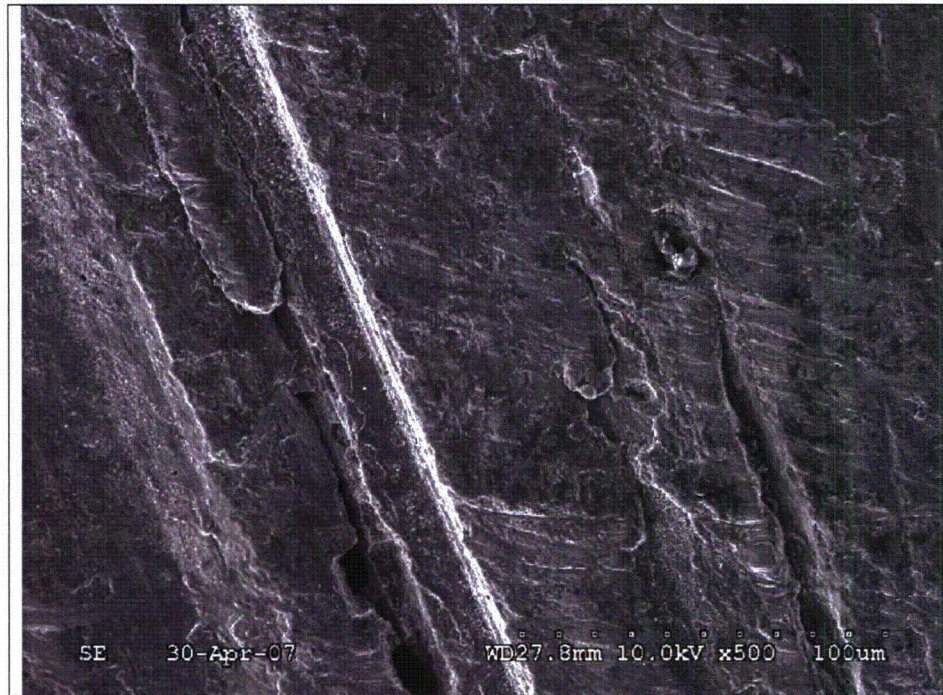
Figure 15 – A representative SEM photo showing fissures that were detected on the non-cut surface. The fissures tended to follow the local grinding marks. None of the fissures were detected by the dye penetrant examination. (500x Magnification)

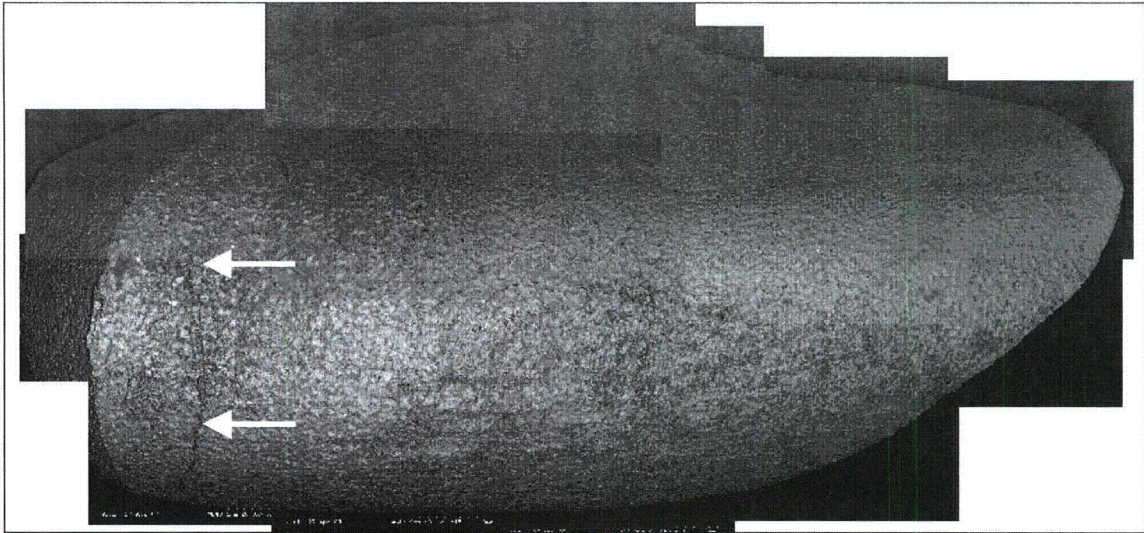
Figure 16 – A backscatter SEM montage of the EDM cut surface. The arrows point to the crack. (4x Magnification)

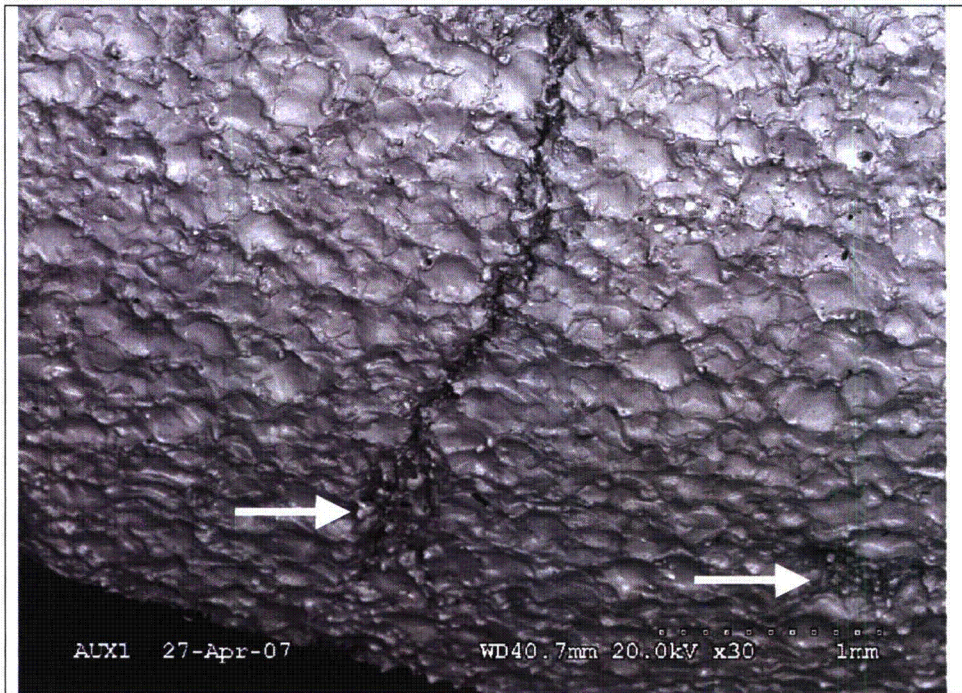
Figure 17 – An SEM photo near the upper end of the axial indication on the EDM surface. The left arrow points to crack branching near the non-cut surface edge. The right arrow points to the globular particles that covered the rounded dye penetrant indication. (30x Magnification)

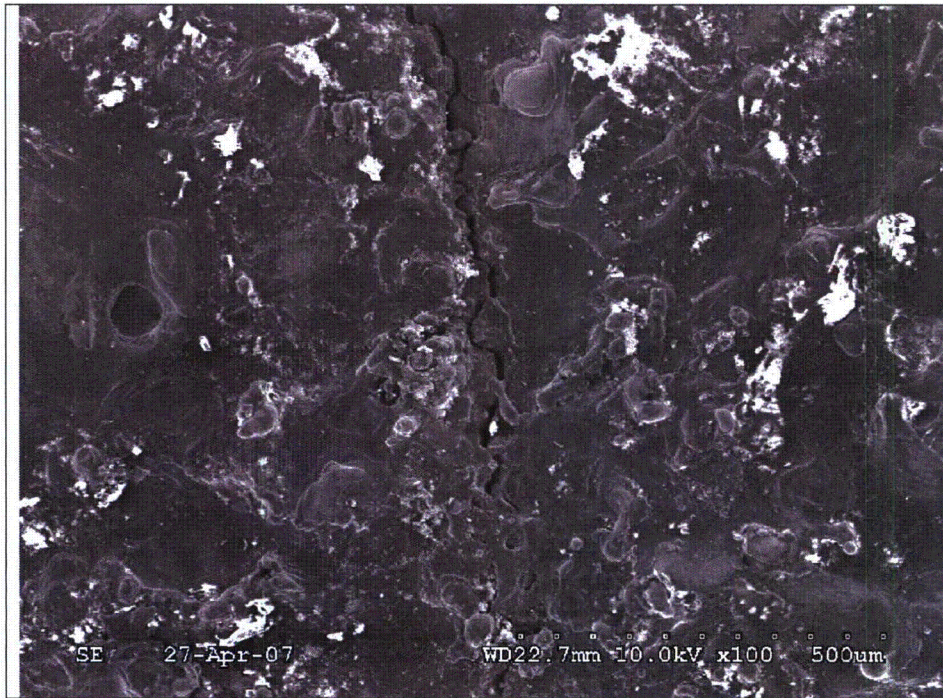
Figure 18 – A typical SEM view of the axial indication on the EDM surface. The crack generally appeared to have intergranular features, although interpretation was difficult due to the EDM process. (100x Magnification)

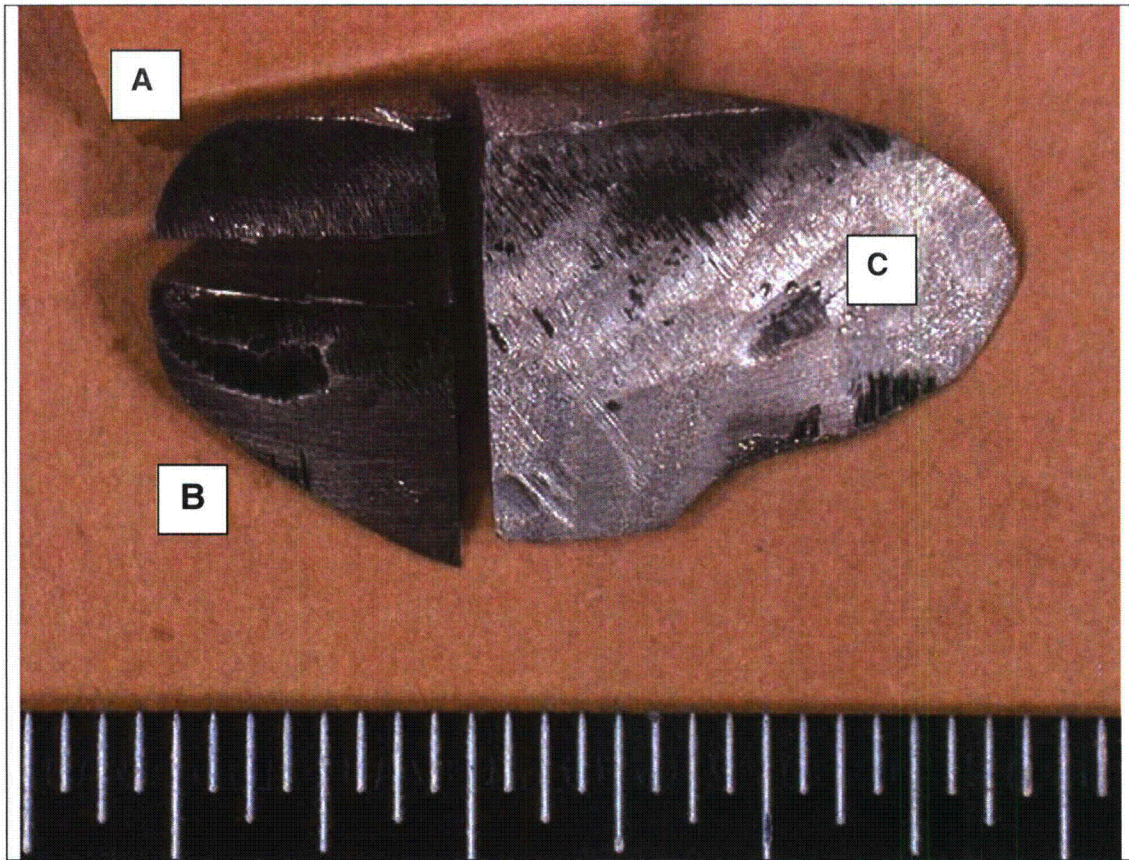
Figure 19 – A photo showing the initial boat sample cuts. The horizontal cut between samples A and B was located approximately 0.050” below the tip of the axial indication. Planned work includes:

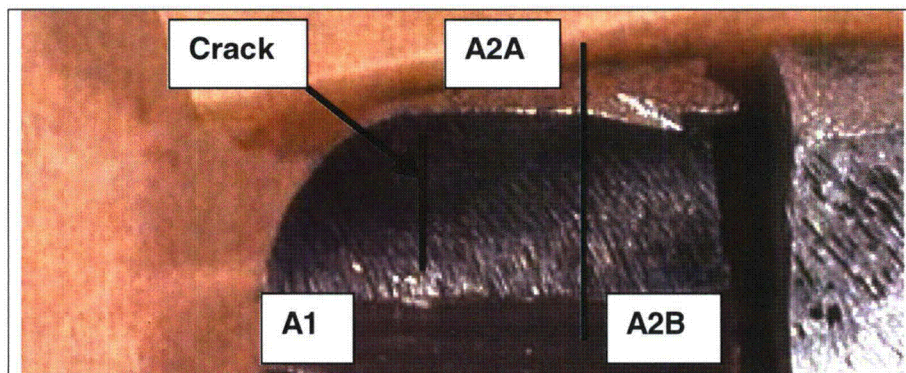
Figure 20 – The sub-sectioning and work plan for Sample A.

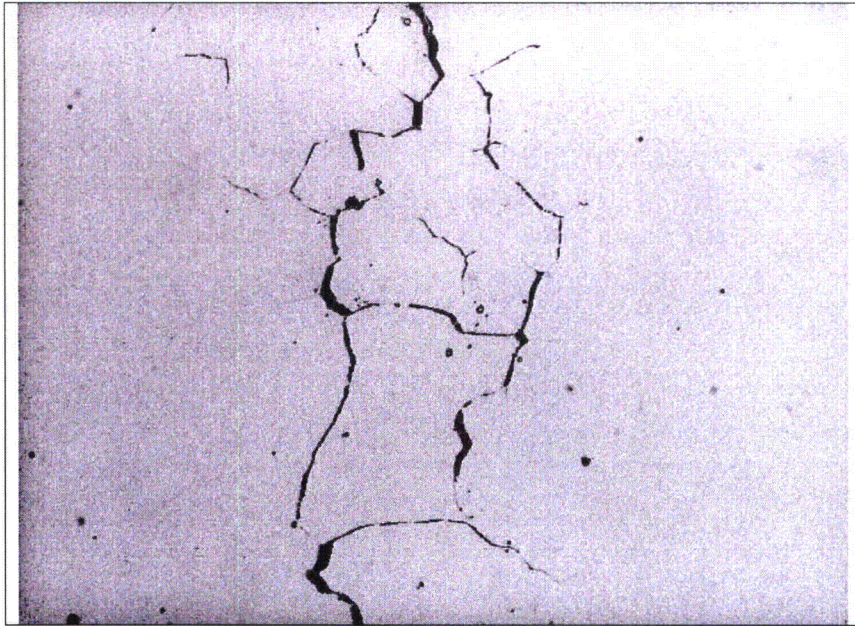
Figure 23 – An un-etched view showing branched, intergranular cracking in the tube portion of the Sample B metallurgical mount. (375x Magnification)

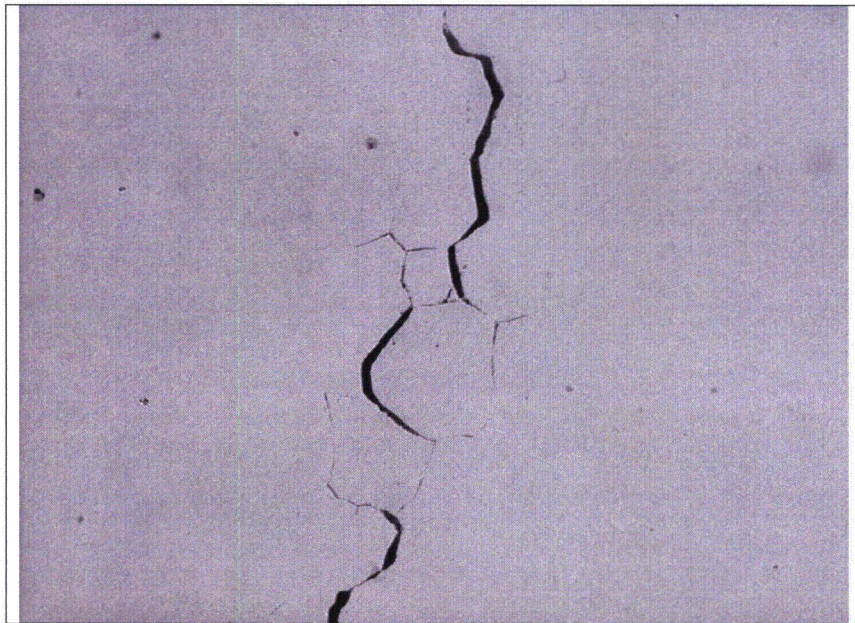
Figure 24 – Additional branched, intergranular cracking in the Sample B tube material. (375x Magnification, Un-etched)

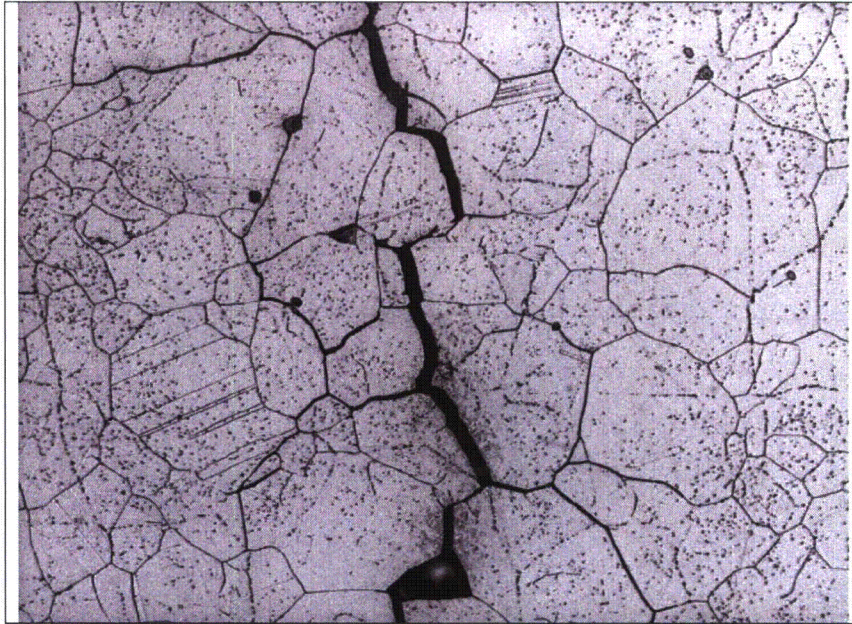
Figure 25 – An etched view of the branched, intergranular cracking in the Sample B tube material. (375x Magnification, Electrolytic Phosphoric-Nital Dual Etch)

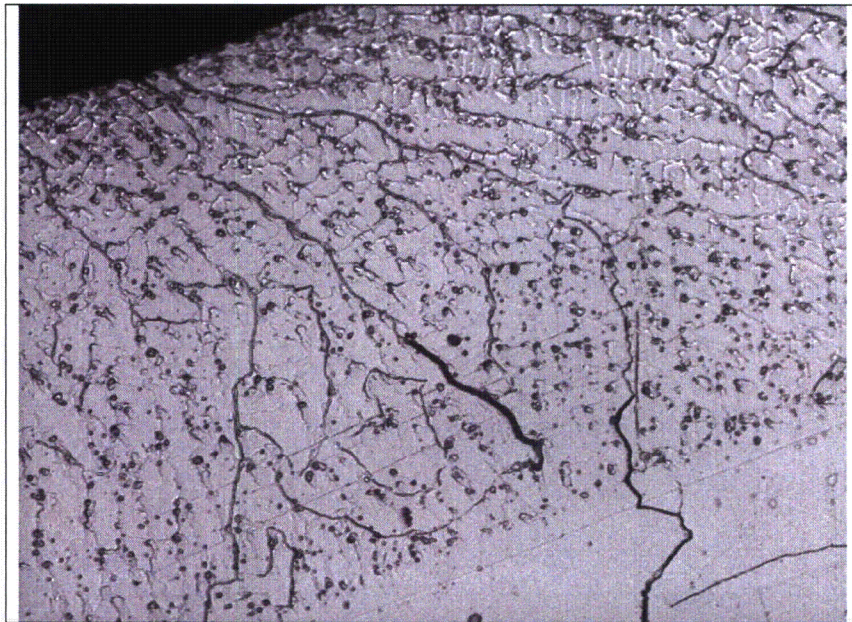
Figure 26 – An etched view near the weld metal crack end in Sample B. The two cracks have an interdentritic appearance. Within Sample B, the cracking did not extend to the wetted surface of the mount. (375x Mag., Electrolytic Phosphoric-Nital Dual Etch)

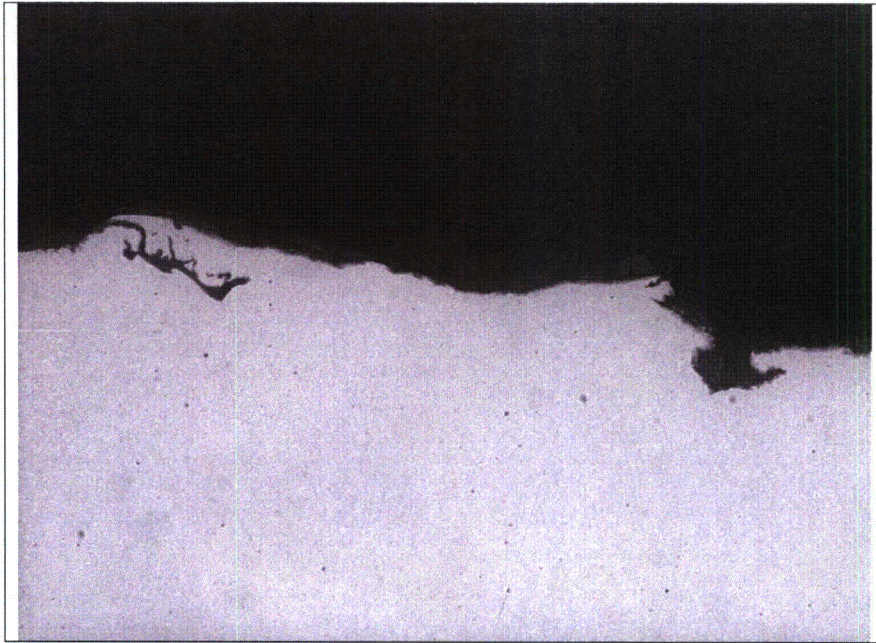
Figure 27 – An un-etched view of two linear irregularities on the weld surface in the Sample B mount. (375x Magnification)

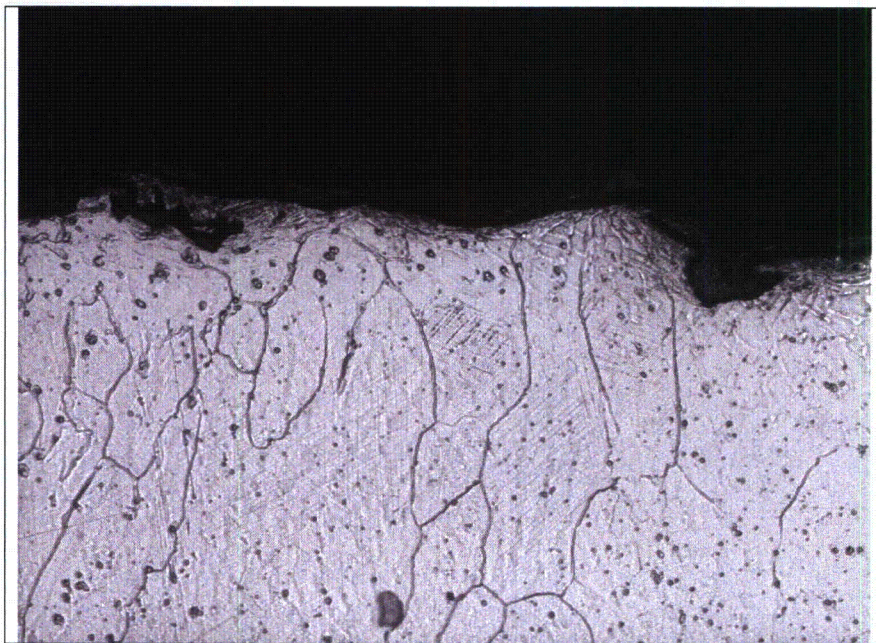
Figure 28 – An etched view of the Figure 27. The locally deformed microstructure suggests the indications were laps from surface grinding. (375x Mag., Electrolytic Phosphoric-Nital Dual Etch)

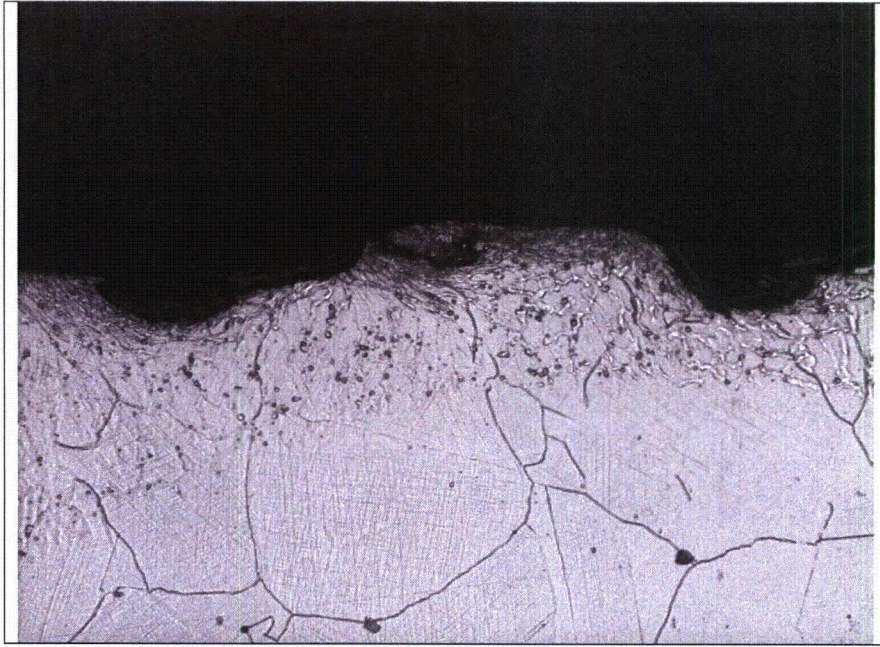
Figure 29 – Another surface indication in the Sample B mount. There was no evidence of crack extension from any of the surface indications. (375x Mag., Electrolytic Phosphoric-Nital Dual Etch)

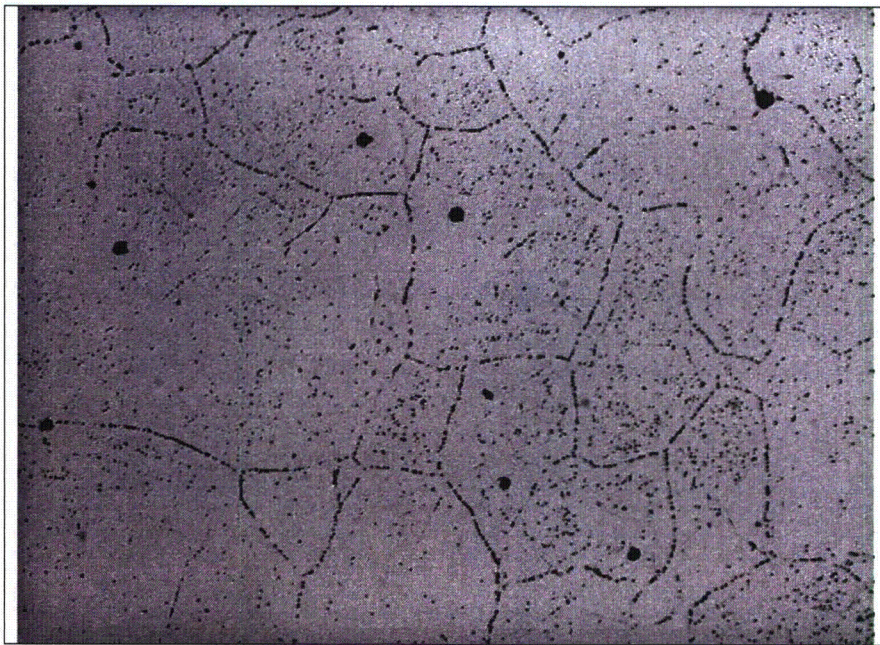
Figure 30 – The Sample B tube material with an electrolytic phosphoric acid etch to reveal the carbide structure. The tube microstructure contained significant intragranular carbides and partially decorated grain boundaries. (375x Magnification)

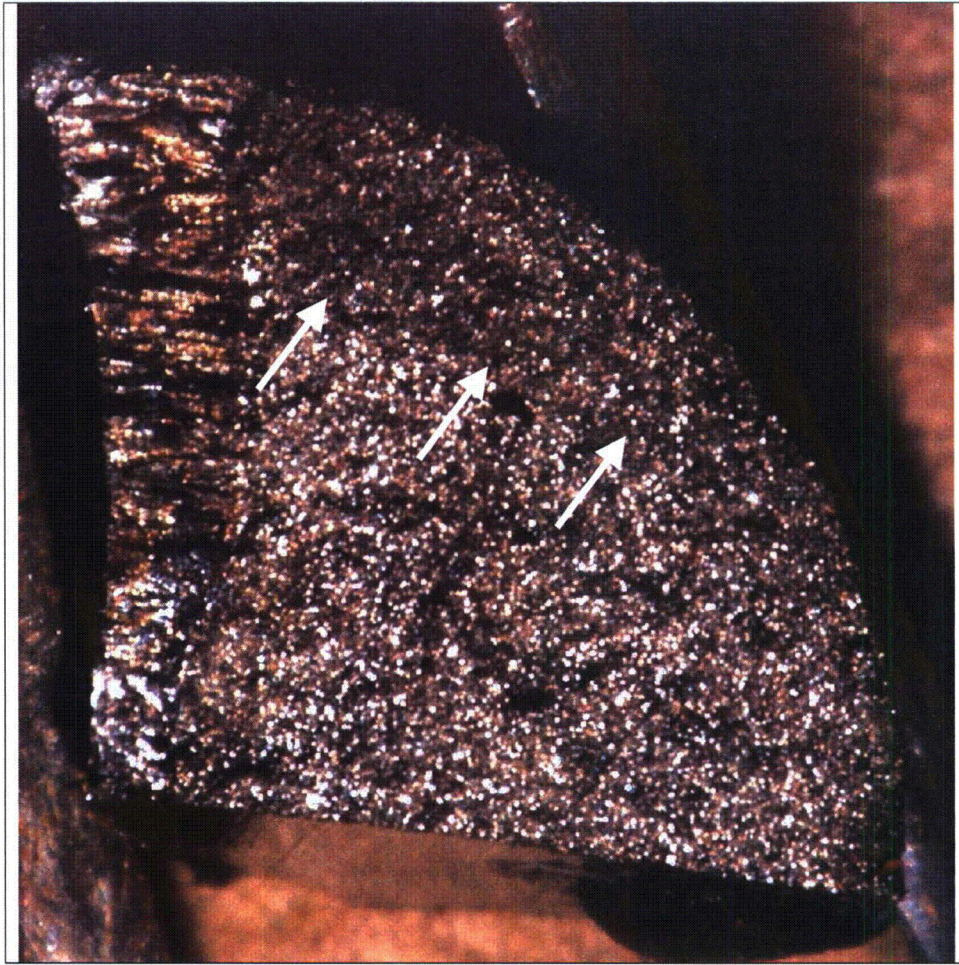
Figure 31 – A stereoscope view of the exposed surface of the axial crack in Sample A1. The weld is toward the left side of the sample. The crack surface was reflective and had an intergranular/interdendritic appearance. The arrows point to the edge of a thumb-nail-shaped region that appeared to be more oxidized than the remainder of the surface.

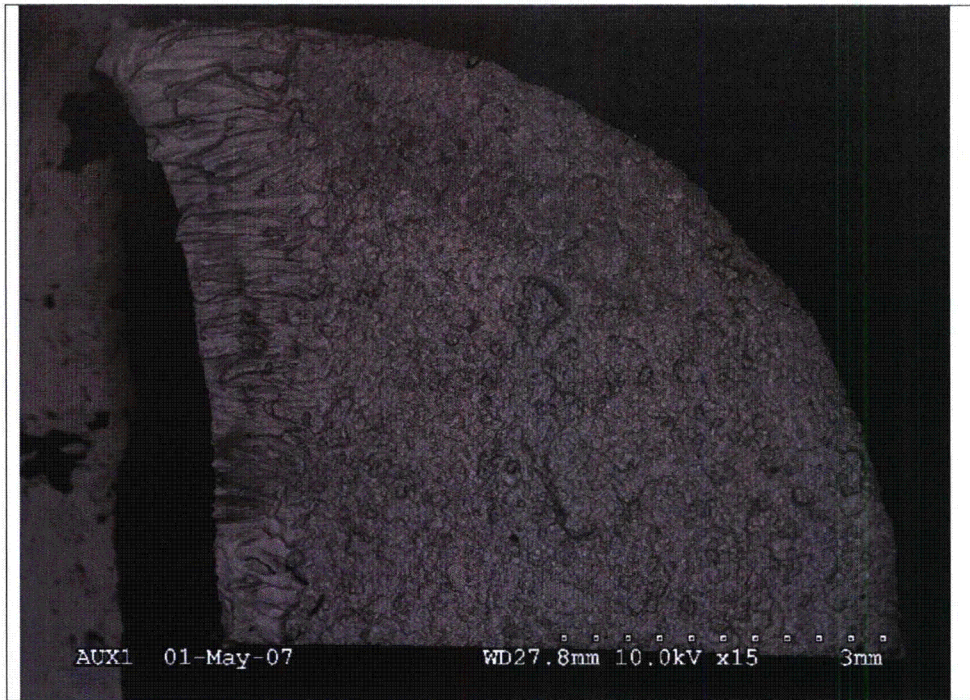
Figure 32 – A low magnification backscatter SEM view of the Sample A1 crack surface with the weld along the left edge of the sample. The ‘thumbnail’ region is also visible. (15x Mag.)

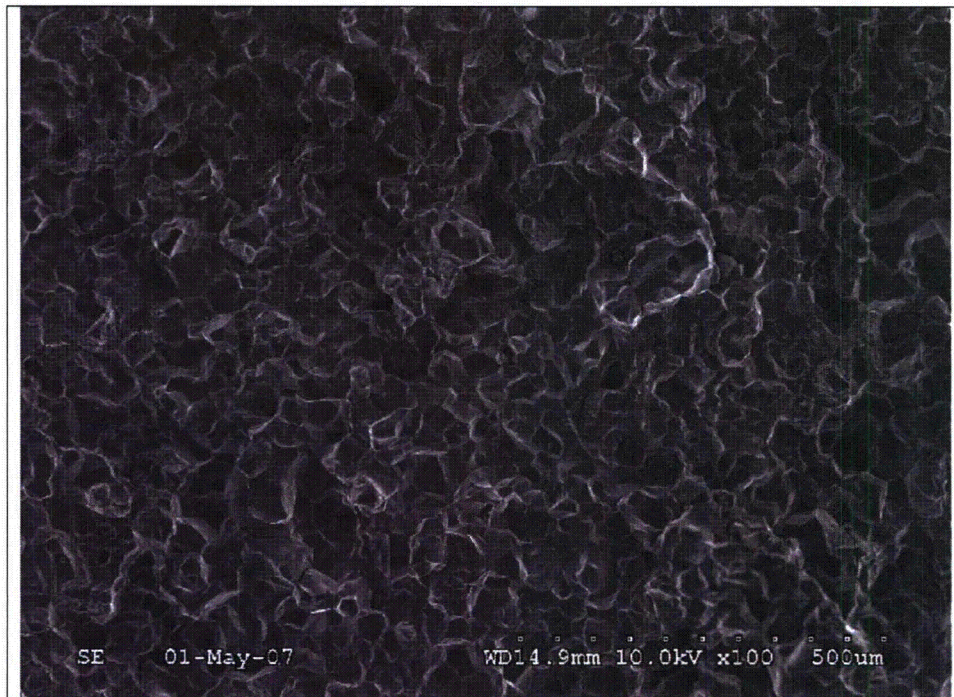
Figure 33 – A typical SEM view of the tube crack surface in the Sample A1. The tube material exhibited intergranular features throughout the sample. (100x Magnification)

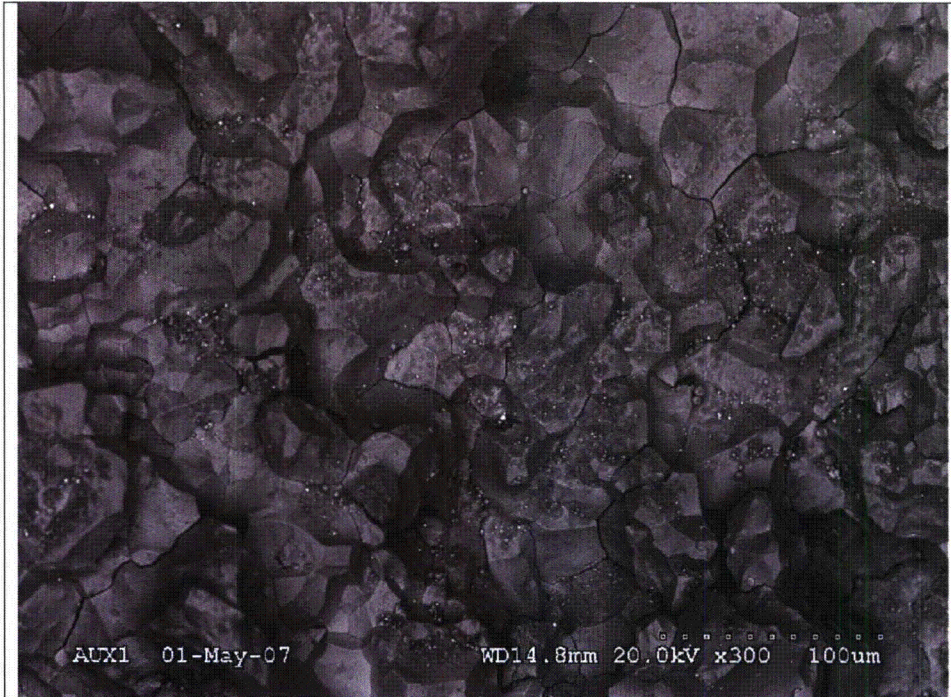
Figure 34 – A backscatter SEM image of the intergranular cracking in the dark ‘oxidized’ region in the Figure 31 stereoscope photo. An EDS evaluation indicated the fine globular particles contained tungsten, which suggests the surface was contaminated with debris from EDM cutting process. (300x Magnification)

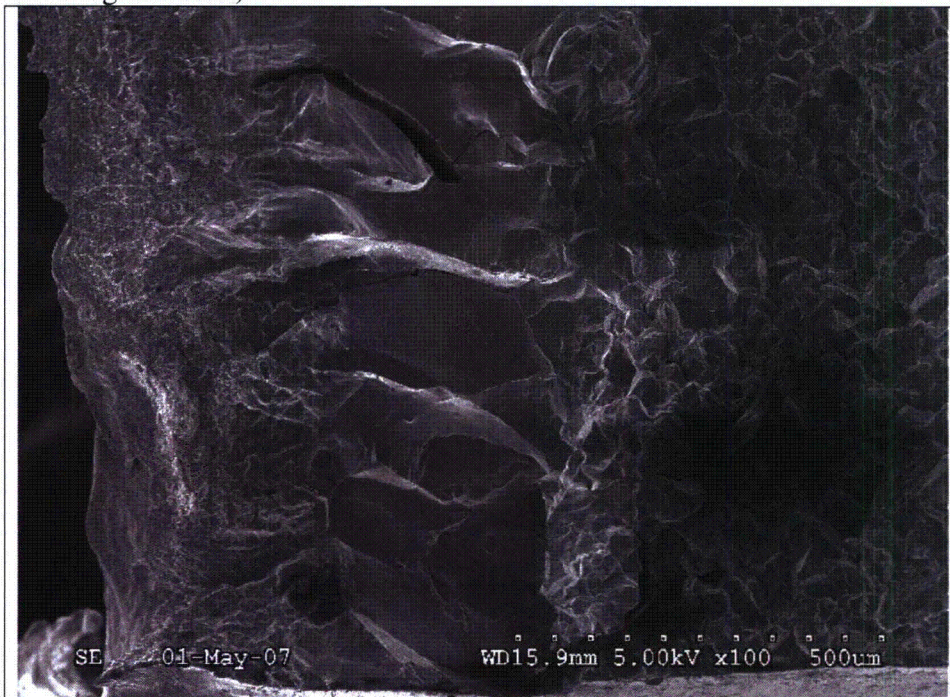
Figure 35 – The lower portion of the exposed crack surface in Sample A1. The left side of the sample is intact weld metal that was broken open in the lab. The large grained area near the center of the photo was located in the base metal heat affected zone. (100x Magnification)

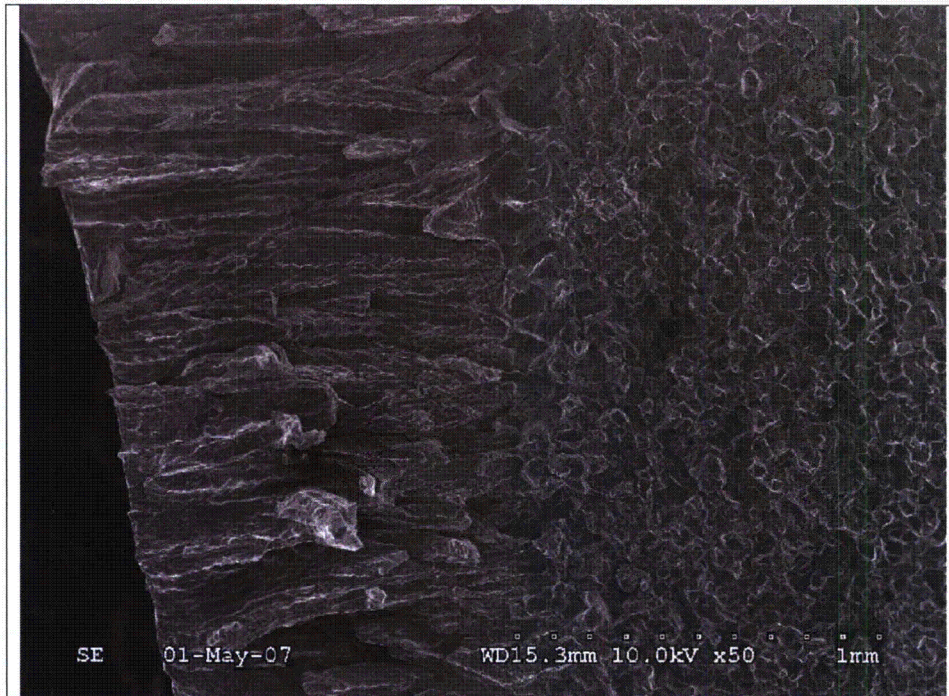
Figure 36 – An SEM photo near the center of the exposed crack in the sample A1 weld. At low magnification, the weld cracking appeared to follow the columnar, interdendritic features of the weld solidification pattern. (50x Magnification)

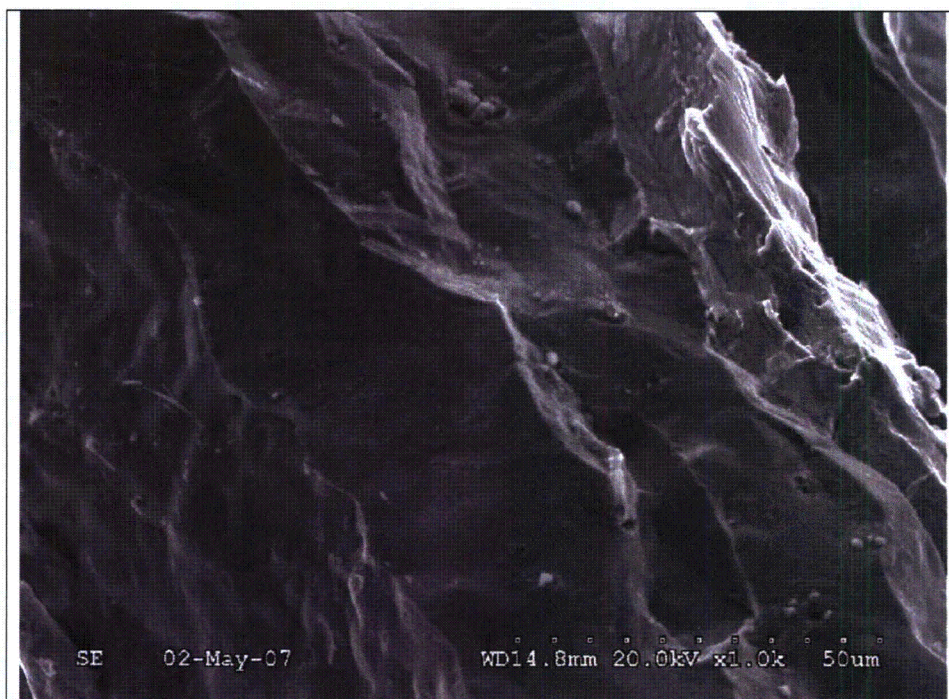
Figure 37 – An SEM photo showing a relatively smooth region of the exposed crack surface of the Sample A1 weld. (1000x Magnification)

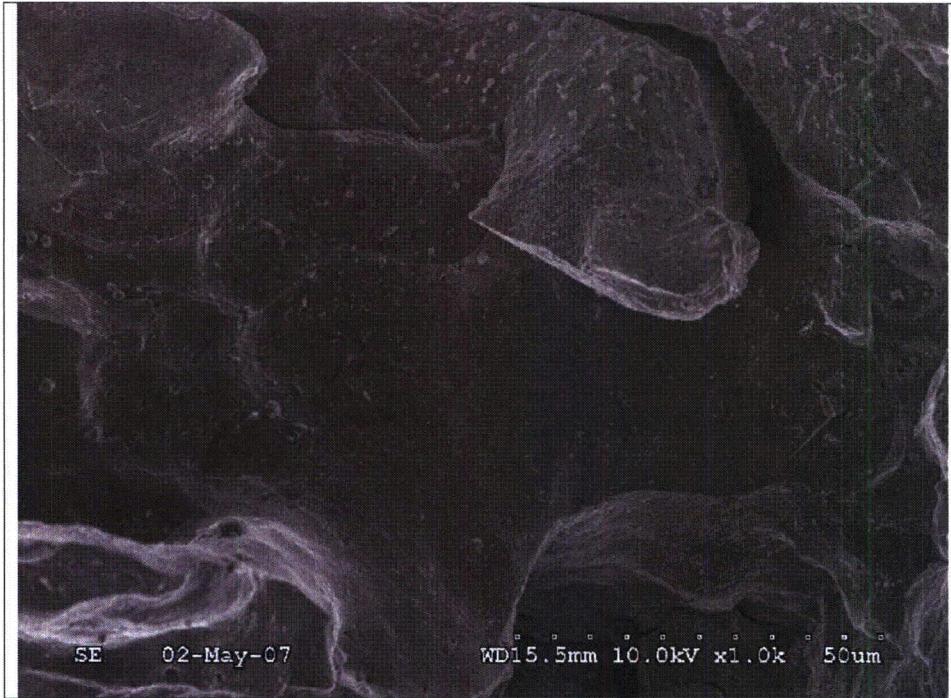
Figure 38 – Another smooth crack surface region in the Sample A1 weld. The smooth appearance is considered more typical of a hot crack than stress corrosion cracking. (1000x Magnification.)

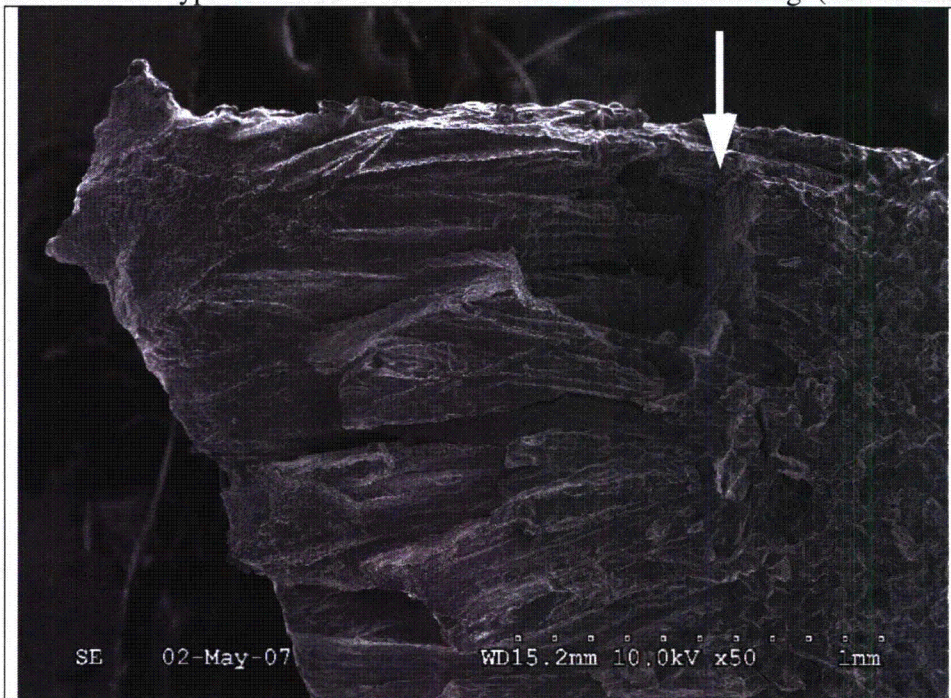
Figure 39 – A SEM view of the Sample A1 crack surface near the upper end of the weld. The arrow points to a planar defect in the weld. There are several cracks within the weld that are connected to the defect. The ductile region toward the upper left corner of the sample was broken open in the lab. (50x Magnification)

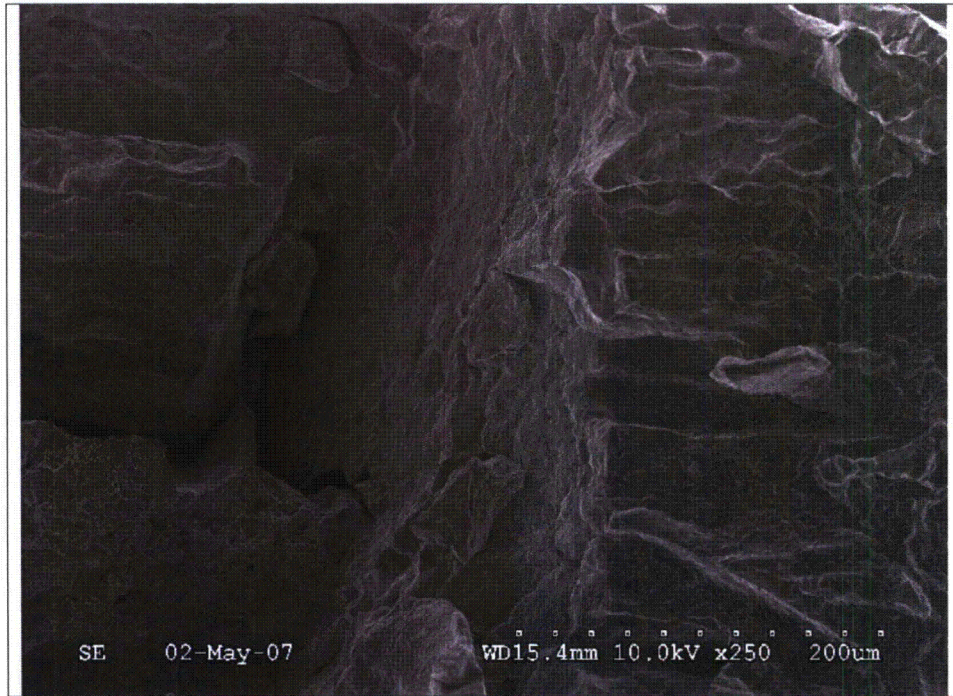
Figure 40 – A higher magnification view of the Figure 39 defect. The defect location and orientation is consistent with lack of fusion between weld passes. (250x Magnification)

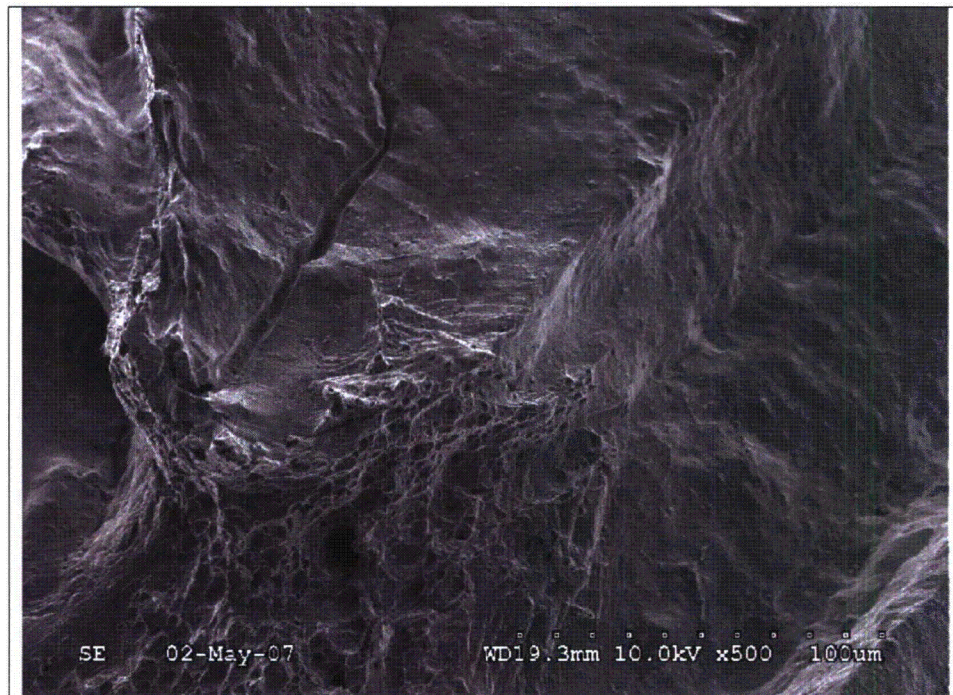
Figure 41 – A local patch of ductile dimples on the exposed crack surface in Sample A1. In general, most of the ductile patches were located toward the wetted surface of the weld. (500x Magnification)
