# **Exelon Nuclear Pre-Submittal Meeting**

Proposed Relaxation Request  
from  
First Revised Order EA-03-009  
Byron Station Unit 2

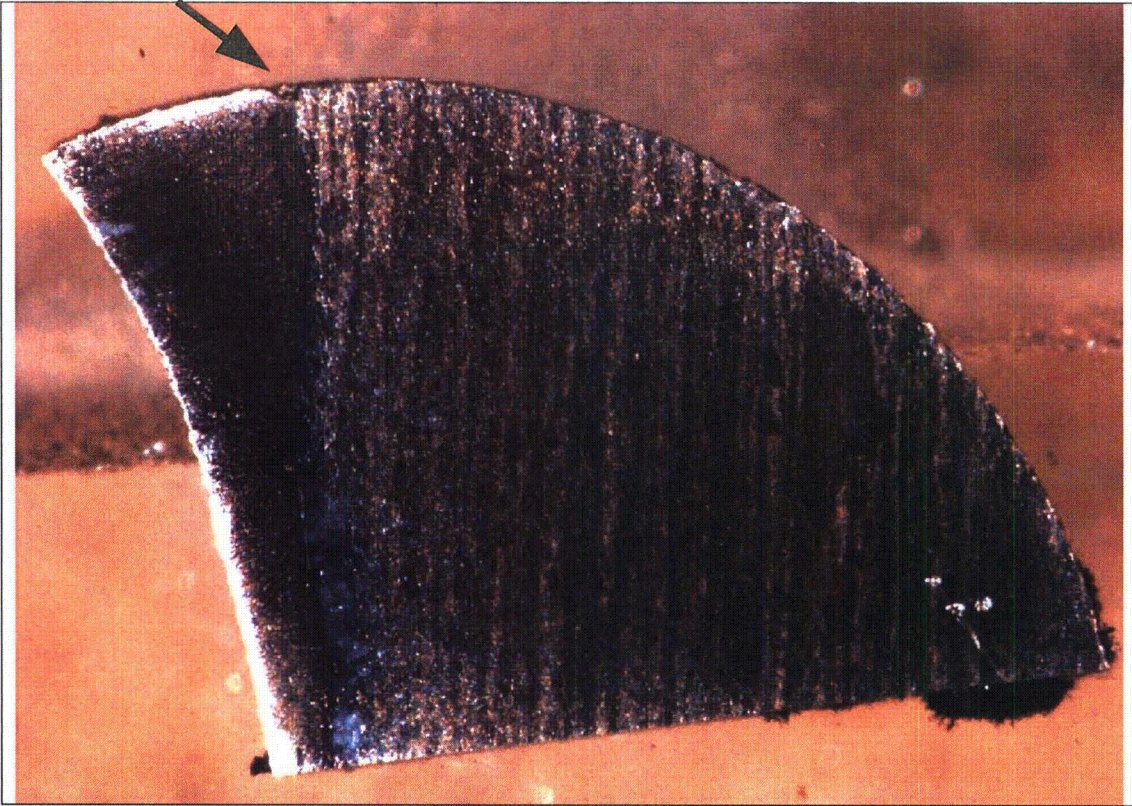
Figure 42 – A stereoscope view of metallurgical Sample A2A. The arrow points to the lack of fusion defect. (17x Magnification)

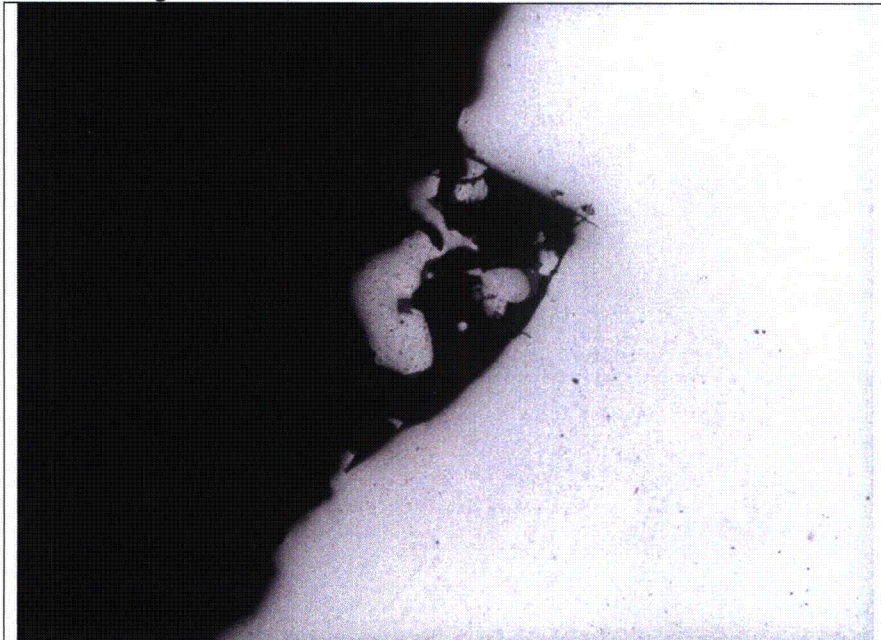
Figure 43 – An un-etched view of the lack of fusion defect. Note the globular debris from the EDM cutting process. The flat region is the tube side of the defect (190x Magnification)

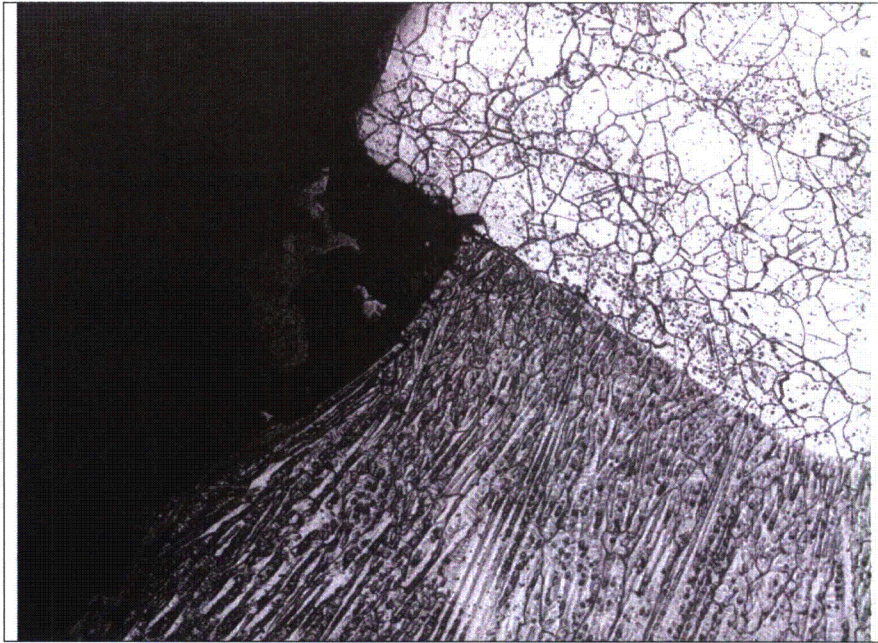
Figure 44 – An etched view of the lack of fusion defect in Sample A2A. Also note the flat interface at the fusion line, which indicates there was little penetration at this location. (190x Magnification, Electrolytic Phosphoric-Nital Dual Etch)

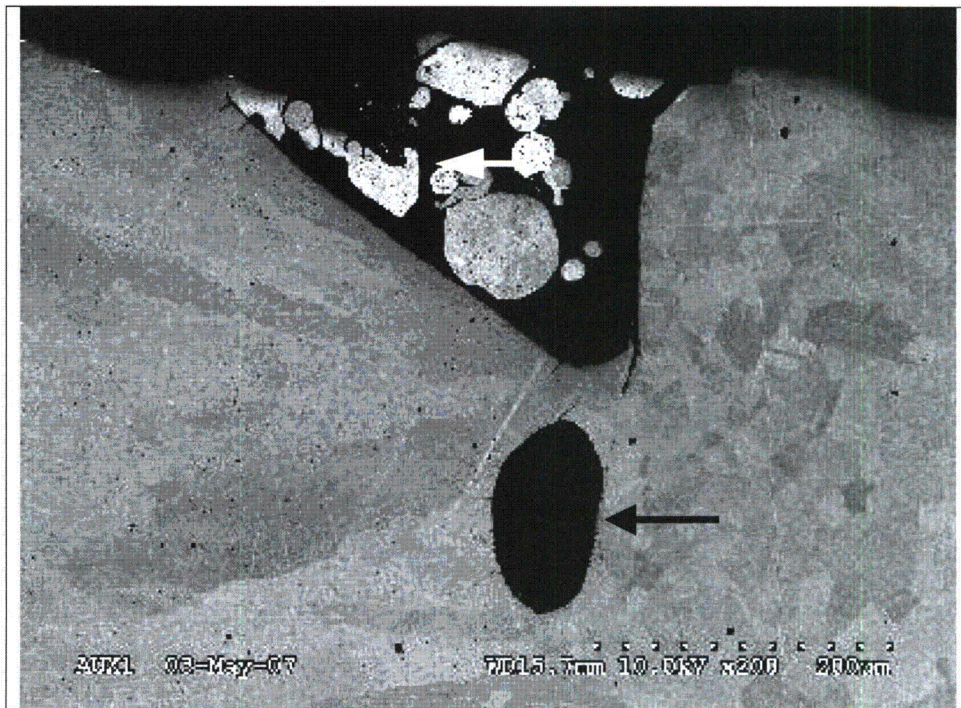
Figure 45 – A SEM photo of the Sample A2A metallurgical mount. Note the large inclusion (arrow) that is adjacent to the lack of fusion defect (200x Magnification).

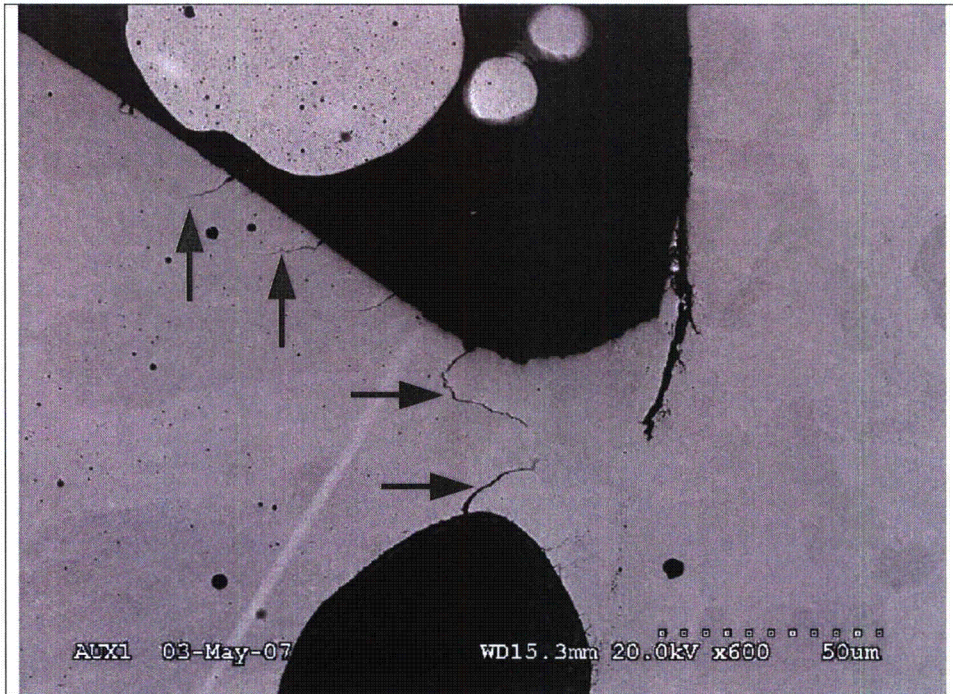
Figure 46 – A SEM photo of the Sample A2A mount. The arrows point to several incipient cracks that initiated from the inclusion and the lack of fusion defects. The defects are typical of hot cracking. (600x Magnification)

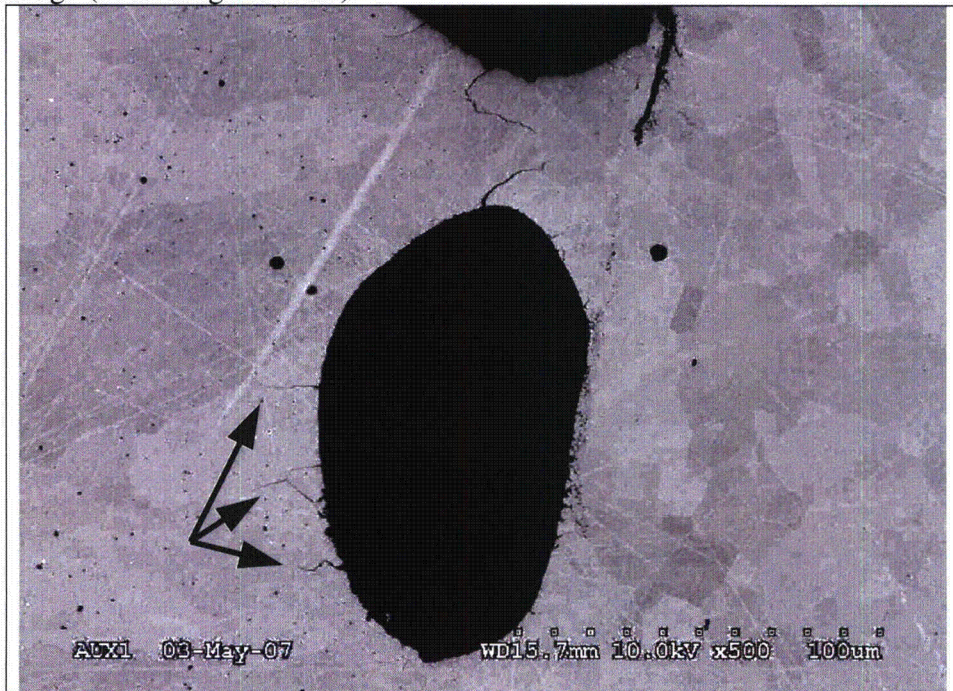
Figure 47 – Another SEM photo with arrows pointing to several cracks that initiated from the edge of the inclusion. The angled appearance of the lower two cracks appears similar to incipient PWSCC. Also note the incipient penetrations along the tube (right) side of the inclusion. (500x Magnification)

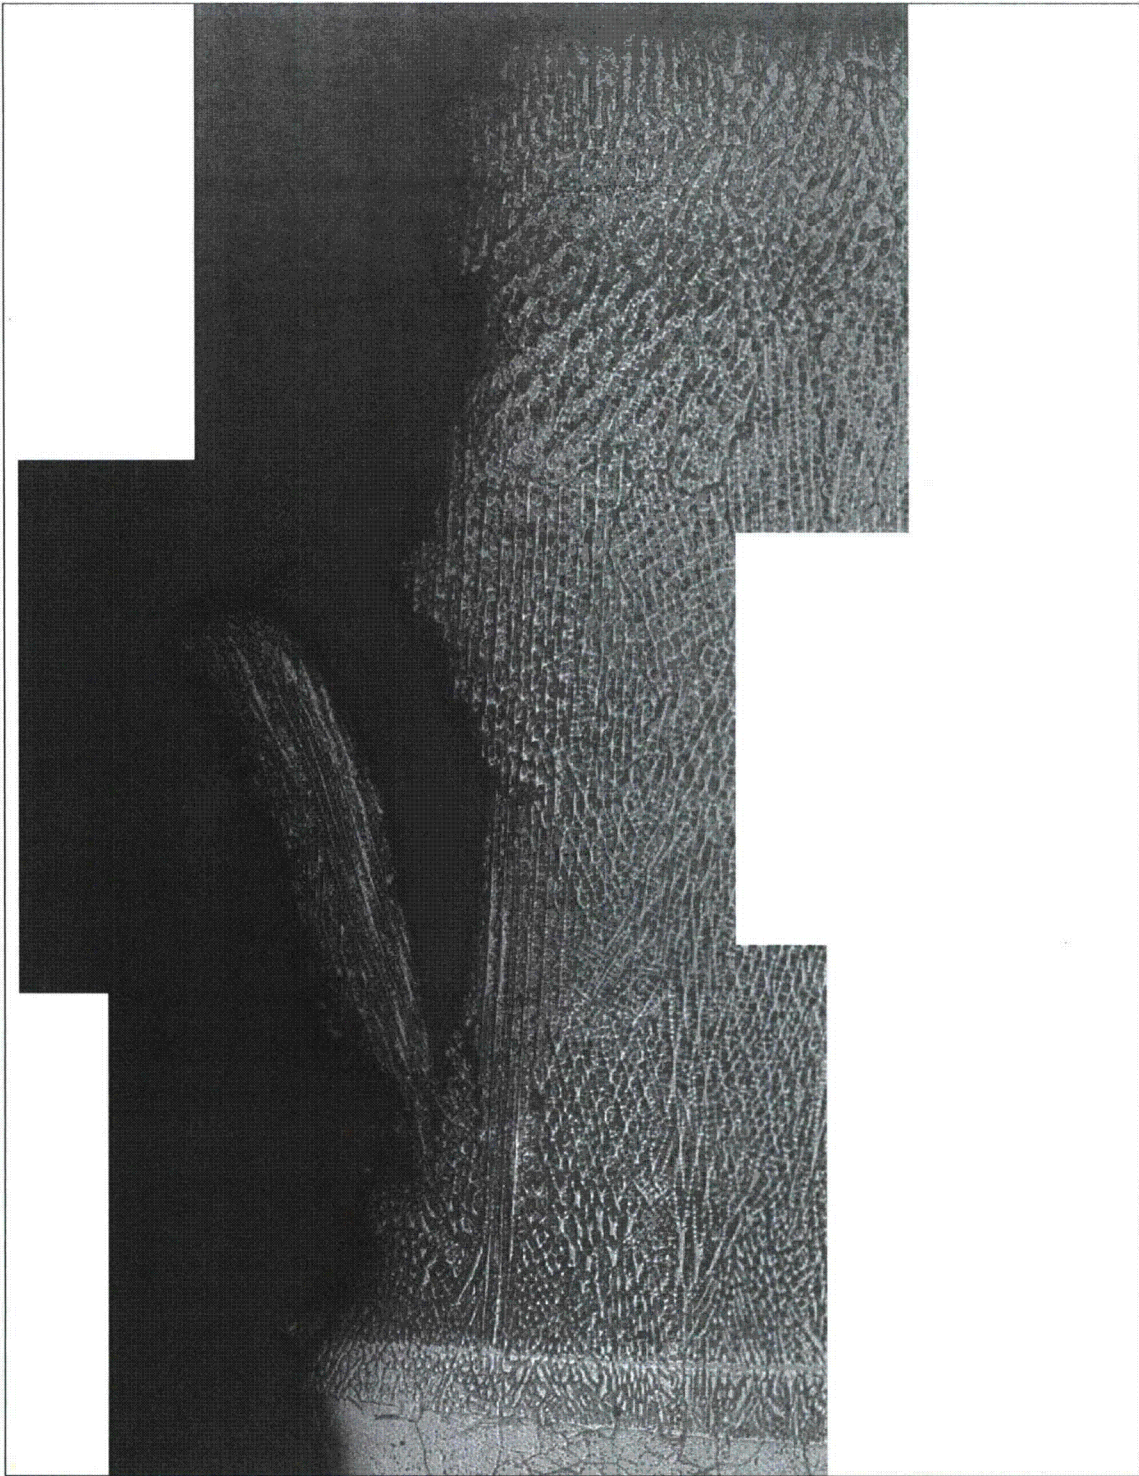
Figure 48 – A montage showing the edge of the axial crack in the Sample A2A weld. There was limited crack branching within the weld. The angled flap was likely pulled open when the crack surface was exposed in the lab. (190x Magnification)

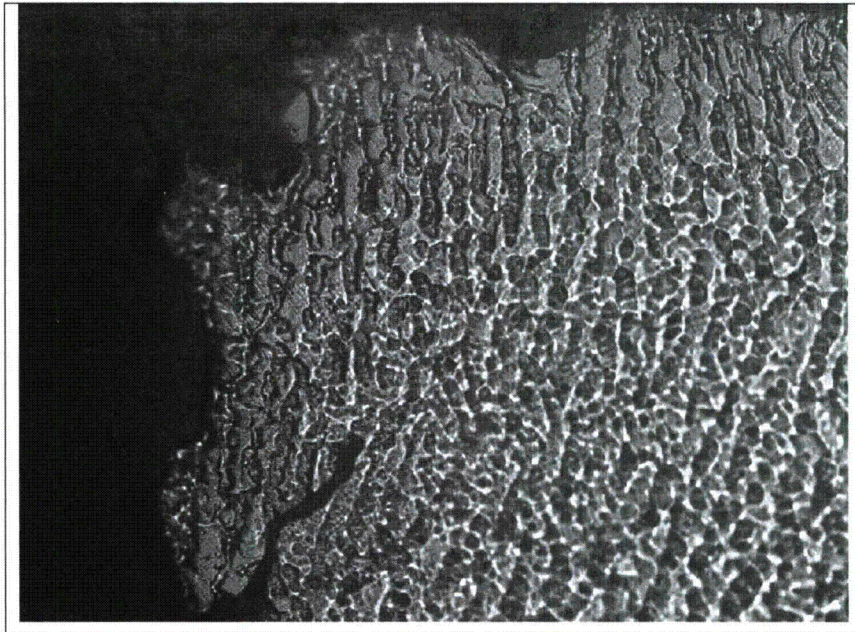
Figure 49 – A higher magnification view of Figure 48 near the wetted surface. In this region, the only branch was angled toward the wetted surface. (375x Magnification, Electrolytic Phosphoric-Nital Etch)

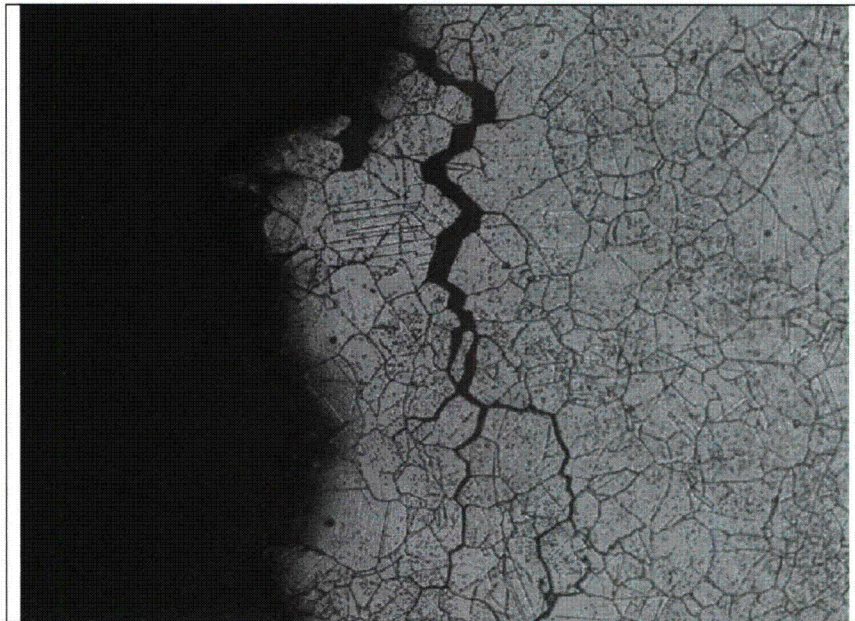
Figure 50 – An intergranular, branched crack that was connected to the axial crack in the Sample A2A tube material. (375x Magnification, Electrolytic Phosphoric-Nital Dual Etch)

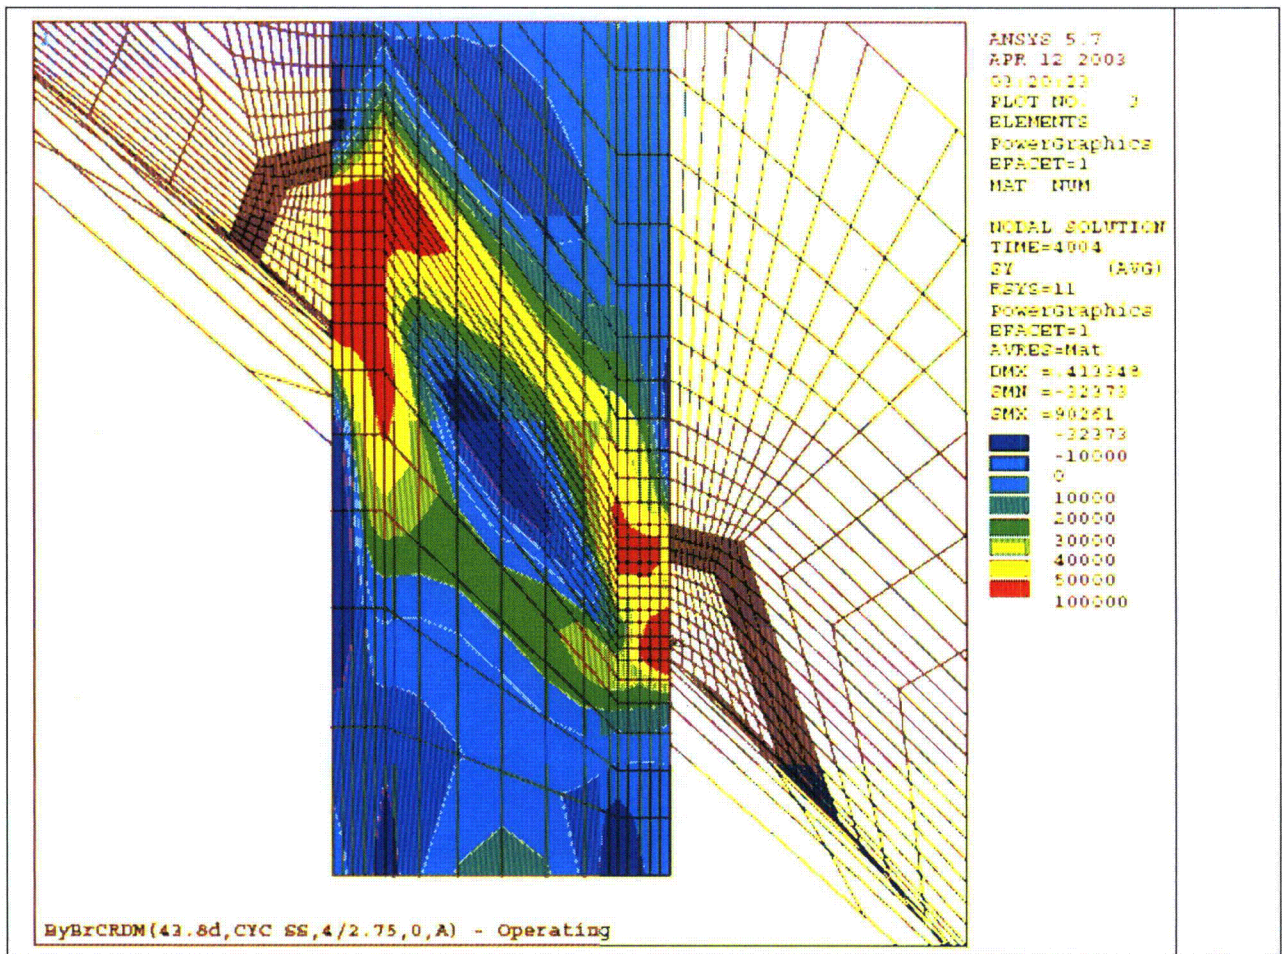
Figure 51 – A hoop stress plot from Reference 9 for the configuration that is applicable to the #68 CRDM penetration. The calculation included residual welding stresses and the stress from the operating pressure. The red areas highlight the high stress regions, which have calculated stresses between 50,000 to 100,000 psi. Note the high stress region at the downhill side of the weld corresponds to the approximate location of the axial indication in the #68 CRDM penetration.
