Comparison of Structural Integrity Manual Phased Array Sizing Measurements Taken on Safety Nozzle "A" Versus LMT Manually Encoded Data

- Objective
 - Evaluate Structural Integrity Depth Sizing
 Measurements using LMT Manually Encoded
 Data
 - Determine if any of the reported flaws are connected to inside surface
 - Determine origin of tip signals reported

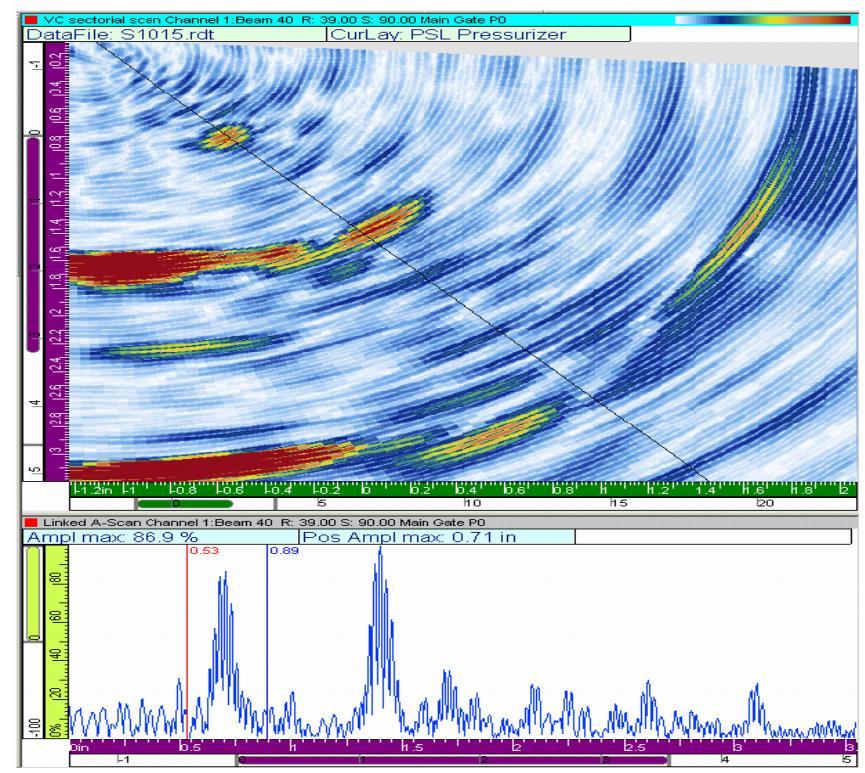
Location 15 Comparison at 14.0"

Not detected circumferential Measurement may be off on manual report <u>"A" Safety Circumferential Indication Profile Data</u>
 Location: 14 inches clockwise from "0" stamp
 Part Thickness used for calculation: 1.7 inches
 Indication through-wall depth at this location: 0.99 inches
 Estimated remaining ligament above the indication: 0.71 inches
 Angle used for measurement: 40 degrees

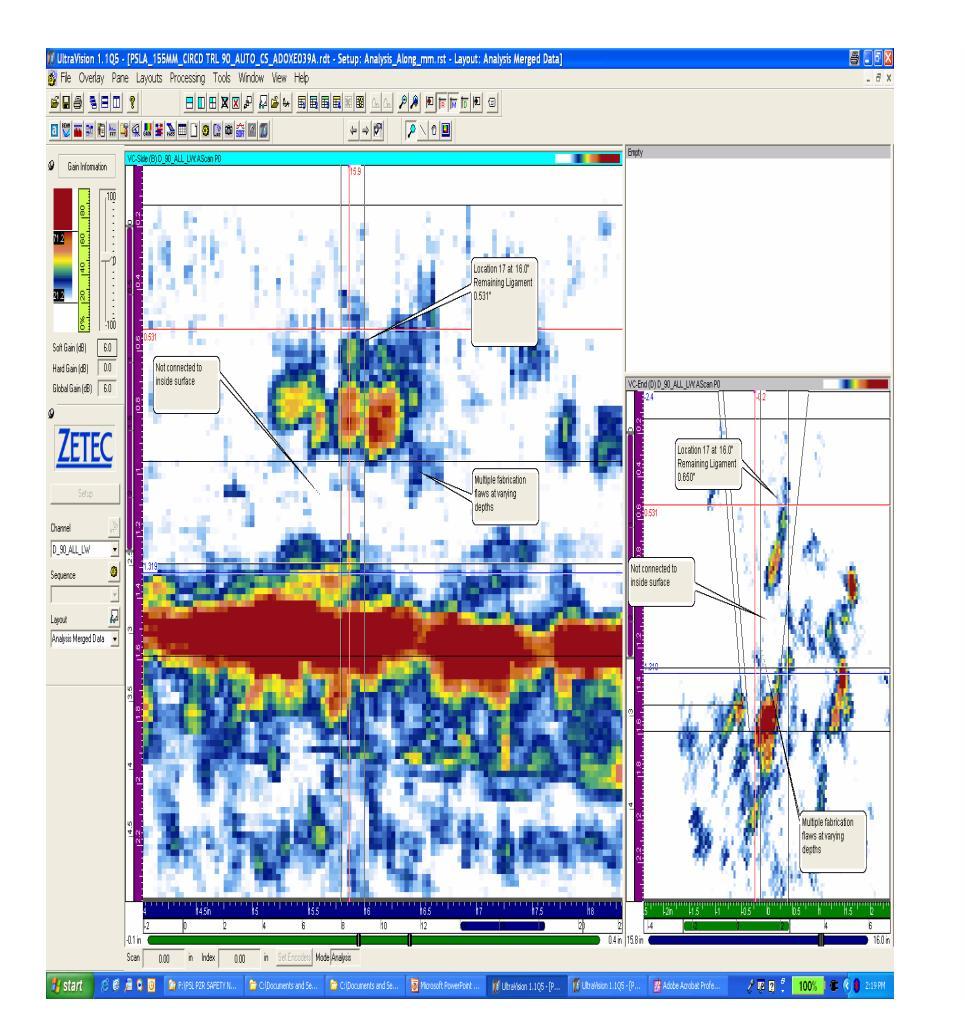
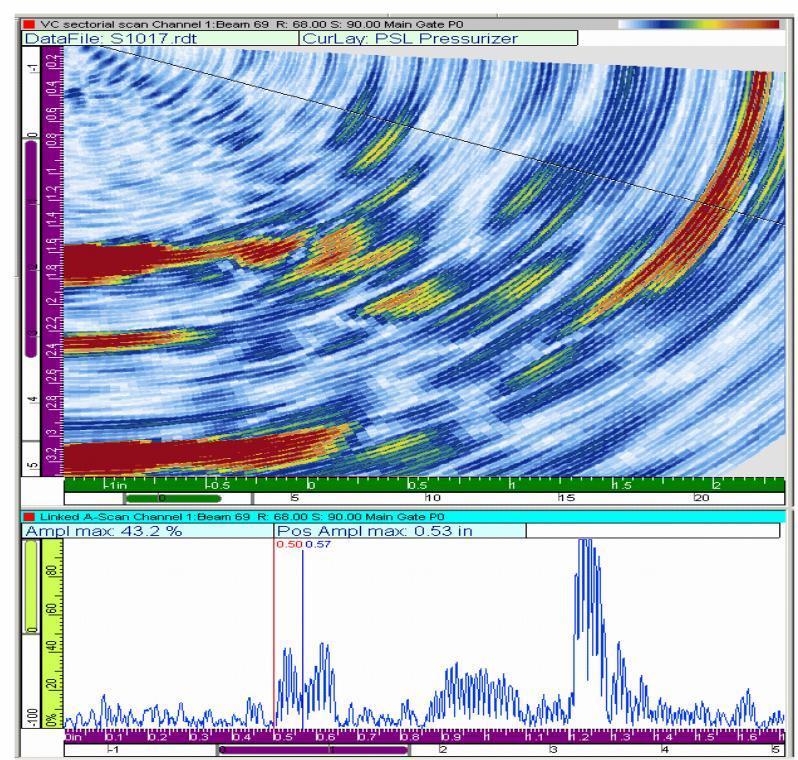
Location 17 Comparison at 16.0"

Part Thickness used for calculation: 1.7 inches

Indication through-wall depth at this location: 1.17 inches

Estimated remaining ligament above the indication: 0.53 inches

Angle used for measurement: 69 degrees

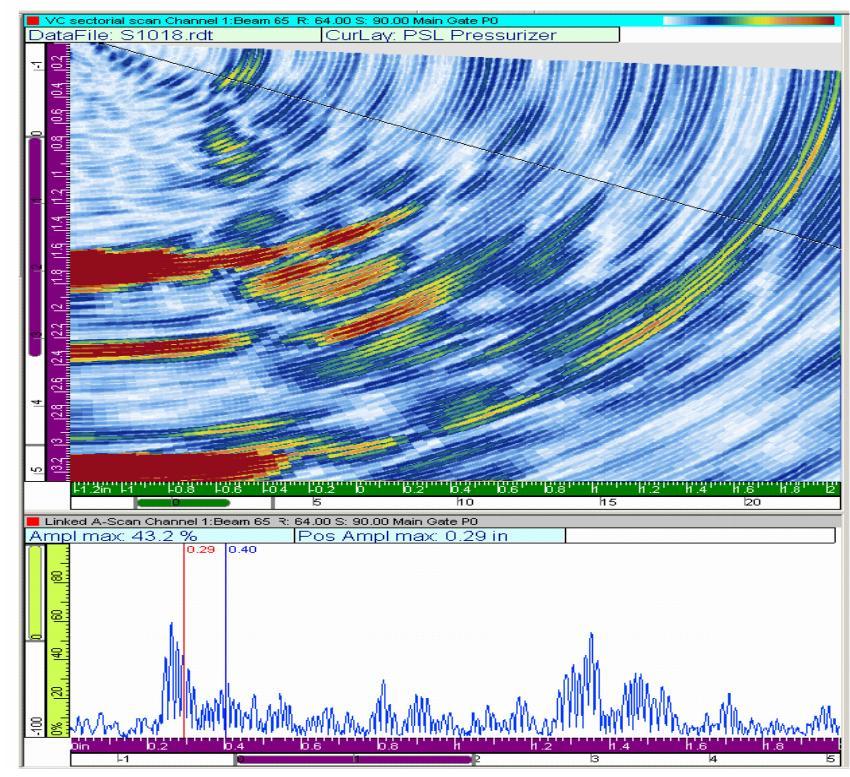
Location 18 Comparison at 17.0"

Unable to resolve indication in this area suspect circumferential position may be off.
 From data it appears to be an additional feature of same flaw measured at 16.0" "A" Safety Circumferential Indication Profile Data Location: 17 inches clockwise from "0" stamp Part Thickness used for calculation: 1.7 inches Indication through-wall depth at this location: 1.41 inches Estimated remaining ligament above the indication: 0.29 inches Angle used for measurement: 65 degrees
