LR-N08-0089

> Salem Nuclear Generating Station Unit 1 Facility Operating License No. DPR-70 NRC Docket No. 50-272

SUBJECT: RAI RESPONSE, STEAM GENERATOR TUBE INSPECTION REPORT - EIGHTEENTH REFUELING OUTAGE (1R18)

REQUEST FOR ADDITIONAL INFORMATION

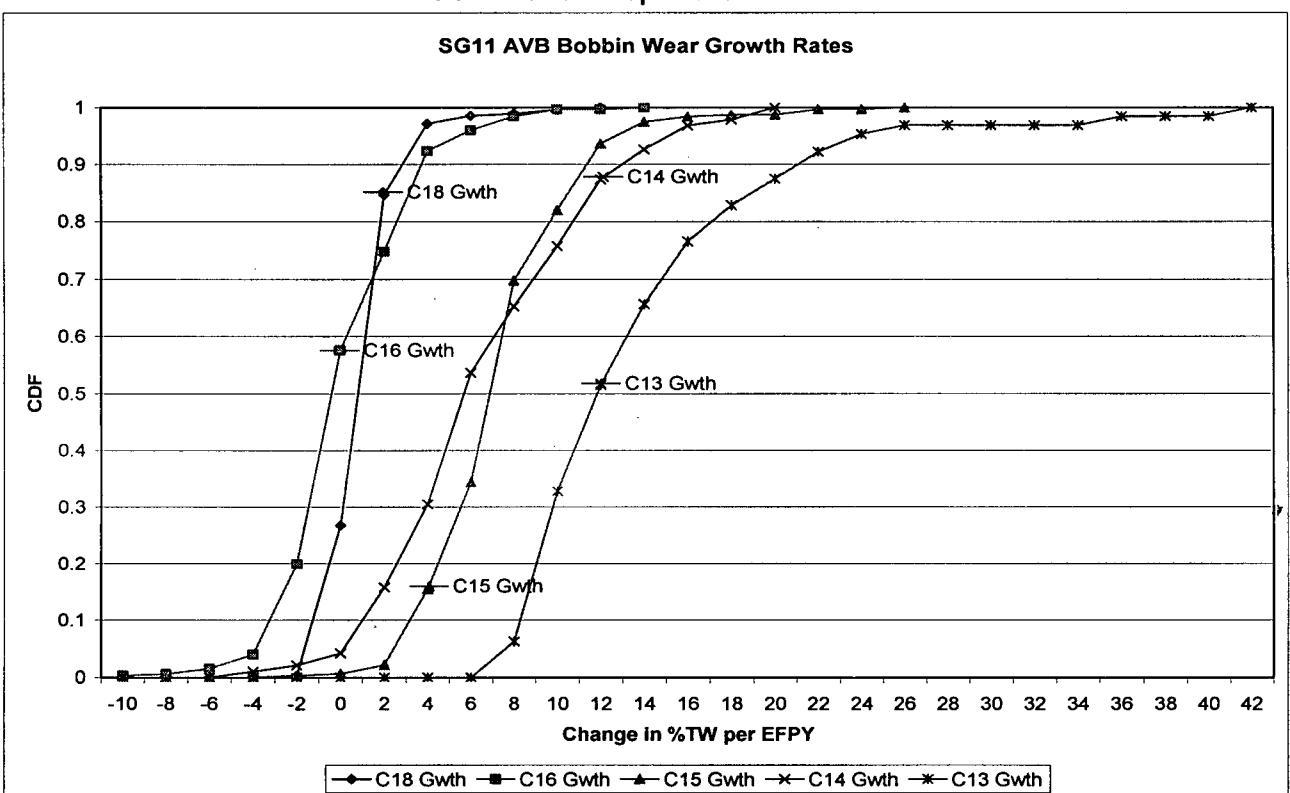
Figure 6-1 SG11 Bobbin Depth Growth Rates

Past inspection results show that growth rates, in general, have become less severe with each successive inspection. This point is demonstrated below in Figures 6-1 through 6-4. These figures show that in general the overall growth rates (especially the more critical upper tail region of the curve) has shifted to the left with each successive inspection. This demonstrates that the majority of AVB wear growth is decreasing over time. Even though the trend is a decrease in growth rate, the EPRI SG Integrity Assessment Guidelines Rev 2, Section 5.2, indicates that low degradation growth rates in the last inspection should not be favored over prior cycle data with larger growth rates until an additional cycle of low growth data has been obtained for added assurance of the low growth trend. Therefore, compliance with EPRI SG Integrity Assessment Guidelines Rev 2 points to the use of the cycle 16 growth rates for the current operational assessment. Both SG13 and SG14 exhibit equivalent upper 95th percentile growth rates, yet SG13 was selected to model the growth behavior due to the better data fit in the upper tail part of the curve. For added conservatism, the SG13 cycle 16 growth rates were used to make OA projections for each of the four steam generators in cycles 19 and 20.
