W3F1-2008-0039

SUBJECT: Steam Generator Conditions Observed at Waterford 3 During Refueling Outage 15 Waterford Steam Electric Station, Unit 3 Docket No. 50-382

SG31 Secondary Side Inspection Results Summary and Conclusions - Spring 2008 RF15 Outage

SG32 Secondary Side Inspection Results Summary and Conclusions - Spring 2008 Refuel 15 Outage

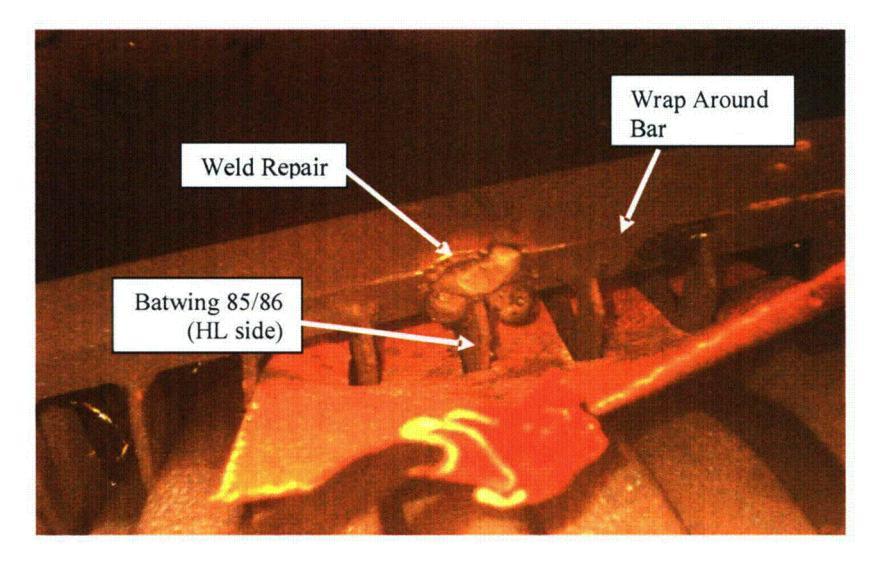
In RF 14, it was noted that the batwing between tube columns 85 and 86 on the hot leg side of SG31 was attached to the wrap around bar with a weld on one side. Since this batwing is in the central cavity region and is required to have a double-sided weld, plans were made to perform a weld repair during RF 15. This work was performed as planned and is documented in Work Order 130172. The batwing weld repair was acceptable.

SG31 – Weld repair on batwing-to-wrapper bar connection for the batwing between tube columns 85 and 86 on the hot leg side

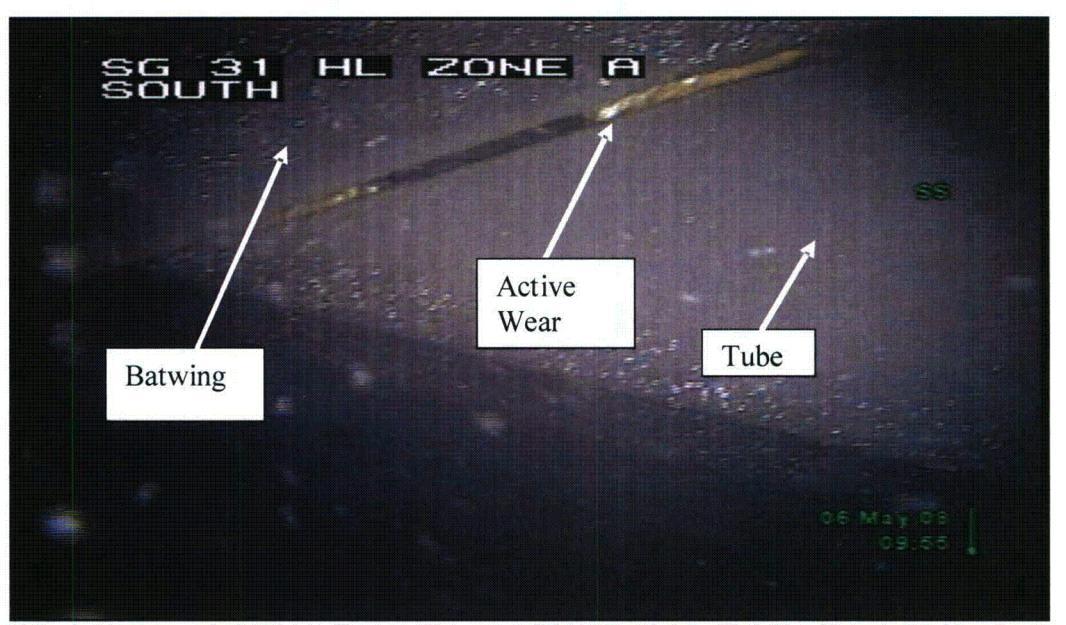
Indication No. 31-01 Active through-wall wear with the batwing shown in original position

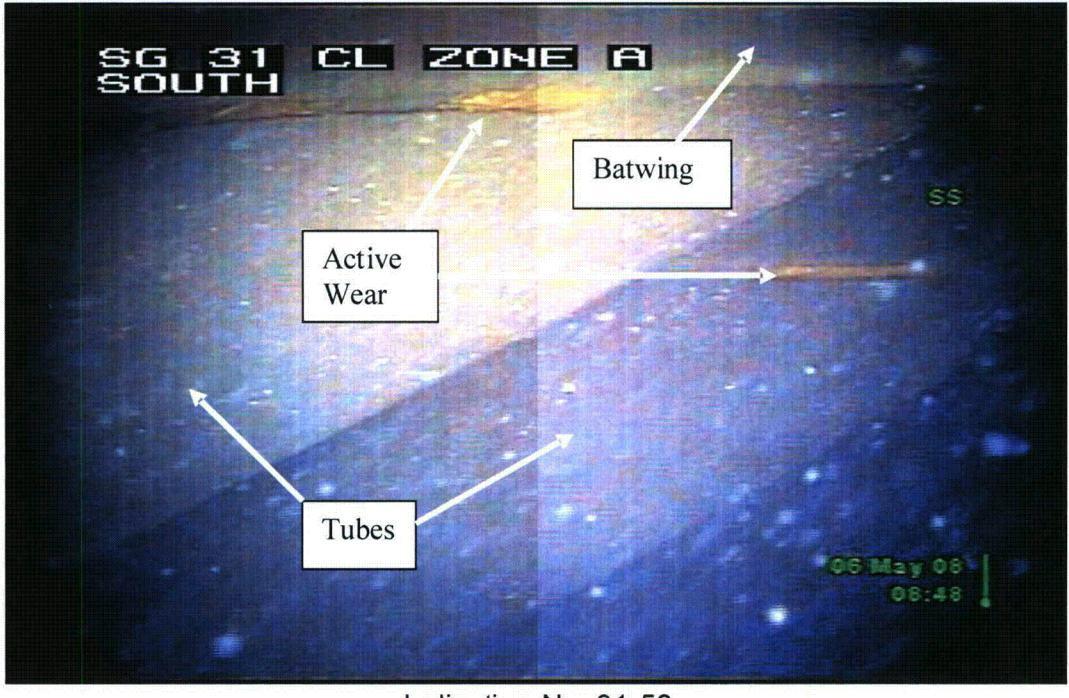
Indication No. 31-58 Two tubes with through-wall indication visible; potential active wear

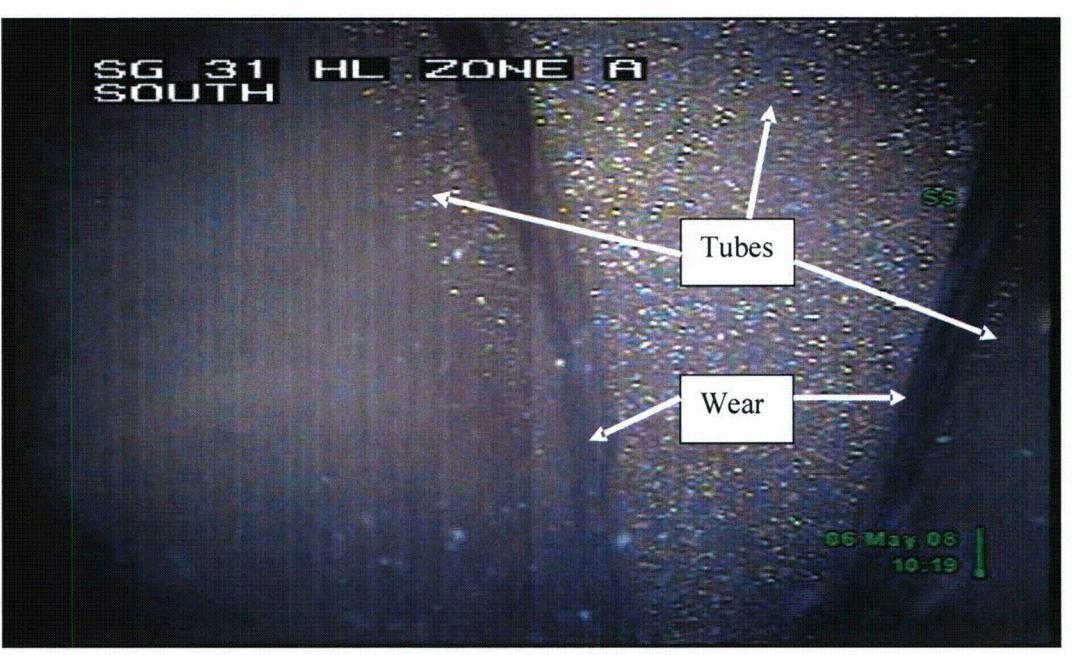
Indication No. 31-10 Two Sided Wear: Single tube with double-sided wear indication

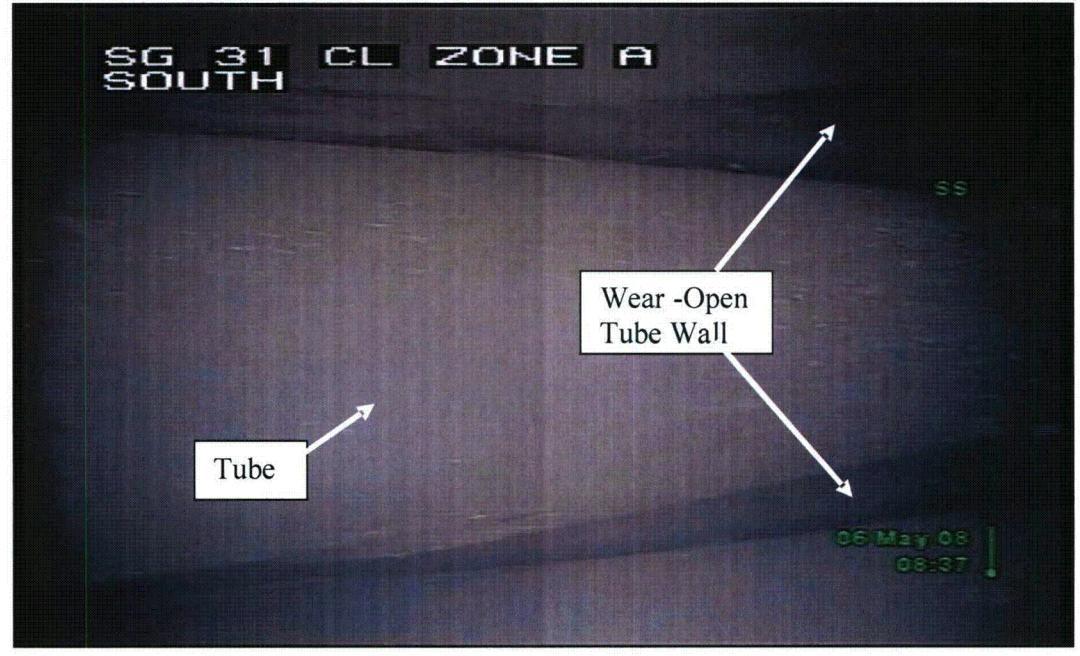
Indication No. 31-54 Two Sided Wear: Single tube with two sided through wall wear indication.

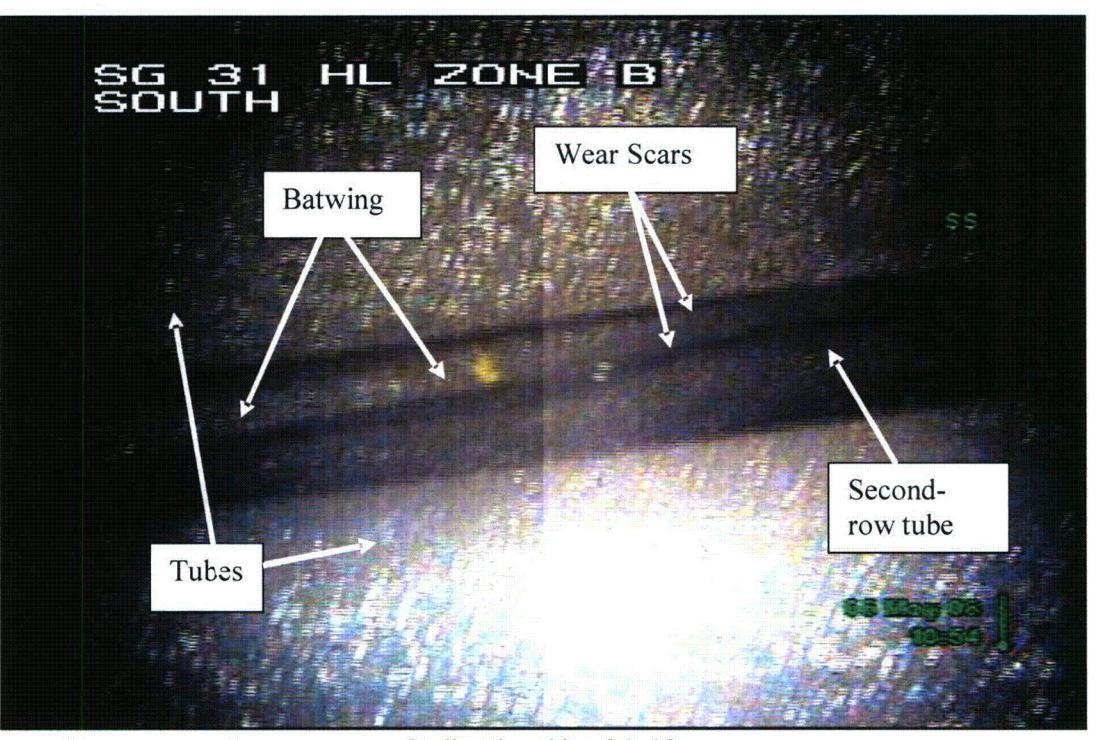
Indication No. 31-18

Second Row Wear: Tube through-wall wear with second row tube wear visible. Batwing is observed in original position.

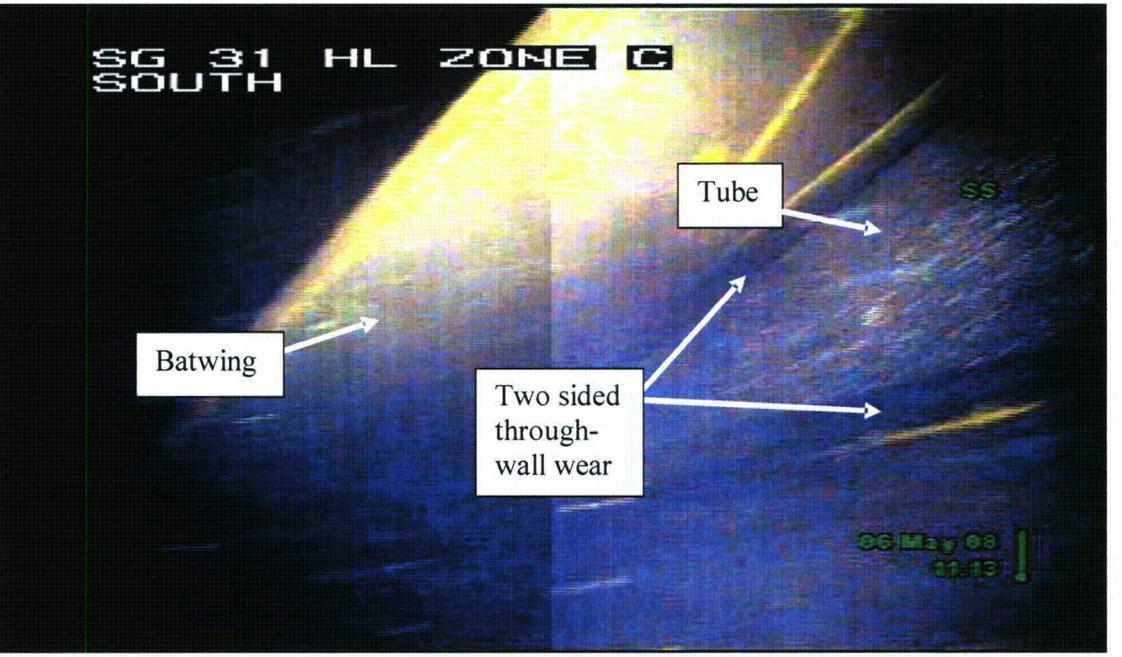
Indication No. 31-25 Second Row Wear: Single tube with two sided through-wall wear indications.

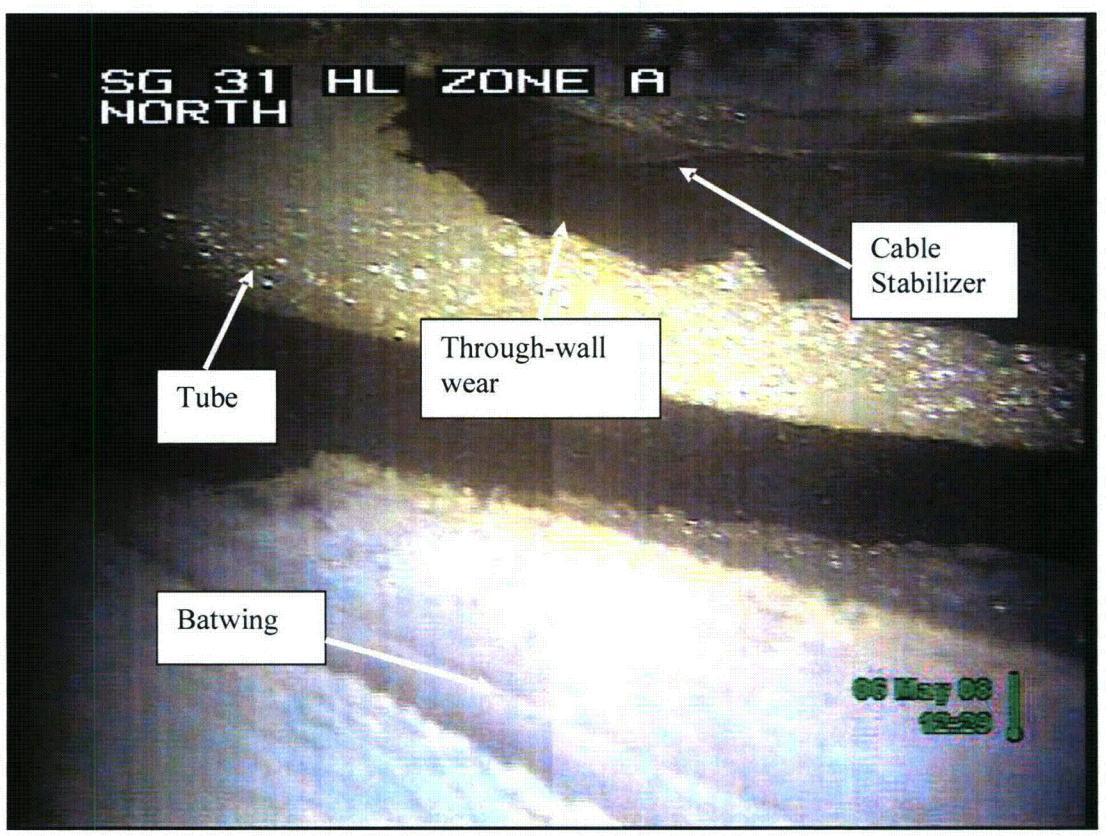
Indication No. 31-31

Through Wall Wear: Tube through-wall wear with clearly visible stabilizer. The stabilizer cable shows no indication of wear. The worn section does not exceed 1/3 tube diameter. Exceeding 1/3 tube diameter would require wear of the stabilizer cable. Since the stabilizer cable is not worn then wear does not exceed 1/3 tube diameter.

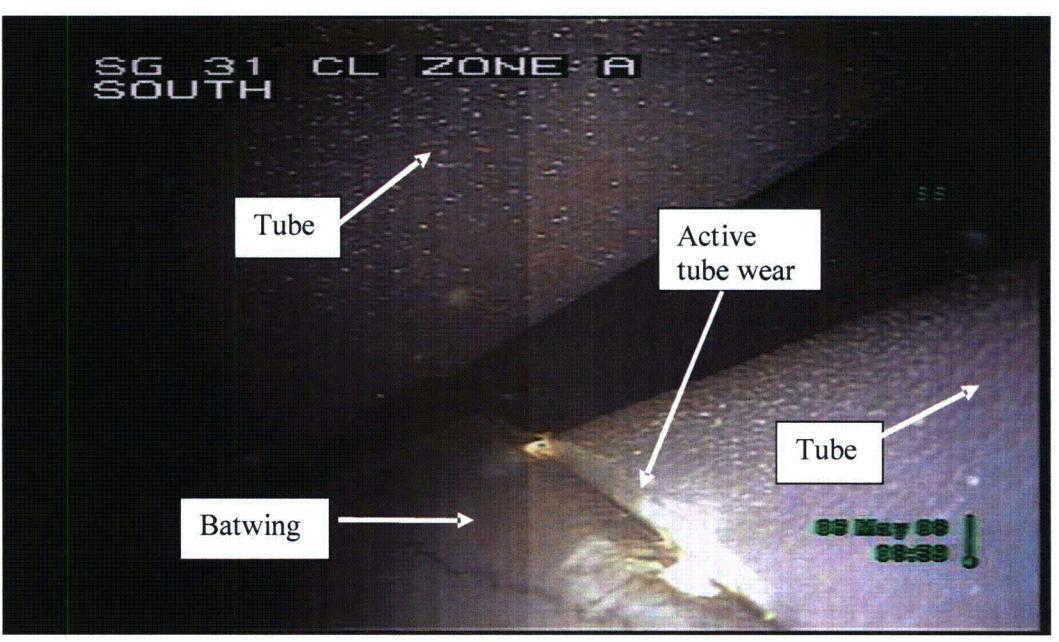
Indication No. 31-55 Two Sided Wear: Two tubes with wear indication from batwing.

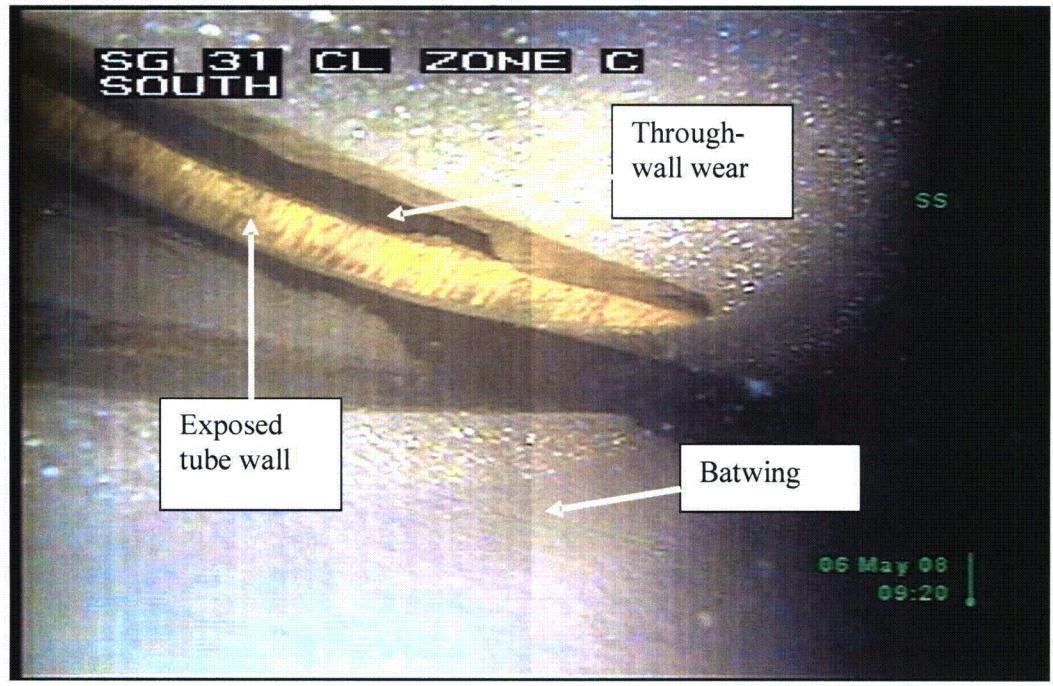
Indication No. 31-65 Tube Through-Wall: Single tube with double sided through-wall wear indication

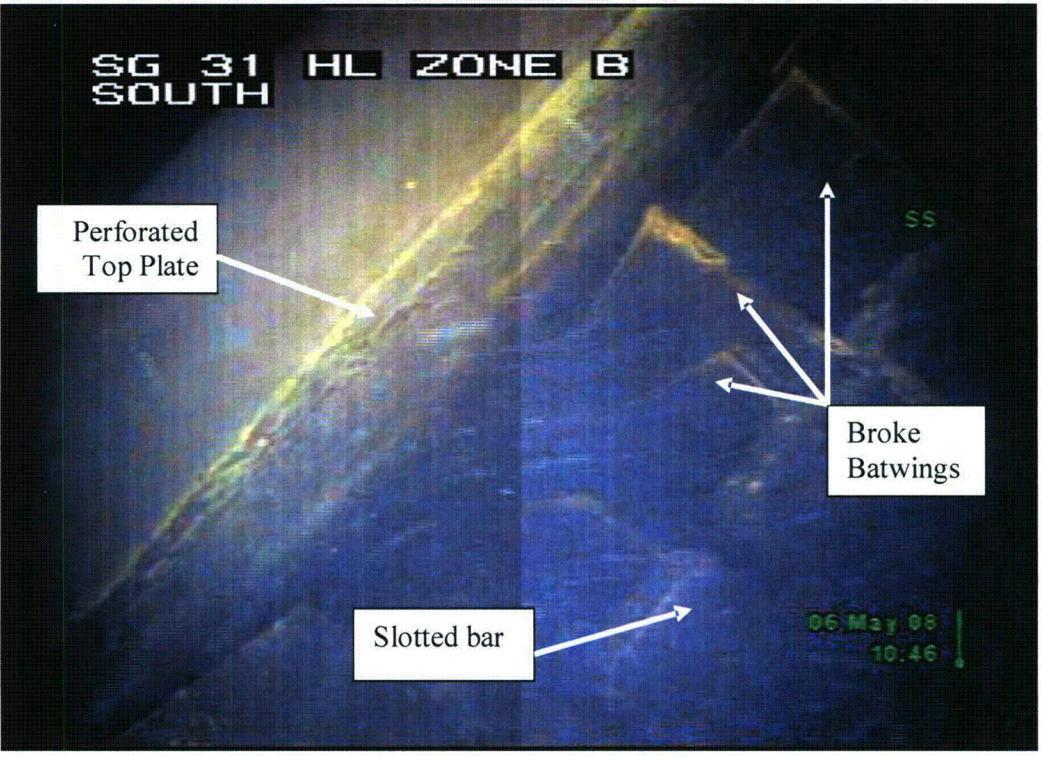
Indication No. INT-05

Broken batwing ends observed remaining in center slot of perforated top plate.

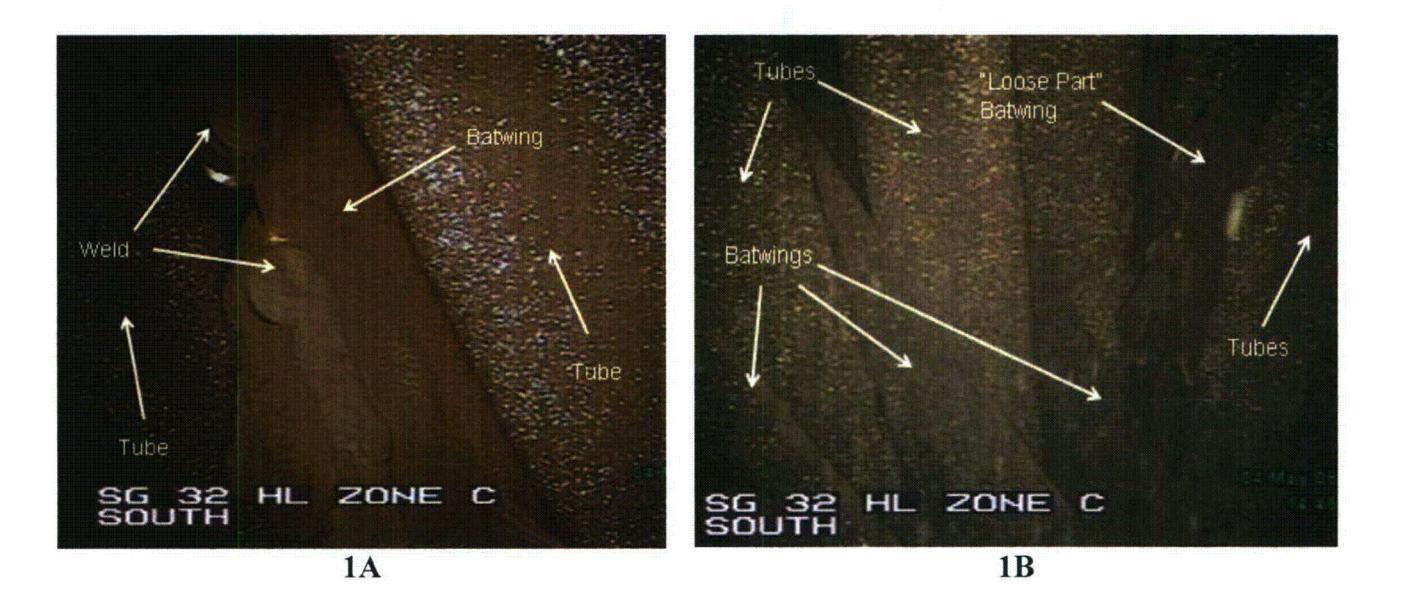
Figure 1: Loose Batwing Section

During the 45° Through-Tube Bundle Inspection, a loose batwing section was identified in the upper tube bundle central stay cavity. Based on the inspection video, the loose part is in the vicinity of the tube at Row 35 and Column 95 on the cold leg side. This piece was not observed during inspections conducted in the PO-07-01 outage. During PO-07-01, four (4) loose parts were observed. During RF15, three of the four loose parts remain at the locations where they were observed in PO-07-01. Based upon batwing inventory and part size it is concluded that the loose part that is lodged between the tubes in the upper stay cavity is one of the four loose parts observed during PO-07-01. Refer to figures 3A, 3B and 3C shown in Attachment 4 for comparison of size and location information.

- The loose section has a maximum potential length of six inches and is the nominal twoinch BW width.
- The section is oriented such that the 2" face of the loose BW in the tube gap is parallel with the centerline of the contacting tubes creating a potential for flat wear against the tube.

- The loose section is approximately two to three tube rows deep into the tube bundle and enters the bundle at approximately a 30° angle.
- The section spans and contacts a minimum of three tube columns as it enters the inner rows of the SG central cavity. All of the tubes that the loose section could potentially contact in this region of the tube bundle have been removed from service by being either plugged or plugged and stabilized.

- The loose BW section appears fixed in its current position and not expected to migrate further into the bundle or become dislodged from its current location during operation.

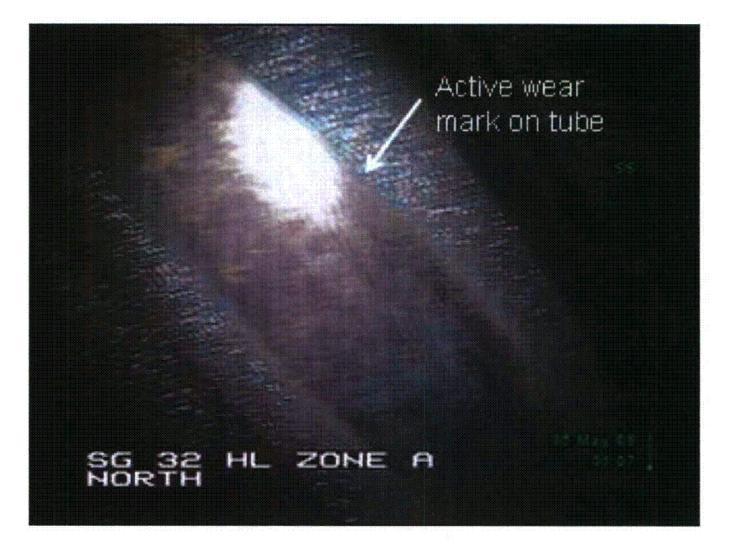
Figure 4: RF15 Active Wear Mark (Not Through-Wall, picture 32-41)

Figure 4 and 5 are also photographs of intrados tube wear observed during RF15. Figure 4 clearly shows a very shiny wear mark on the tube, but does not appear to be through–wall wear. Figure 5 also contains indications of abrasion or rubbing of batwings. However, it does not appear to be through-wall tube wear.

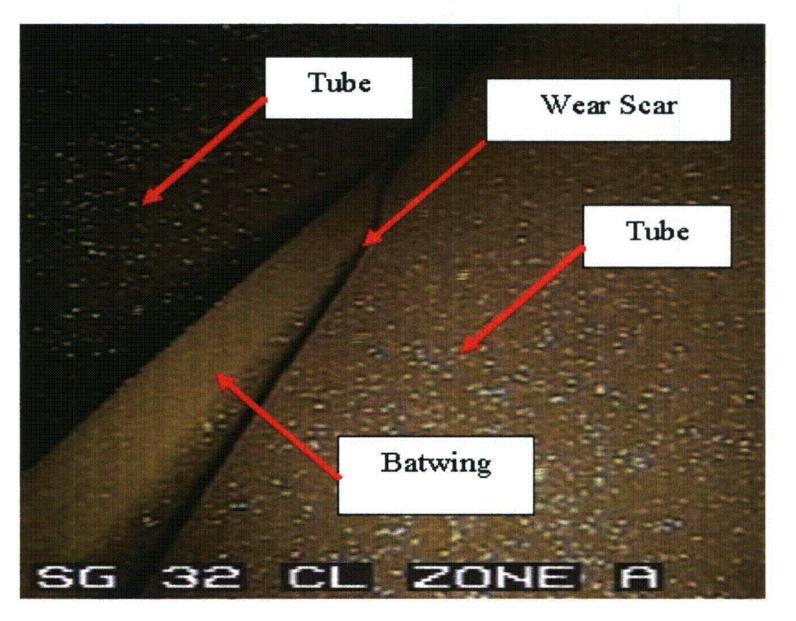
Indication 31-10

Active Wear: Tube being worn by adjacent batwing. Wear is not through wall.

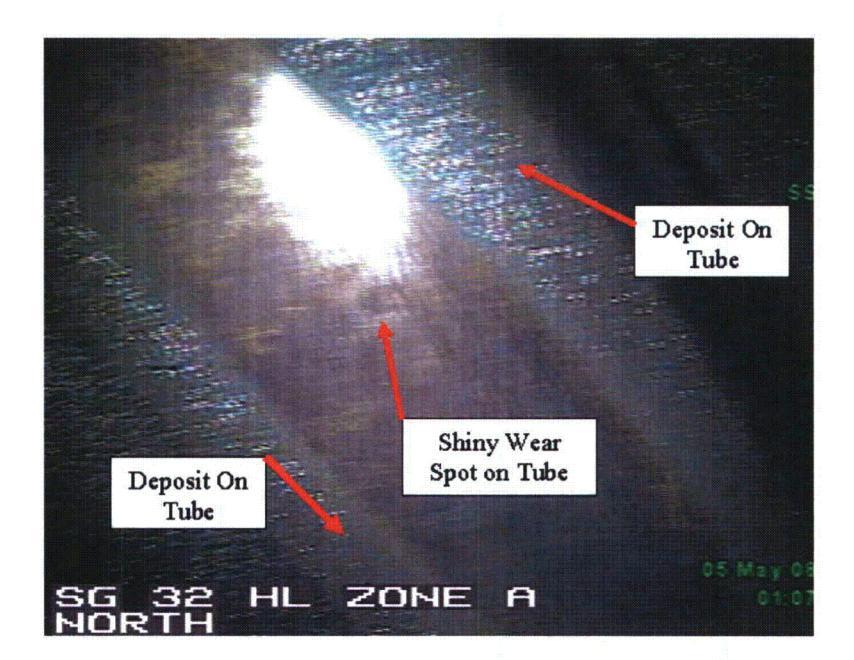
Indication 32-41

Active Wear: Exterior sludge deposits have been worn away by contact with a broken batwing. The shiny area is the tube surface. Wear is not through wall

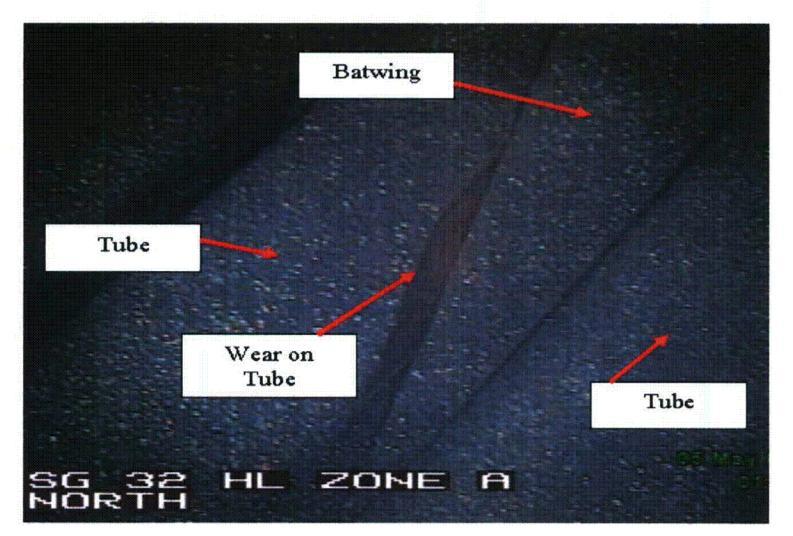
Indication 32-43

- Tube Batwing Wear Surface Cable Stabilizer
- Active Wear: Exterior Sludge deposits have been worn away by contact with an intact batwing. The shiny area is the tube surface. Wear is not through wall.

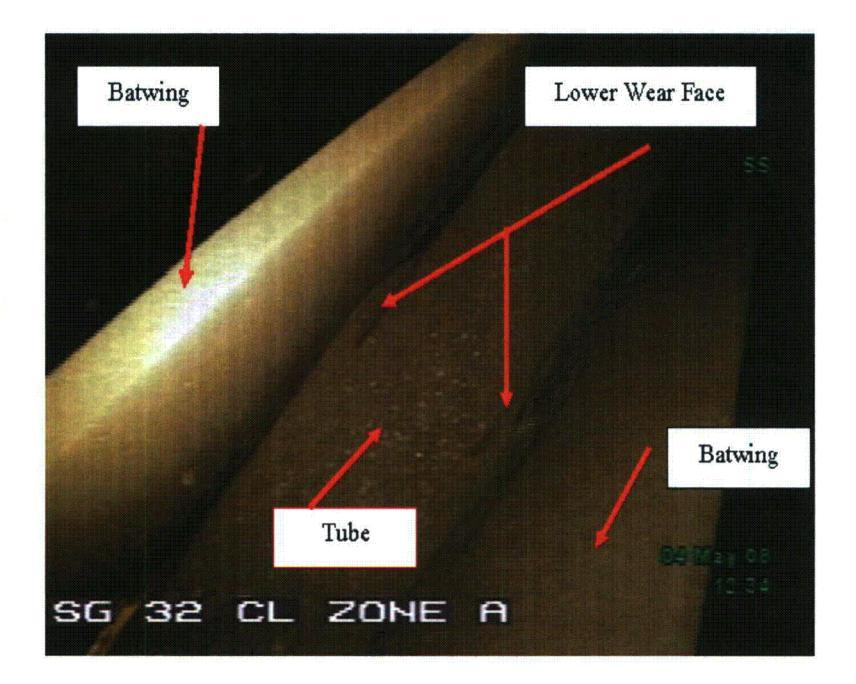
Indication 32-05-2

Slide Down Wear: Through wall tube wear showing the stabilizer cable. Observed wear is at the original batwing to tube interface. The batwing has now dropped and wear is not continuing. The stabilizer cable shows no indication of wear. The worn section is on the order of 4 inches long and does not exceed 1/3 tube diameter. Exceeding 1/3 tube diameter would require wear of the stabilizer cable. Since the stabilizer cable is not worn then wear does not exceed 1/3 tube diameter. Slide Down Wear is wear associated with original batwing wear issues. The batwing has now slid down exposing the wear area.

Slide Down Wear: Two sided tube wear. The stabilizer cable shows no indication of wear.

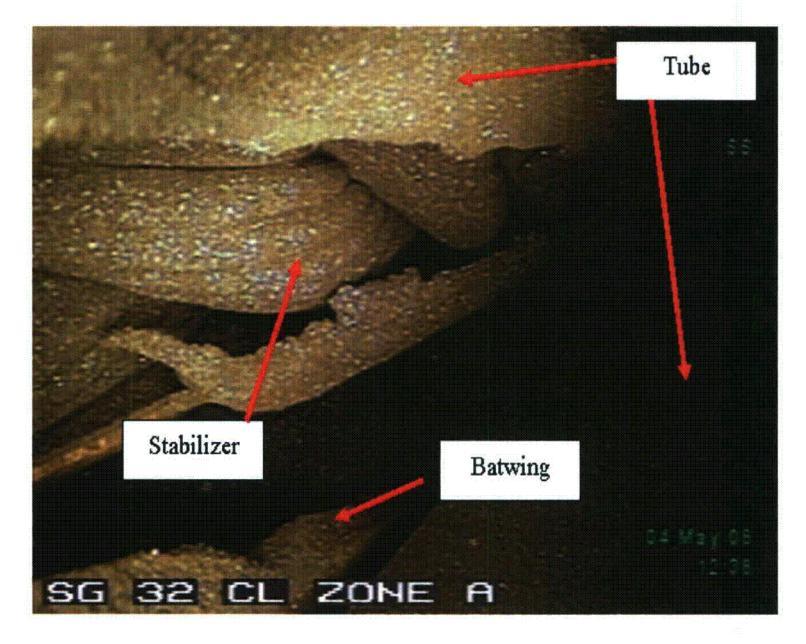
Indication 32-25

Slide Down Wear: Through wall tube wear showing the stabilizer cable

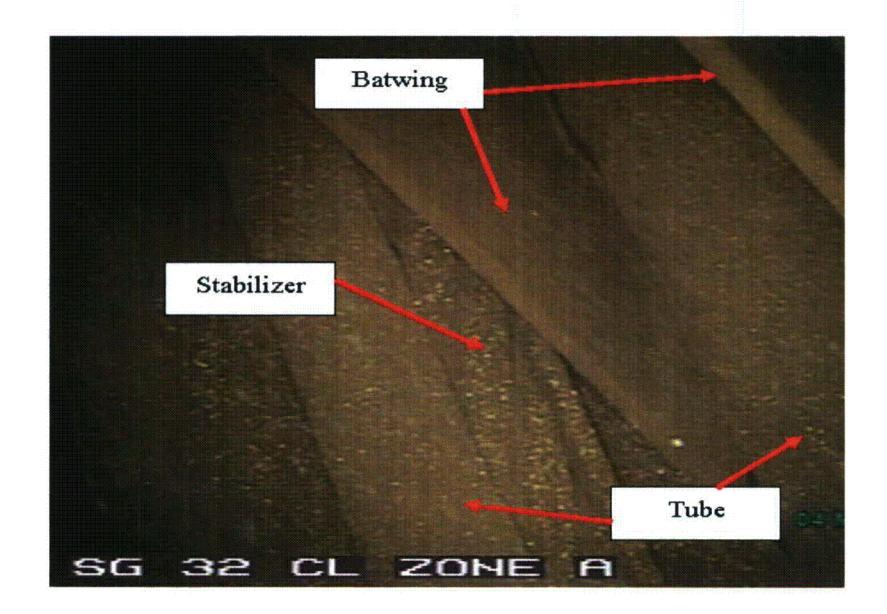
Indication 32-26

Slide Down Wear: Through wall tube wear showing the stabilizer cable

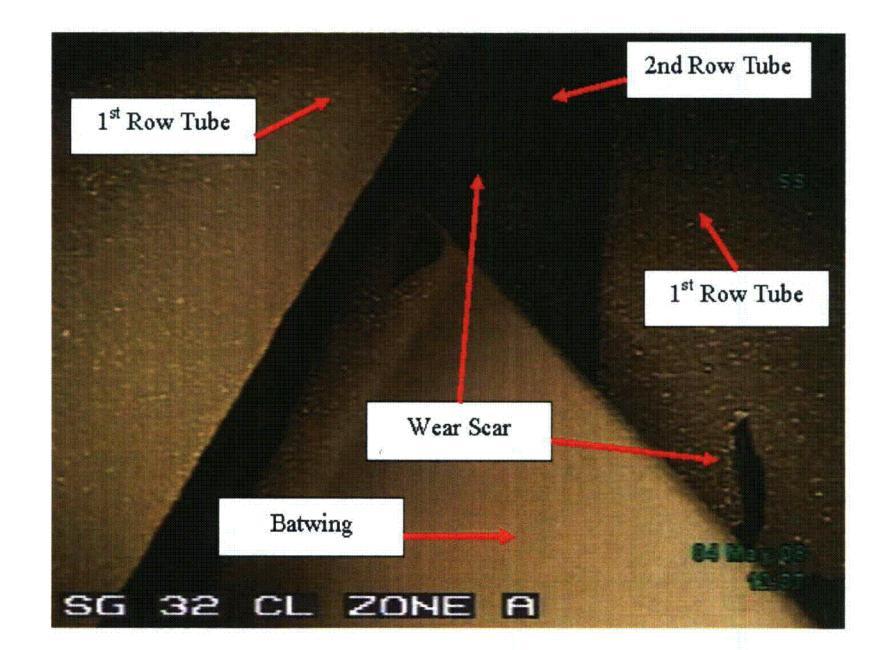
Indication 32-23-1

Second Row Tube Wear: Example showing both 1st and 2nd row tube wear.

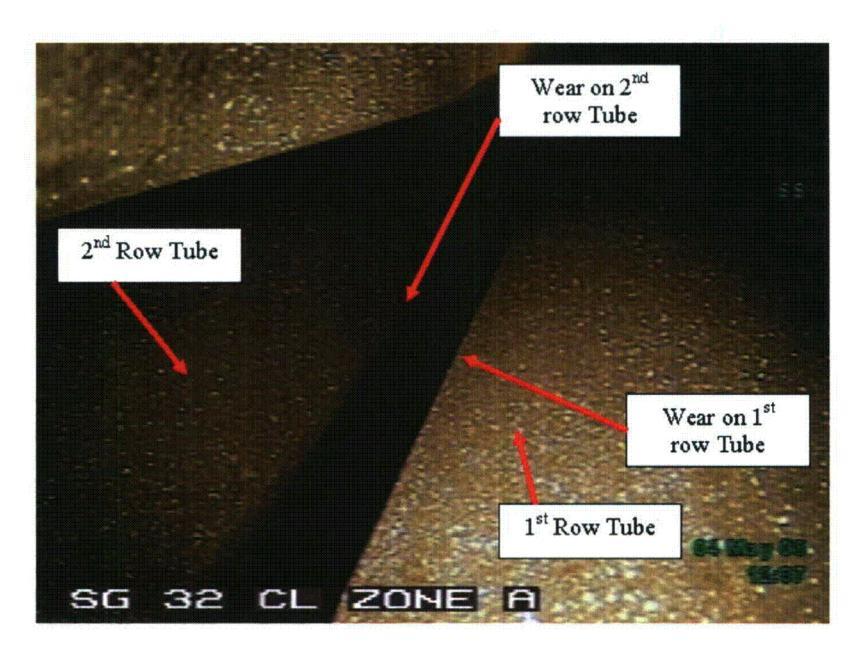
Indication 32-24

Second Row Tube Wear: Through wall batwing wear in second row out from the center cavity; Appears to be 'old' batwing wear.

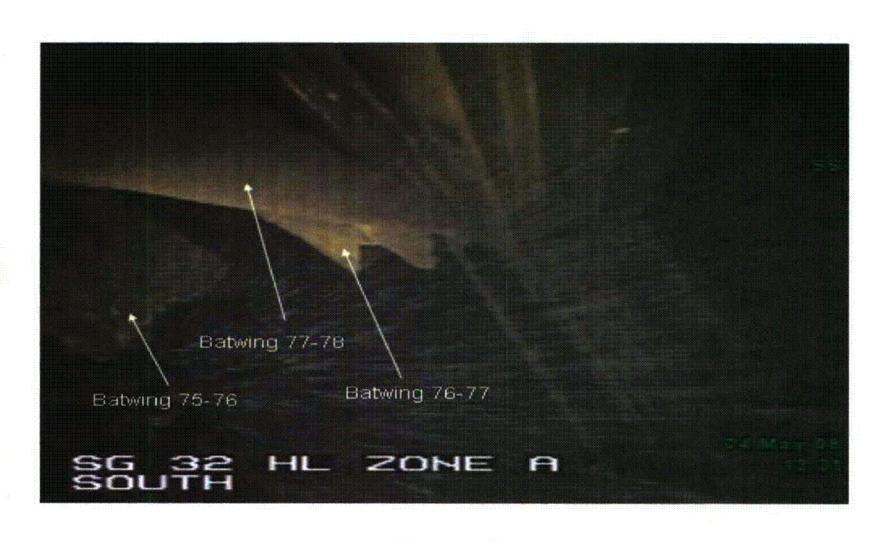
RF15 - View from above the horizontal batwing sections showing severed batwings

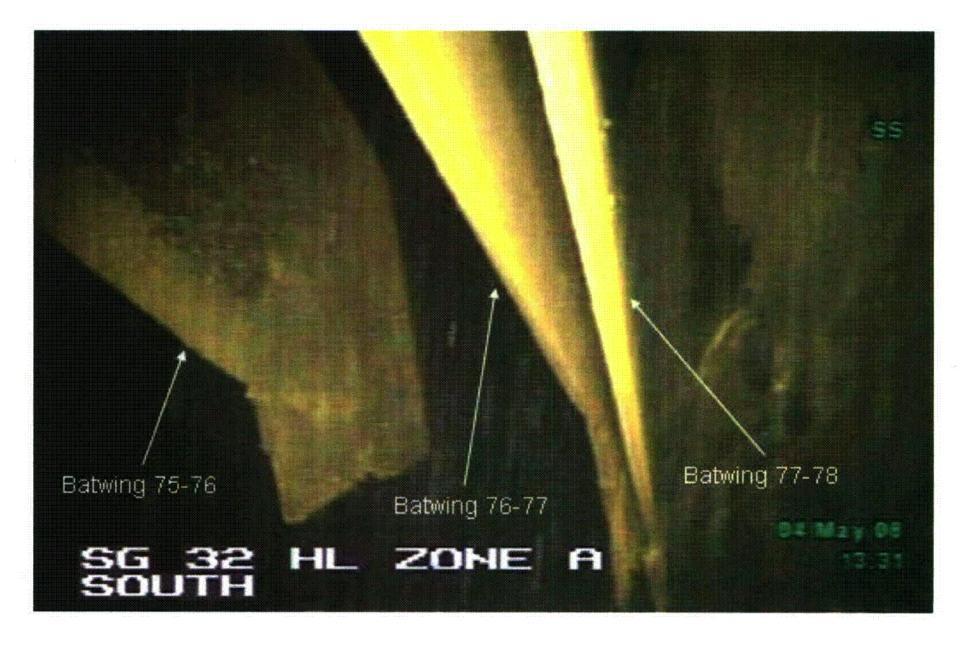
RF15 - Close-up View of severed batwings

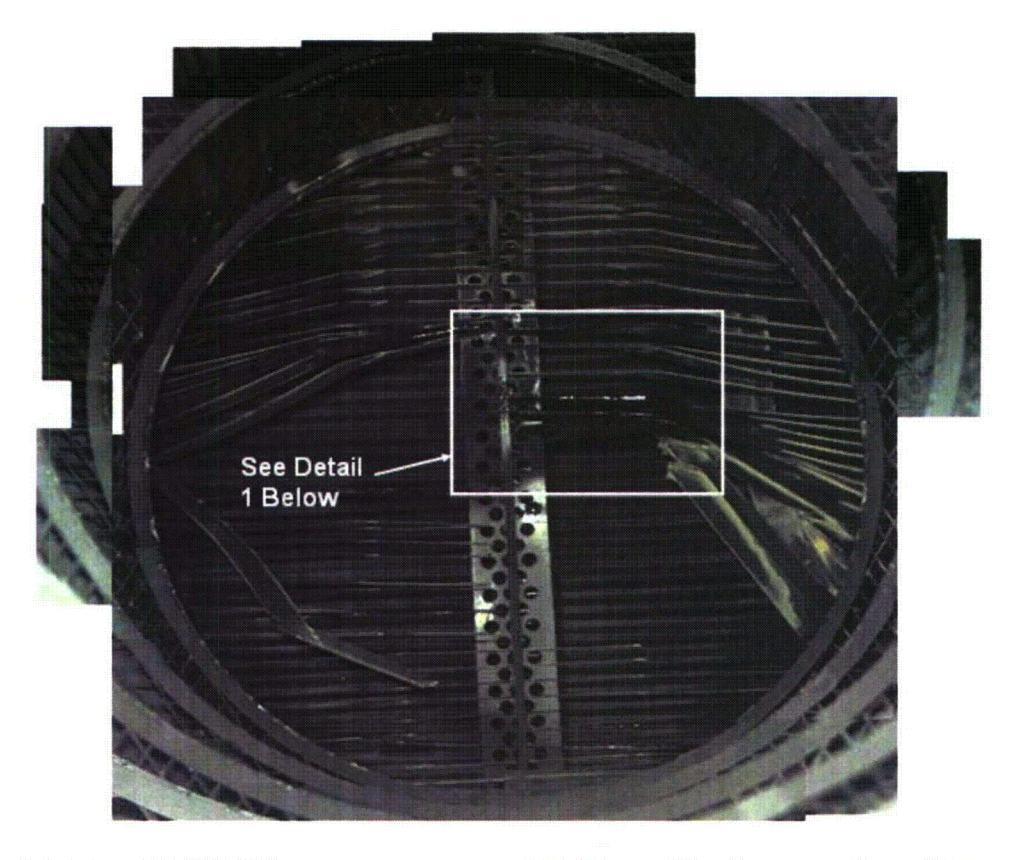
RF15 - SG32 Post Expansion Bottom-Up Inspection View

The photo below was obtained from video data taken after the tube expansions were performed in SG32 to secure the detached batwing between tube columns 84 and 85 on the cold leg side. Comparison of this picture with the RF15 Bottom-Up view shown in Attachment 2 confirms that the expansion process did not alter the batwing configuration.

Batwing 84/85 was repaired during Refuel 15 by hydraulically expanding five (5) adjacent tubes. Expanding the adjacent tubes will apply additional restraining force on the detached batwing which will secure it in its current position. Additionally, the tubes along the blowdown lane were stabilized and plugged to the first tie rod.
