SUBJECT: CERTIFICATION OF THE MINUTES OF THE ACRS SUBCOMMITTEE  
MEETING ON THE OYSTER CREEK GENERATING STATION LICENSE  
RENEWAL APPLICATION, JANUARY 18, 2007 - ROCKVILLE,  
MARYLAND

# Oyster Creek Generating Station License Renewal – ACRS Review

Reference  
Material from  
January 18,  
2007 ACRS  
Subcommittee  
Meeting

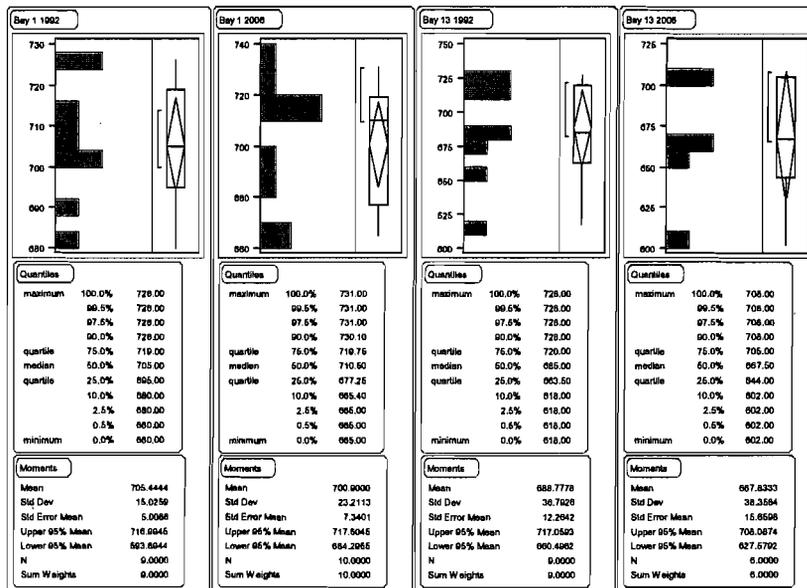
## 2006 External UT Results: Details

- Systematic measurement error in 1992 – unlikely, major concern if true
- External corrosion occurring despite the preventative measures taken – all coatings were visually inspected as satisfactory, would mean that corrosion could occur when coating is visually intact
- Internal corrosion – water inside the drywell identified as a normal operating condition in October 2006
- Cause of thinning is probably corrosion

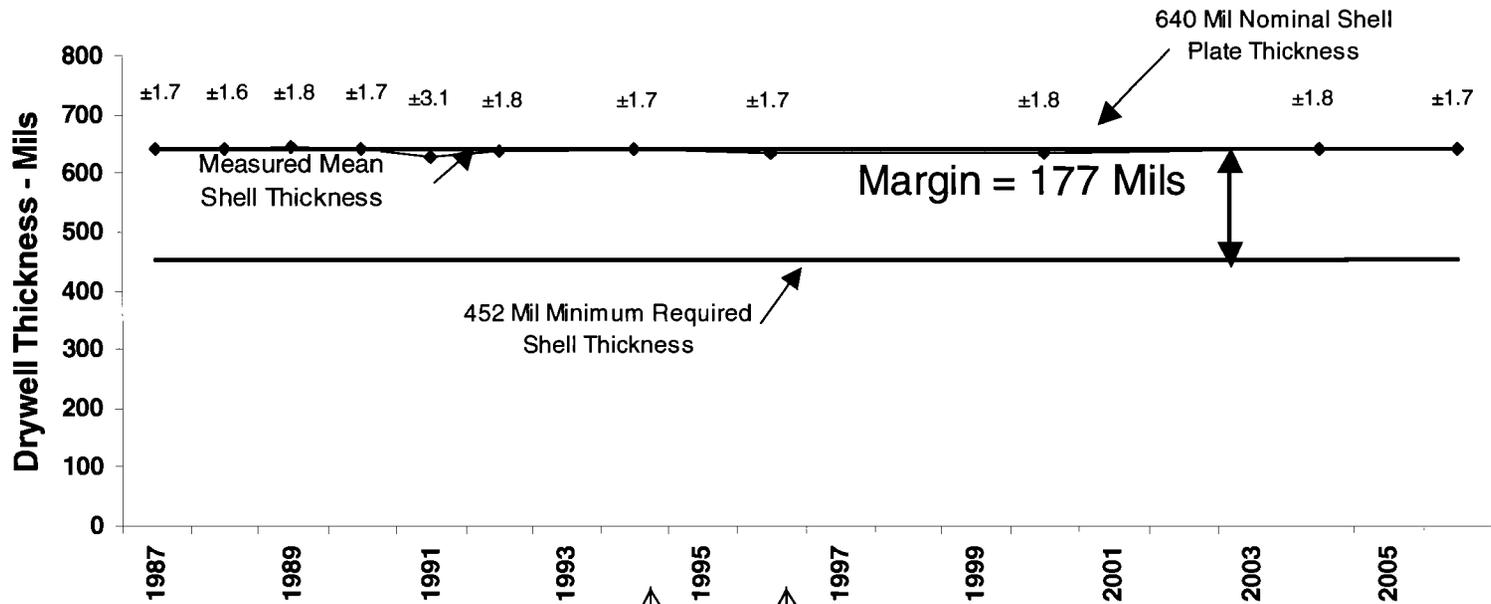
## 12. Upper Drywell Corrosion Trend and Margin

452 Mil Minimum Required Shell Thickness

Margin = 177 Mils
