SUBJECT: CERTIFICATION OF THE MINUTES OF THE MEETING OF THE
SUBCOMMITTEE ON PLANT LICENSE RENEWAL REGARDING
PILGRIM NUCLEAR POWER STATION ON APRIL 4, 2007, IN
ROCKVILLE, MARYLAND

SUBJECT: THE MINUTES OF THE MEETING OF THE SUBCOMMITTEE ON
PLANT LICENSE RENEWAL REGARDING PILGRIM NUCLEAR
POWER STATION ON APRIL 4, 2007, IN ROCKVILLE, MARYLAND

ACRS License Renewal Subcommittee Presentation

April 4, 2007

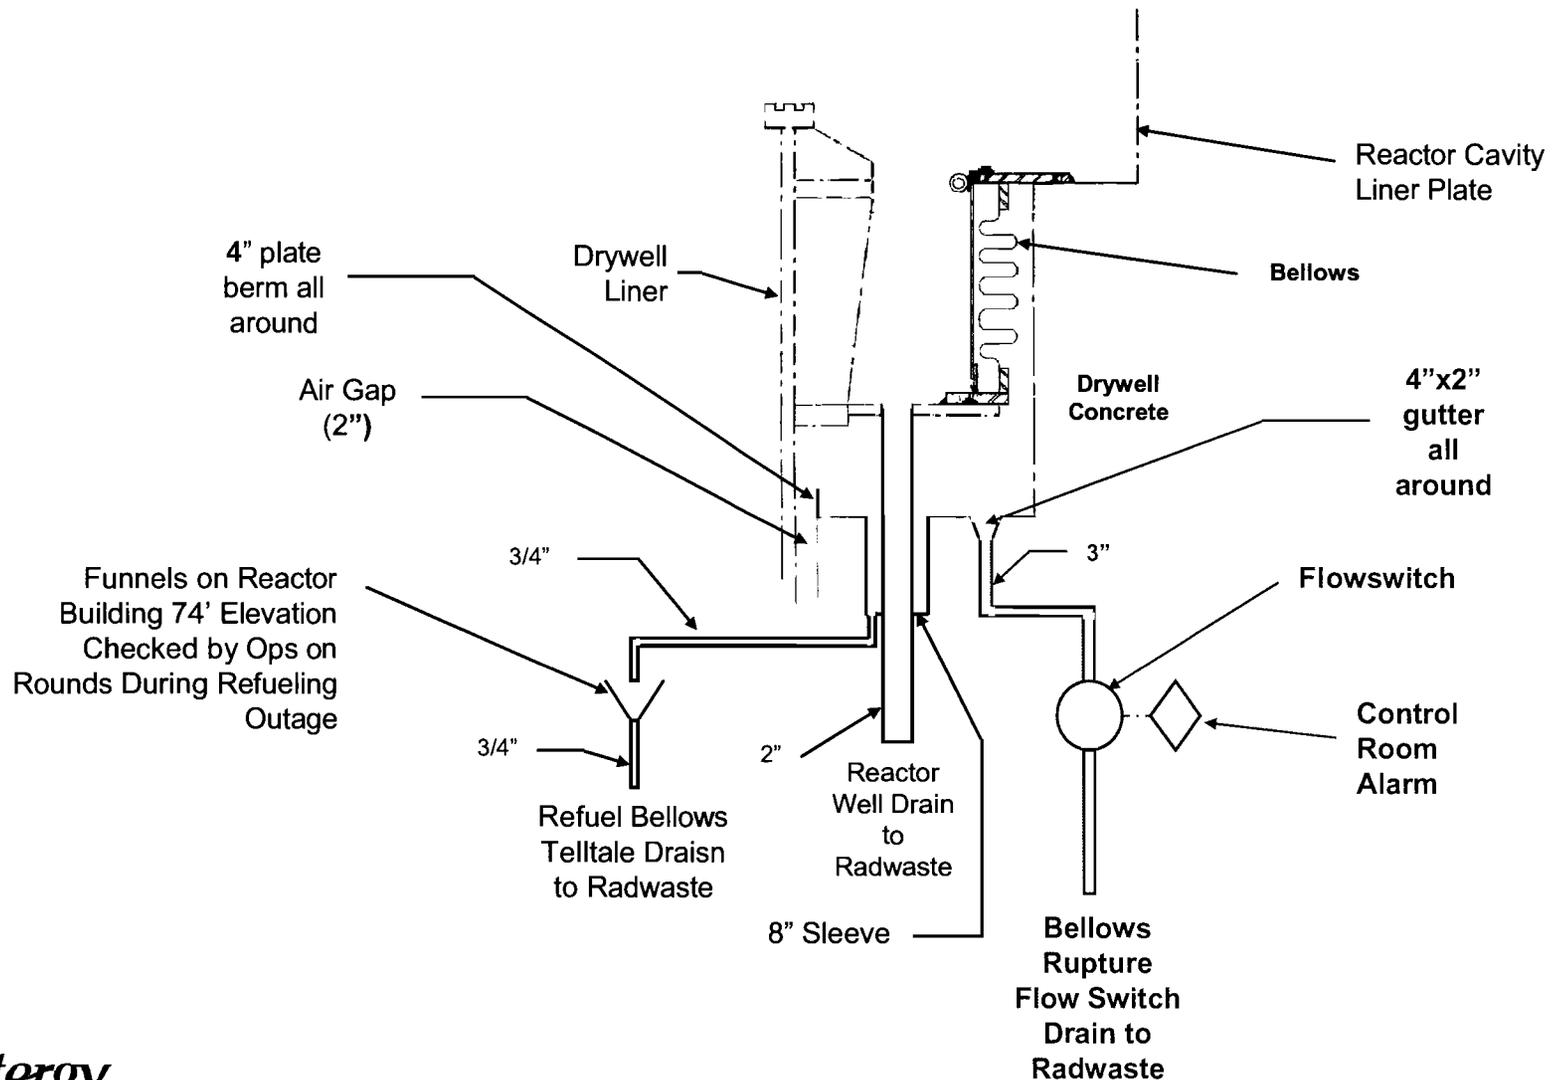
3" instrumented drain line alarms in control room

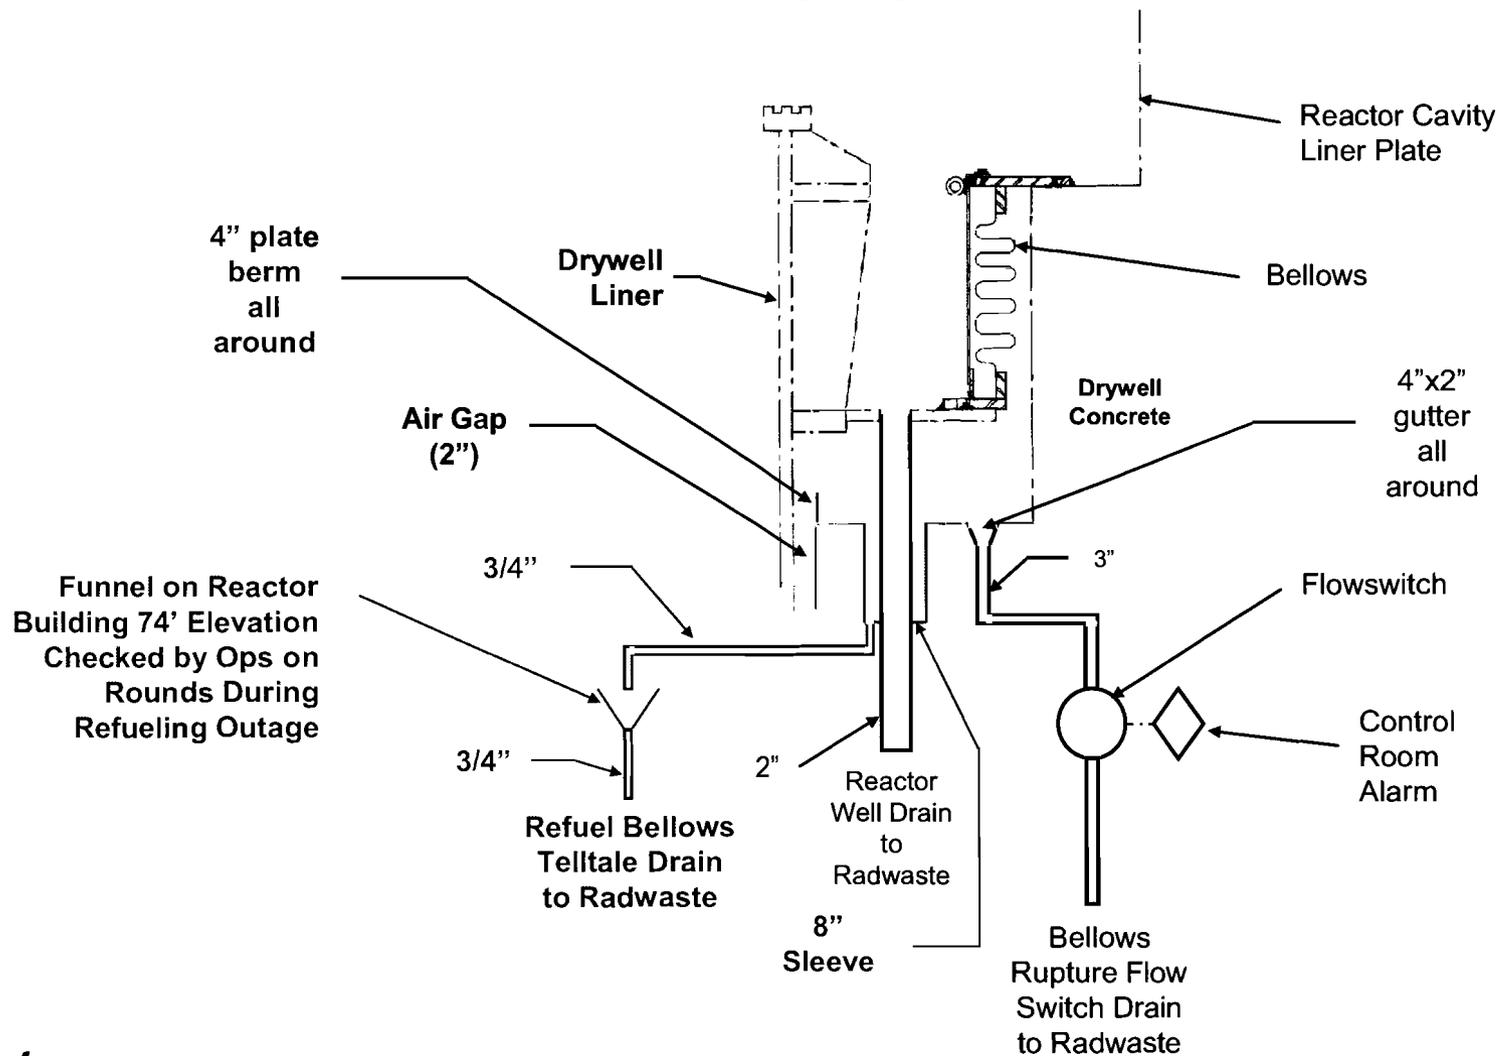
Four $\frac{3}{4}$ " drain lines which exit to 74' floor drains checked during operator tours

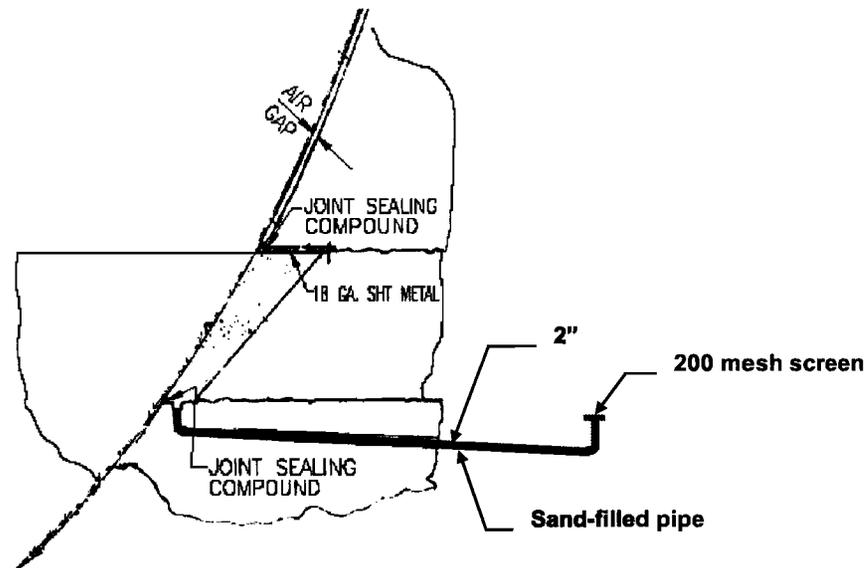
Four sand cushion drains provide further detection capabilities
