SSINS No.: 6835 Accession No.: 8011040265 IN 81-04 DUPLICATE

February 27,1981

IE Information Notice No. 81-04: CRACKING IN MAIN STEAM LINES

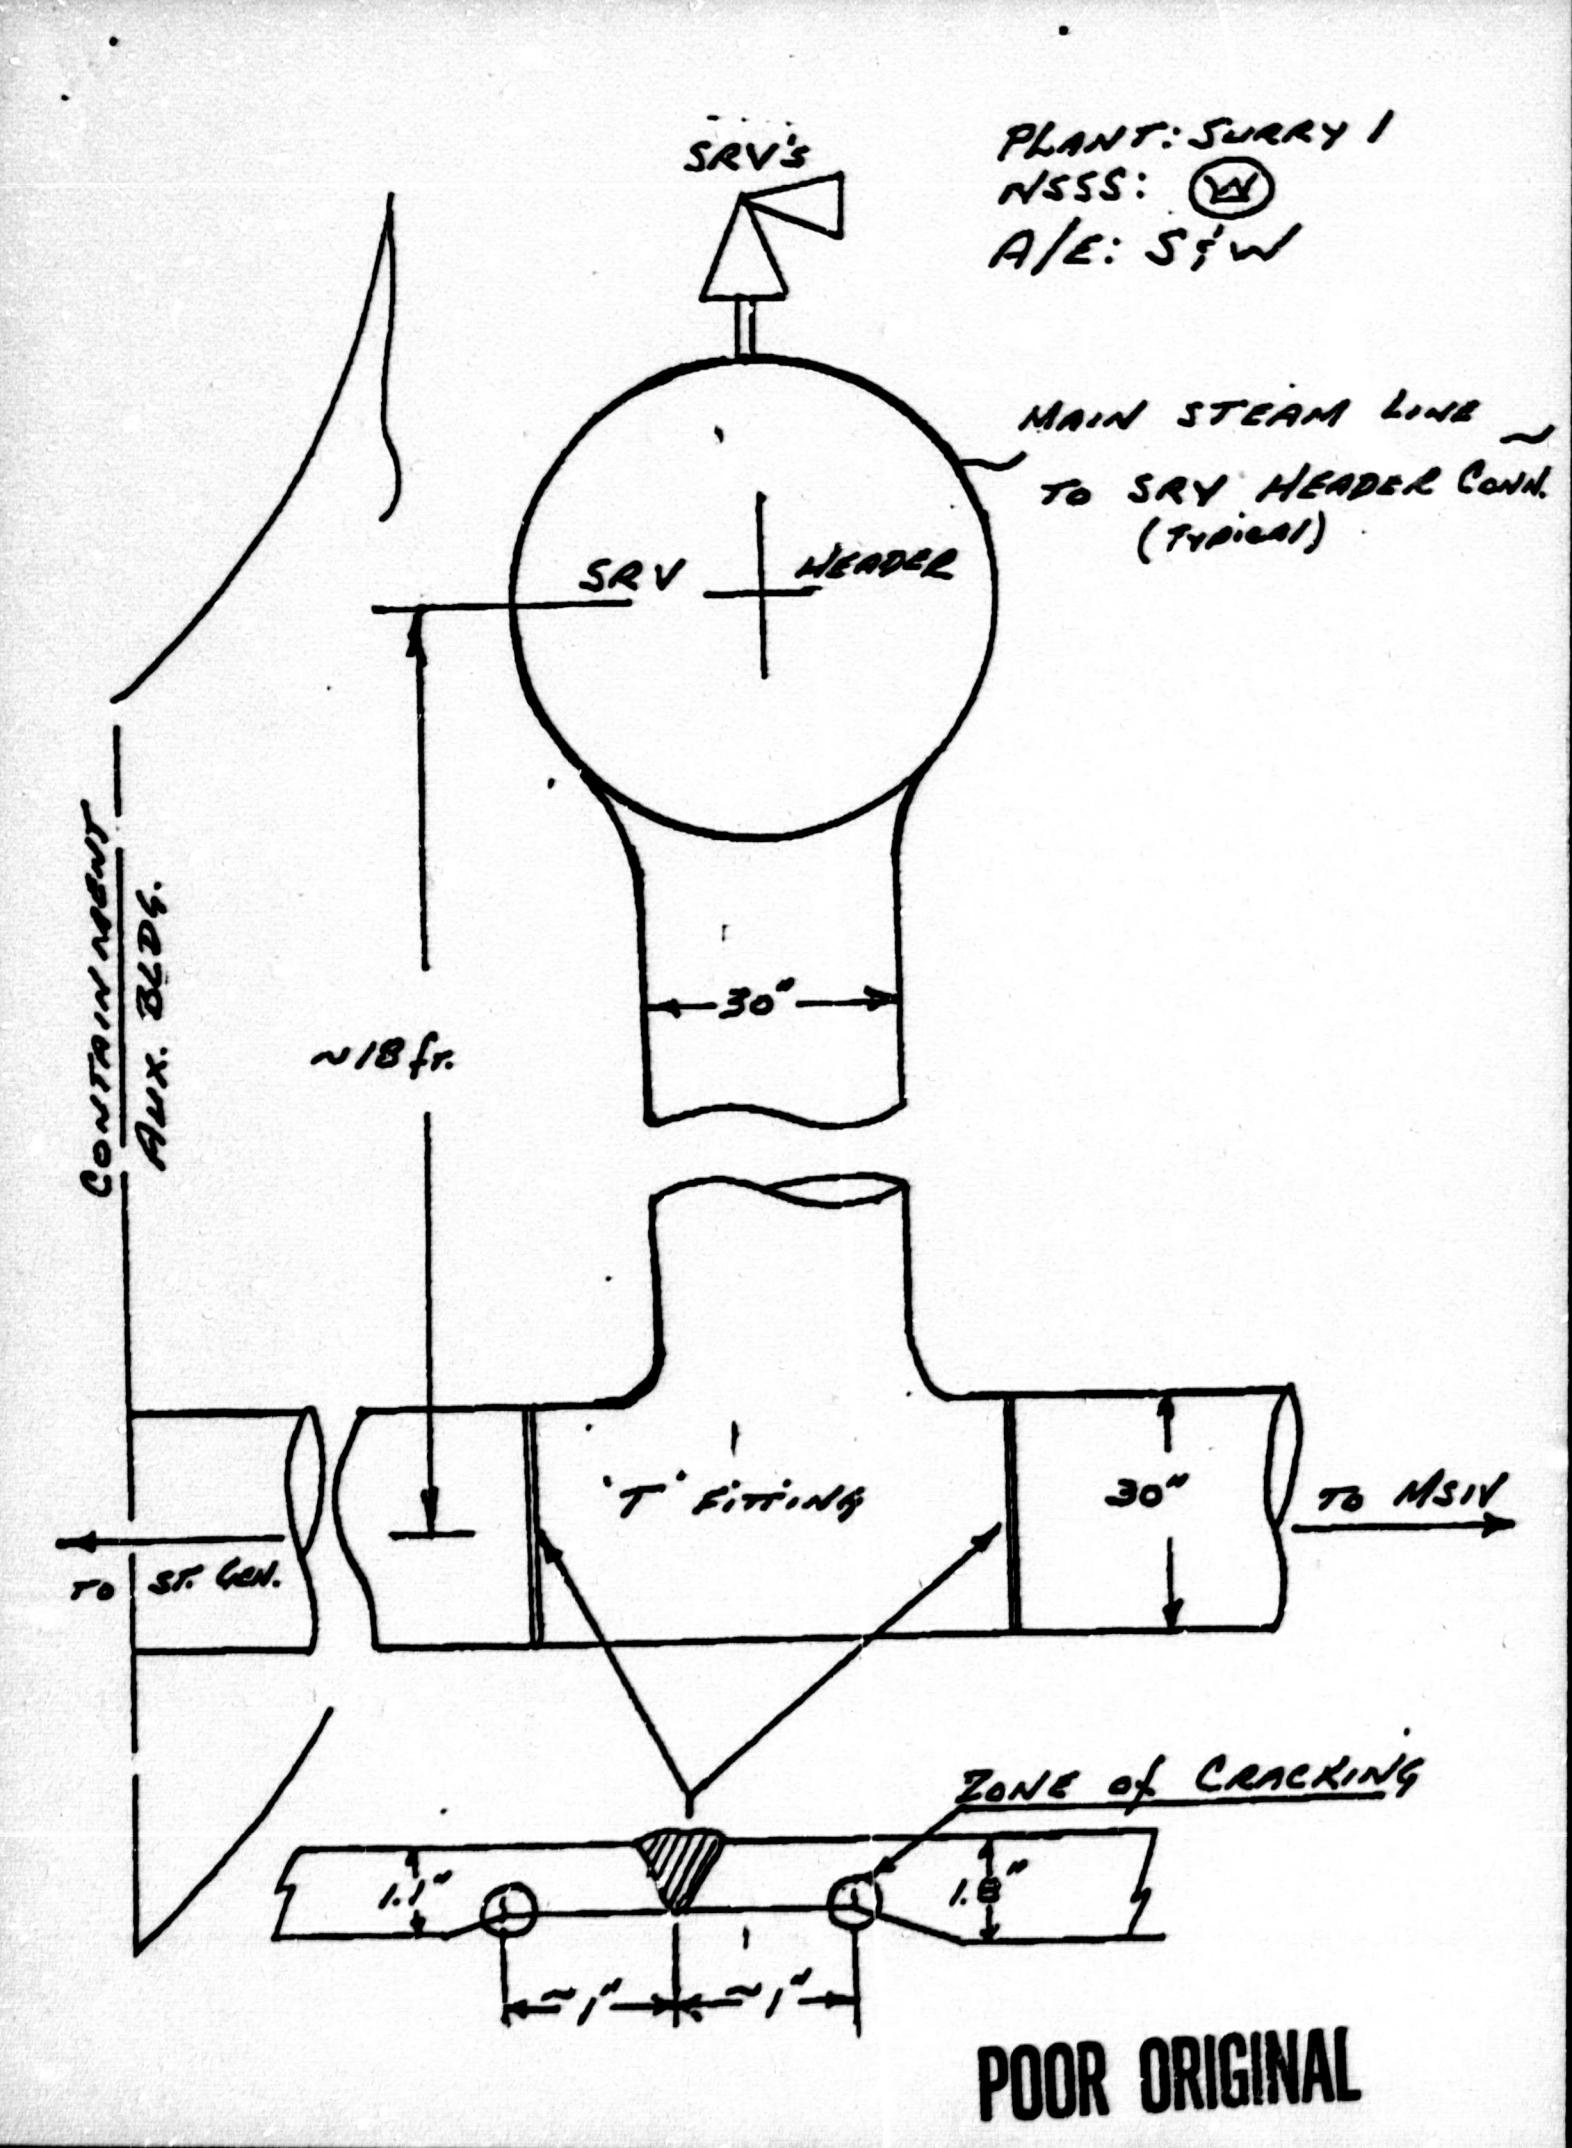
1. Sketch

The Virginia Electric Power Company promptly notified the NRC on February 23, 1981 that a radiography examination, during the ongoing steam generator replacement outage at Surry Unit 1, had revealed a lengthy crack indication in the I.D. counterbore area of a weldment on the in-line "T" fitting which connects the vertical run of 30-inch piping to the safety relief valve header and 30-inch main steam line of Steam Generator "A". This piping connection is located outside the containment penetration immediately upstream of the main steam isolation valve as shown in the attached sketch.

A visual and dye penetrant examination on the pipe I.D. surface of the weldment nearest the containment penetration established that the cracking extended about 120° around the fitting counterbore between the 4 o'clock to 8 o'clock position. Cracking was also observed in the weld counterbore at the opposite end of the T-fitting during visual examination of the piping interior. Radiographic examination of "B" and "C" main steam line T-fitting welds disclosed crack indications at similar locations.

Mctallurgical specimens of the cracking were trepanned from the T-fitting of the "A" main steam line for analysis. Controlled excavation and depth measurements of the crack at its mid-length indicated a crack depth of about 0.090" in this location. The cause of cracking has not yet been established.

This information is provided as an early notification of a significant safety matter that is still under review by the NRC staff. It is expected that recipients will review the information for possible applicability to their plants. For those plants having similar main steam line configurations which are currently in a refueling or extended repair outage, it is recommended that a ultrasonic and/or radiographic examination of the three welds and counterbore areas of the T-fittings be performed before resumption of operations, unless some current basis for assurance of piping integrity is available.
