SSINS No: 6830 Accession No.: 8011040282 IEC 81-05

# UNITED STATES NUCLEAR REGULATORY COMMISSION OFFICE OF INSPECTION AND ENFORCEMENT WASHINGTON, D.C. 20555

## IE Circular Nu. 81-05: SELF-ALLIHING ROD END BUSHINGS FOR PIPE SUPPORTS

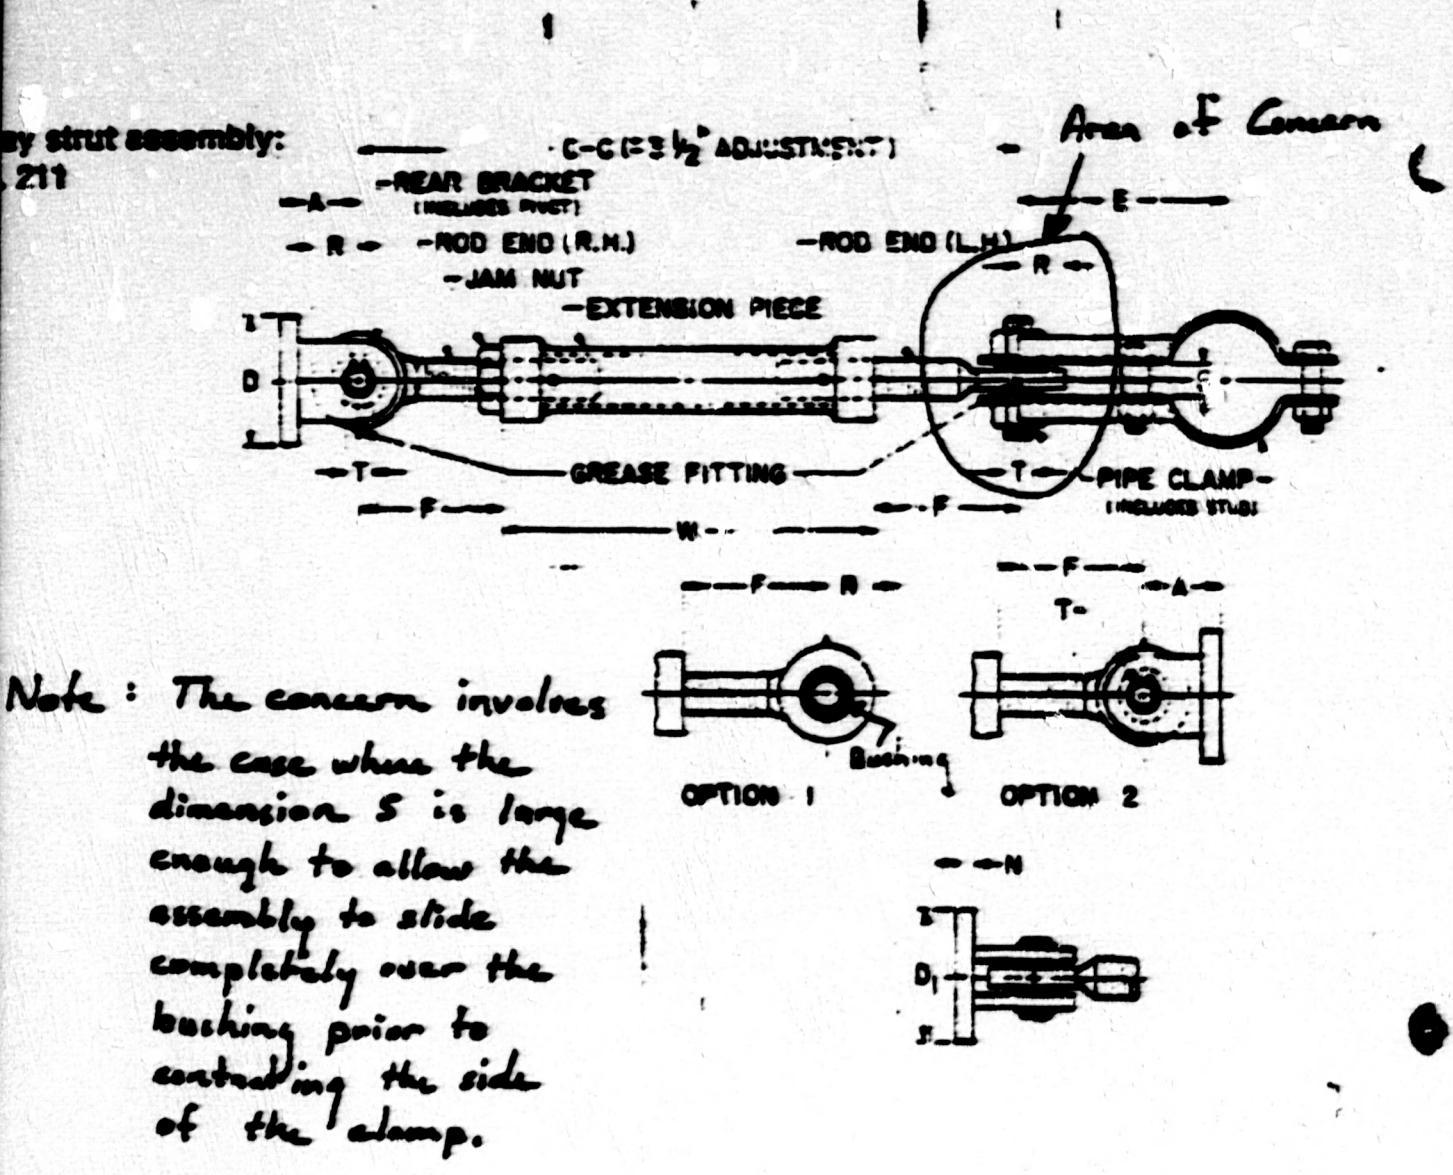
Attactment 1 March 31; 1981

The problem of loose bushings in snubler and sway strut assemblies is potentfally generic to all sizes of all manufacturers' assemblies. However, the potential for complete disengagement of the bushing from the assembly is limited to those cases in which the assembly is attached to a clamp where the gap is sufficiently large to permit the padule to slide completely over the bushing.

The consequences of complete disengagement of the bushing would be to invalidate the original analytical assumption; used in the piping analysis, potentially creating an overstress condition in the piping or overloading the supports. This would be more significant for the seismic event since the gap would change the dynamic characteristics of the system and lead to impact loads that could damage the piping or supports.

The corrective actions taken by licensees have been to replace the defective struts or to "stake" the loose bushing in place. However, sume of the staked bushings subsequently became loose and had to be reworked. Another potential corrective action would be to shim the clamps where the potential for complete disengagement of the assembly from the bushing is possible. This method would prevent total disengagement even if the bushing became loose. If shims are used, consideration should be given to preventing any interference with required rotation of the assembly.

- Determine whether your facility uses pipe strut or snubber assemblies using bushings that could potentially become loose.
- Identify from design drawings or field inspections those supports using the strut or snubber assemblies identified in item I above where sufficient gap exists in the clamp attachment for complete disengagement of the bushing and the assembly.
- 3. Inspect where practical the snubber or strut assemblies identified in item 2 above to determine if any bushings are loose or disengaged. If a large number of supports are involved in this inspection, a statistical sampling may be appropriate to determine if your facility has a problem with loose or disengaged bushings.
- 4. If loose or disengaged bushings are found at your facility, take appropriate corrective actions to ensure that complete disengagement of the assembly from the bushing cannot occur.
