Estimating Loss-of-Coolant Accident (LOCA) Frequencies Through the Elicitation Process

NUREG-1829
Vol. 2

PIPING BASE CASE RESULTS OF BENGT LYDELL

**An Application of the Parametric Attribute-
Influence Methodology to Determine Loss of
Coolant Accident (LOCA) Frequency Distributions**

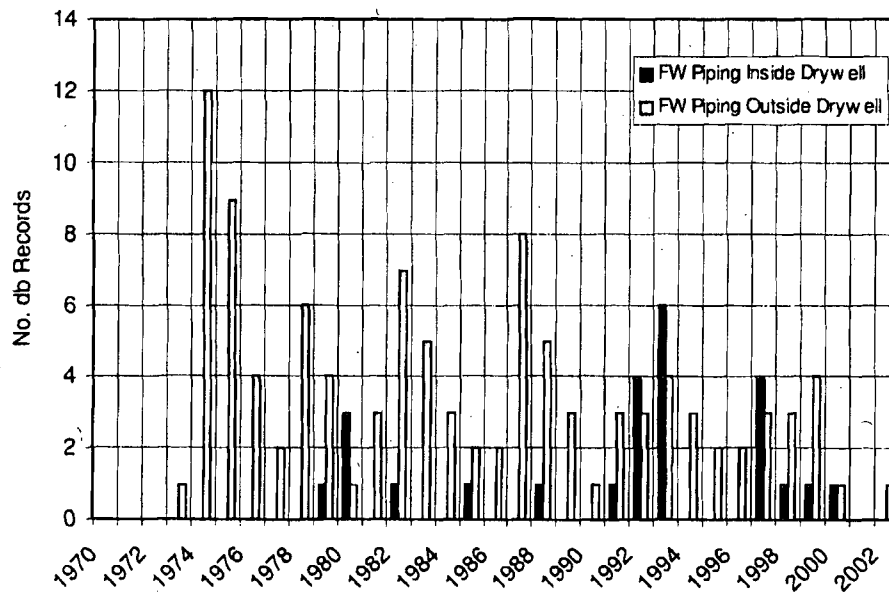
Figure D.9 Service Experience with FW Piping (i)

D.3.2.2 FW Piping Service Experience - Figures D.9 and D.10 summarize the service experience with FW piping. With respect to plant designed by General Electric, the Code Class 1 portion of BWR carbon steel feedwater piping has performed well in the field. There are no reported leaks in medium-or large-diameter RCPB piping. Foreign plants have experienced (and in some cases, continue to experience) thermal fatigue damage due to thermal mixing and stratification. In fact, 80% of the degradation of the RCPB portions of FW piping has occurred in foreign plants with a piping system design that differs from that of U.S. BWR plants.

The U.S. service experience includes a few instances of non-through wall cracking of FW nozzle-to-safe-end (bimetallic) welds. The root cause of the cracking is attributed to weld defects from original construction. As documented in Information Notice 92-35 [D.19], Susquehanna Unit 1 has experienced flow-accelerated corrosion damage about 250 mm (10 inches) from a weld connecting NPS12 piping to a 20-inch by 12-inch reducing tee. There have been no reported flaws in any U.S. plant beyond T = 15 years of operation.
