# WATTS BAR NUCLEAR PLANT (WBN) – DAM SAFETY INSPECTION RESULTS AND FUTURE SCHEDULING

### Watts Bar Nuclear Plant Dam Safety Inspection Report

#### Dam Safety Inspection Report - Class A Watts Bar Hydro Plant Special, Nuclear Yard Drainage Holding Pond

Date of Inspection: 05/28/04

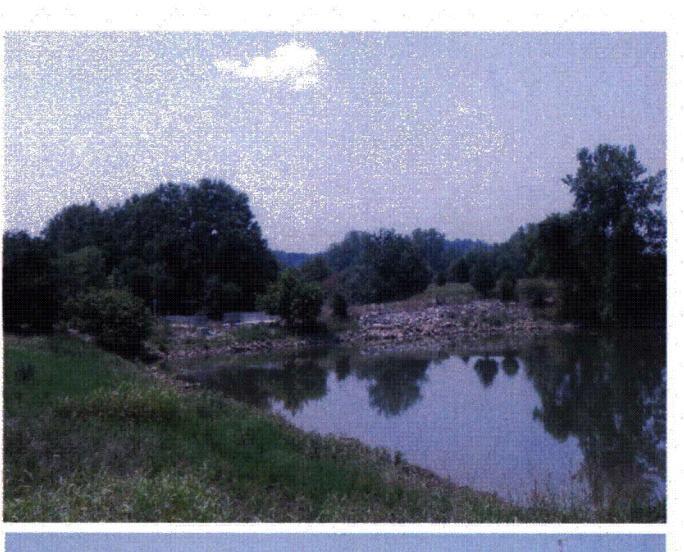
Figure 4:

View of upstream side of dam with the concrete spillway. Note numerous trees that will need to be removed.

- PM Remove the trees located on the upstream and downstream side of the small embankment dam and spillway. Include all trees within 20' of the toe and groin areas. Responsible Organization: Facilities Maintenance, Darrel Reed Estimated Cost: \$4,000.00 Estimated Completion Date: 3/30/09
- PM Fill the small hole that is undermining the left side of the spillway slab just downstream from the crest of the dam with small 1/2" washed stone.
  Responsible Organization: Facilities Maintenance, Darrel Reed
  Estimated Cost: \$500.00
  Estimated Completion Date: 3/30/09

The embankment dam is in satisfactory condition. Numerous trees will require removal per Dam Safety requirements. See Exhibit 1 for recommendations.

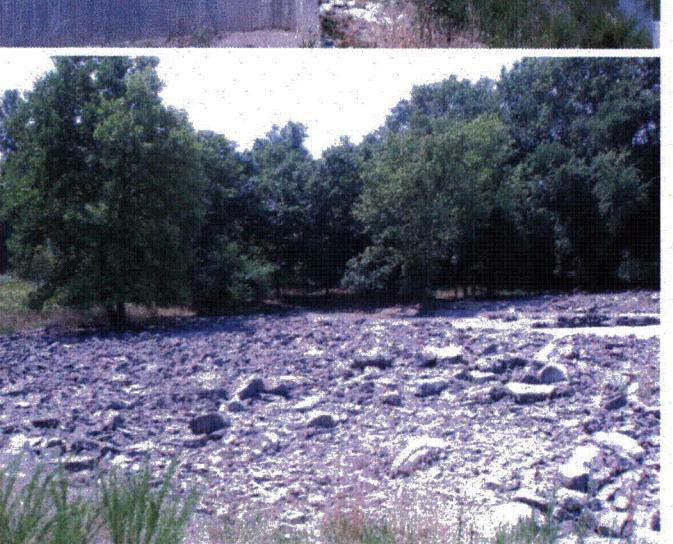
Figure 6:

View of downstream slope of dam, with concrete spillway slab. Note trees located along the toe which will require removal.

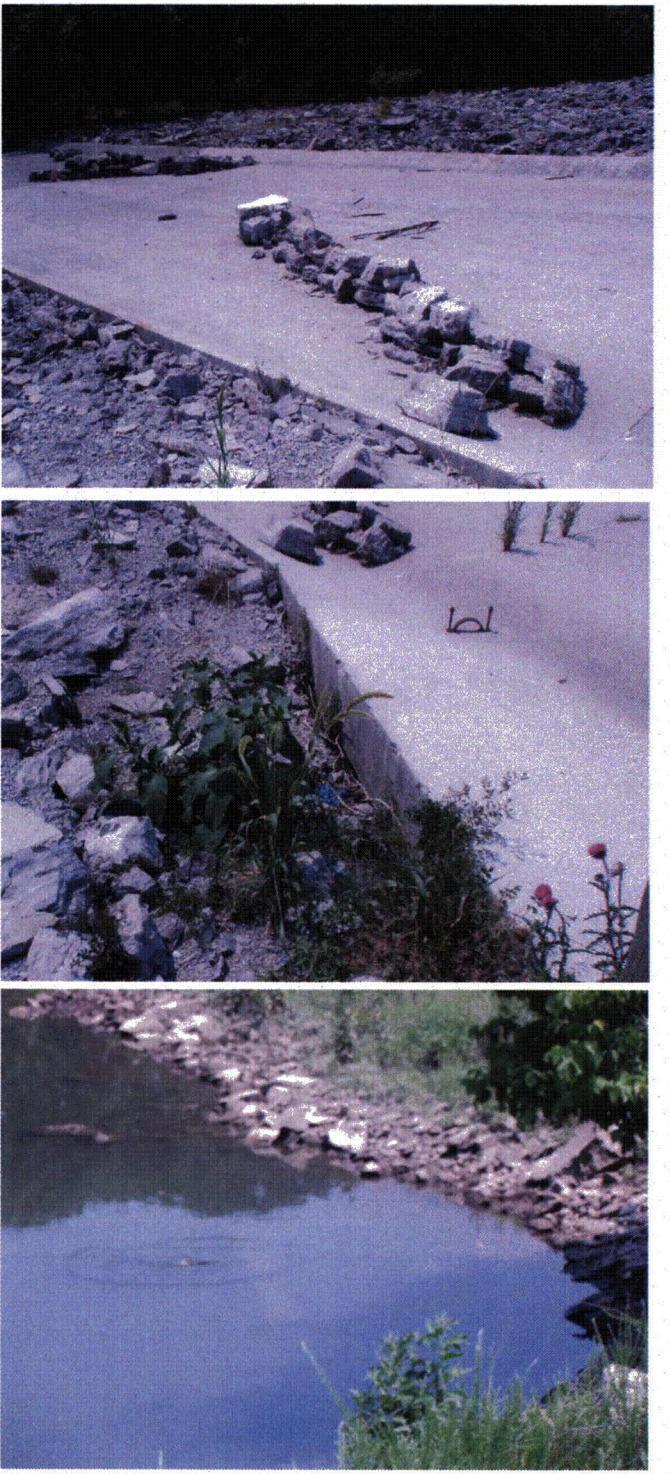
The spillway section is in satisfactory condition. A small undermined area is located on the left side of the spillway slab, which allows water to flow underneath the slab. This hole should be filled with small 1/2" stone. See Exhibit 1 for recommendations.

Figure 8: View of a small hole that has undermined the concrete spillway slab.
