The MacArthur Maze Fire: How Hot Was It? - 9223

Christopher S. Bajwa, Earl. P. Easton, and Darrell S. Dunn U.S. Nuclear Regulatory Commission Washington, DC 20555

ABSTRACT

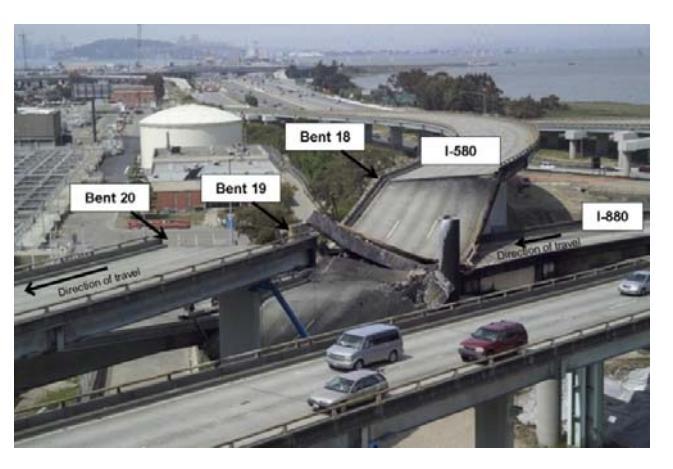
The fire, fueled by the gasoline from the tanker, heated the steel girders to temperatures where the steel strength was reduced and was insufficient to support the weight of the elevated roadway. The I-580 overpass collapsed about 17 minutes after the fire started, based on surveillance video taken from a water treatment plant adjacent to the highway interchange. The main portion of the fire spread along a section of the I-880 roadway. Some of the gasoline went through the scupper drain on I-880 and burned on the ground around the support pillar. An aerial photograph of the area with the accident site identified is shown in Figure 1 [1]. A photograph of the scene after the fire was extinguished is shown in Figure 2^1 [2].

Fig. 2. Postfire aerial view of the collapsed section of I-580 looking west. Picture from Caltrans http://www.dot.ca.gov/dist4/photography/images/070429

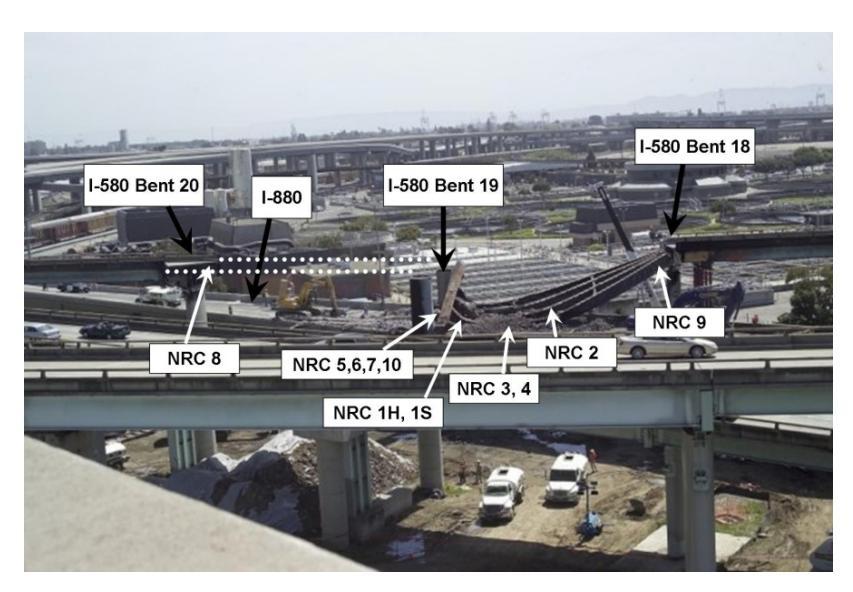
Samples from the plate girders were obtained from the structures near Bents 18 through 20. Samples obtained near the connection to Bent 20 showed some signs of fire damage to the latex paint. The underlayer of red-colored lead-containing paint was mostly intact but had evidence of blistering from the thermal exposure. For plate girders near Bent 18, damage to the latex paint was variable. On the outermost I-580 girder located the greatest distance from the I-880 road bed, the latex paint was mostly intact retaining its original gray color.

Between Bent 18 and Bent 19, the plate girders from I-580 were in contact with the I-880 roadway. Significant beam distortion is apparent as a consequence of heating, the resultant weakening of the steel structure, and the load of the concrete structure. No paint was noted on these beam sections. Based on this observation, it was determined that the plate girder section designated as Plate Girder 5 in Figure 4, and shown in detail in Figure 5, was originally located between Bent 18 and Bent 19 where the I-580 overpass was in contact with the I-880 road bed. Originally, the plate girder was approximately 122 cm [48 in] high. As shown in Figure 5, the end of Plate Girder 5, that was believed to be closest to Bent 19, buckled as the result of a loss of strength at elevated temperature and the subsequent impact with the I-880 road bed.

Fig. 3. View of damage during demolition looking southwest. Bent 18, 19, and 20 and approximate locations of collected specimens are indicated. Dotted lines represent pre-accident overpass structure that was demolished and removed prior to this photograph. Original picture from Caltrans website http://www.dot.ca.gov/dist4/photography/images/070430/index2.html

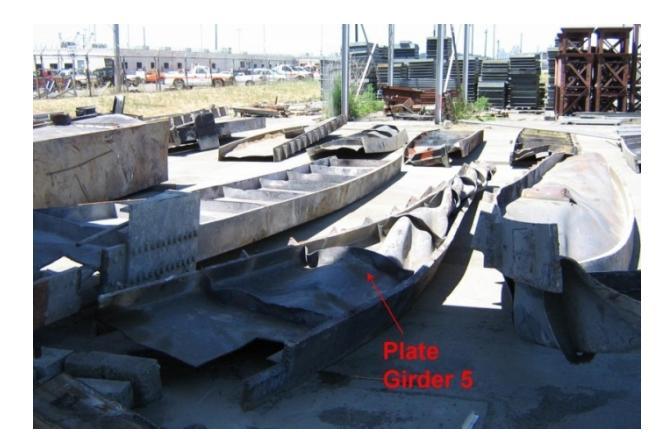
Fig. 4. Girders at the Caltrans storage yard.

The damage to the paint on the steel girders may also indicate the temperature [7]. Photographs taken during demolition and the condition of the girders observed in the Caltrans storage yard clearly indicate that the paint was destroyed on girders closest to the fire. For the thermally exposed samples described in this paper, discoloration and significant damage of the paint was observed after the exposure at 550° C [1,022°F]. After exposure, the paint appeared to be a yellow-green color. At 700° C [1,292°F], the paint was completely destroyed. At higher temperatures, the specimen was covered with a dark gray oxide layer.

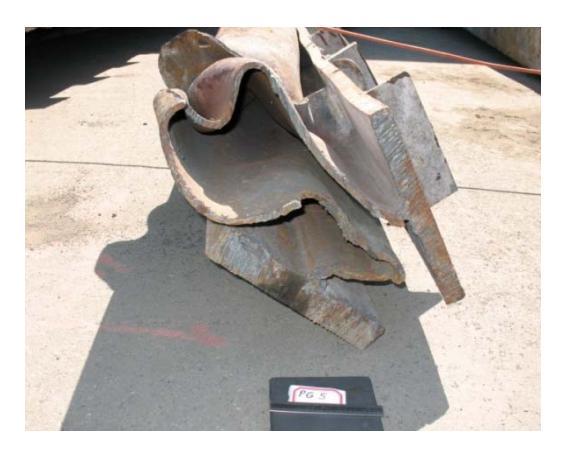
Fig. 5. Photograph of Plate Girder 5 believed to be between Bent 18 and Bent 19.

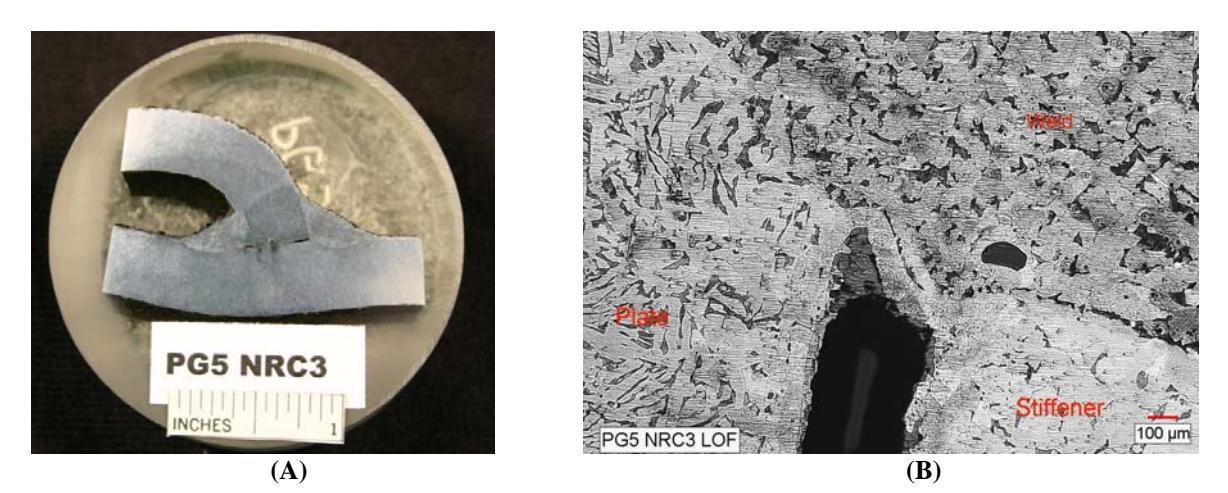
Figure 6 (A) shows a specimen from Sample NRC 3 after mounting, polishing, and etching. The distortion of the plate and the stiffener are obvious, given that the plate and stiffener were originally perpendicular to each other. Figure 6 (B) shows the microstructures of the plate girder, the stiffener, and the weld. As expected, the plate and the stiffener consist of ferrite and pearlite. The welds are also ferrite and pearlite and contain no indication of a dendritic structure that would have been present immediately after welding.

A specimen from Sample NRC 4 is shown in Figure 7. The microstructure of the weld, plate, and stiffener consists of ferrite and pearlite. Similar to Sample NRC 3, the weld on Sample NRC 4 shows no signs of any dendritic structure that was likely to be present after welding. The stiffener welds in both Samples NRC 3 and NRC 4 are fully transformed and practically indistinguishable from the plate.

Fig. 6. Metallurgical specimen from Sample NRC 3 after mounting, polishing, and etching (A). Microstructure of stiffener fillet weld, plate girder, and stiffener (B).
