FAQ Number 07-0035

FAQ Title Bus Duct Counting Guidance for High Energy Arcing Faults

Plant: Harris

Date: January 21, 2009

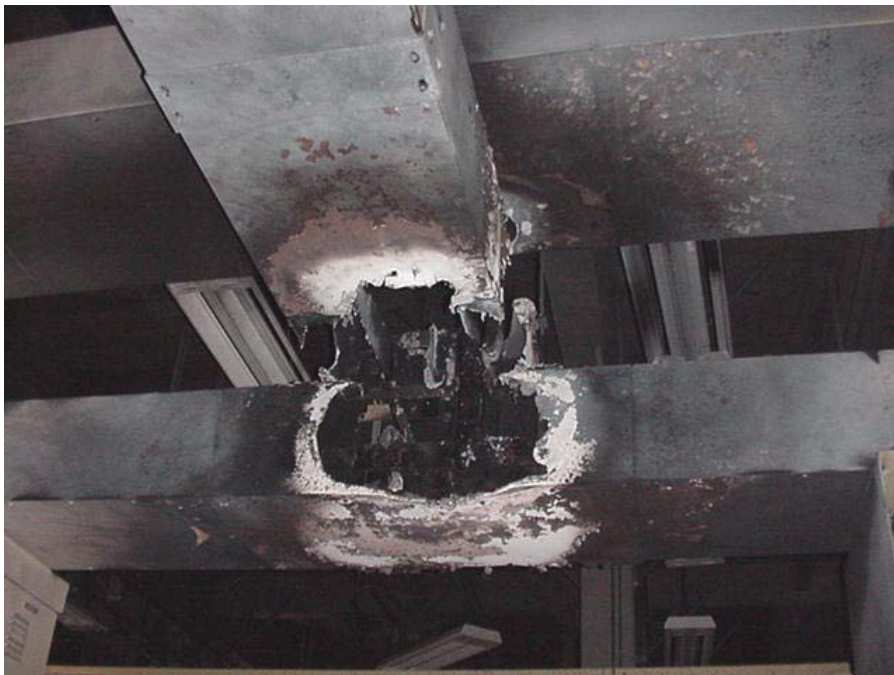
For reference, one well documented event considered prototypical of a bus duct fire occurred at Diablo Canyon on May 15, 2000². Figures 1 and 2 provide photographs taken after this event (as provided in the cited inspection report - see footnote). Note the damage visible to the face panels on cabinets located below and to the side of the fault point. The photos show clear evidence (soot traces) that the surface-mounted components (e.g., the dial indicators, labels, switches, etc.) ignited and burned. Individual points of charring on the panel face are taken as indicative of impinging molten metal droplets. The exterior surfaces of cabinets on both sides of the access walkway directly below the primary faulting point were damaged. The fire did not extend to the interior of these cabinets. Surface damage occurred on cabinets on both sides of the aisle-way directly below the fault point, and extended to three adjacent panels on each side of the aisle.

Figure 1: Photograph of the point on the bus duct where the arcing fault at Diablo Canyon was manifested (the fault point). Note that the tops of the cabinets to the left and right (the cabinets to the left are shown in figure 2) are visible in the lower corners of this photograph.

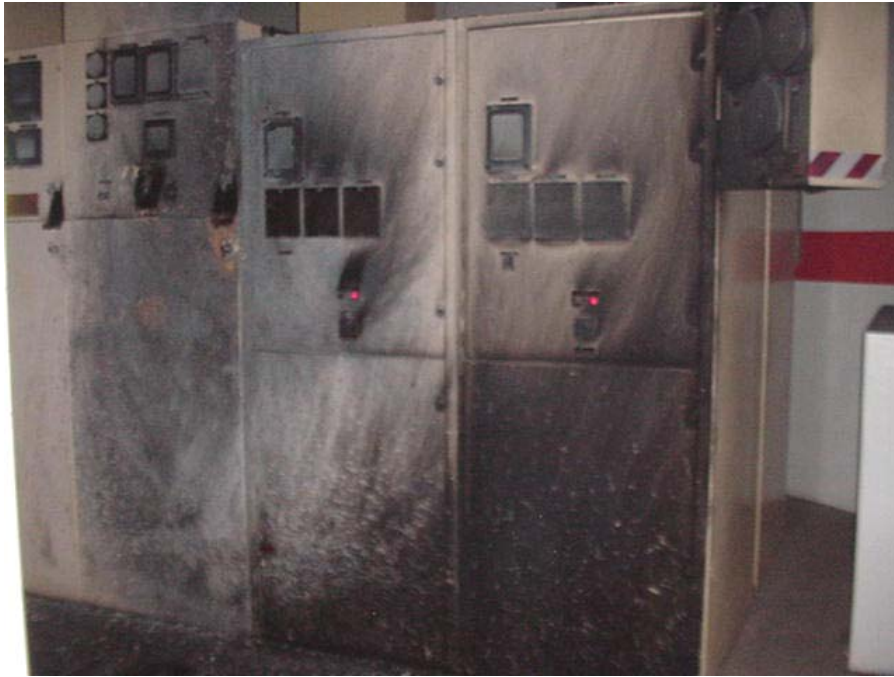
Figure 2: Photograph of the surface damage and burning observed for the more heavily impacted cabinets on one side of the aisle-way below the fault point (the cabinets to the left as seen in Figure 1).
