May 11, 2009

US Nuclear Regulatory Commission  
Document Control Desk  
Washington, DC 20555-001

RE: Reply to a Notice of Violation; EA-09-069  
License No. 15-27070-01

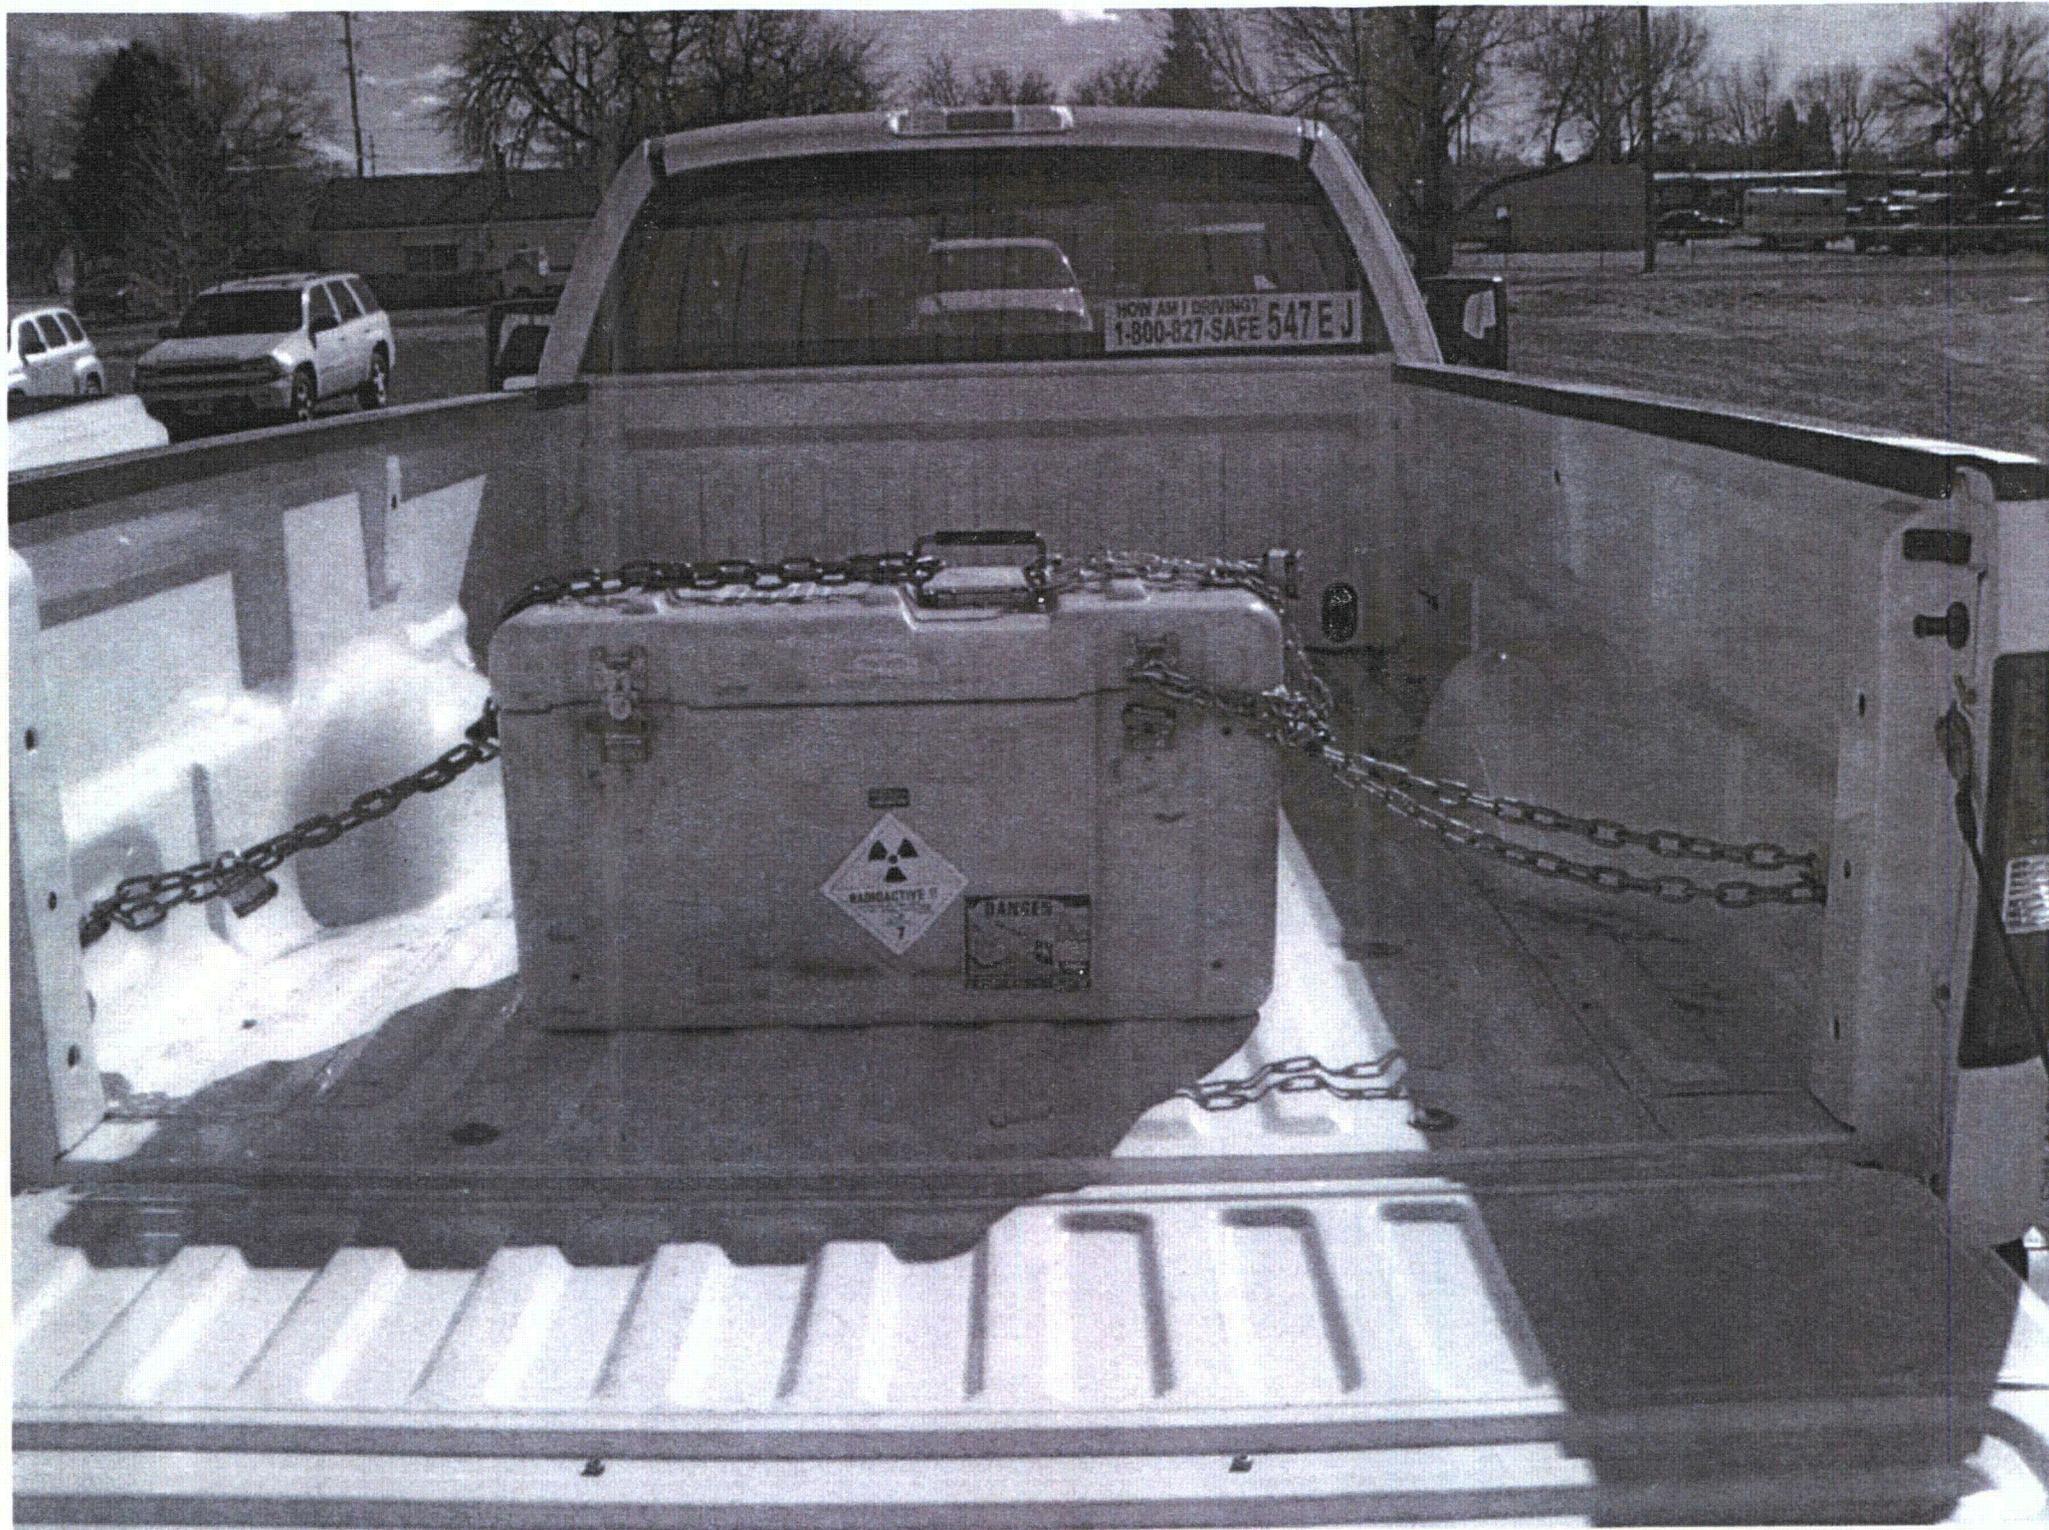
Unfortunately, the inspector found storage of the gauge observed on our project site storage location in violation of the "dual security" rule. Although the gauge case was secured to the vehicle with two separate chains and padlocks...there was only one lock keeping the gauge itself from being stolen. We'll be cited for "escalated enforcement" based on this finding. To correct this in advance...We need to make sure that we are securing gauges such that there are always TWO independent barriers against theft. That means we either have a padlock on each hasp thru a length of suitably strong

chain securing the gauge to the vehicle...or...we have the gauge case LOCKED, and have two chains and independent locks fished thru both side handles and across the top of the gauge case. These should be just short enough to go from one side of the pickup bed to the other so that someone can't open the gauge case with the chains in place over the top of the case. Here are some pictures with acceptable DUAL SECURITY chains in place to prevent theft of the gauge and case. If you have two locking hasps on your gauge case, a padlock and chain thru each the vehicle structure will serve. Your cooperation in re-instruction your technicians on the requirements of the dual security rule will be greatly appreciated.
