AERIAL PHOTOGRAPHIC MONITORING, FLORIDA POWER CORPORATION, CRYSTAL RIVER POWER PLANT SALT DRIFT STUDY

FINAL REPORT 1993 AERIAL PHOTOGRAPHY

March 8, 1994

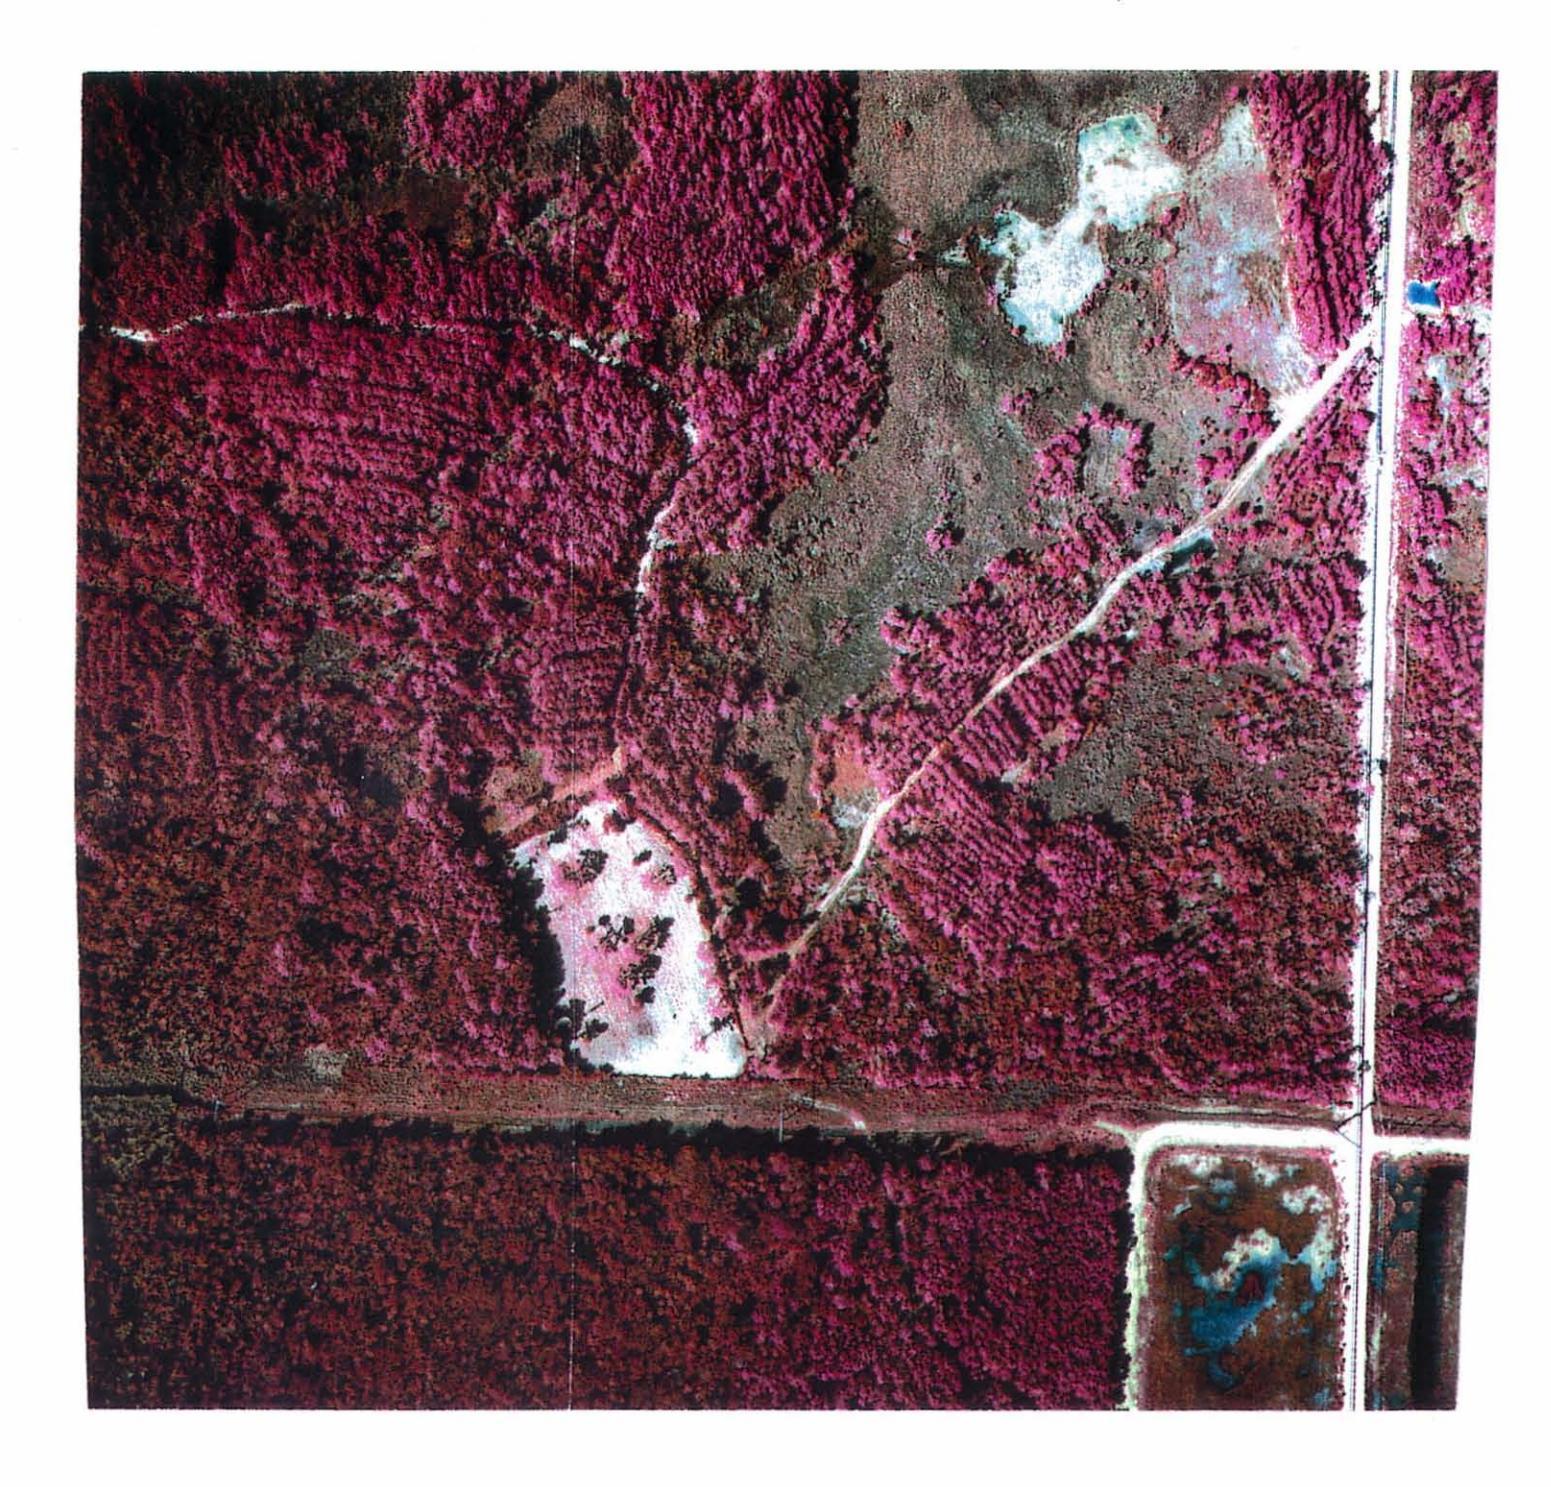
Figure 2: Aerial Photograph of Forested and Herbaceous Communities in the Vicinity of the Northwest Open Test Site (3) and Northwest Open Pine (8) Sites, Fall 1993.

Figures 2 and 3 represent coverage of forested areas located west and northwest of the cooling towers; these areas have been of particular interest during the monitoring program due to the modeled pattern of salt drift from those towers. A mixture of upland and wetland hardwood forest, intermixed with stands of slash pine (*Pinus elliottii*), occur in this general area. Figure 2

demonstrates a generally closed, healthy canopy throughout the area, with only occasional "snags" (dead trees) or stressed foliage. These conditions are comparable to observations in the previous monitoring years. The western portion of this area which transitions into the coastal brackish marshes does, however, show evidence of stress to several canopy species; this pattern has been documented at other locations west and south of the power plant.

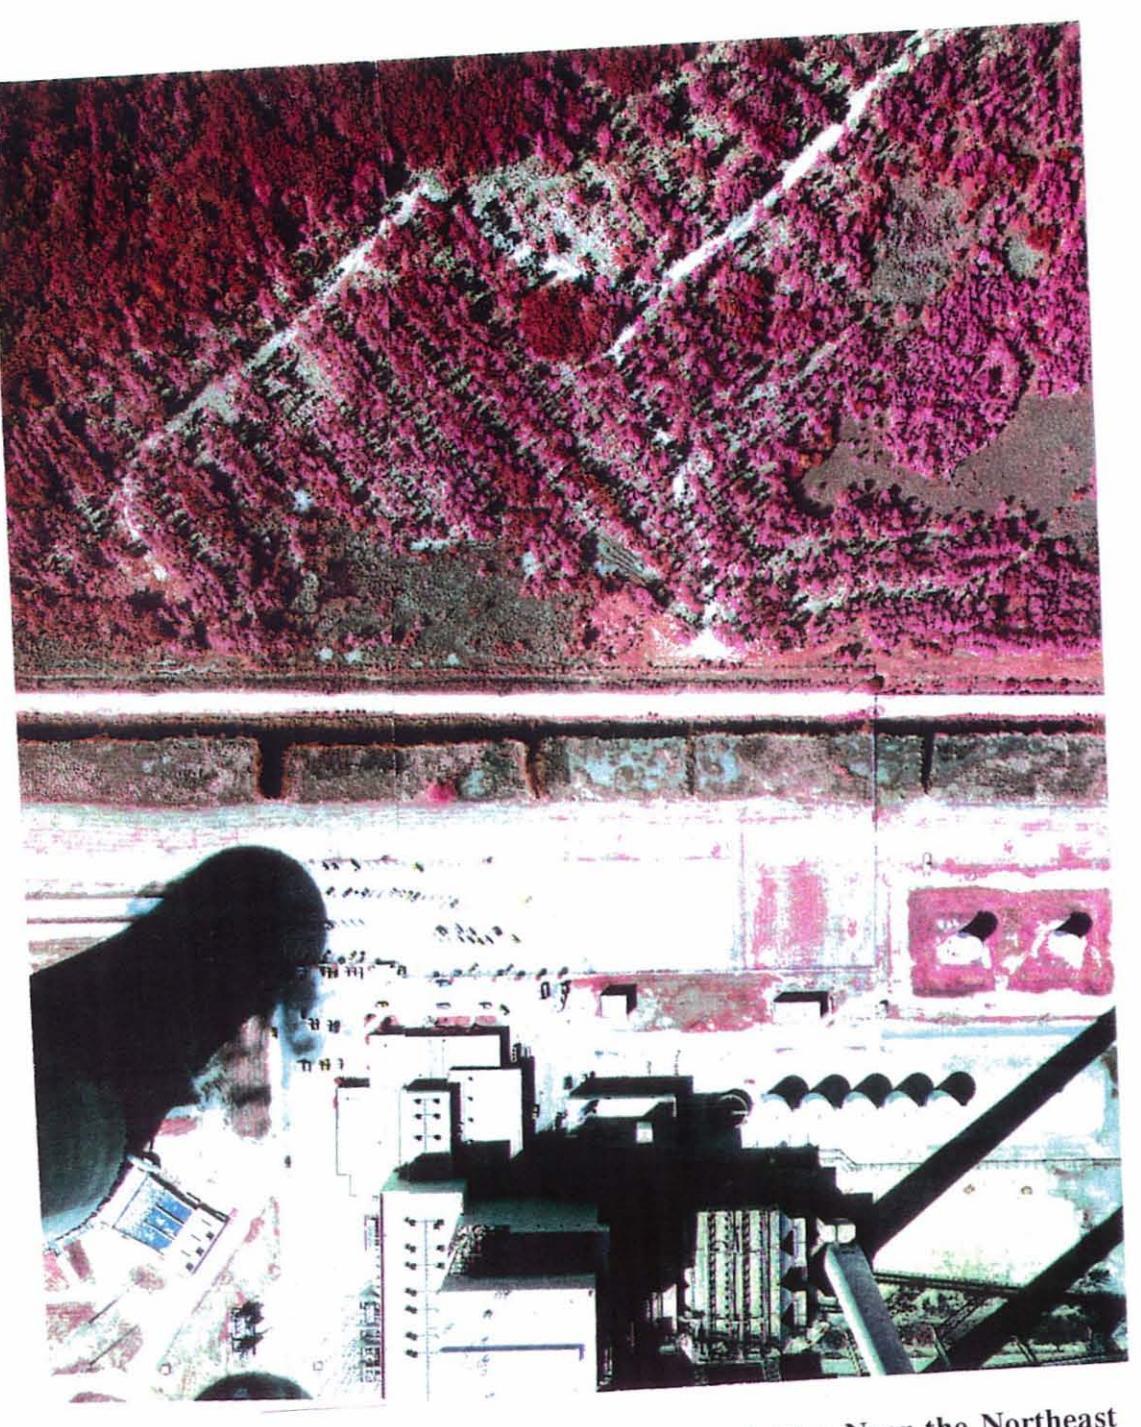
Figure 4:

Figures 4 and 5 demonstrate the current conditions immediately north of the fossil-fuel plant. Selective timbering of pine (little or no clear-cutting) has occurred in this area. Otherwise, conditions are generally typical of the forested and herbaceous communities observed in previous years. It is possible that a slight increase in stress or mortality of the pines, may occur following the timbering, due to their sensitivity to disturbance. The timbering disturbance may also provide an opportunity for some temporary invasion of opportunist herbaceous or shrubby species which may be reflected in slight differences of color signature in the future growing seasons. This is considered a normal vegetative response.

Aerial Photograph Demonstrating Timbering Activities Near the Northeast Open Test Site (5) North of the Plant Facility.

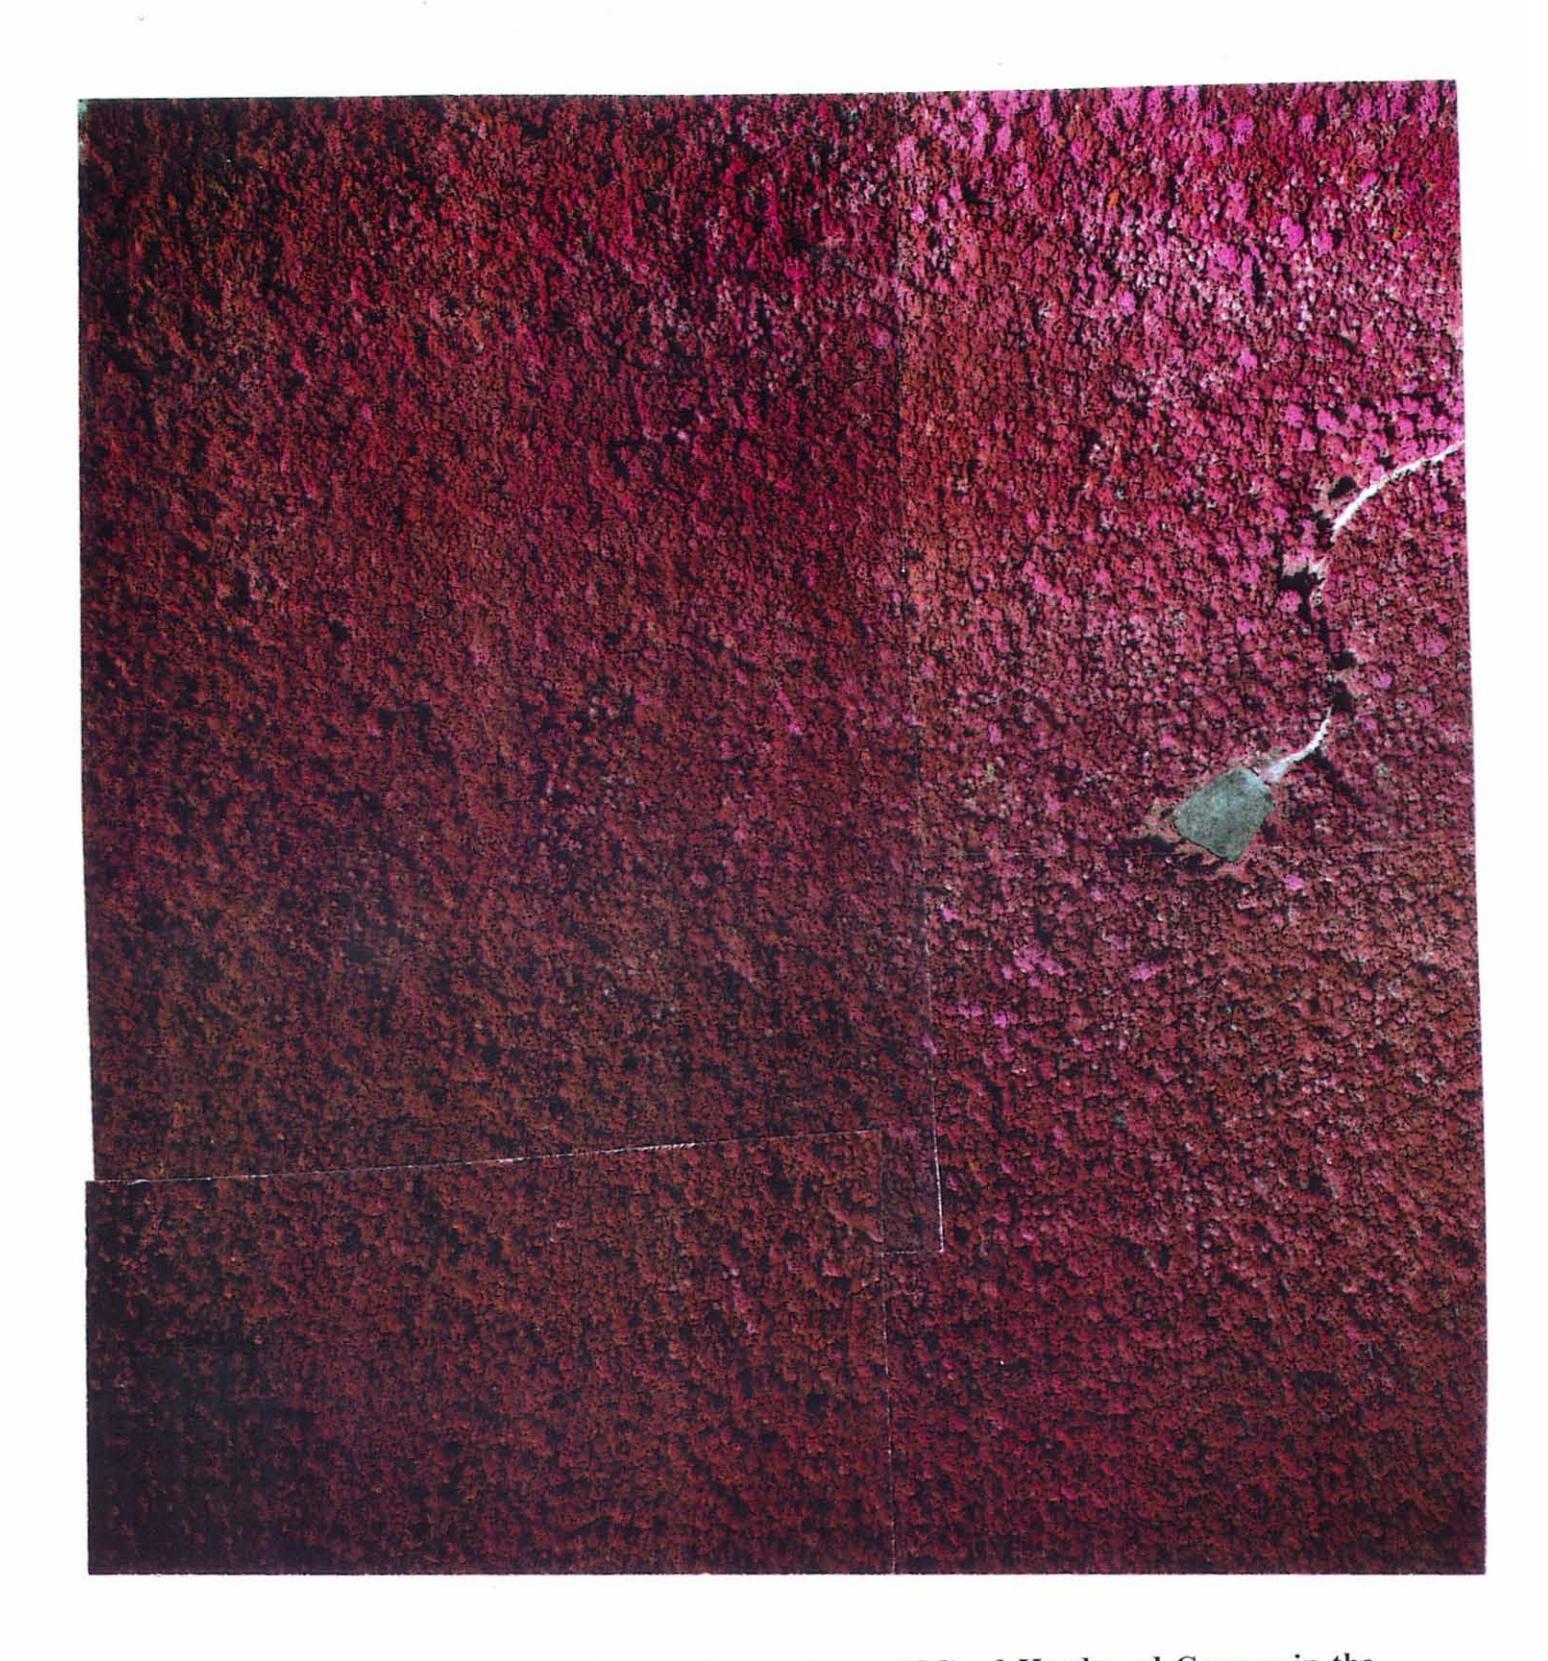
Figure 6: Aerial Photograph Showing Large Area of Mixed Hardwood Canopy in the Vicinity of the Control (6) and Open Hardwood Control (12) Sites.

Figure 6 shows a large area of mixed hardwood forest located to the southeast of the power plant. This community transitions southward into the brackish marsh system, and eastward into mixed pine and hardwood forest. Depressional forested wetland areas intergrade with the upland communities. This system has continued to appear healthy during the last several years of observation. The aerial signatures reveal scattered dead or stressed canopy, most of which have been previously observed in the low-altitude aerials. Inspection of the understory vegetation along the western edge of this system near the Control Site (Figures 7A and 7B), indicate the probable occurrence of stress or mortality to some ground cover or subcanopy species (such as ironwood (*Carpinus caroliniana*)) which may have resulted from the March storm event which produced high winds and back-flooding.

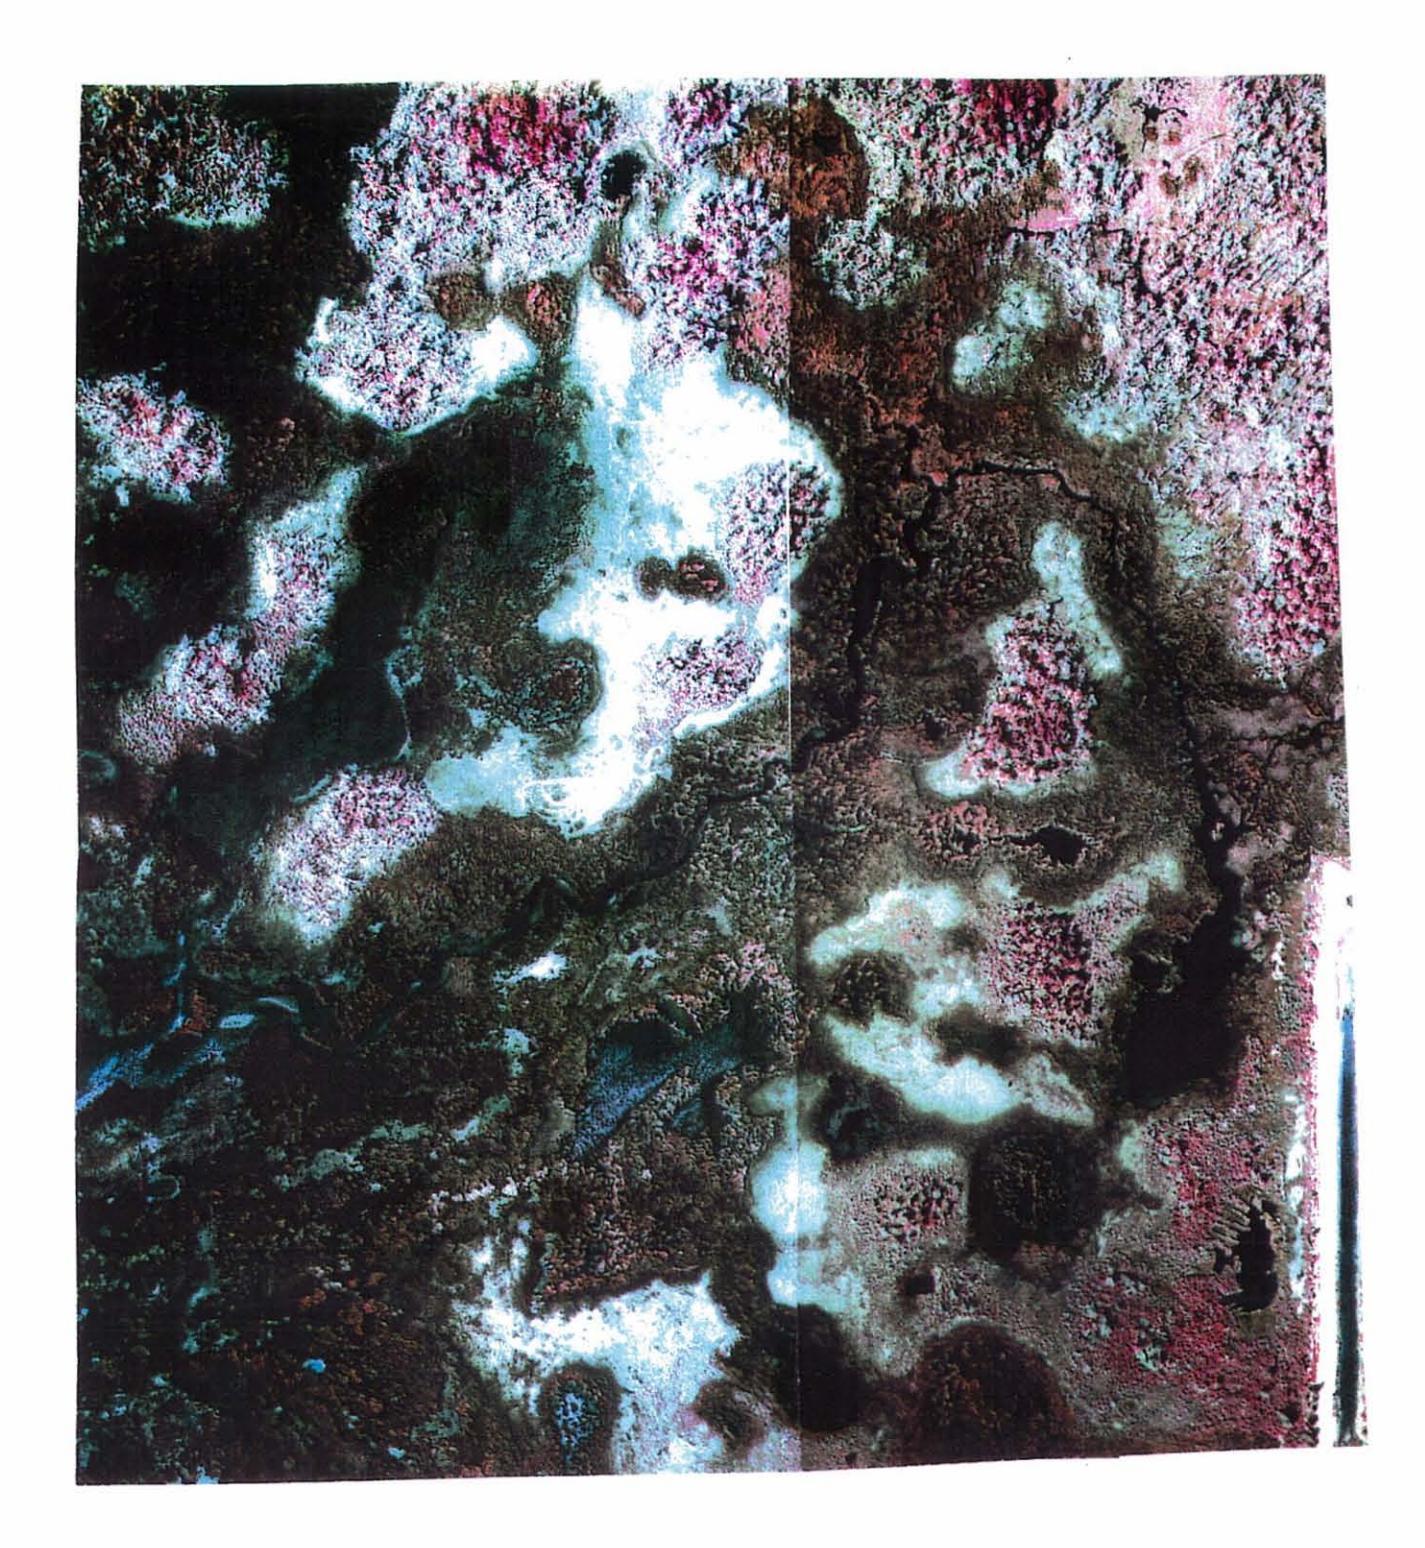
Figure 8: Brackish Marsh Transition Area West of the Southwest Open Hammock Site (7), Fall 1993.

Aerial coverage of the forested and brackish marsh areas in the vicinity of the Southwest Open Hammock Site (Figures 8 and 9) have consistently shown the pattern of change in the vegetative conditions, particularly several woody species. Moderately heavy stress and mortality has occurred in cabbage palm (*Sabal palmetto*), southern red cedar (*Juniperus silicicola*) and live oak (*Quercus virginiana*); however, observations during the current monitoring year indicate evidence of some regrowth of the southern red cedar. Many of the island hammocks within the marsh show this pattern of stress (Figure 9A), and relatively high densities of dead or heavily stressed trees extend eastward into portions of the forested community (Figure 9B).

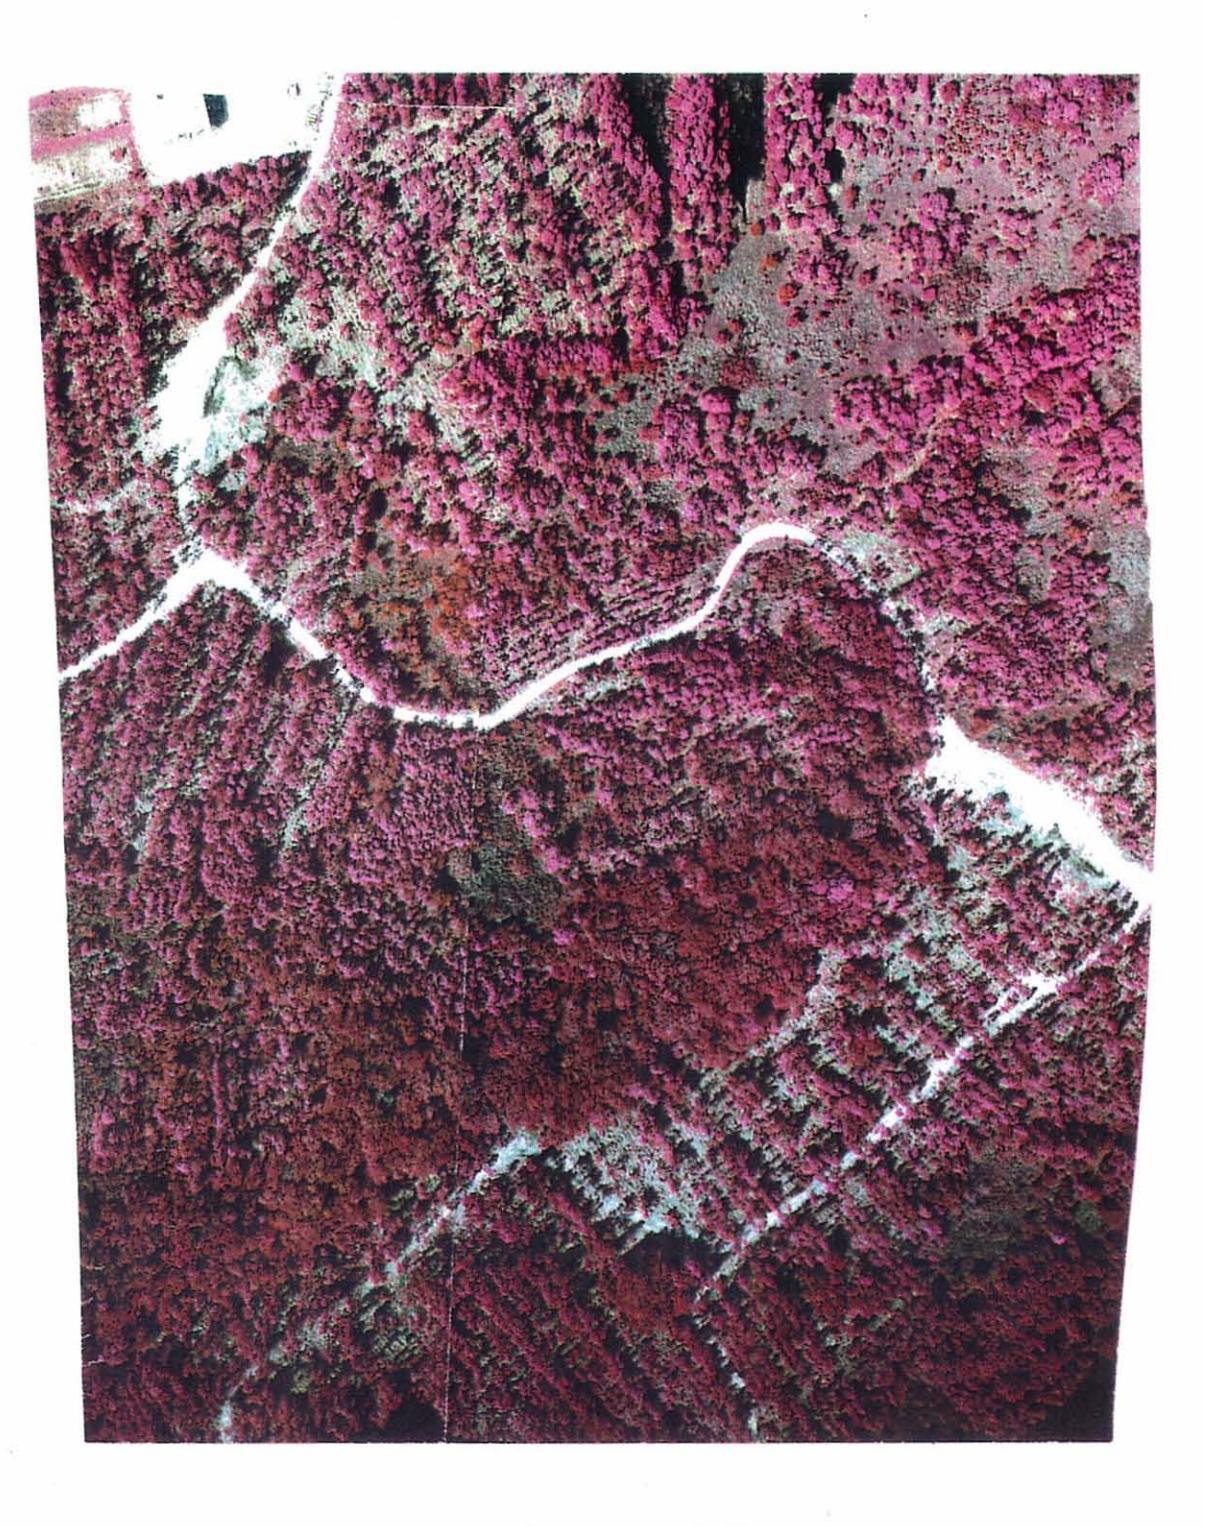
Figure 10: Aerial Photograph of Planted Pine, Mixed Hardwood, and Herbaceous Communities in the Vicinity of the North Open Pine Site (9), Fall 1993.

Figures 10 and 11 show the conditions of young pine forest and open herbaceous vegetation in an area between the fossil fuel plant and the limestone quarry operation, near the North Open Pine Site. In general, conditions are similar to previous observations, with the exception of occasional disturbance from the timber harvesting operations.

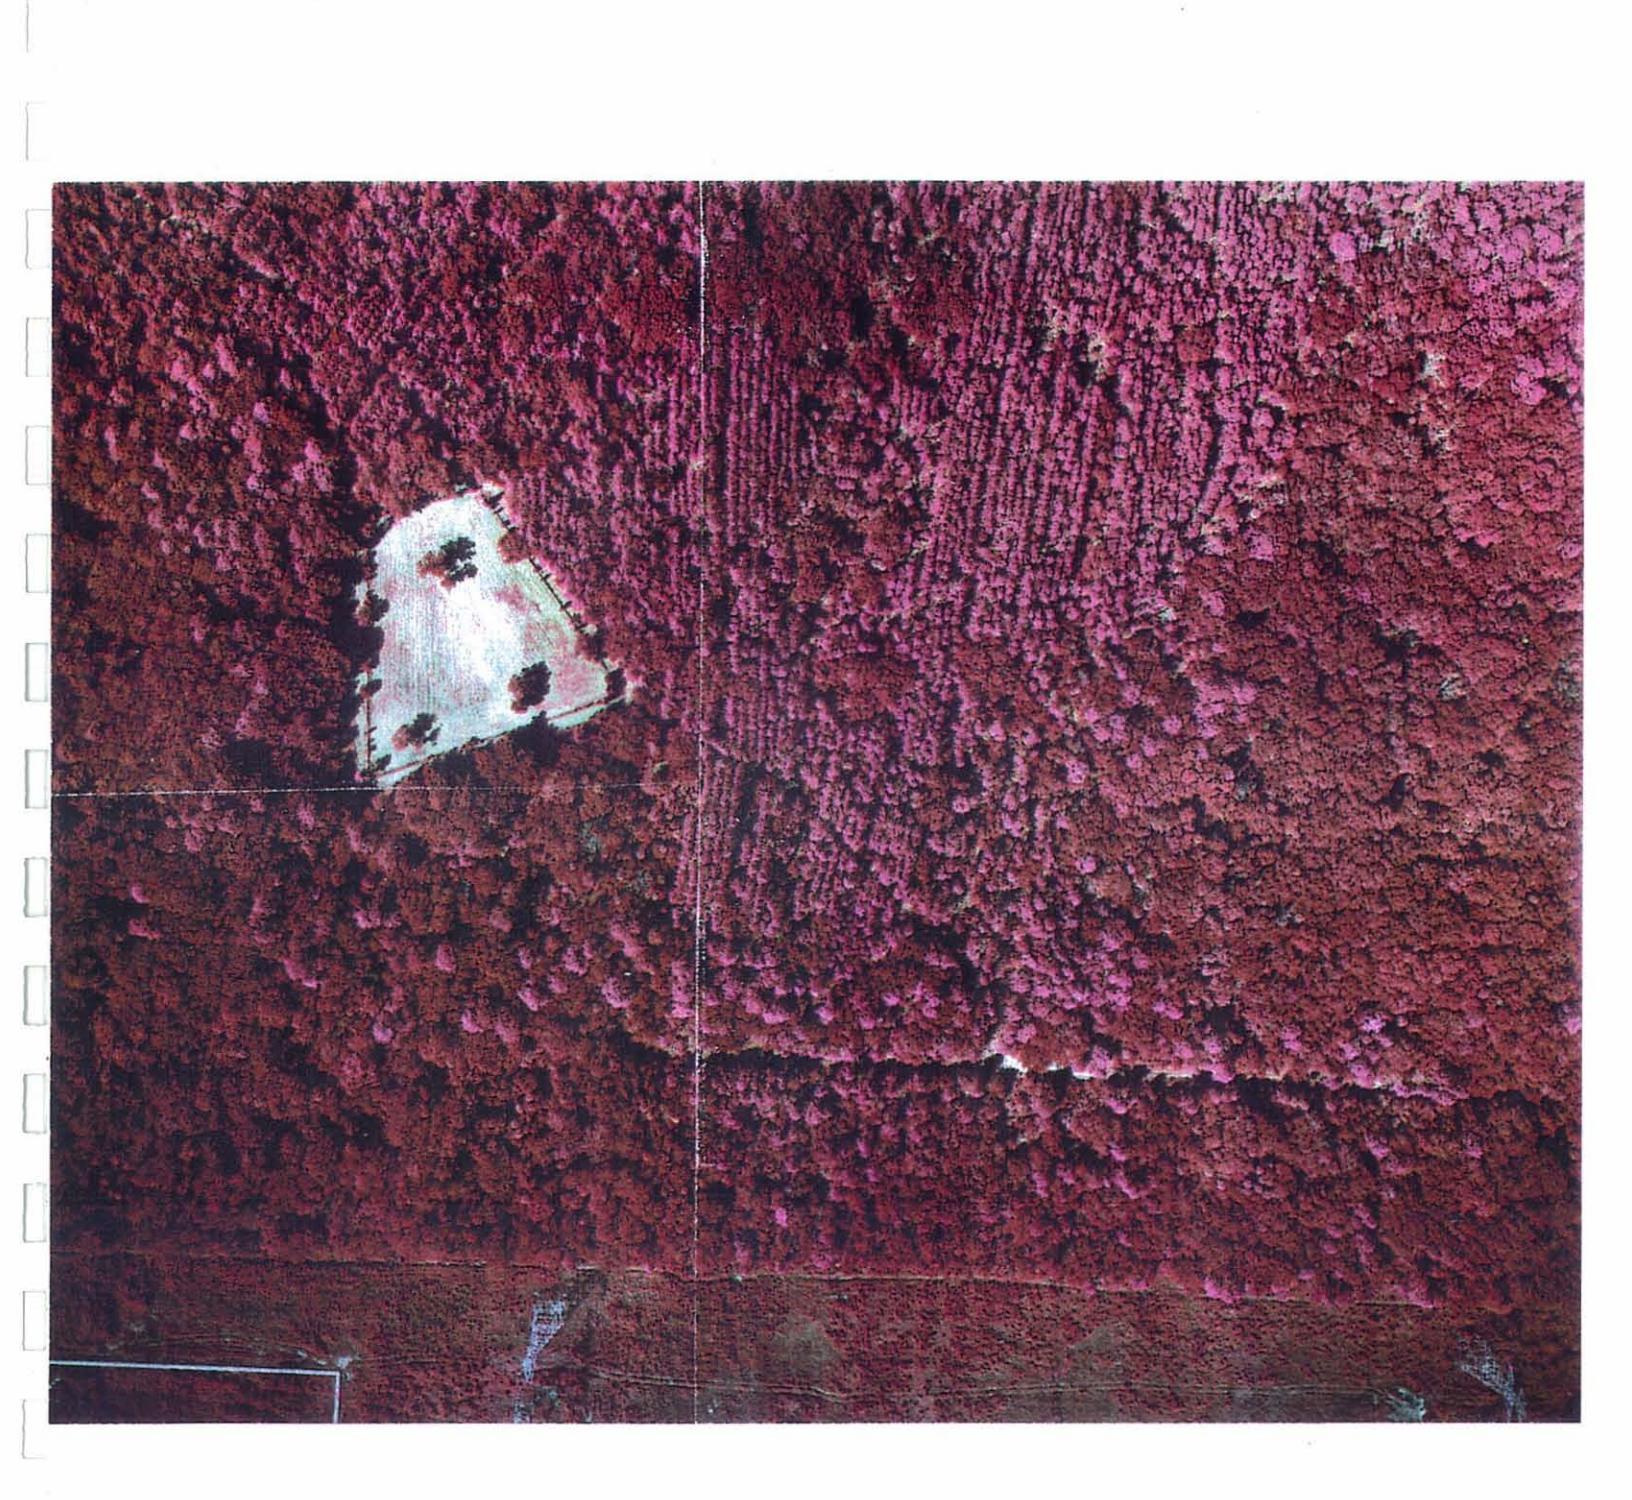
Figure 12: Aerial Photograph (Fall 1993) of the East Open Pine Site, Located Within Planted Pine and Mixed Hardwood Forest.

The East Open Pine Site (Figures 12 and 13) is in comparable condition to that observed in previous years. The mixed hardwood community to its east is healthy; planted pines dominated the canopy to the east and north. The high-altitude photography shows the occurrence of recent timbering in the area. Otherwise, there appears to be no significant change in the integrity of the remaining forested areas. Figure 14 shows the pine and hardwood forest to the northeast of the plant, in the vicinity of the Northeast Open Pine Site. Other than the small "patchy" disturbance related to the silviculture activities, this area is comparable to conditions in previous years.

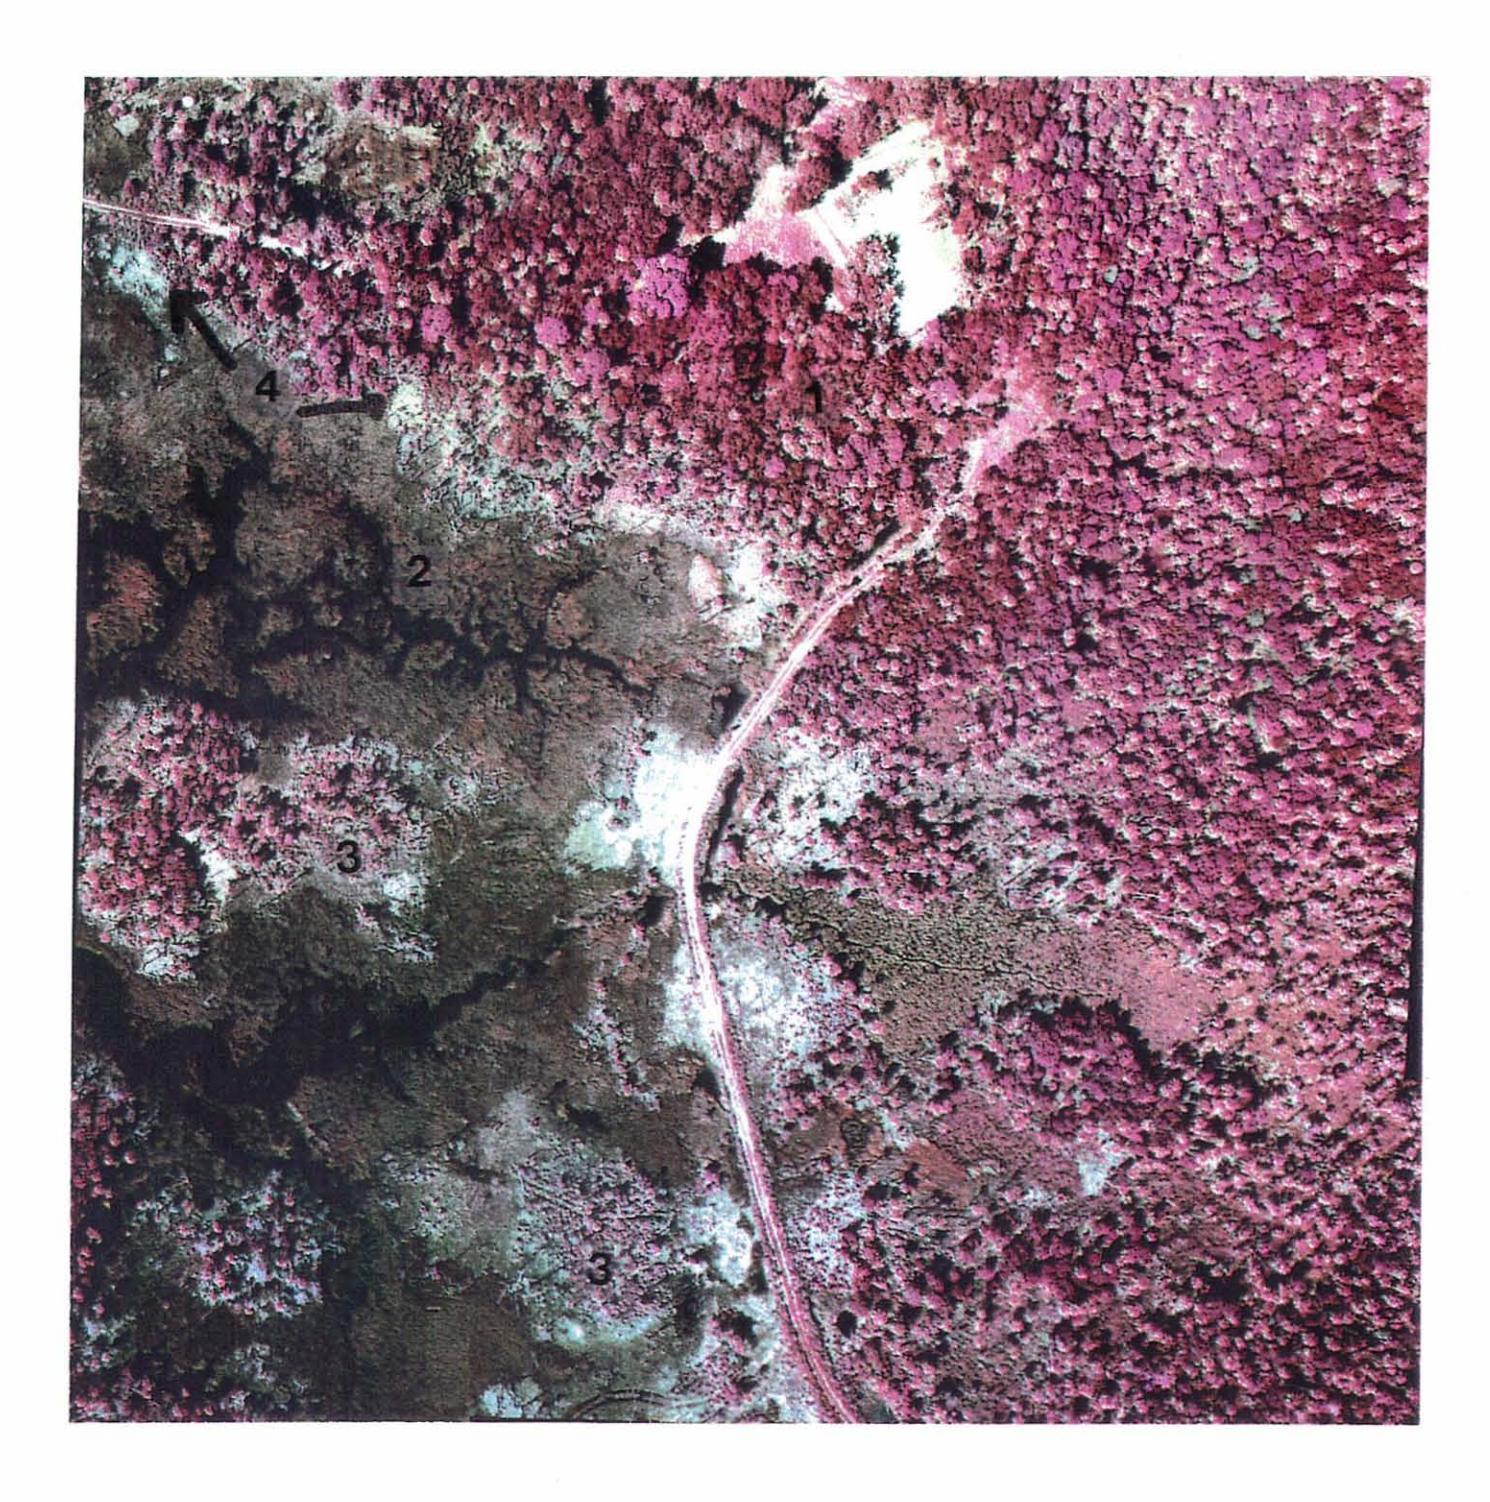
Figure 14: Aerial Photograph (Fall 1993) Demonstrating conditions of Planted Pine and Hardwoods in the Vicinity of the Northeast Open Pine Site (10) Figure 15 demonstrates the conditions of the coastal strand forested and brackish marsh community south of the power plant, in the vicinity of the Coastal Control Site. It reveals a similar, large-scale pattern as observed west and north of the plant site. Some of the outlying island hammocks reveal stress and mortality to the woody species (including some pines); lower-lying areas along the forested edge have similar conditions of stress (particularly cabbage palm), while the higher areas appear relatively unaffected. Figure 16 is a panoramic view taken in the vicinity of the Coastal Control Site.
