COMMUNICATIONS PLAN

Oyster Creek Inservice and License Renewal Commitments Inspection

November 9, 2006

Revision 4

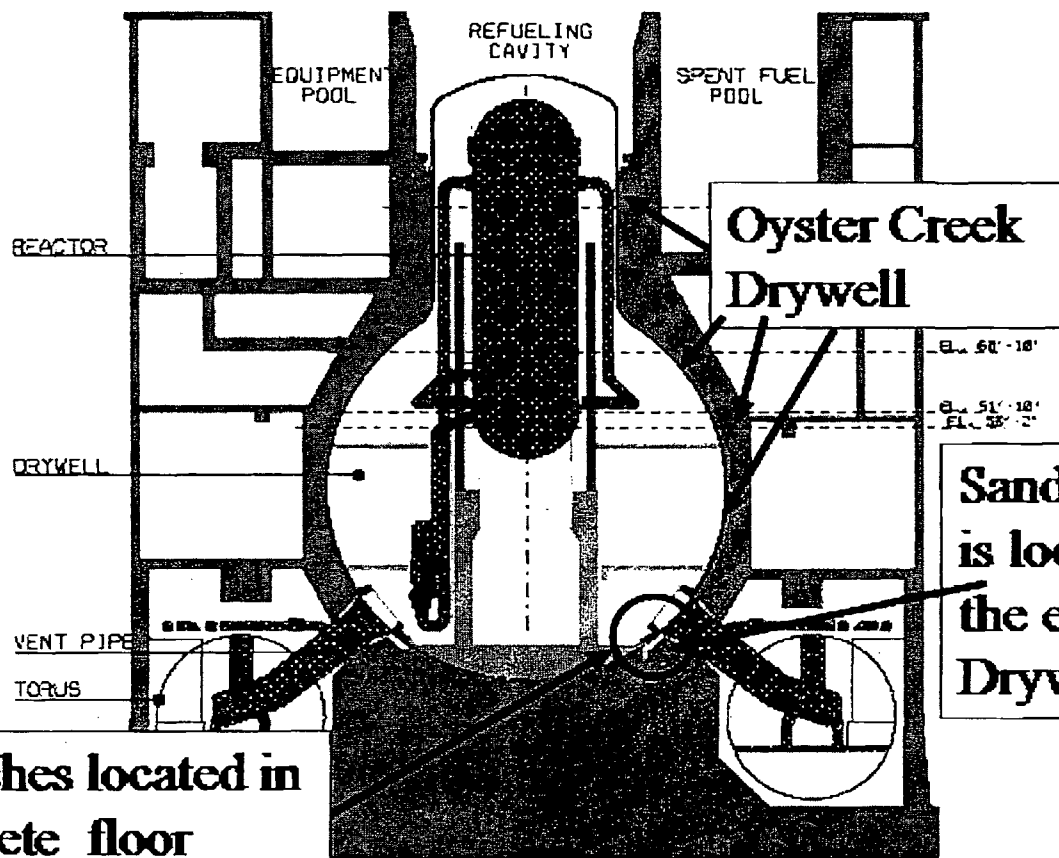
**Oyster Creek
Drywell**

**Sandbed region
is located on
the exterior of
Drywell**

**Trenches located in
concrete floor
inside the Drywell
in two locations**

In 1986, the station removed concrete at two locations inside the drywell to create the "trench area" to gain access to the drywell shell adjacent to the sand bed region. The purpose of clearing out the area was to obtain UT thickness measurements.
