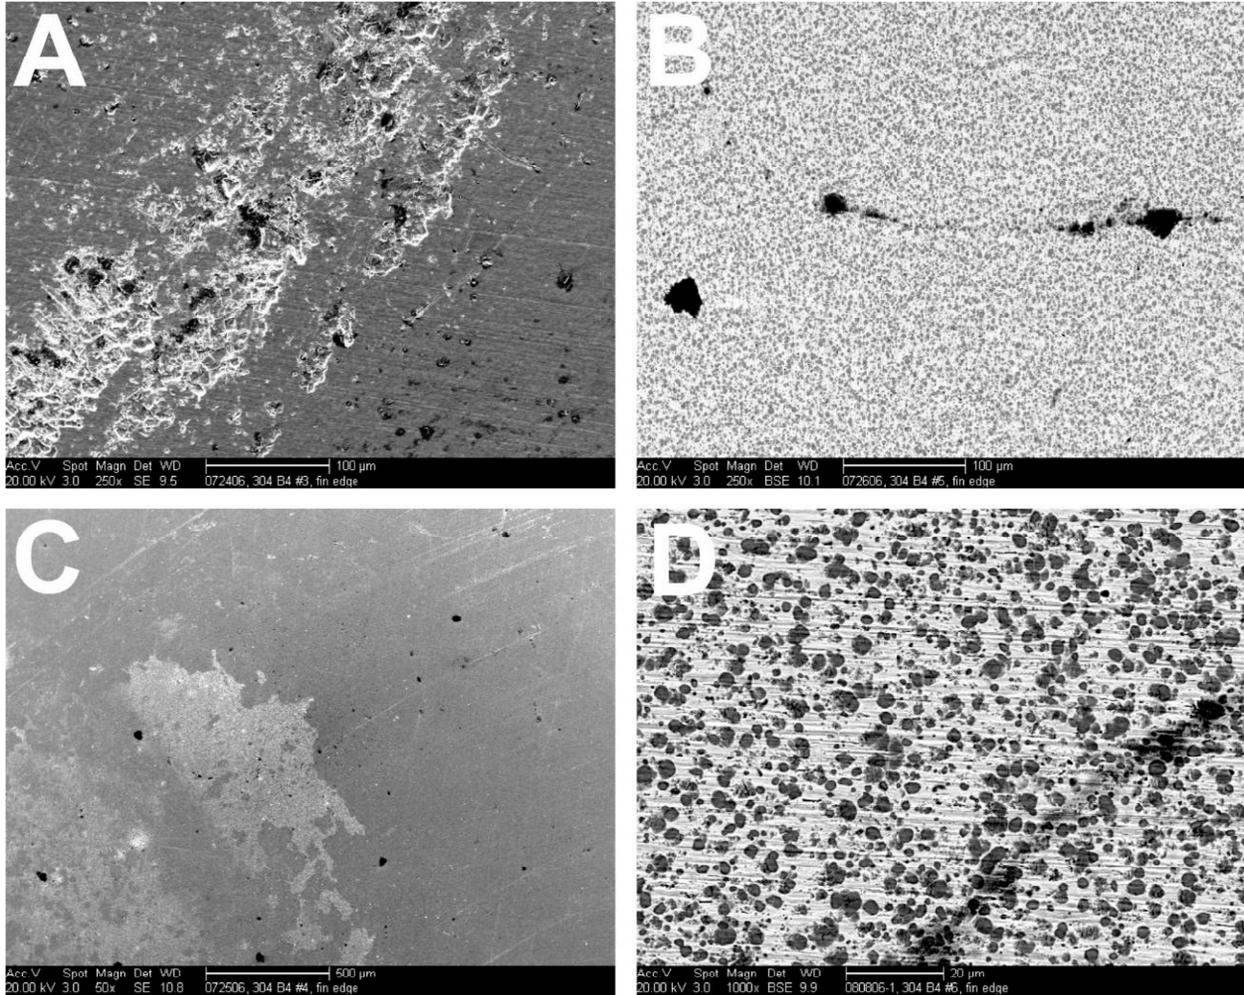
Figure 20. Scanning electron microscopy (SEM) images of 304B4 alloy corrosion specimens following testing. The images were obtained in SE (A and C) and backscatter electron (BSE) (B and D) modes.

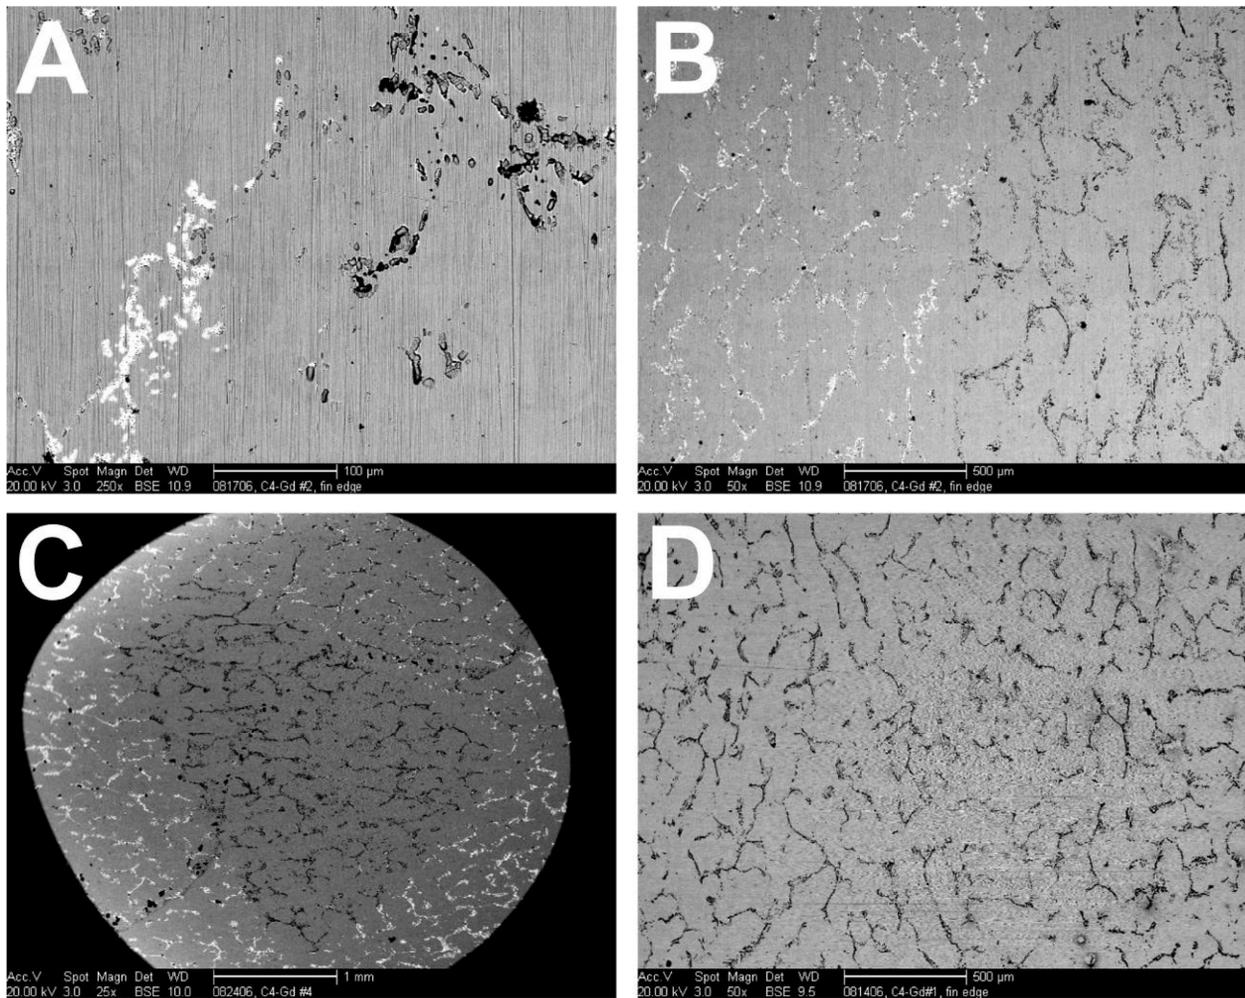
scale. Figure 21 shows the Ni-Cr-Mo-Gd alloy after corrosion testing. The bright areas are due to the gadolinide phase particles, which appear to be partially removed. Figure 21C shows the area of an entire MCA tooth where the gadolinide under the tooth is removed while the surrounding material is still intact. Figure 21A and B shows the edge of the crevice former where the inner gadolinides are removed, while gadolinides outside the crevice appear intact.

Figure 21. SEM images of Ni-Cr-Mo-Gd alloy corrosion specimens following testing. The images were obtained in BSE mode.

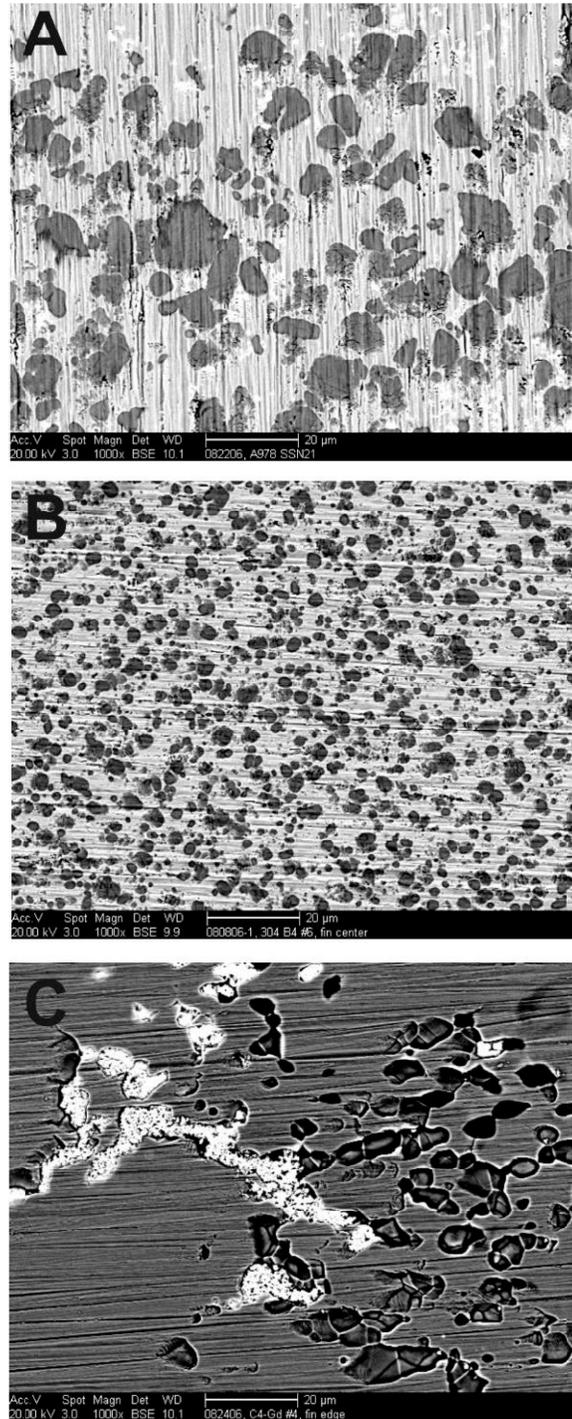
Additional SEM work was performed to show the microstructure of the secondary phases after testing. The SEM images were obtained in BSE mode to enhance the contrast of the secondary phase. Figure 22A and B shows the microstructure of the A978 alloy (Test 080206), with large secondary-phase particles compared with the 304B4 specimen (Test 080806-1), having smaller, more evenly distributed secondary-phase particles. The SEM image of the Ni-Cr-Mo-Gd specimen from Test 082406 shows the partial removal of the gadolinide phase. Small cavities remain from particles that were dissolved. No evidence of localized corrosion damage extending beyond these cavities was found.

Figure 22. SEM images obtained in BSE mode showing the secondary phase particles for (A) A978, (B) 304B4, and (C) Ni-Cr-Mo-Gd alloys.

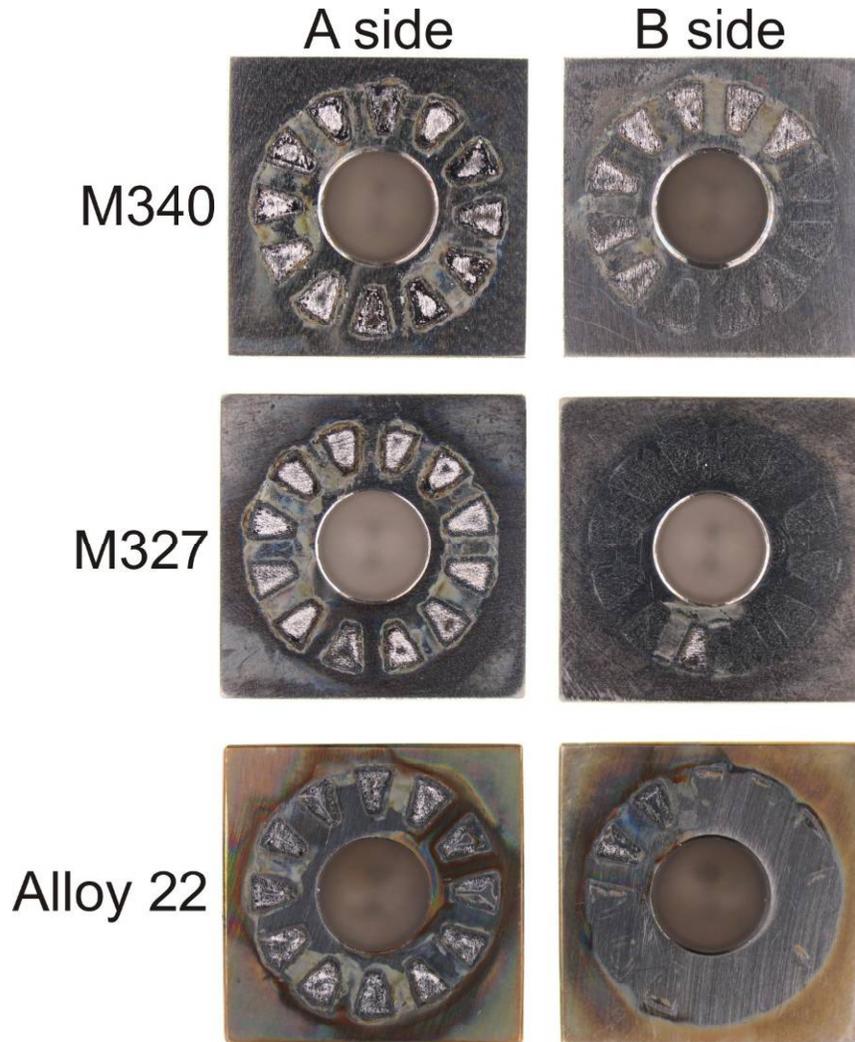
Figure 23 shows photographs of the specimens after descaling. All the specimens show a similar amount of damage and number of crevice corrosion sites attacked. There was a difference in the amount

of crevice corrosion from one side to the other. This is likely due to the N₂ purge affecting the chemical transport, with the side most affected having less crevice attack. There are some differences in the attack of the Ni-Cr-Mo-Gd alloys versus Alloy 22. The Alloy 22 attack was more at the edges of the crevice tooth, while the Ni-Cr-Mo-Gd is more uniform across the crevice tooth. There is more pronounced staining of the Alloy 22 specimen.

Figure 23. Macro photographs of the three alloys after descaling. The most damaged side is in the “A” column, and the less damaged side is in the “B” column.

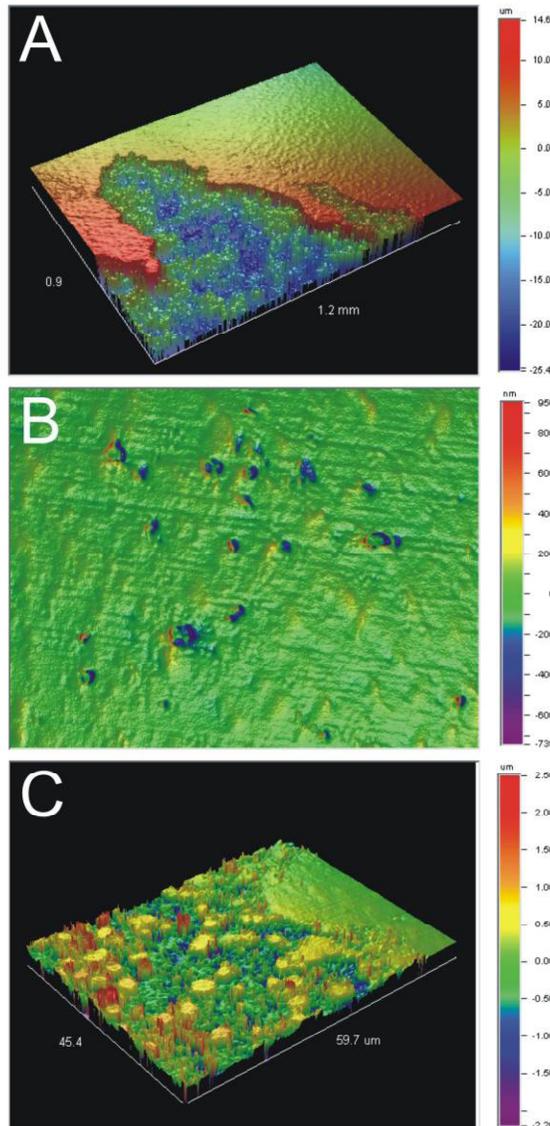
Figure 24 shows optical profilometer data acquired on Neutrosorb Plus 304 stainless steels after corrosion testing. Figure 24A shows the extensive crevice corrosion damage to 304B6 at the Teflon compression gasket during exposure to solution B3 at 60°C at E_{corr} . Figures 24B and C show damage from a PS test for 304B4 under the Teflon MCA. Figure 24B shows what appears to be removal of material around secondary-phase particles in what could be the initiation of localized corrosion. Figure 24C shows the edge of a crevice corrosion pit where islands of material, on the same level as the polished surface, remain. These islands are likely secondary-phase particles (borides) that had not been released from the surface as the stainless steel austenite matrix was etched around them.

Figure 24. Optical profilometer data of specimens after corrosion experiments. (A) is 304B6 after E_{corr} measurement for 4 weeks in solution B3, and (B) and (C) are the 304B4 specimen damage from under the Teflon crevice former after the PS test at 0.1 V in solution B3.

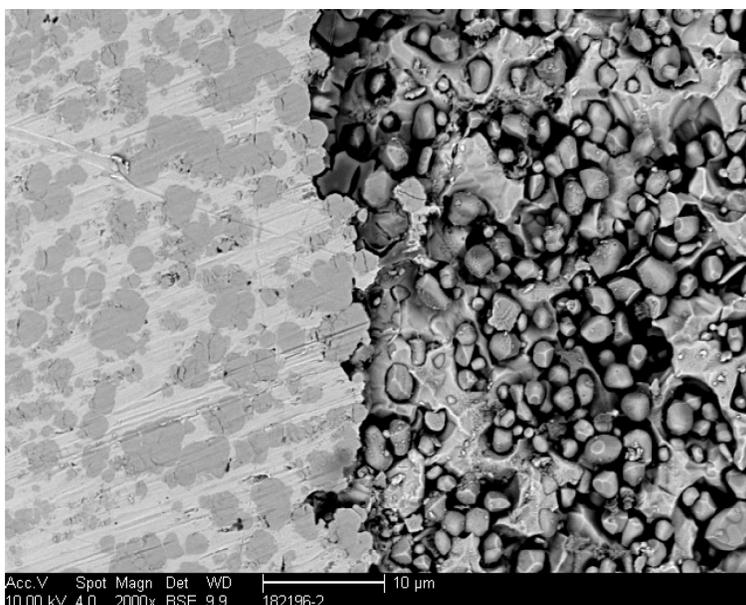
There was no evidence of a corrosion product detected on the surface of any of the Grade A borated stainless steel specimens in the testing program. As discussed in Section 3.2.5, the only damage was observed at the electrical connection point under the Teflon gasket. Representative images of the damage in this area are shown in Figures 25 and 26. The particles are the chromium-rich borides, and the corrosion mechanism appears to be localized corrosion around the borides, which allows them to fall free from the surface. The test solutions were filtered to gather a sample for XRD analysis, but the measurement results were inconclusive due to a very small sample size.

Figure 25. BSE image of localized corrosion near gasket in 304B6.

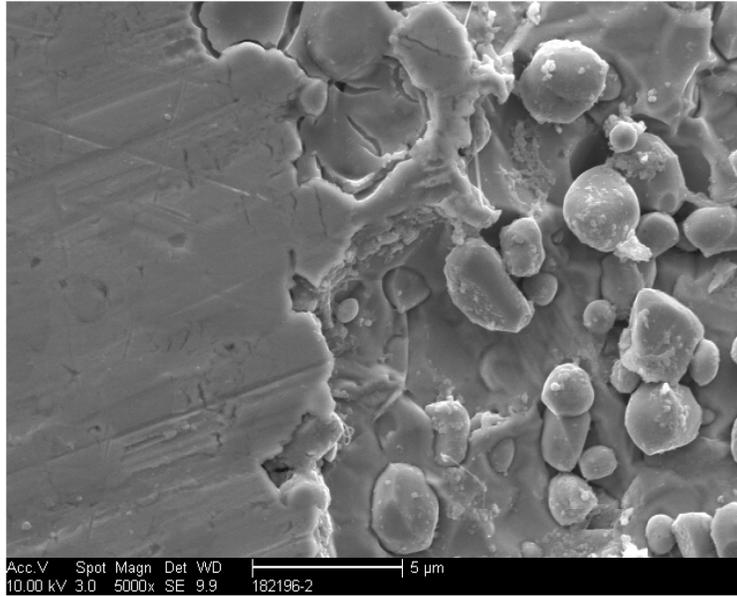
Figure 26. Secondary electron (SE) image of localized corrosion near gasket in 304B6.

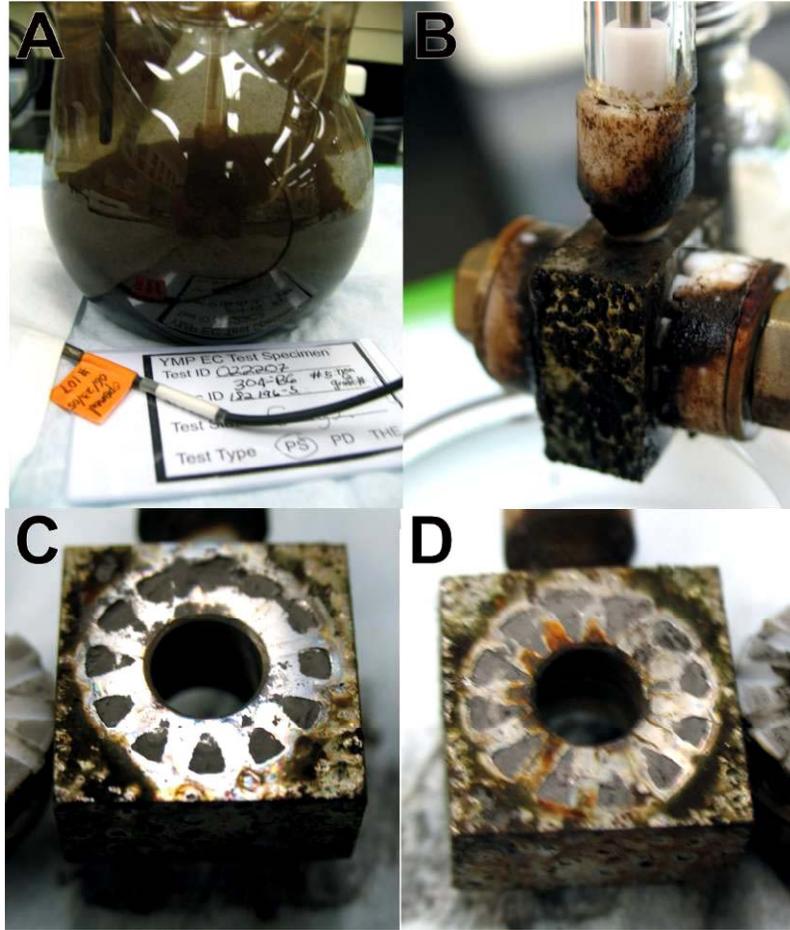
To increase the amount of corrosion product for XRD analysis, an accelerated corrosion test was performed using a 304B6 crevice-corrosion specimen polarized above the expected E_{corr} value (0.4 V versus SCE) at 90°C for 24 hours in solution B3. The 304B6 alloy was chosen as it shows a reduced resistance to localized corrosion compared to alloys 304B4 and 304B5 as reported in Section 3.2.6. This resulted in an excessive amount of crevice corrosion product that clouded the solution significantly (see Figure 27) and resulted in catastrophic attack to all surfaces of the specimen. The precipitate and corrosion product on the specimen was black and mostly lacked additional color. A total charge of 5616 C (355.4 C/cm^2) was passed during the test, with a maximum current of 5.29 A/cm^2 and a minimum of 2.25 A/cm^2 . Thus, localized corrosion was initiated instantly and remained active throughout the test. The specimen lost 1.83141 g during the test. Precipitate was collected during descaling, with sonication in 10% HNO_3 . After descaling cleanup, the specimen continued to produce small grey particles upon shaking. The particles from descaling were analyzed by XRD and matched with FeCr_2B . A similar match was made with settled precipitate collected at the bottom of the flask, which also indicated significant amounts of amorphous material.

Figure 27. Photographs of corrosion damage from 304B6 specimen in accelerated test: (A) corrosion flask, (B) specimen immediately after removal, and (C) and (D) two sides of specimen.
