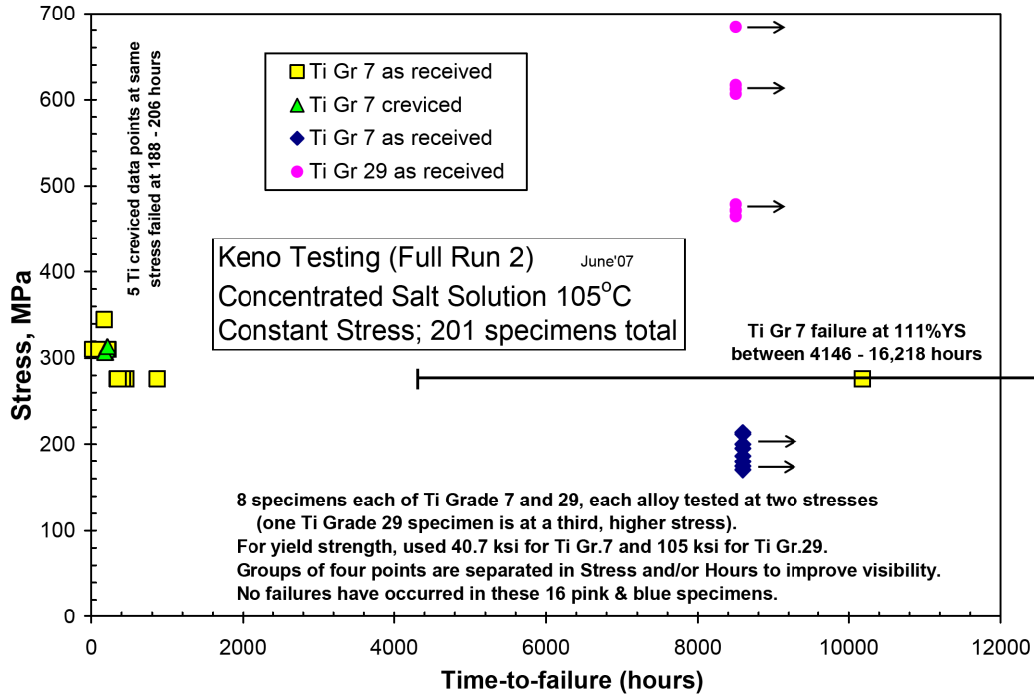
Figure 7. 105 °C SCC initiation response of newer Ti Grade 7 and Grade 29 specimens.

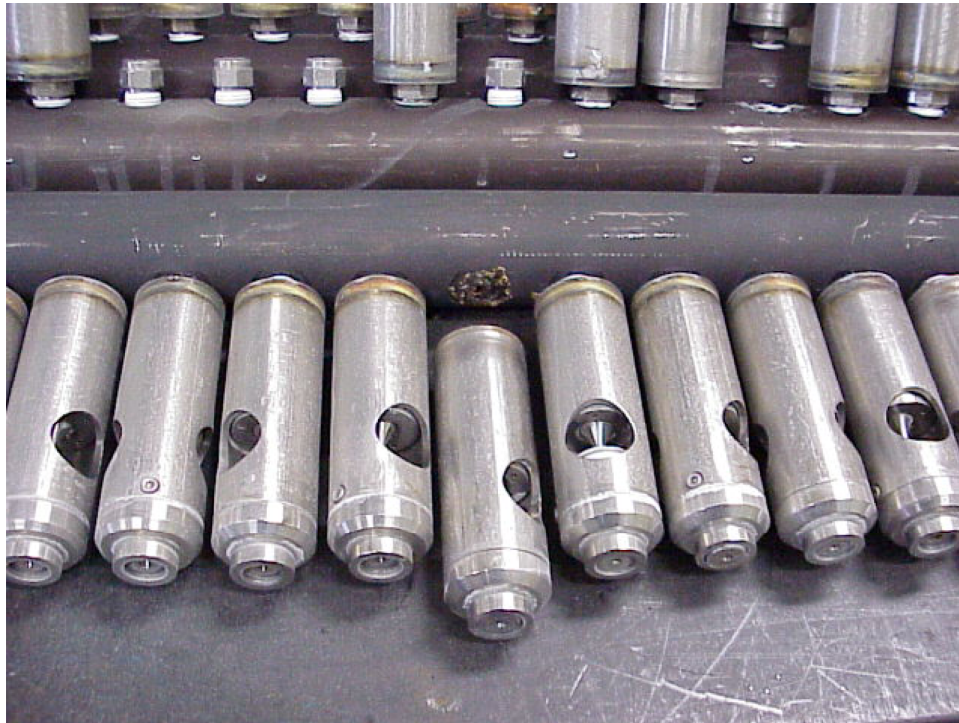
Figure 8. Corroded and fractured threads at the module/manifold interface produced unacceptably high leakage rates from the Keno autoclave. Three 316L stainless steel manifolds were ordered and manufactured to replace the 304 stainless steel manifolds damaged by corrosion during Keno Run 2, and subsequently Alloy 825 has been used.

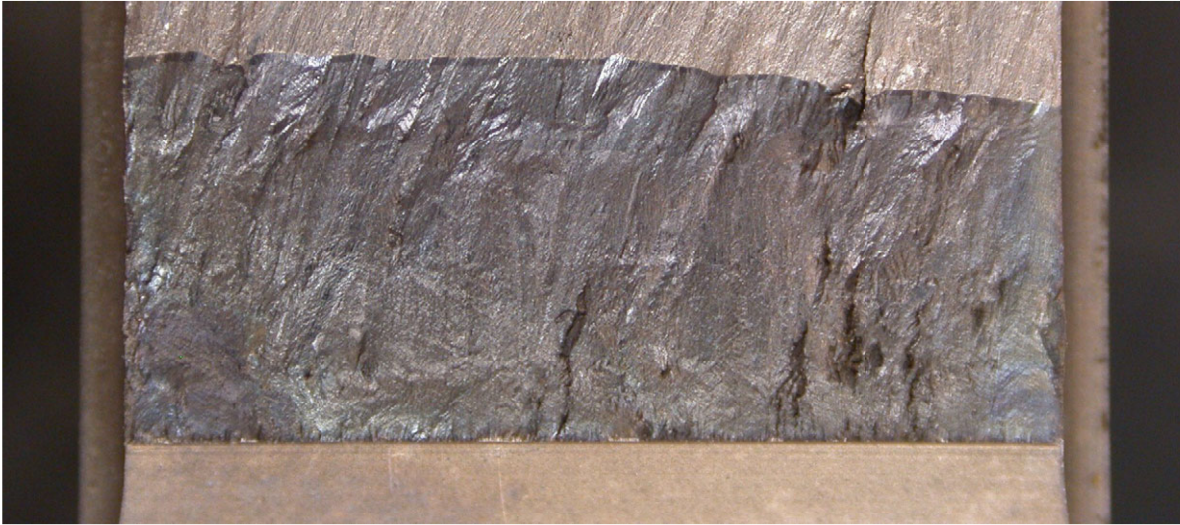
Figure 9. Macro photograph of Alloy 22 CT-String defect specimen CTS 05. To achieve 30 ksi√in, the fatigue precrack length is quite long ( $a/W=0.554$ ), and the crack exposed to the test environment is the large tinted area just above the smooth machined notch. The specimen width is 0.5 inch.

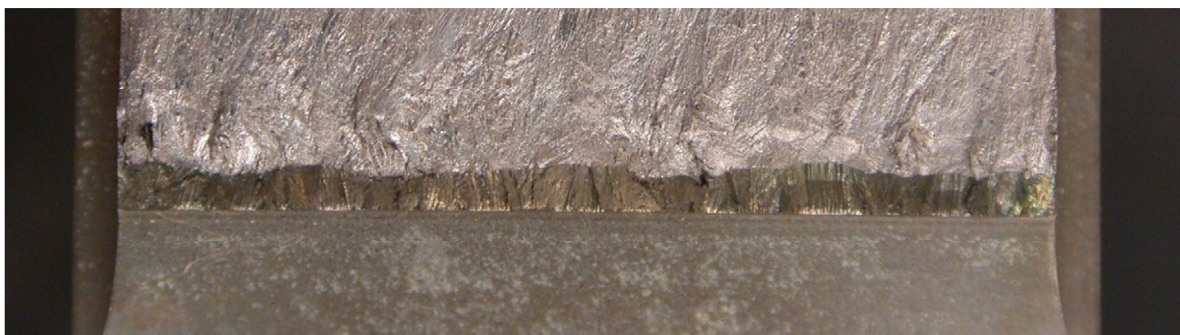
Figure 10. Macro photograph of CT-String defect specimen CTS 06. To achieve 20 ksi√in, the fatigue precrack length is quite short ( $a/W=0.420$ ), and the crack exposed to the test environment is the thin area just above the smooth machined notch. The specimen width is 0.5 inch.
