VIRGINIA ELECTRIC AND POWER COMPANY SURRY POWER STATION UNIT 1 STEAM GENERATOR TUBE INSERVICE INSPECTION REPORT FOR THE 2009 REFUELING OUTAGE

SURRY UNIT 1 180-DAY NRC REPORT REGARDING STEAM GENERATOR TUBE INSPECTION PER TECHNICAL SPECIFICATION 6.6.A.3

180-DAY NRC REPORT REGARDING STEAM GENERATOR TUBE INSPECTION SURRY UNIT 1 - SPRING 2009 END-OF-CYCLE 22 (EOC22) / REPLACEMENT-END-OF-CYCLE 17 (REOC17)

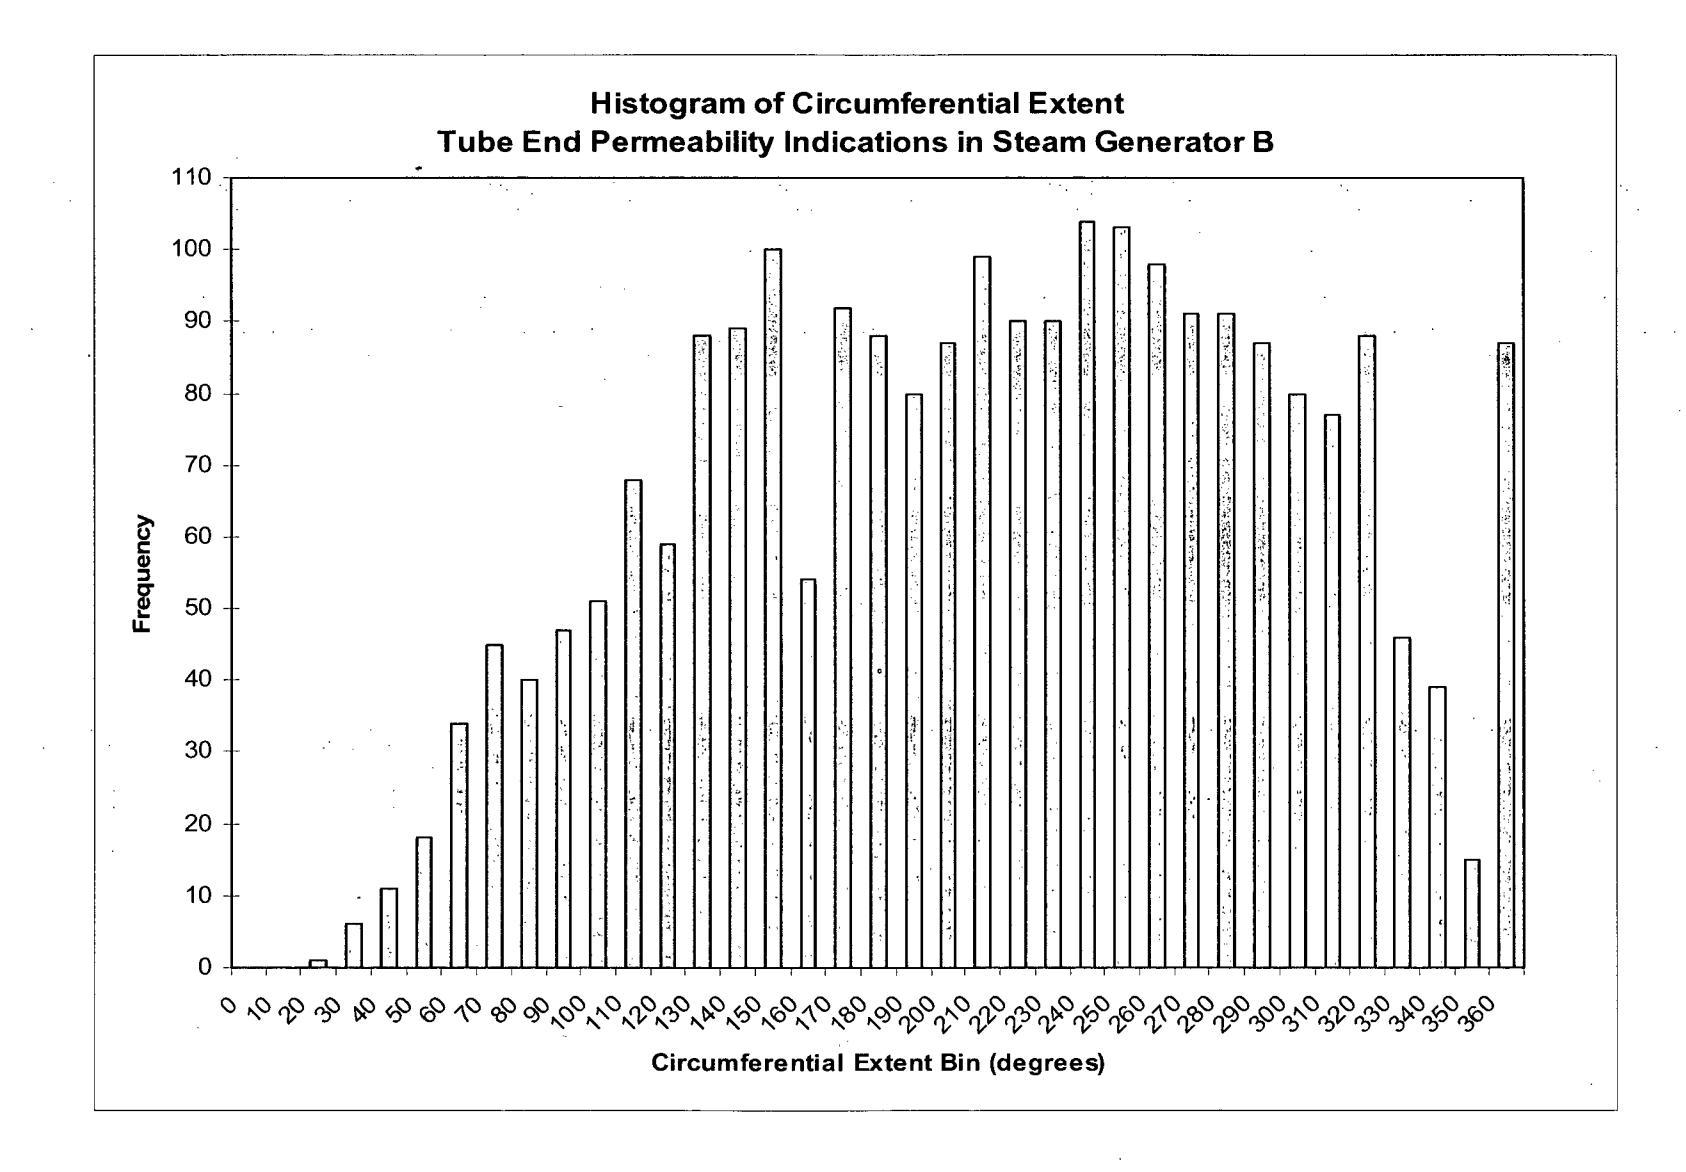
The distribution of measured circumferential extents is provided in Figure 3 below. In addition, Attachment 5 of the letter dated May 5, 2009 (Serial No. 09-295) submitted by Virginia Electric and Power Company provided details for the indications.
