Crystal River Nuclear Plant Docket No. 50-302 Operating License No. DPR-72

Subject: Crystal River Unit 3 – Relief Request (RR) 09-004-II, Revision 0

RELIEF REQUEST 09-004-II, REVISION 0

Proposed Alternative in Accordance with 10 CFR 50.55a(a)(3)(ii)

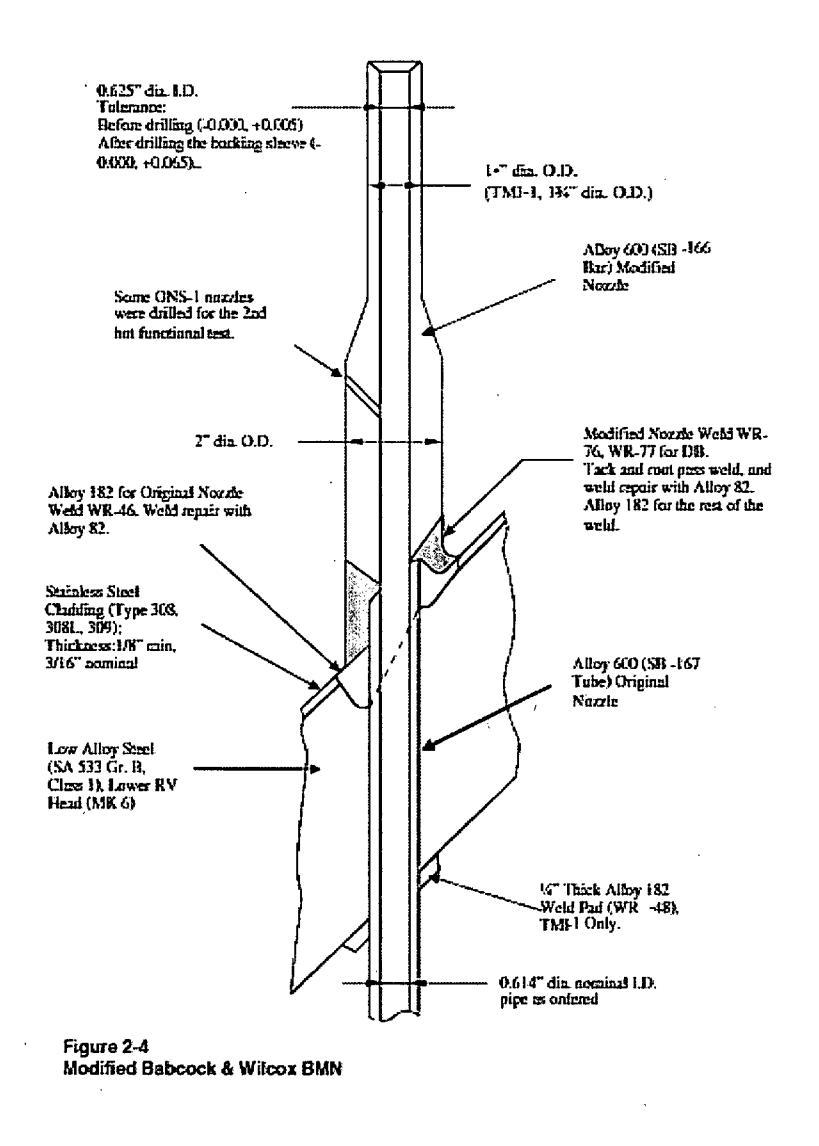
Figure 1 – B&W repaired bottom nozzle configuration

Following failures of several tubes inside the reactor vessel at Oconee-1, during initial start-up hot functional testing, the nozzles at CR-3 were modified. The BMN design was modified (see Figure 1) to strengthen the nozzle portion inside the reactor vessel. The portion of the original nozzles inside the reactor vessel were cut off above the J-groove weld, and replaced by a two (2)-inch OD Alloy 600 nozzle that was attached by a full penetration butt weld for all plants. The modification was performed in the field without post-weld heat treatment (PWHT). The modification to the Babcock & Wilcox (B&W)-designed BMNs results in two nozzles joined end to end with two slightly different diameters, and potentially, a slight diametrical offset resulting from the welding.
