*Appendix G*  
*Calvert Cliffs Acoustic Bottom*  
*Survey*

# **Calvert Cliffs Acoustic Bottom Survey, August 21, 2008**

Robert D. Conkwright  
Katherine A. Offerman  
Stephen Van Ryswick

Maryland Geological Survey / Resource Assessment Service  
**Department of Natural Resources**

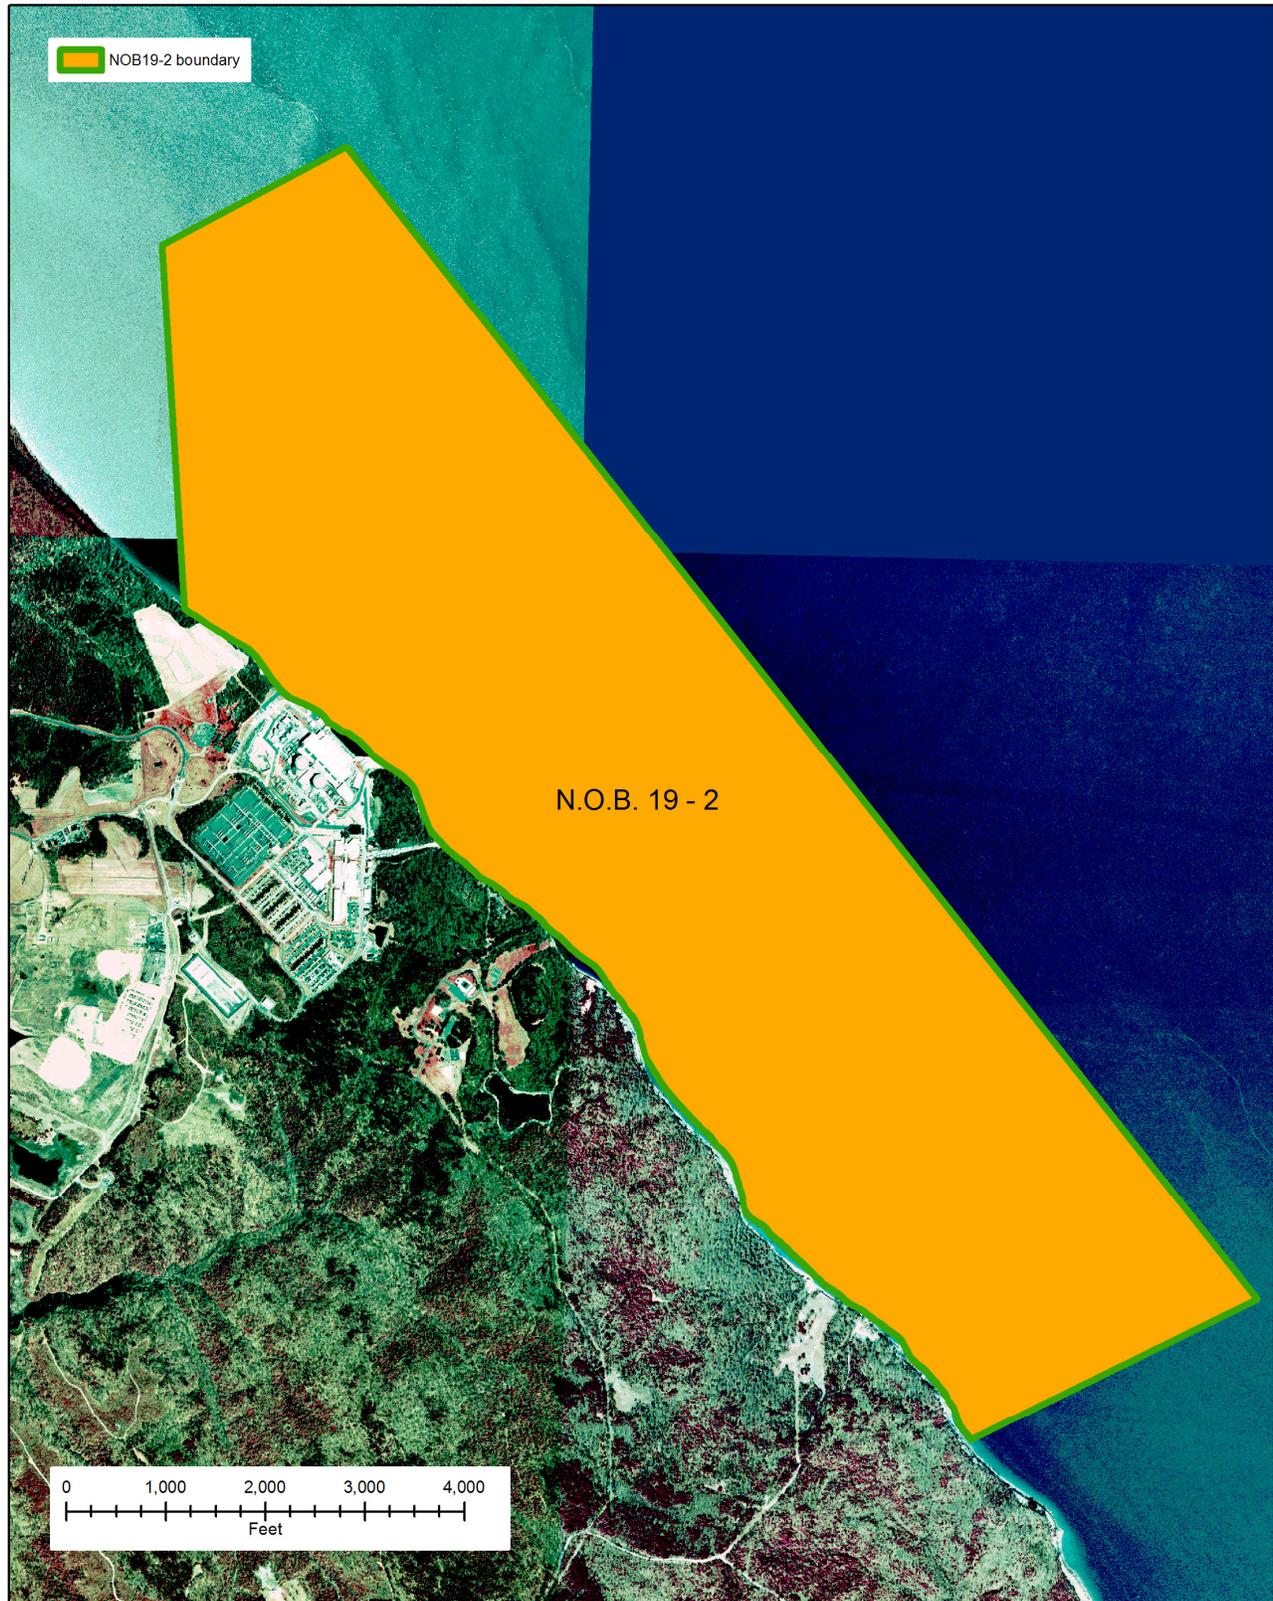
**Figure 1: USGS digital orthophotoquadrangle imagery of Calvert County shoreline and Natural Oyster Bar 19-2 polygon.**

Figure 1 presents the extent of Natural Oyster Bar 19-2 and USGS orthophotoquadrangle imagery of the shoreline. This figure gives the overall project geometry. The survey region and the proposed project are contained within NOB 19-2.

The original shoreline that existed at the time the NOB 19-2 boundary was established has been modified by construction, erosion and accretion. The current shoreline and the original western boundary of NOB 19-2 are no longer coincident. For illustrative purposes the western edge of NOB 19-2 was graphically manipulated so that the relationship between the existing shoreline and bottom features can be shown. The actual NOB 19-2 western boundary, as originally surveyed, is not depicted in this report because the polygon representing this area would obscure shoreline imagery.

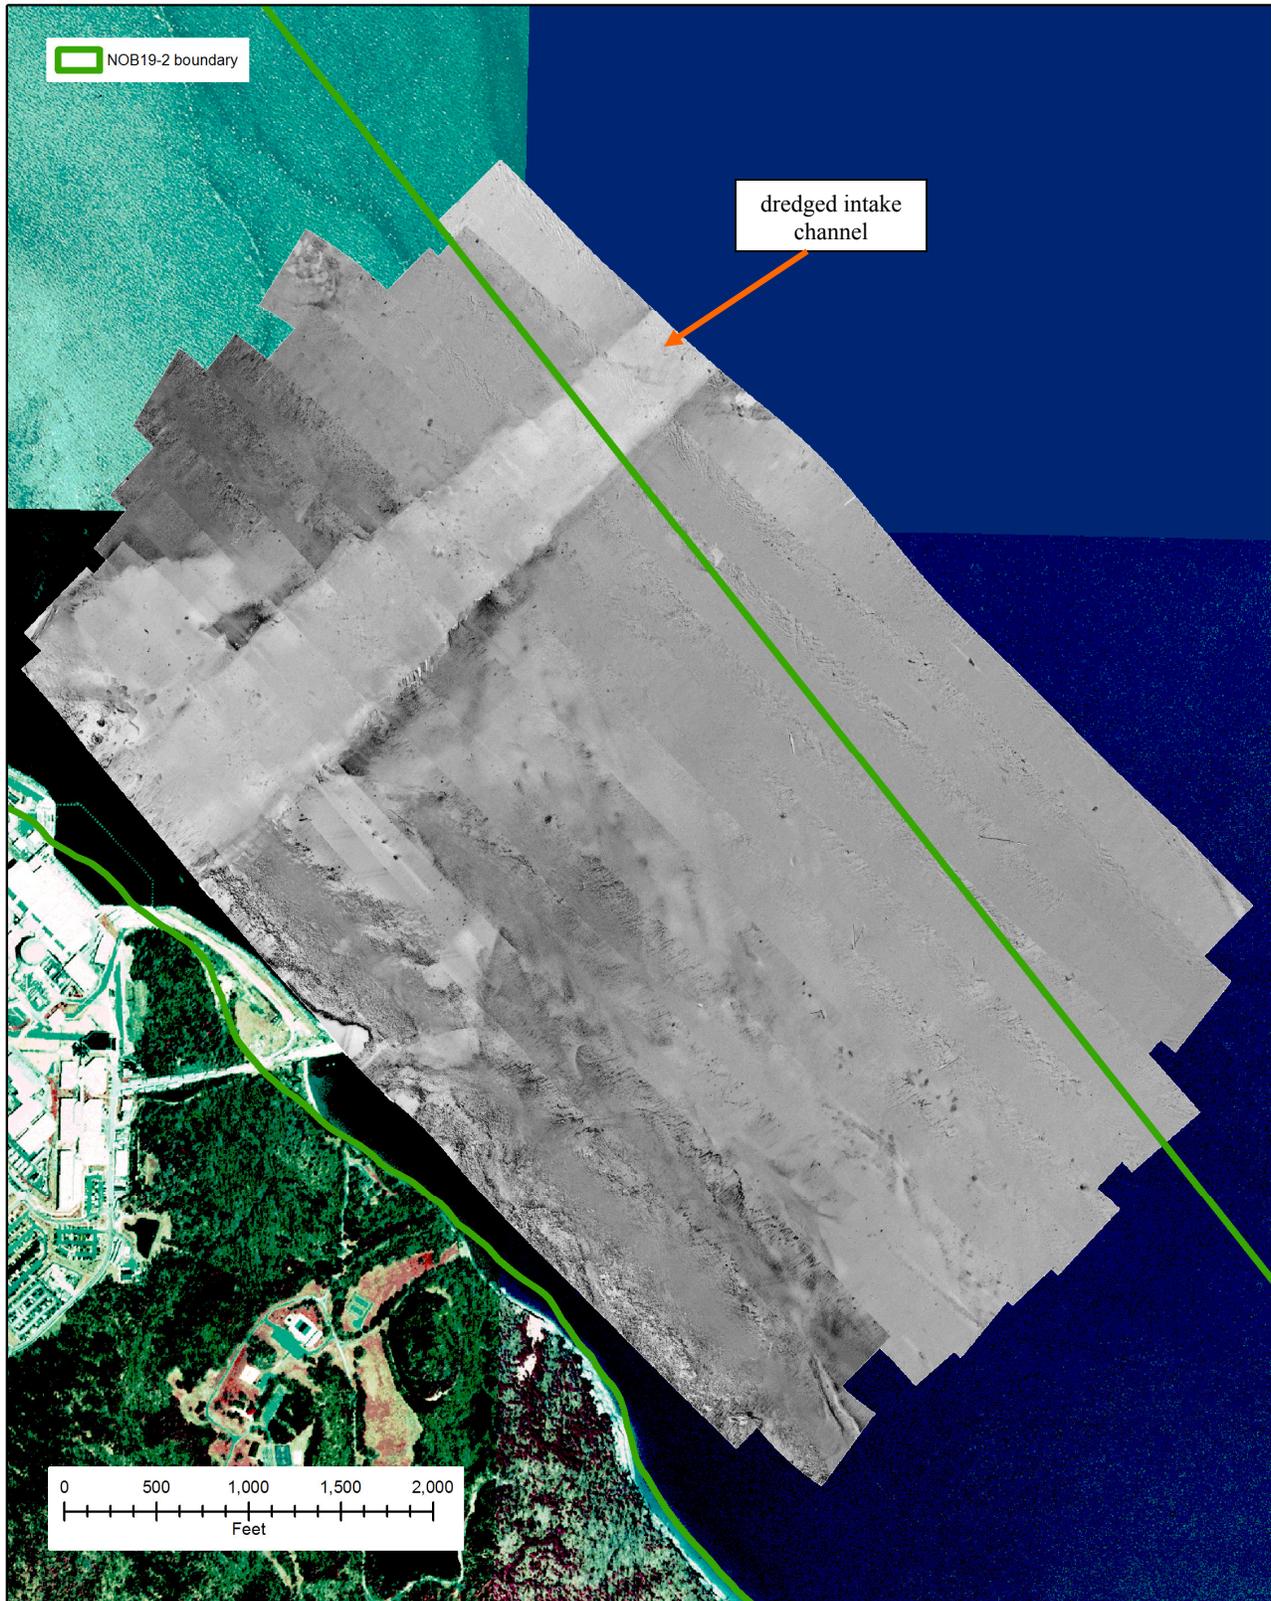
**Figure 2: Side scan sonar imagery of survey area. Various bottom features including the dredged intake channel are visible in the image.**

Figure 2 shows the survey area side scan sonar imagery and its position relative to the shoreline. The range of gray shading and textures is indicative of a variety of bottom features. The most obvious feature is the dredged intake channel which appears as the light-gray, relatively featureless swath in the upper left portion of the sonar image. The channel depth is relatively constant from west to east, approximately 11 meters (36 feet) deep in the survey area.

The darker-gray, rough areas near the shoreline are indicative of oyster bars and shell deposits on the bottom. These shell-bearing surfaces are interrupted on the northeast side by troughs containing sand and/or mud. Eastward of these troughs the sonar again shows darker-gray, mottled bottom with rough-appearing areas. This bottom type is shell-rich sand and hard clay, shell hash and shell deposits.

The dark-gray gradually lightens toward the east and becomes smoother-appearing. This is a transition area to sand and muddy sand, with little to no significant shell.

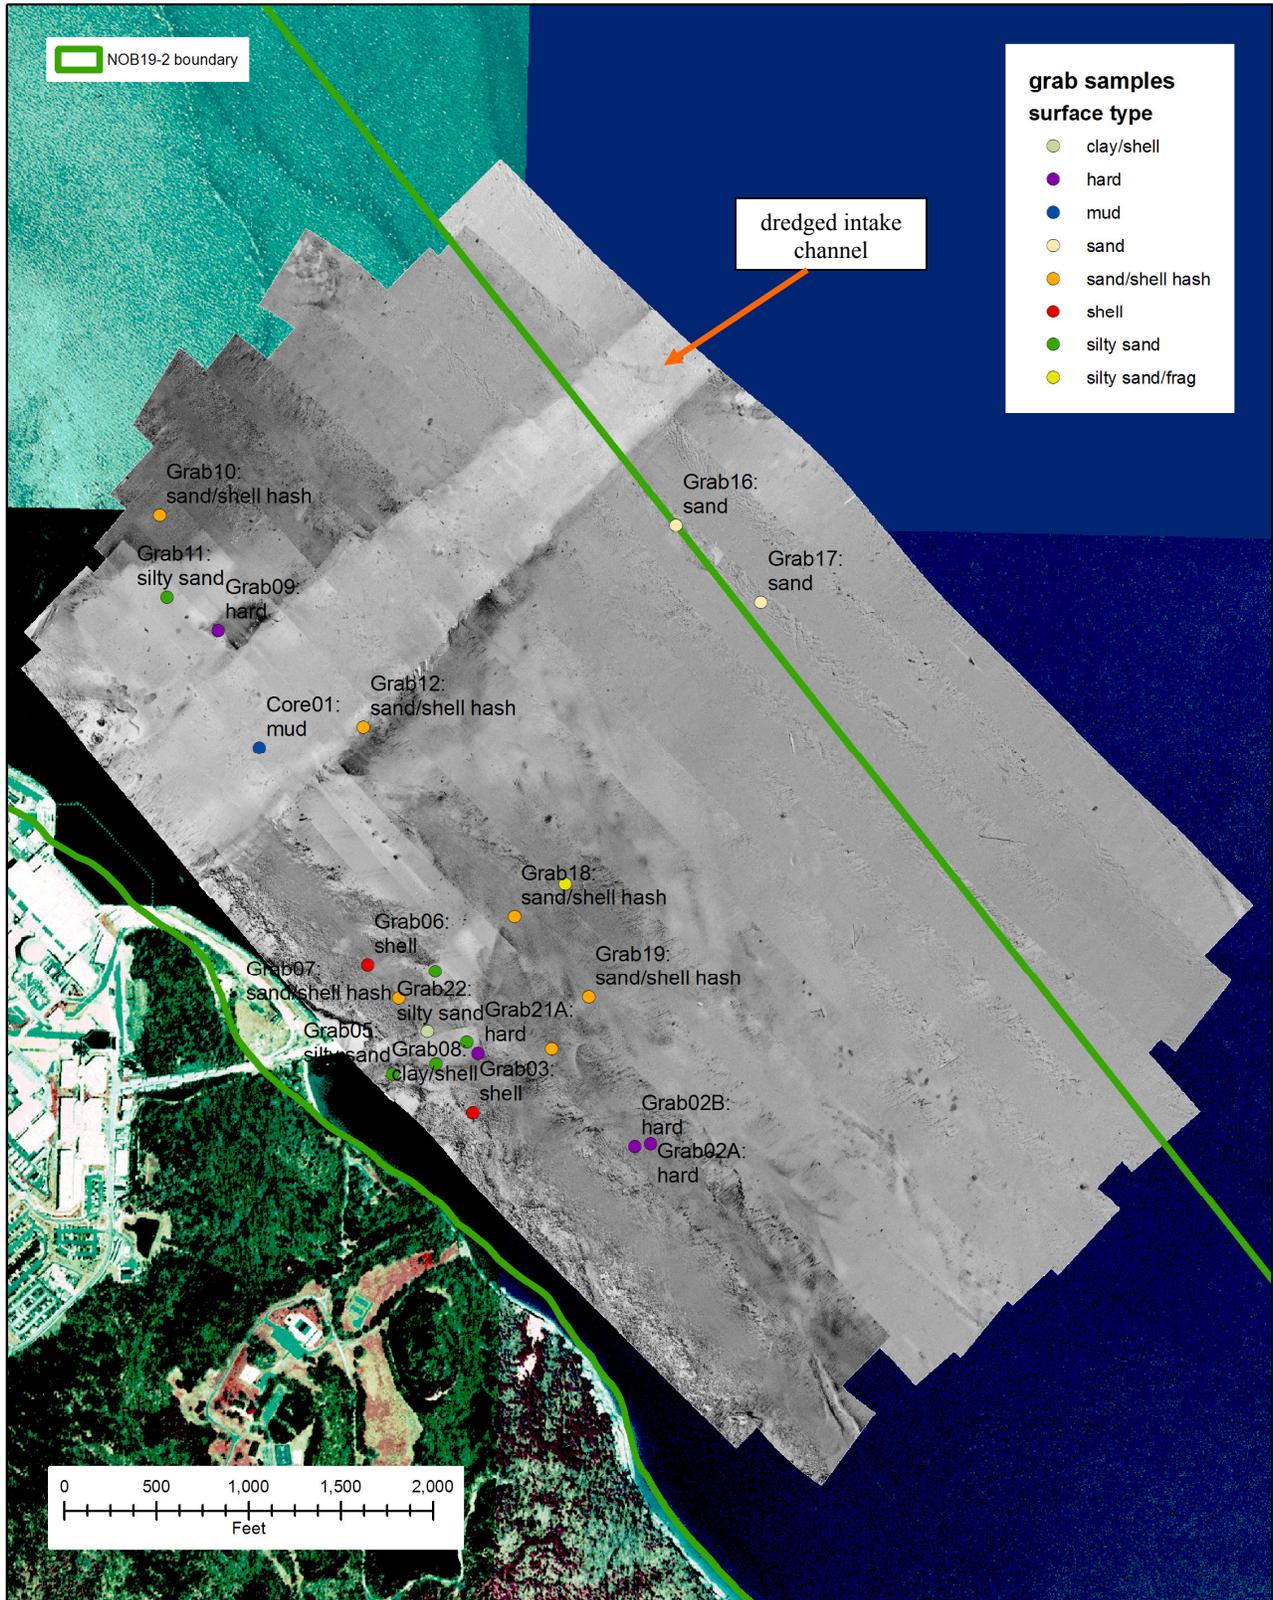
Figure 3: Surface grab sample locations.

Figure 3 maps the location and general description of samples. Table 1 is a more complete list of sample descriptions. Notably, one sample, Grab06, contained 2 live oysters. Several samples contained live crustaceans and mussels, indicative of viable oyster habitat. Two samples, Grab16 and Grab17, were taken in 30 feet of water. These two samples consist of sand with presence of hydrogen sulfide odor. Hydrogen sulfide indicates anoxic conditions at this depth and time of year, making oyster survival unlikely in this portion of the survey area. It should be noted that the anoxic samples were taken at the extreme eastern edge of NOB 19-2, and far from the eastern edge of the project area.

The bottom of the dredged intake channel is predominantly mud, and seismic profiles indicate the mud may contain anoxic gases such as methane and hydrogen sulfide, making the channel an unlikely environment for oysters. From this experience, it would not be unreasonable to expect that future dredged channels would develop similar conditions unfavorable to benthic shellfish communities, particularly if deeper than 25 feet.

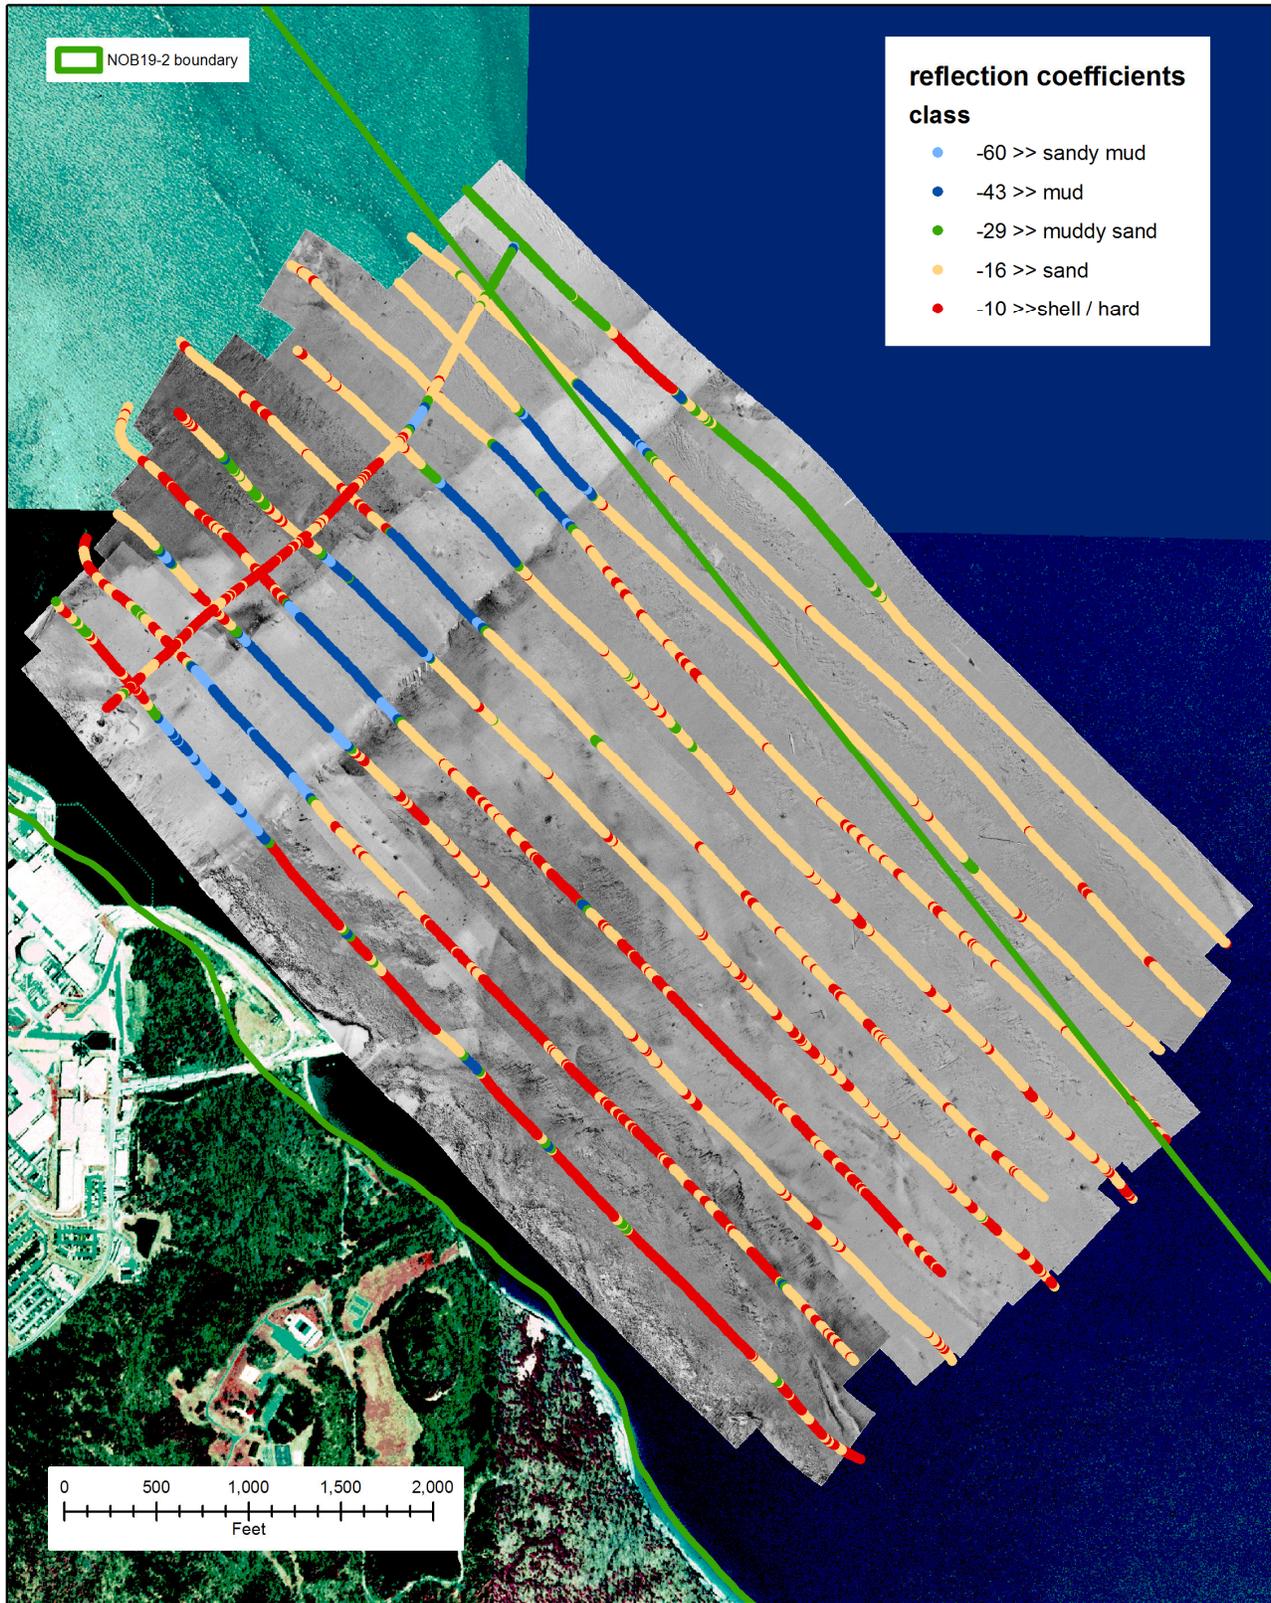
Figure 4: Reflection coefficients from seismic data. This is a gross indicator of surface roughness/hardness.

Figure 4 shows reflection coefficients from the seismic data collected during the survey. Normally this survey would have included an acoustic seabed classification system. However, Maryland Geological Survey's system was being upgraded at the time of the survey, so reflection coefficient data was substituted. These data are cruder and are not refined to the extent that a seabed classification system produces. However, the reflection coefficients contain useful information, and the pattern displayed by these data correlates well with the grayscale and roughness seen in the sonar imagery, and also track well with grab samples.

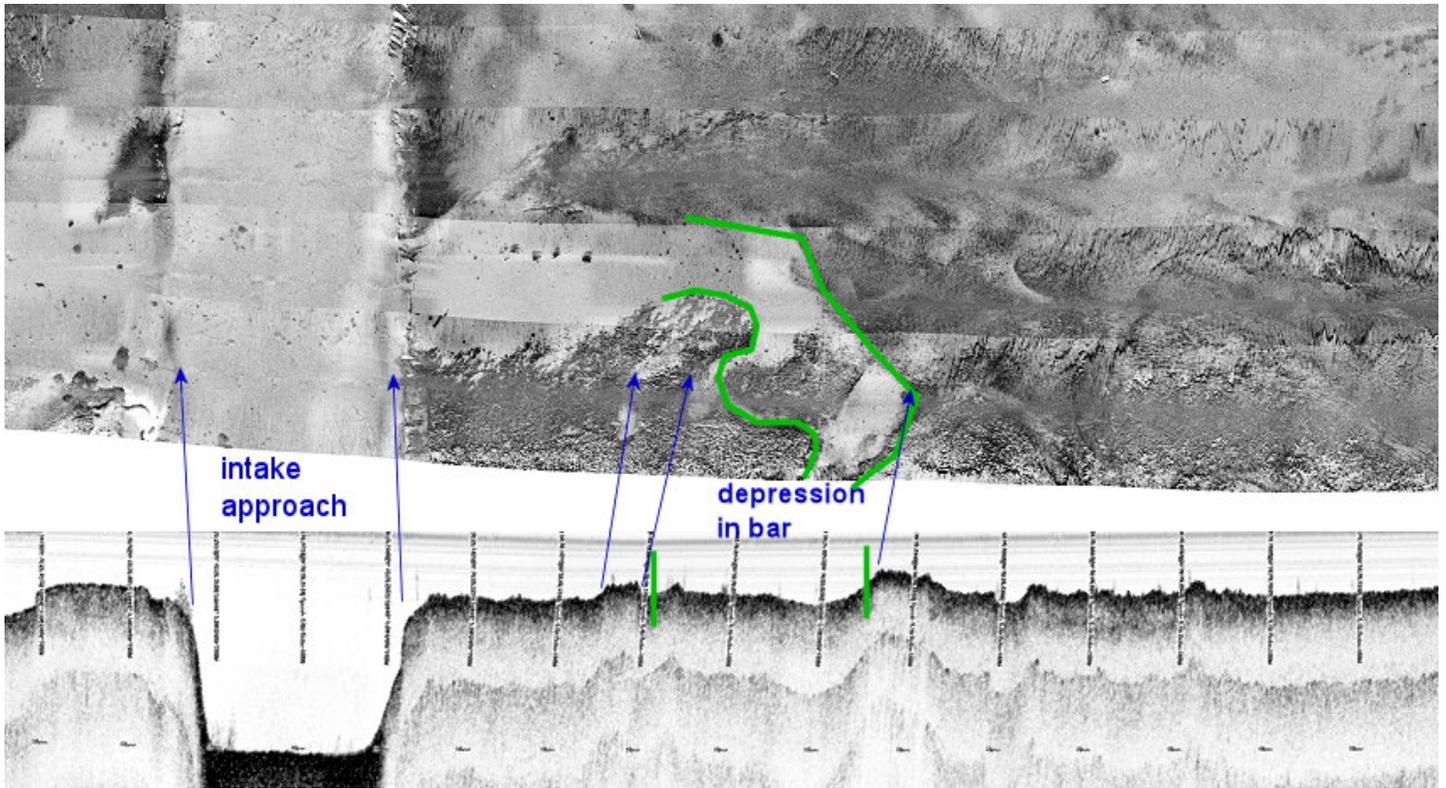
**Figure 5: Side scan sonar imagery of survey area. Various bottom features including the dredged intake channel are visible in the image.**

Figure 5 compares a seismic profile along a side scan sonar track line. The 10-meter (33-foot) deep intake channel is clearly evident.

The shell-free depression in the shelly bottom is outlined in green. The origin of this depression is not clear. However, dark, sinuous shell beds can be seen encroaching on the depression.

Possible buried shell deposits can also be seen on the right side of the seismic profile. The high points, or mounds, protruding from the bottom are exposed shell.

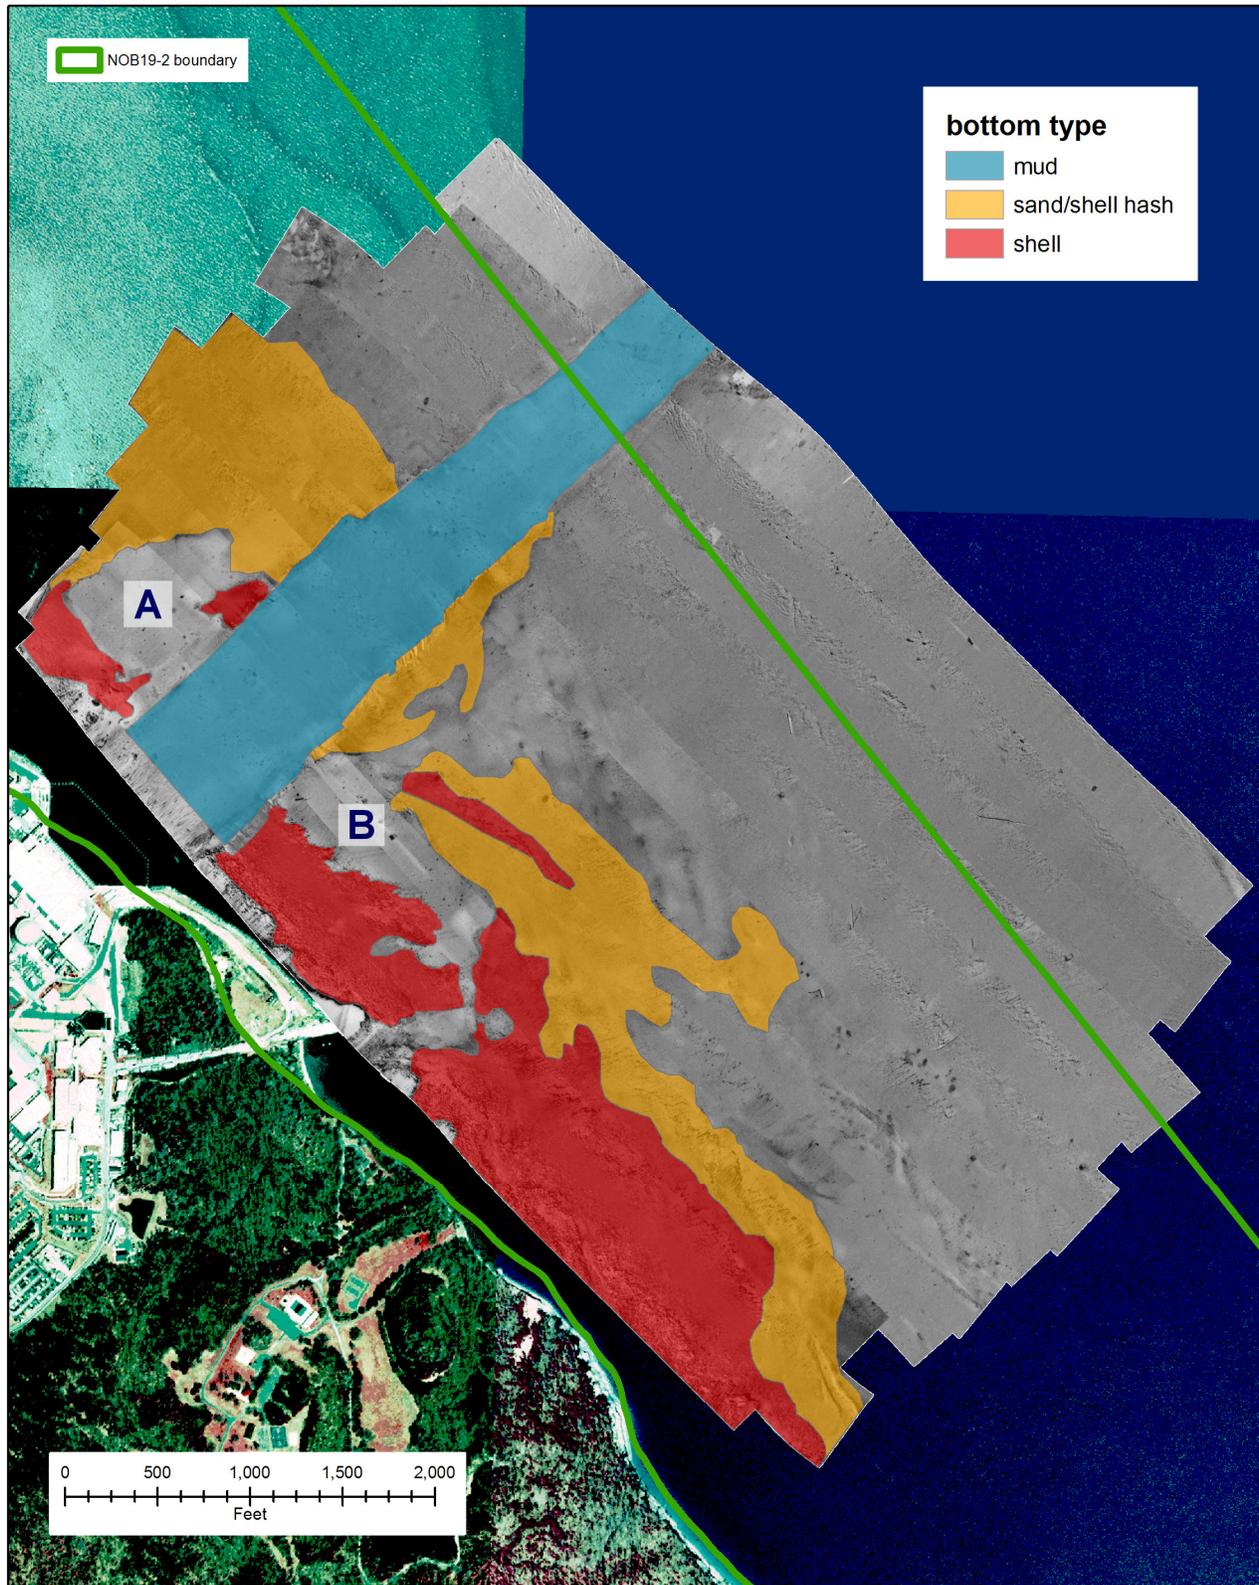
**Figure 6: Bottom-type polygons.** Polygons determined by side scan sonar imagery and seismic reflection coefficients.

Figure 6 presents an interpretation of bottom types based on acoustic survey data. Employing side scan imagery, seismic profiling and reflection coefficient data, polygons containing 3 major bottom types were constructed. The types are:

The red polygons near the shore represent significant reefs and shell deposits. These areas contain the highest quality oyster habitat in the study area. At least two market-sized live oysters were sampled in this bottom class. Water depth, currents and the presence of existing shell material are most favorable for oyster development within the red areas. Hard bottom is either shell on hard sand or hard clay. Both hard sand and clay will support shell deposits, unlike mud.

There are two notable, shell-free patches associated with the red polygons, marked "A" and "B" in Figure 5. These appear to be depressions in the shelly bottom, covered with sand, mud and hard-clay. Samples from these areas have a slight hydrogen sulfide odor indicating anoxic conditions at the time of sampling. It is unclear whether these areas were dredged at some point, or if they were scoured by prop wash or other man-induced activity. Patch B provides a sinuous path from the dock area on the shoreline, through the shell bottom to the intake channel to the north and to deeper water to the east. The field survey does not reveal the western extent of Patch A and whether it extends to the shore.

East of the red polygons are several orange polygons which delineate sandy bottom with significant shell content. Side scan sonar imagery suggests patches of shell on the surface within these areas, which may support living shellfish communities. Seismic data indicates this type of bottom once supported significant shellfish populations, and could provide habitat in the future. The presence of shell and shell hash at the surface is proof of bottom hard enough to support reef materials, and abundant calcium is available for shell formation. Additionally, seismic imagery reveals the presence of shell material just below the surface, an indication that old reefs have been covered by sand and shell hash. This buried material has the potential for being exhumed and reused to restore lost habitat. The shelly sand bottom within the orange polygons is interpreted as having once supported shellfish communities and is capable of restoration.
