Title: Tritium Identified in Emergency Service Water (ESW) Vault Unit(s): Oyster Creek, Unit 1

Event Date: April 15, 2009 Event Time: 15:38

Action Tracking Item Number: 00907846 Report Date: June 5, 2009

Root Cause Evaluation Report

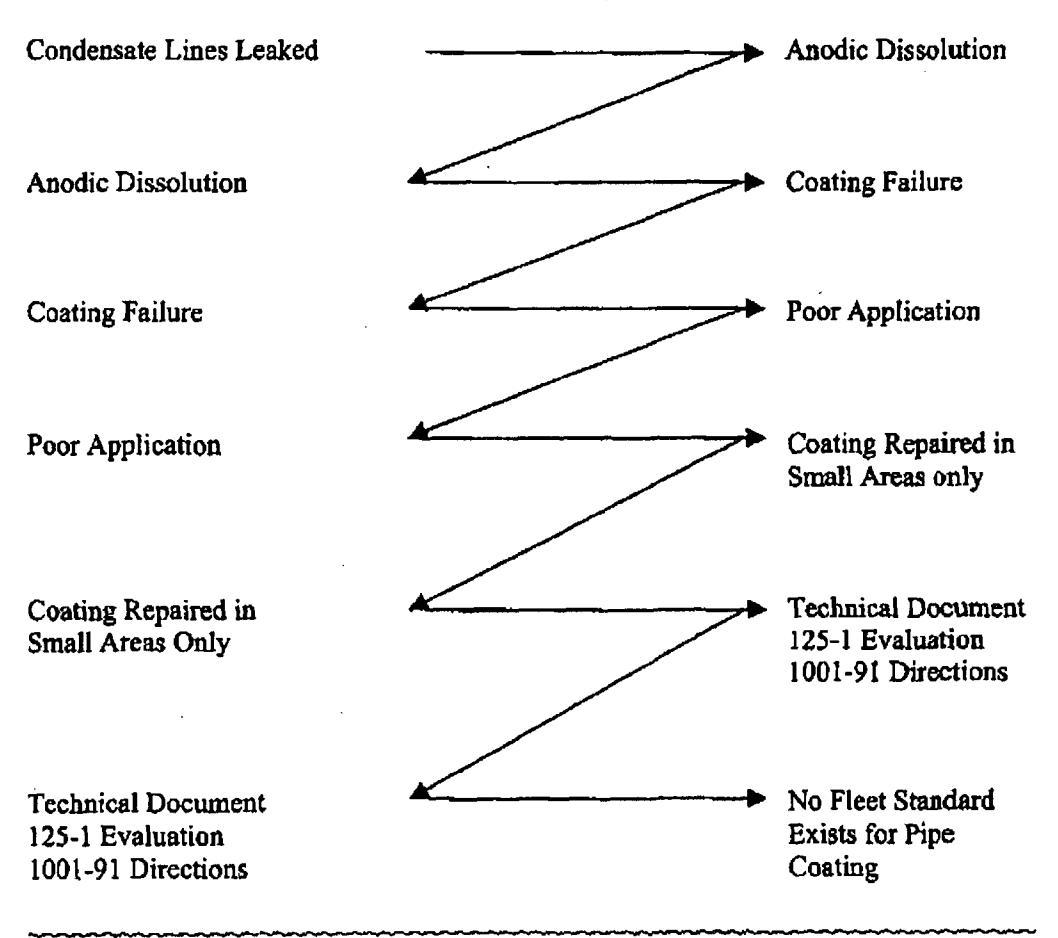
Attachment C: Event and Causal Chart

In conjunction with the above description and the Event and Causal Factor Chart (Attachment C of this report), the following causal factors were identified: 1) anodic dissolution resulting from disbondment of the coating and susceptible material; 2) a flawed program basis document; 3) inadequate work Instructions, documentation, and work quality; 4) the change management processes prior to implementing the Exelon Burled Pipe Program did not support effectively managing design changes and related projects during site ownership and management changes; and 5) limitations in available technologies used to assess pipe material condition.
