Subject: CONSOLIDATED EDISON COMPANY OF NEW YORK
(Indian Point Nuclear Generating Unit 2)

Re Indian Point Unit No. 2
Docket No. 50-247
Facility Operating
License No. DPR-26

In accordance with the discussion held on November 27, 1973 with Mr. Brunner of your office, this letter is to provide you with supplemental information concerning the incident which occurred at Indian Point Unit No. 2 on November 13, 1973.

Feedwater Piping to No. 22 Steam Generator

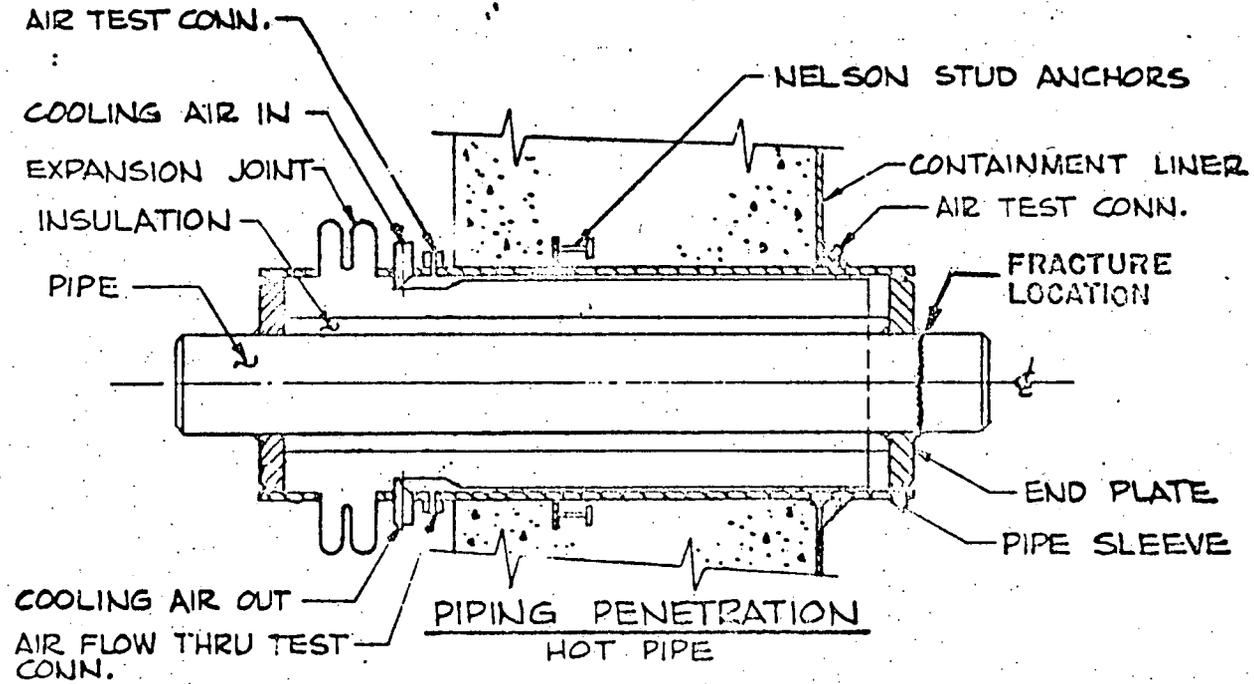
A visual inspection of the 18-inch diameter feedwater line inside containment indicated a fracture adjacent to a fillet weld between the feedwater line and the end plate which is welded into the penetration sleeve in the containment wall. The fracture extended approximately 180° around the pipe. The origin of the fracture was at the 3 to 4 o'clock position (from inside the containment when facing the containment wall). At the 3 to 4 o'clock location, the fracture was at the toe of the fillet weld. The fracture appeared to have propagated up to the 12 o'clock position, and down to the 6 o'clock position, and its path led away from the toe of the weld approximately 1/2 inch. Immediately above the 3 o'clock position, a short branch of the crack traveled along the toe of the weld.

The fractured portion of the pipe was offset from that portion remaining in the penetration so that at the 12 o'clock and at the 3 o'clock positions, it was raised 1/4 of an inch. The maximum measured width of the crack was 5/32 of an inch.

1. The failed section of feedwater piping has been removed and is being replaced with a new section of feedwater piping. The section to be replaced extends from the first elbow outside of containment, through the penetration, to near the first elbow inside containment (see Figure A attached to this report). In addition, the containment penetration end plates and expansion joint are being replaced. The undamaged containment penetration sleeve and penetration cooling coil will be retained.
2. As mentioned previously, the feedwater regulating valve in the feedwater line to Steam Generator No. 22 has been removed and sent to the vendor for inspection and maintenance as necessary.
3. All damaged or removed insulation will be replaced or repaired as necessary.
4. All piping supports and other components and/or structures removed for access will be reinstalled.
