# UNITED STATES OF AMERICA NUCLEAR REGULATORY COMMISSION

In the Matter of Tennessee Valley Authority Bellefonte Nuclear Power Plant Units 1 and 2 Construction Permits CPPR-122 and CPPR-123

Docket Nos. 50-438 and 50-439

# JOINT PETITIONERS' SUPPLEMENTAL BASIS FOR PREVIOUSLY SUBMITTED CONTENTION 6 – TVA HAS NOT AND CANNOT MEET THE NRC'S QUALITY ASSURANCE AND QUALITY CONTROL REQUIREMENTS

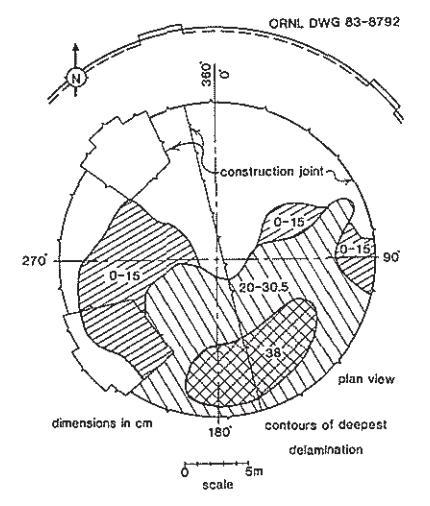
Concrete cracking and grease leakage were noted at various locations on the dome surface, predominately in the southern portion as shown in Fig. 3, after tensioning of approximately two-thirds of the dome tendons at Turkey Point Nuclear Power Plant (Unit 3) [12]. After a thorough examination of the concrete materials, construction method and prestress tensioning sequence, it was concluded that the dome delaminations were caused by the combined action of inadequate concrete consolidation and weakness at construction joints. Some engineers at NRC, however, believe that the delaminations were caused by exceeding the radial tensile strength of "weak" concrete and that well designed radial reinforcing would help prevent the situation from repeating in the domes of similar containments.

Fig. 3. Extent of dome delamination in Unit 3 containment at Turkey Point.

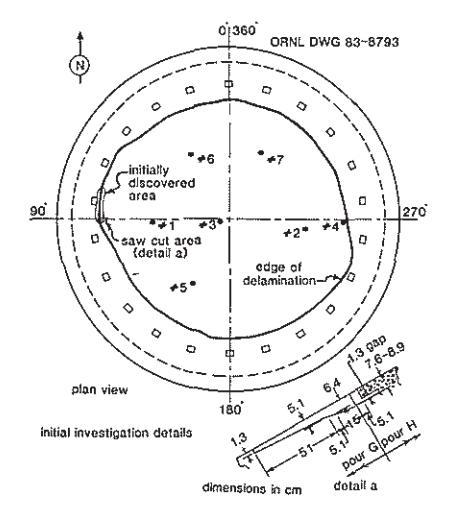
In April 1976, surface cracking and voids in the dome concrete at Unit 3 of Crystal River Nuclear Power Plant were discovered (by accident) after the dome had been constructed

and fully post-tensioned (Fig. 4) [13]. Primary causes of the delaminations were thought to be the use of low quality coarse aggregate materials accompanied by high radial tension forces above the top tendons, and compression-tension interaction. Other potential contributing factors were tendon misalignment and construction methods. Corrective measures included detensioning of some of the tendons, removal of the delaminated cap, installation of top orthogonal and radial reinforcing, and installation of a new cap concrete.

Fig. 4. Extent of dome delamination in Unit 3 containment at Crystal River.
