U.S. NUCLEAR REGULATORY COMMISSION REGION I

Report No50-247/86-19	
	Docket No	
	License No. DRP-26	
	Licensee: <u>Consolidated Edison Company of New York, Inc.</u>	
	Broadway and Bleakley Avenue	
-	Buchanan, New York 10511	
	Facility Name: Indian Point Nuclear Generating Station Un	it 2
	Inspection At:Buchanan, New York	·
	Inspection Conducted: July 21 - August 1, 1986	·
	Inspectors:	9/10/8/
)	Jon R Johnson for J. W. Chung, Lead Reactor Engineer	<u>9/10/86</u> date

EXECUTIVE SUMMARY

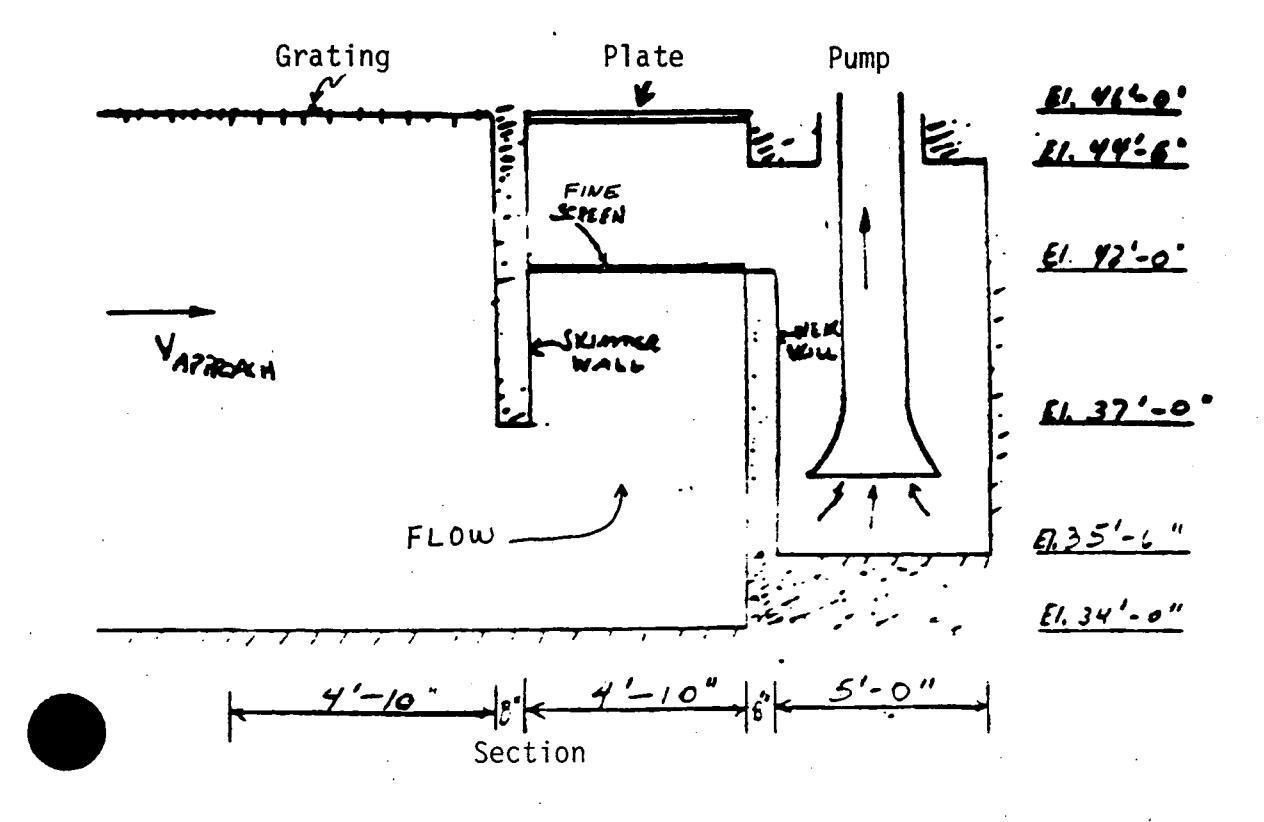
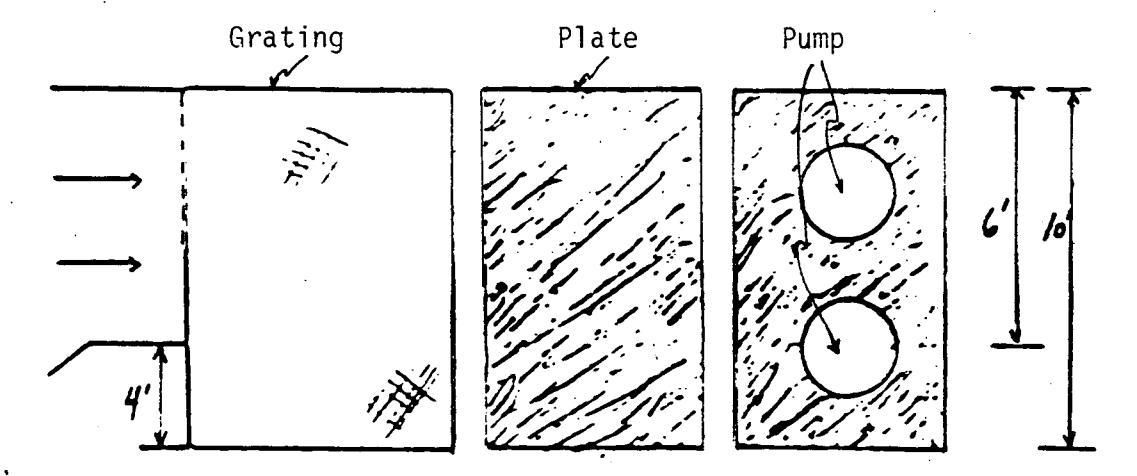
Figure 4.8.1 Recirculation Sump Arrangement

The inspector reviewed modification No. MPC 82-11004-10 which changed recirculation sump level instrument LT 939 in December 1982. At that time QC inspection records indicated that floor grating and floor plating were installed in accordance with drawings.

The inspector also reviewed the last four completed Station Operating Procedures (SOP) 10.6.2 Containment Entry and Egress, Revision 18. No abnormal conditions were indicated on March 12, June 5, July 7 and July 15, 1986. The inspector also reviewed PI-BW1, Revision 3, Containment Building Inspection for Anomalous Conditions, conducted on March 20, 1986 and PI-M2 Containment Building Revision 0 (replaced PI-BW1), completed on May 25, 1986. None of the above inspections
