Indian Point Unit No. 2 Docket No. 50-247

## Steam Generator Examination

## Program and Results

Consolidated Edison Company of New York, Inc. Indian Point Unit No. 2 Docket No.50-247

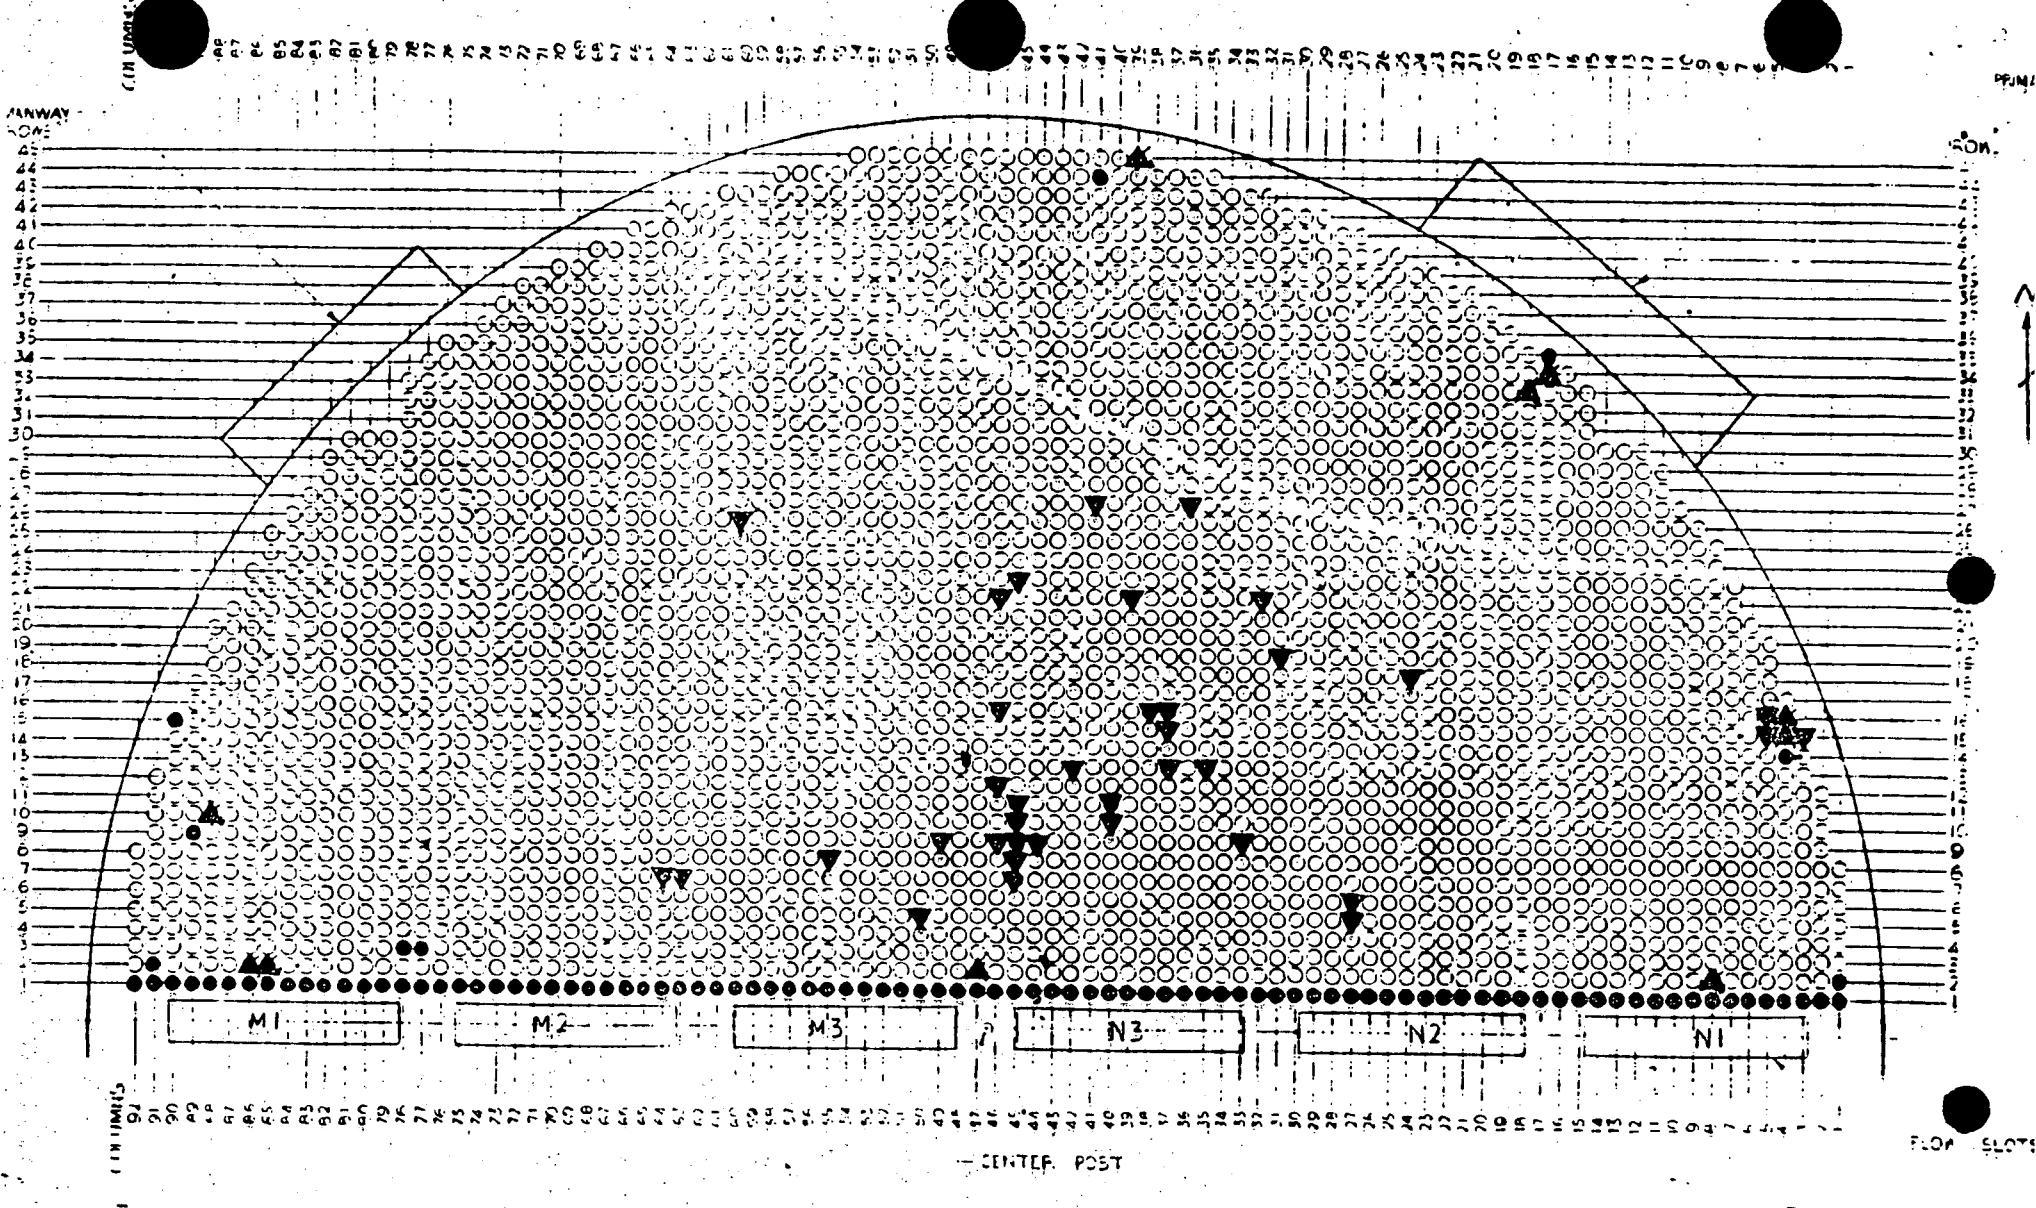
## \*21 STEAM GENERATOR TUBE IDENTIFICATION LAYOUT

The steam generator with the most indications was No. 21, which had 38 tubes with indications in excess of 40%. This comprises about 1.2% of the active tubes in Steam Generator No. 21, and results in a C-3 categorization, prior to plugging. Steam Generator No. 21 is the only steam generator which may be characterized as category C-3 in light of the complete inspection results.
