SUBJECT: INSPECTION REPORT NO. 70-0027/2010-201 AND NOTICE OF VIOLATION

Docket No.:	70-27
License No.:	SNM-42
Report No.:	70-27/2010-201
Licensee:	Babcock and Wilcox Nuclear Operations Group, Inc.
Location:	Lynchburg, VA
Inspection Dates:	January 25-29, 2010
Inspectors:	Dennis Morey, Senior Criticality Safety Inspector
	Christopher Tripp, Senior Criticality Safety Inspector

Babcock and Wilcox Nuclear Operations Group, Inc. NRC Inspection Report 70-27/2010-201

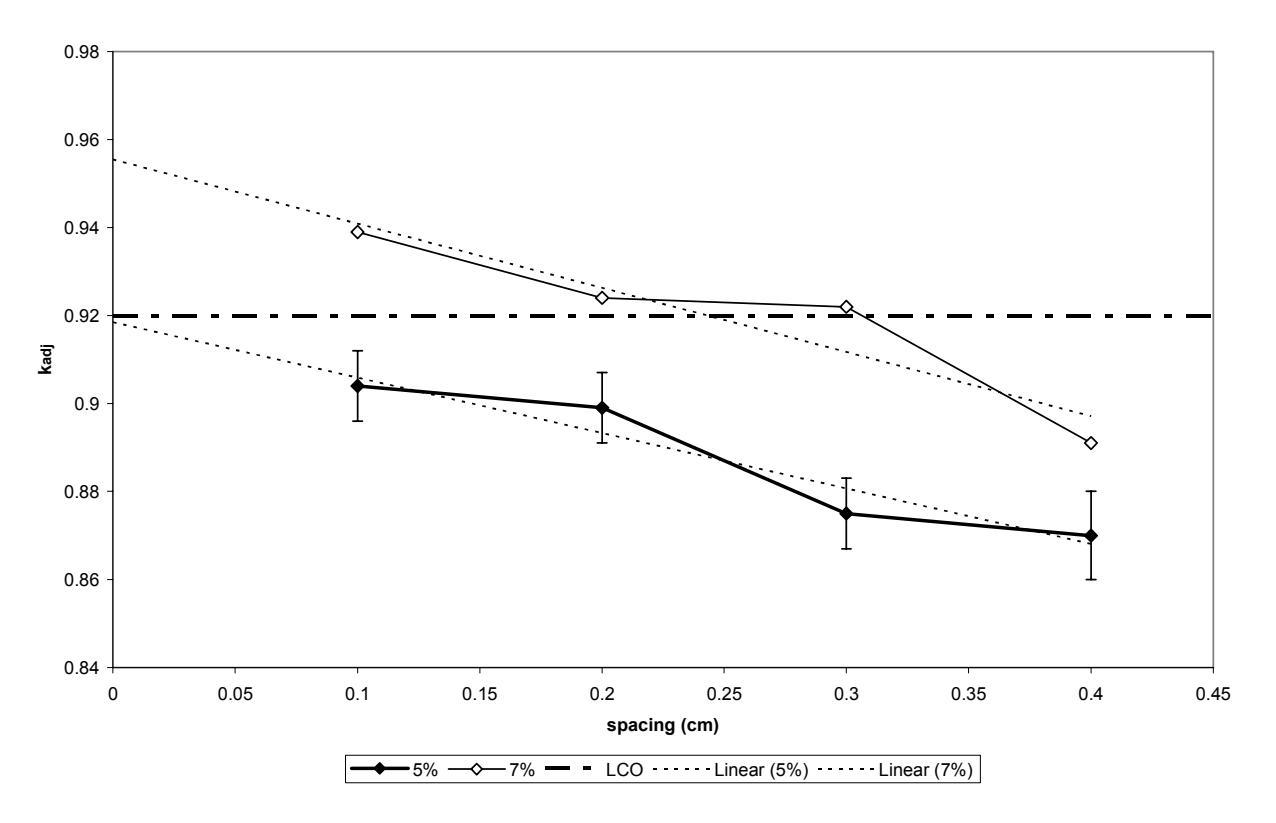
kadj vs. spacing

The inspectors reviewed a licensee Safety Concern Analysis (SCA) for an incident involving the bowing of fuel stored on a vertical fuel cart in RTRT. Current analysis (NCS-1986-024) requires the fuel to be stored at least 0.1" apart, but bowing allowed the fuel to be closer than 0.1" at the ends. The SCA determined that the spacing restriction was not necessary, as the allowed number of elements would be subcritical with any degree of interstitial moderation, even if they were in contact (i.e., spacing reduced to zero). The inspectors determined that the licensee had extrapolated to a spacing of zero from four prior calculations performed with spacing from 0.1 to 0.4". The inspectors note that the licensee extrapolation range was approximately 1/3 of the total range covered by the data, that the equation of the linear fit was not provided, and that the uncertainty in the extrapolation or the linear correlation coefficient of the regression

fit was not discussed. The licensee stated that it had not extrapolated the data rigorously because it expected that k_{eff} will decrease as spacing is reduced to zero. While this is likely, it is also possible that k_{eff} reaches a maximum at some nonzero value less than 0.1".

With regard to interstitial moderation, the licensee stated that it had originally believed that 5% was bounding but, upon further examination, an optimum value of 7 - 10% should have been used. Based on the prior analysis, increasing interstitial moderation from 5 to 7% results in an increase in k_{eff} of ~3%. The limiting condition for operation (LCO) as specified in the license application, for this high-enriched system, is:

The licensee's extrapolation at 5% interstitial moderation, the corresponding curve at 7% interstitial moderation, and the LCO value are shown in the figure below:

Because there were no controls to limit the maximum amount of interstitial moderation, an optimum value should have been chosen for the extrapolation. Failure to adequately demonstrate subcriticality under bounding moderation and spacing conditions for bowed fuel on the RTRT vertical spacing cart is **Violation VIO 70-27/2010-201-02**.

Following discovery of the bowed fuel, the licensee had issued Corrective Action CA200903655, dated December 14, 2009. Immediate corrective actions included completion of an SCA to justify continued operation of the carts. Operations of the cart

have continued under the existing limits and postings. Long-term corrective actions included completion of a formal NCS analysis to verify that the spacing between elements does not need to be controlled when the effect of interstitial moderator is taken into account. The inspectors noted that the long-term corrective actions are pending.
