RS-10-094

Braidwood Station, Units 1 and 2
Facility Operating License Nos. NPF-72 and NPF-77
NRC Docket Nos. STN 50-456 and STN 50-457

Byron Station, Units 1 and 2
Facility Operating License Nos. NPF-37 and NPF-66
NRC Docket Nos. STN 50-454 and STN 50-455

Subject: Additional Information Supporting License Amendment Request to Change Fire Protection Program Requirements for Upper Cable Spreading Rooms

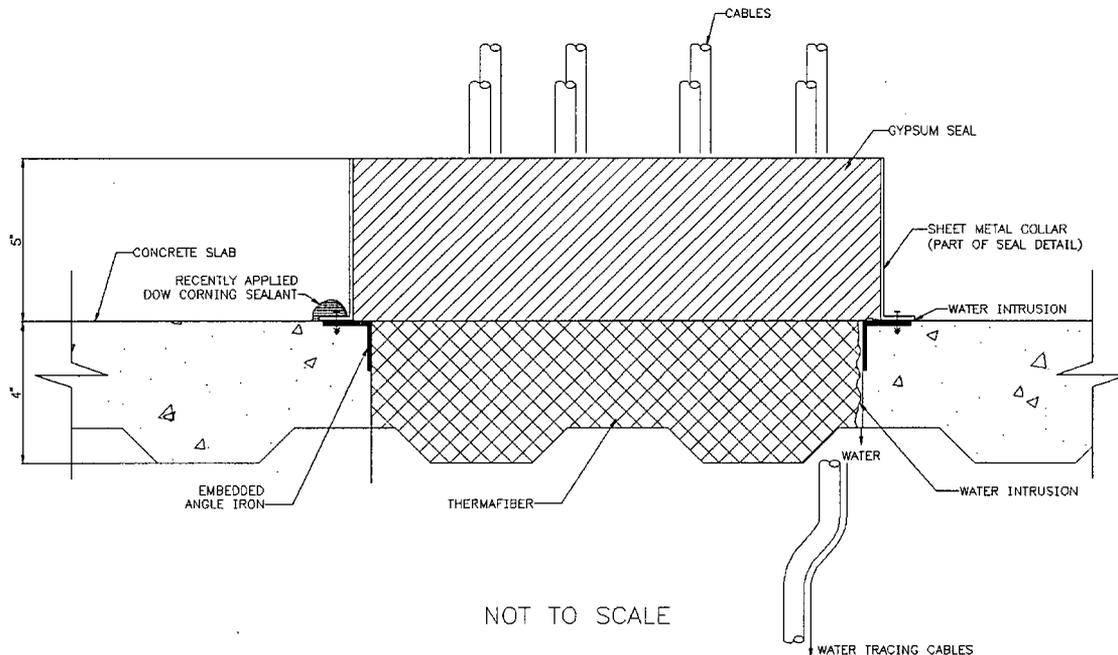
Figure: Typical UCSR Cable Riser Floor Seal

The configuration of a typical cable riser floor fire seal in the UCSRs is shown in the figure below. The configuration of the subject fire seals consists of a 5" high, 18 gauge, sheet metal collar anchored to the floor surrounding the floor opening. The collars are approximately 1" to 2" longer and wider than the opening, creating a horizontal overlap between the gypsum and the concrete. During installation, damming material was installed inside the opening below the collar, and the gypsum material was then poured into the collar, starting flush with the surface of the concrete floor, overlapping the concrete horizontally approximately 1" to 2" around the perimeter of the seal, and rising up within the collar to form a seal around the penetrating items. The installed gypsum overlaps the opening on each side, but does not extend below the top surface of the floor into the opening.

The seals have been qualified as 3-hour fire seals per IEEE 634, "Standard Cable-Penetration Fire Stop Qualification Test," and ASTM E119, "Standard Test Methods for Fire Tests of Building Construction and Materials." The fire seal testing included multiple hose stream tests per ASTM E119, which verified that a hose stream would not dislodge a fire seal and would not project water beyond the unexposed surface of the fire seal. Note that these fire seals are also rated as ventilation seals; however, these seals do not have a flood seal rating.

Recently, two instances of water leakage at Byron Station from the UCSRs into either the MCR or the Unit 1 AEER were documented in IRs 934040 and 1046792. These IRs were initiated on June 23, 2009, and on March 24, 2010, respectively. Water leakage from hose stations resulted in some quantities of standing water on the UCSR floor. The standing water was able to migrate between the metal surfaces of the concrete embedded angle iron and the sheet metal fire seal collar. The seal installation details, as shown in the above figure, call for the gypsum seal to overlap the surface of the concrete opening. It is this interface that eventually allowed water to pass through the seal. The standing water then leaked into the MCR or AEER. The identified leakage path was at the fire seal-floor interface, and not through the depth of the poured gypsum.

A potential leak path for the standing water would be through the interface between the collars and the floor. However, actions are being taken to caulk this interface to address the concern about water leakage through the collar/floor interface. Since water levels above the top of the curbed openings or fire barrier collars are not expected, the caulked fire/ventilation seal configuration will be sufficient to prevent potential water intrusion/leakage events during normal plant operation (i.e., postulated line breaks or hose station leakage) and during fire fighting conditions where water spray may be used.

Since the recent events at Byron Station, both stations have taken actions in accordance with the Corrective Action Program to improve the water resistance of the UCSR floor penetrations. Byron Station recently completed the process of applying sealant at the floor to collar interfaces, bolt holes, and vertical seams. During this process, additional potential sources of in-leakage (i.e., conduit sleeves, ventilation ducts, and support base plates with through-bolted floor attachments) were also sealed.

The fire/ventilation seal configuration was modified at Braidwood Station in 1987 via the design change process due to water leakage issues identified during original construction activities. The design change added a requirement to provide a sealant at floor to collar interfaces, bolt holes, and vertical seams to provide a barrier to prevent water intrusion/in-leakage. This requirement is documented on drawing 20E-0-3600, Note 208 BR, and was implemented in 1987. Additionally, sealant was also applied to various ventilation and equipment hatch configurations during this evolution. The application of this sealant eliminates the leakage/seepage paths between the collar to floor interfaces. Additional information regarding the 1987 Braidwood Station events is provided below in response to NRC Request 9.c, along with a discussion of Byron Station's review of the events.
