UNITED STATES NUCLEAR REGULATORY COMMISSION REGION II 245 PEACHTREE CENTER AVENUE NE, SUITE 1200 ATLANTA, GEORGIA 30303-1257

July 2, 2010

# SUBJECT: H. B. ROBINSON STEAM ELECTRIC PLANT – AUGMENTED INSPECTION TEAM REPORT 05000261/2010009

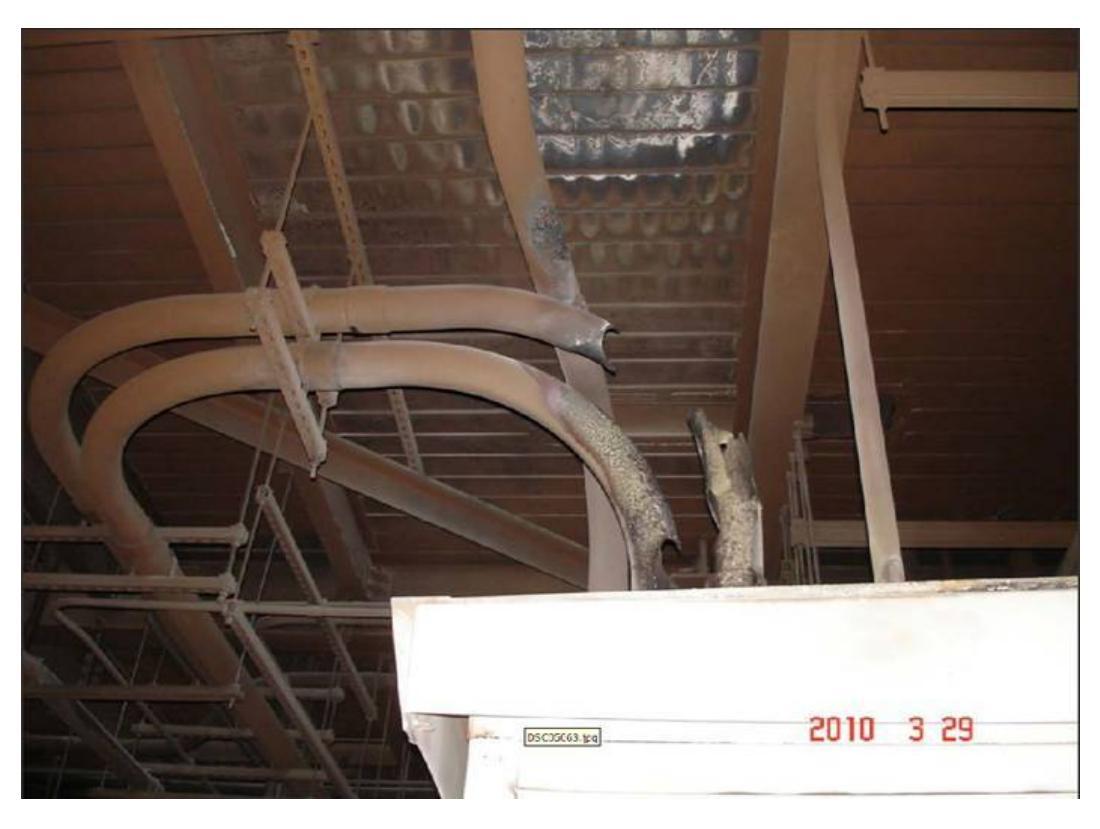
The second electrical fault and fire, which also damaged plant equipment, was caused by inappropriate recovery actions following the first fire. At 21:26 operators transitioned from the EOPs to General Plant Procedure (GPP)-004, Post Trip Stabilization. At 22:34 operators attempted to reset the generator lockout relays per GPP-004. Because the UAT sudden pressure trip signal still existed, attempting to reset the generator lockout relays caused another fast transfer of 4 kV Bus 4 from the UAT to the SUT, reenergized Bus 4, and caused a fault at breaker 52/24. The electrical fault and corresponding arc flash damaged surrounding equipment. Breaker 52/19 opened on over-current, cleared the fault, and ended the second fault event. Figure 4 below is a photograph showing damage to Bus #4 resulting from the second fault event.

Figure 2 – Damaged Conduits from Bus #4 to Bus #5

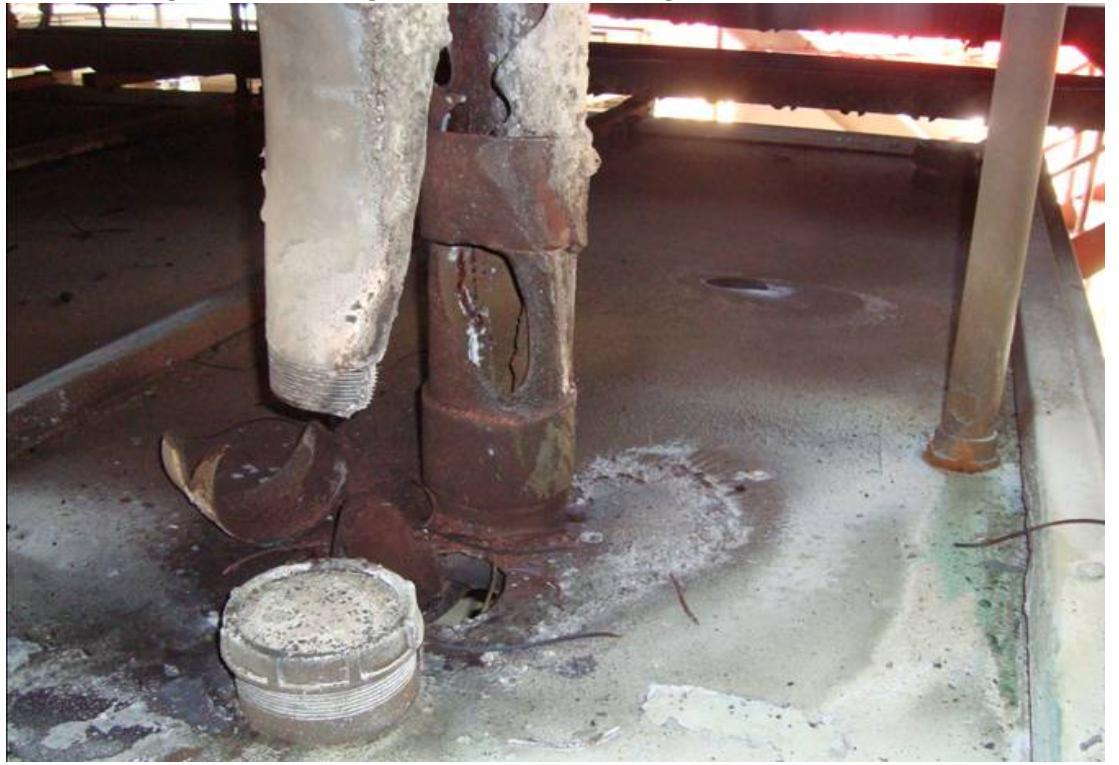
Figure 3 – Damaged Conduits Entering the Top of the Bus #5

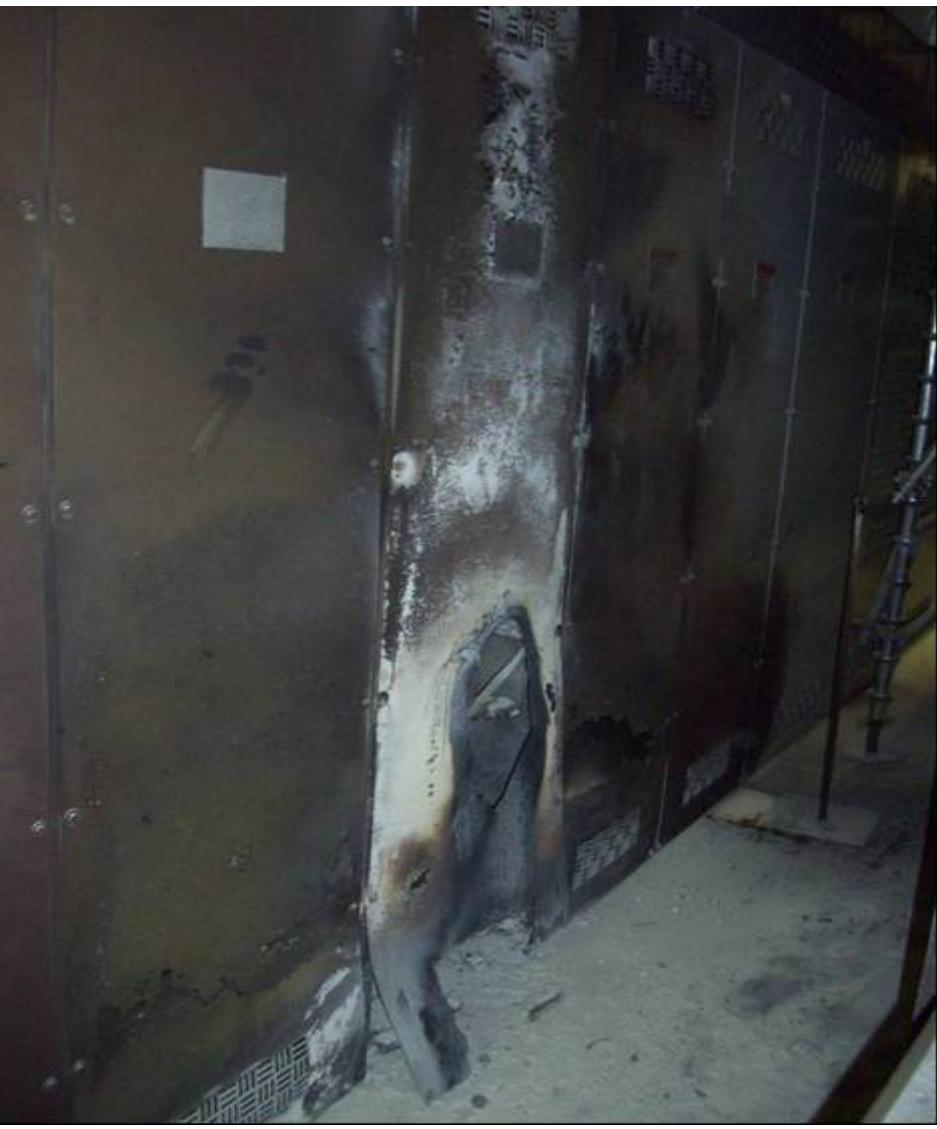
Figure 4 – Back of Bus #4 Containing Breaker 52/24

A secondary fault at the Bus 4 cable compartment for circuit breaker 52/24 was caused by plasma gas migrating inside the conduit and through a hole in the conduit seal, along with terminations that were not taped. The ERT postulated that the hole was caused by pressure built up in the conduit as a result of the fault. The ERT further postulated that this secondary fault at circuit breaker 52/24 created permanent degradation of the insulation at that location. All of the cable within the compartment was completed destroyed when Bus 4 was reenergized about four hours after the initial fault was cleared.
