Re: Mine Unit 5 Response, Irigaray–Christensen Ranch In Situ Operations, Permit No. 478

Uranium One Americas (Uranium One) has prepared this excursion status report for Monitor Well 5MW66 at the Irigaray–Christensen Ranch Project. A corrective action plan was previously submitted to the Wyoming Department of Environmental Quality-Land Quality Division (WDEQ-LQD) that proposed implementation of a phased approach to delineate and to recover (if necessary) the excursion identified at Well 5MW66, located downgradient of Mine Unit 5 (MU5). A follow-up phase of additional monitoring proposed on August 13, 2010 has been completed. Results and interpretation of the additional monitoring are summarized in this status report. Further corrective actions are proposed in this report. A summary of the phased corrective action plan is also provided at the end of this status report.

Table 1. Monitoring Results 5MW66 Excursion Investigation, Mine Unit 5, Christensen Ranch, Wyoming

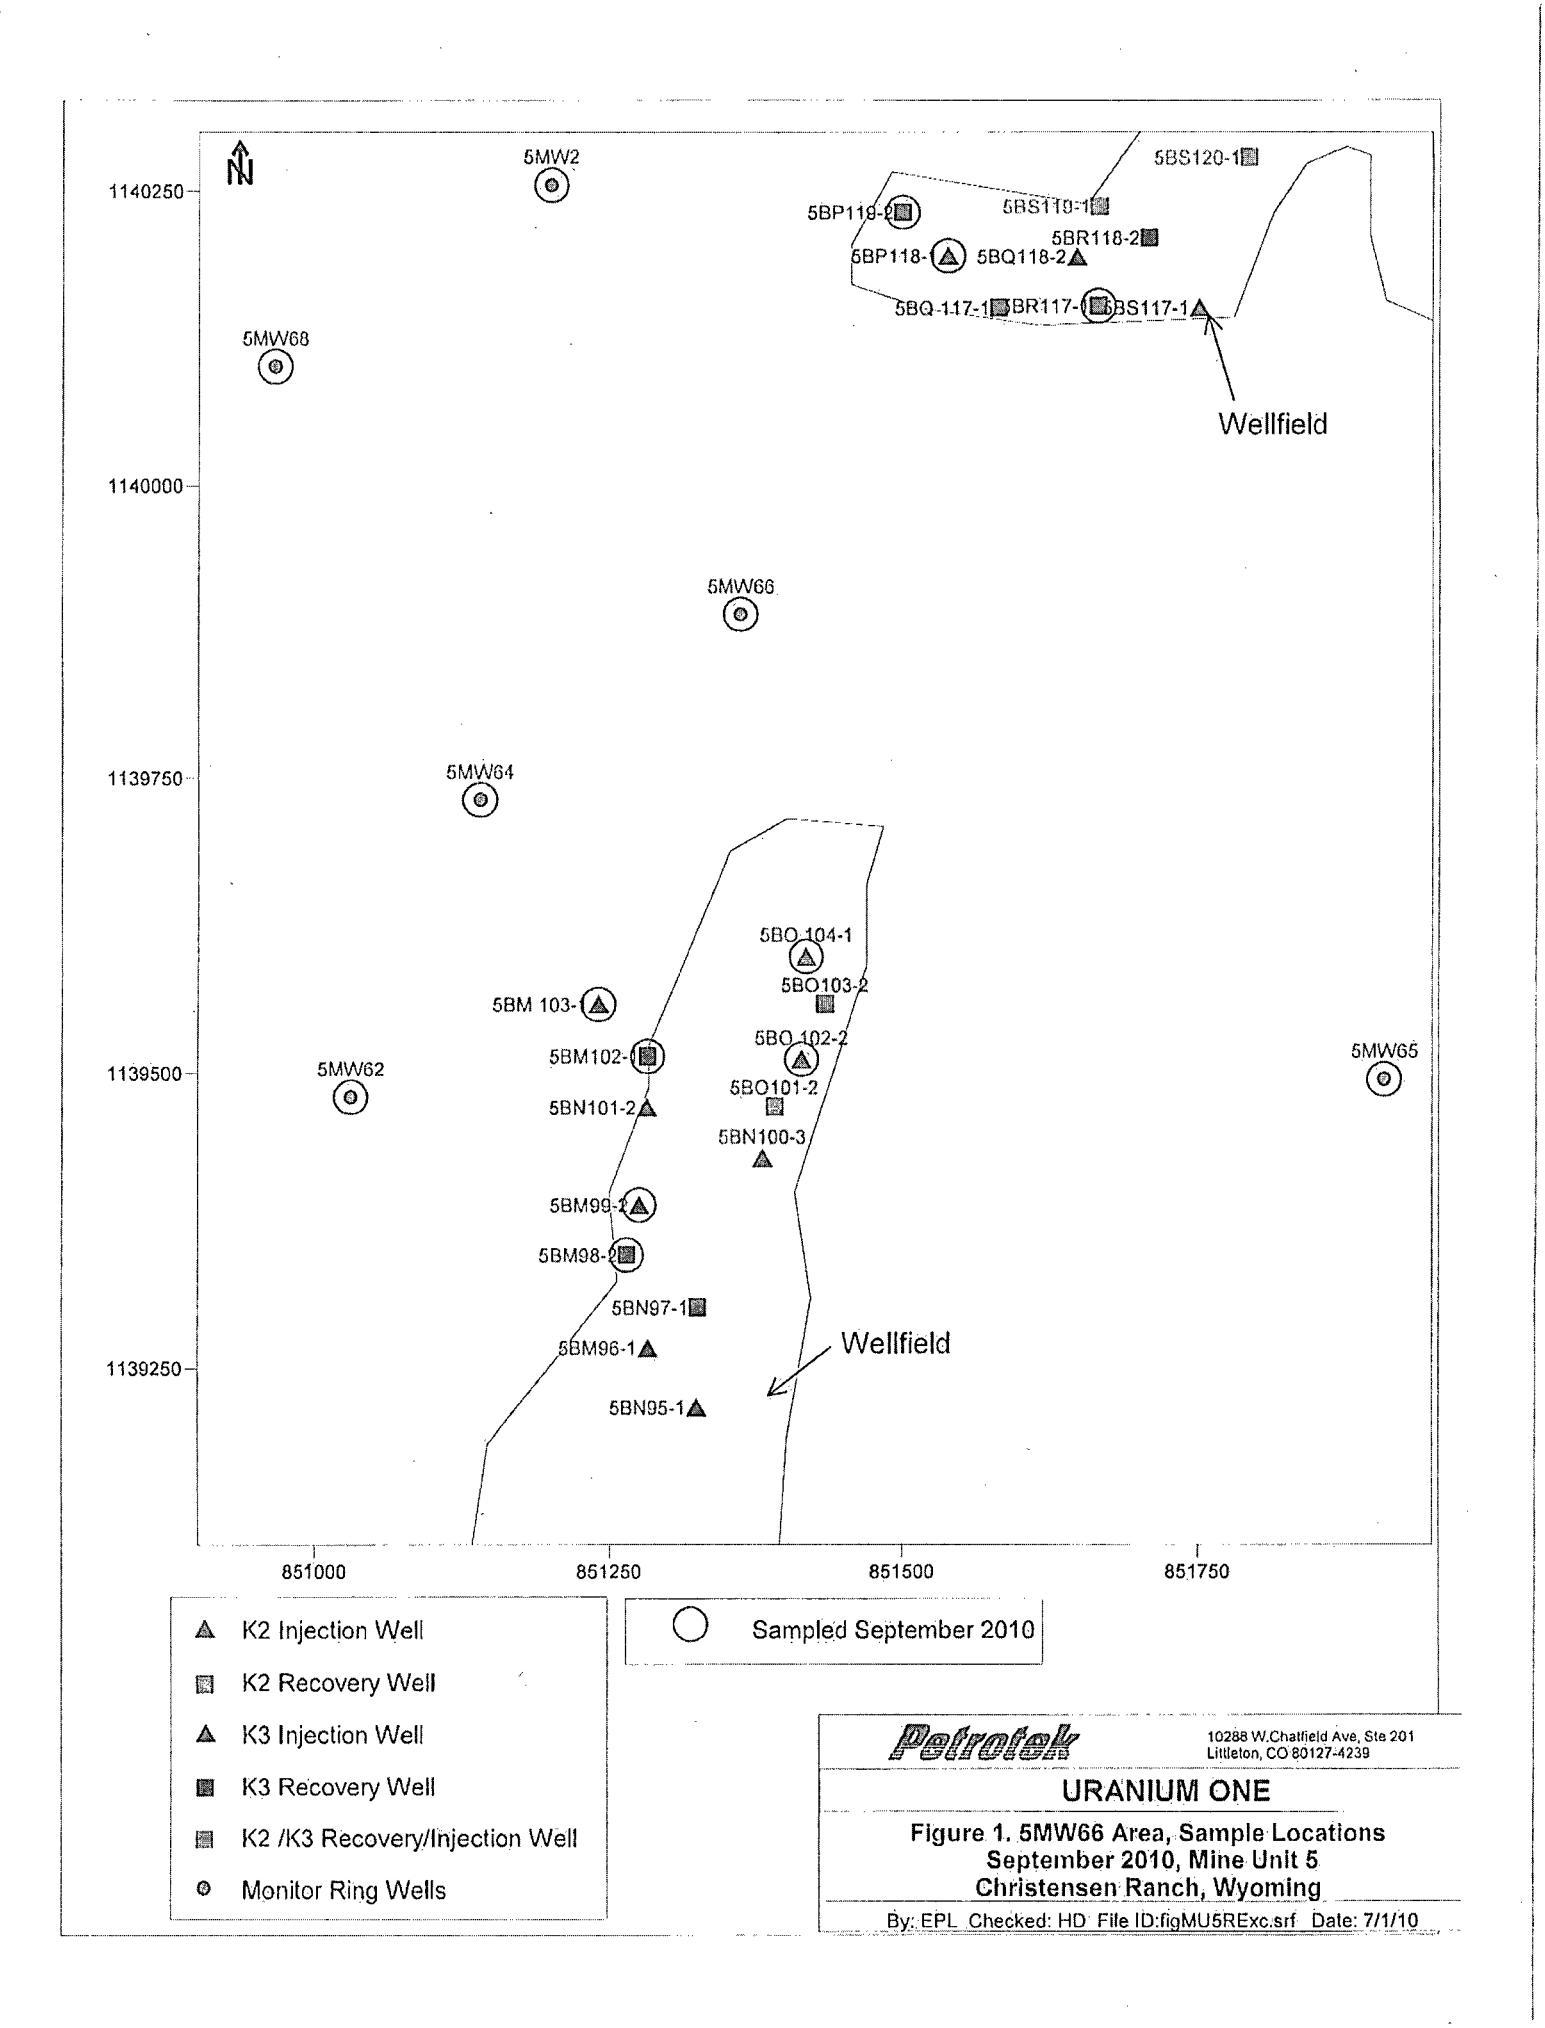
Figure 1 shows the location of all the sampled wells. Results of the June and September monitoring are included in Table 2. The chloride, conductivity, alkalinity, uranium and pH data from the wells were plotted and contoured. Potentiometric surface maps were developed from water level data collected at the time of sampling.

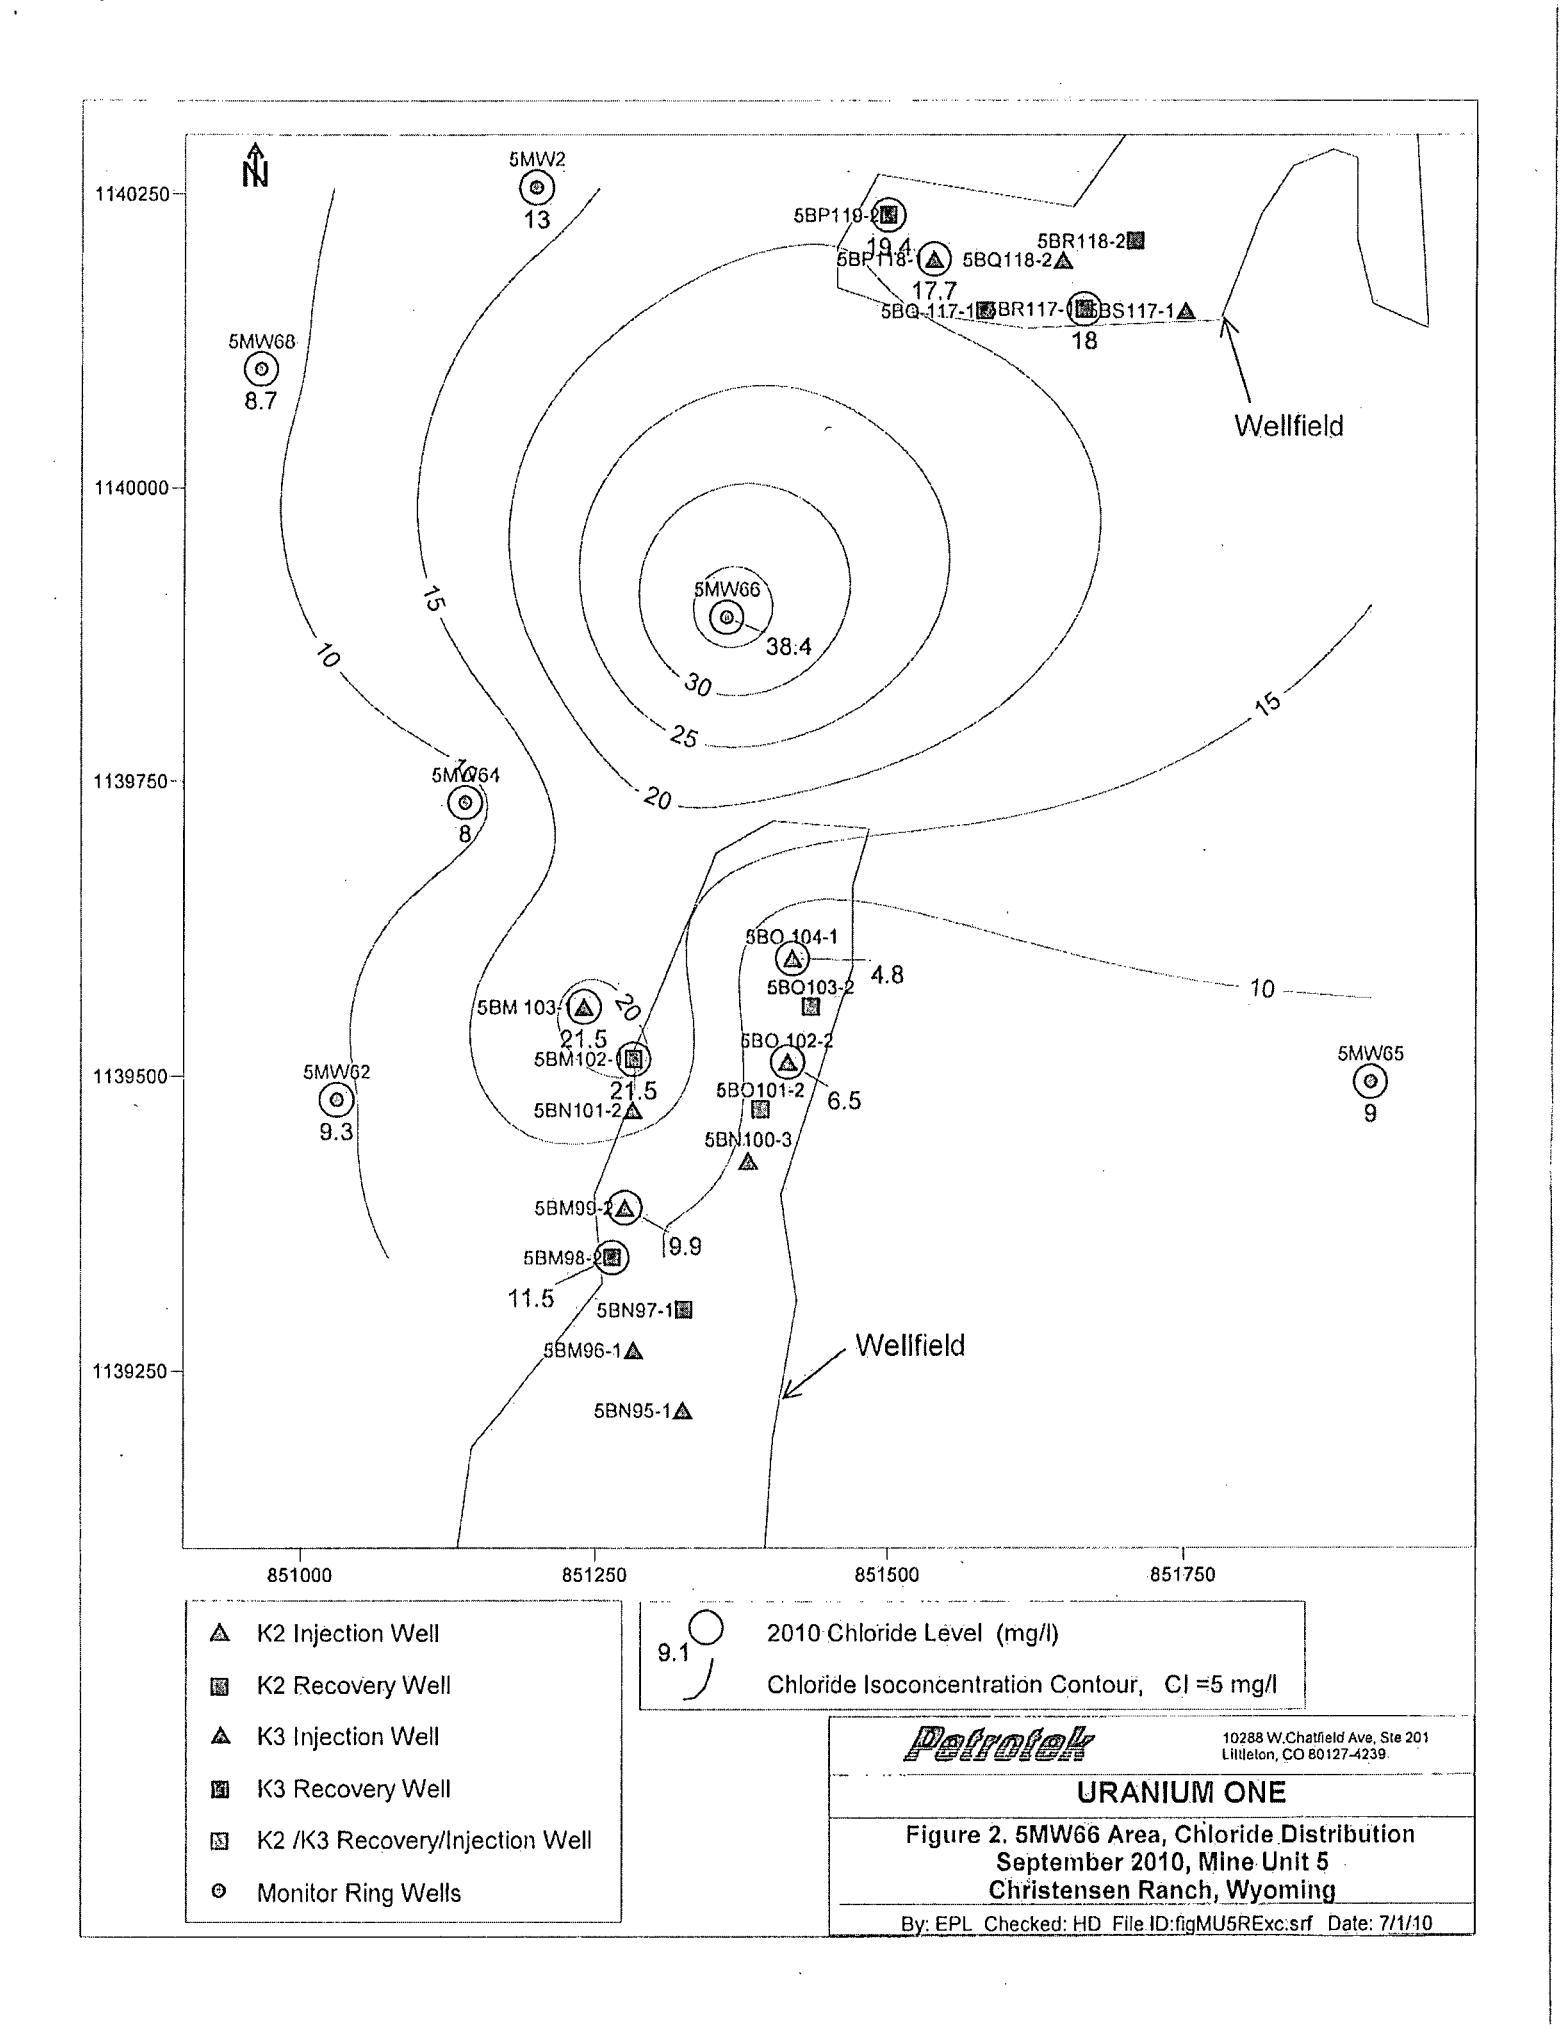
Figure 2 shows the distribution of chloride in the vicinity of Well 5MW66 for the September 2010 sampling round. Well 5MW66 has the highest concentration among the sampled wells, although wells 5BM103-1, 5BM102-1, 5BR117-1, 5BR118-2 and 5BR119-2, located along the western edge of the MU5 wellfields, and completed across the "K3" Sand, also had relatively elevated chloride levels. No wells have been identified within the wellfields northeast and southeast of Well 5MW66 that have values as high as those observed at well 5MW66.

The distribution of chloride, conductivity and alkalinity suggest that the extent of the excursion is generally focused in the area around Well 5MW66.

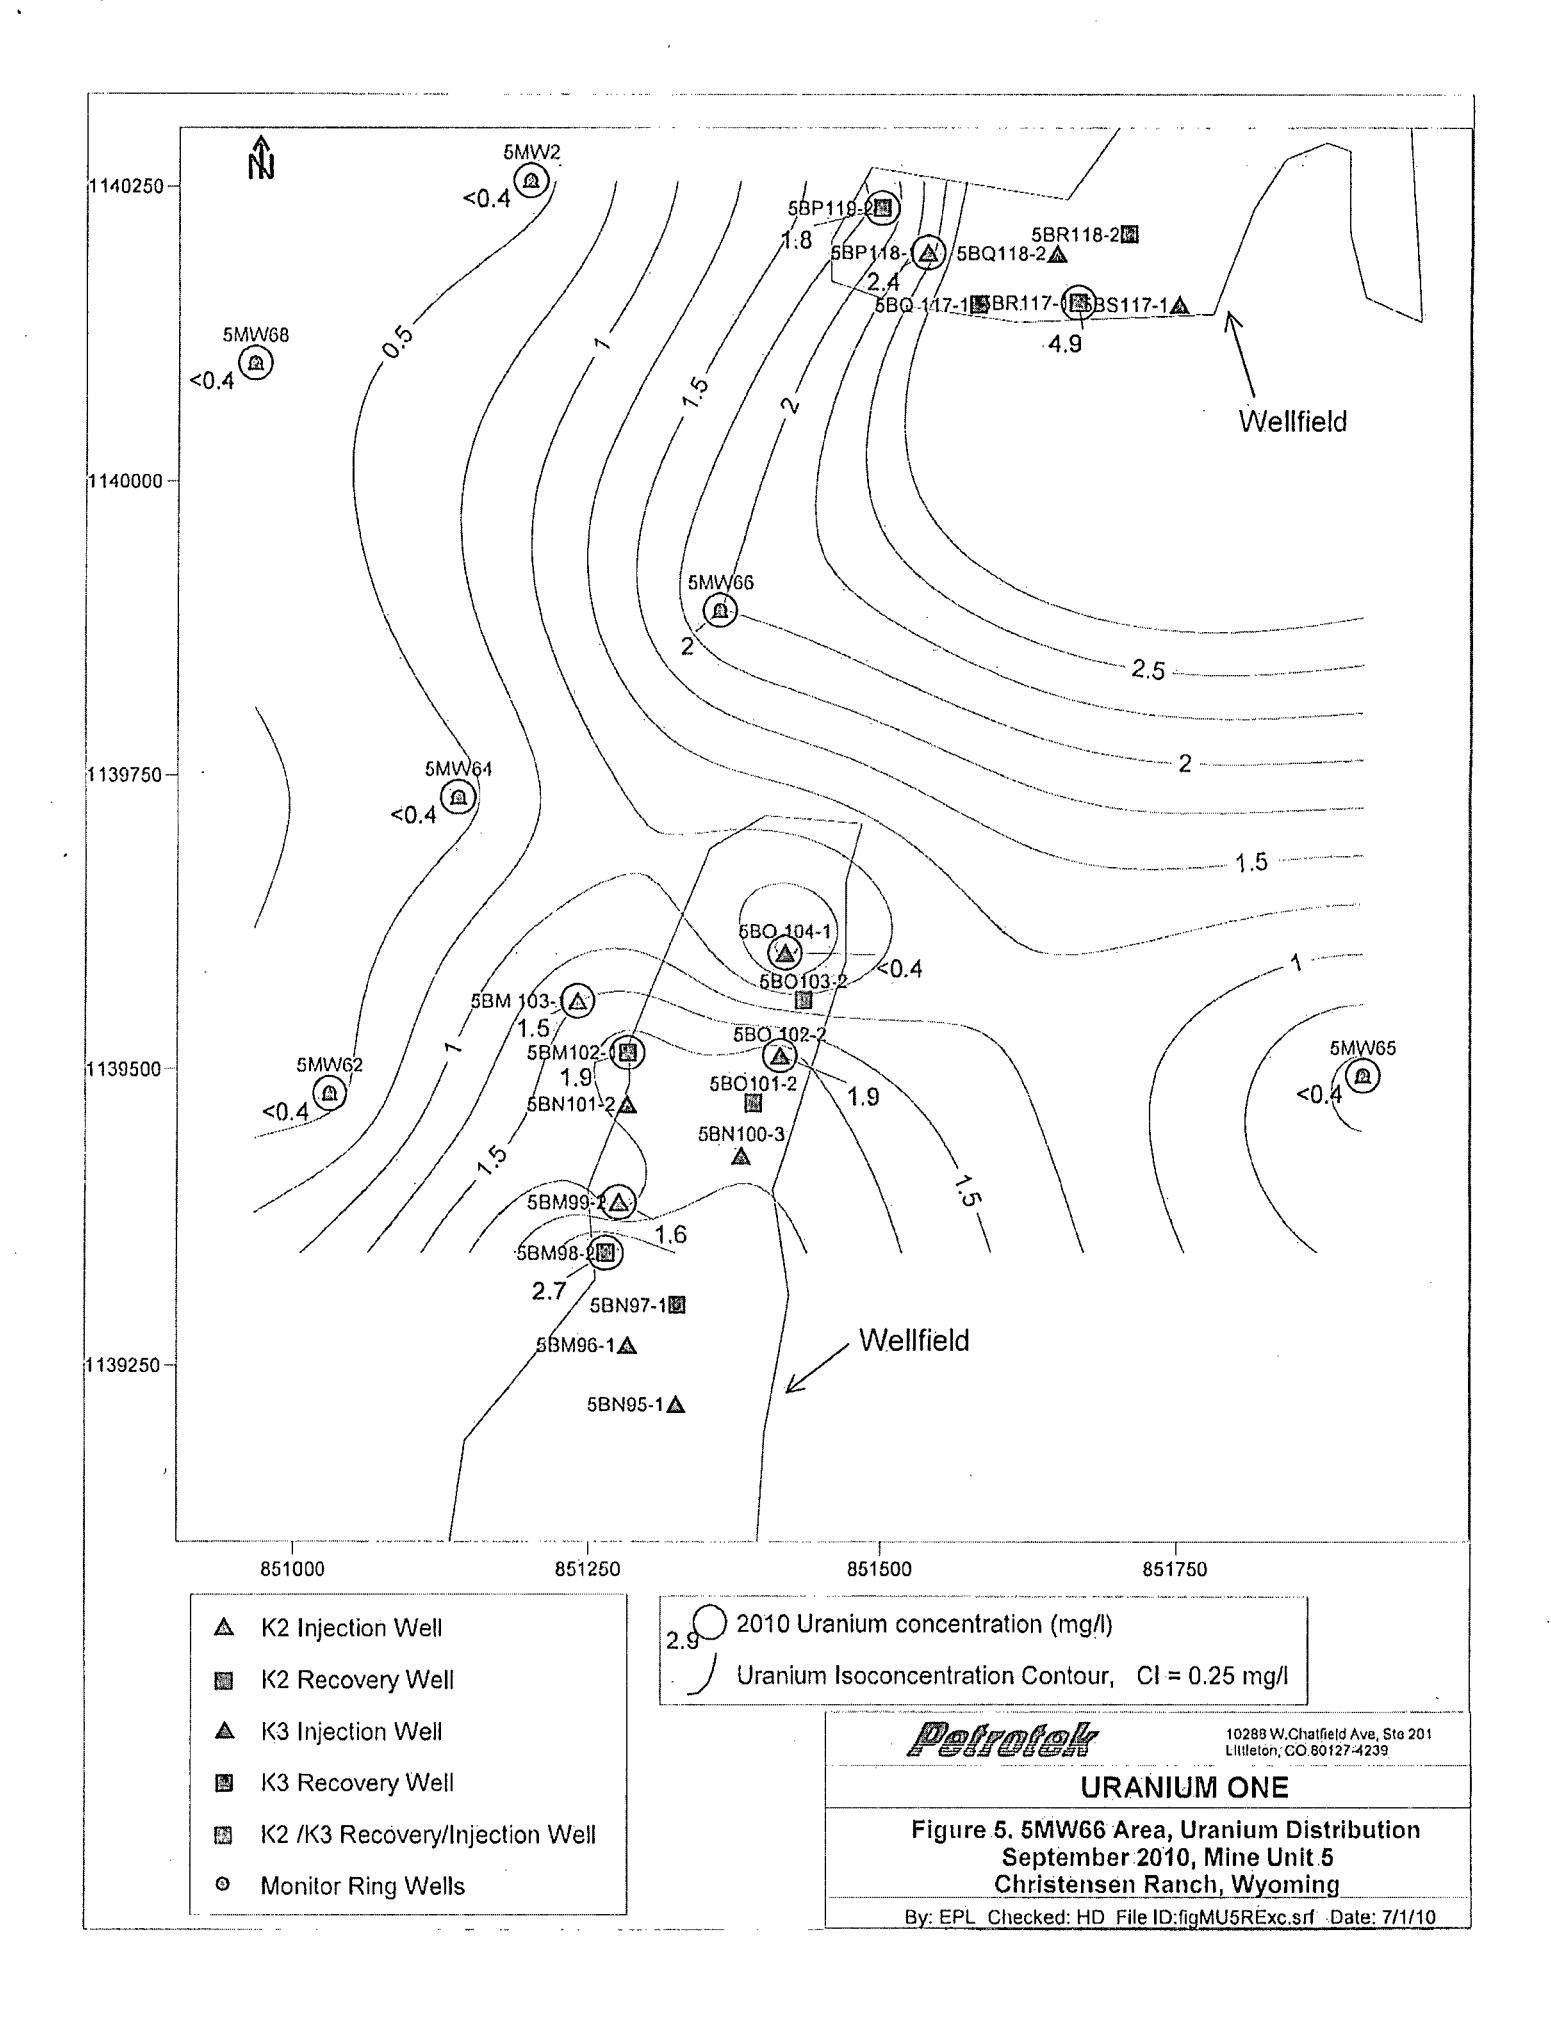
The distribution of uranium for September 2010 indicates that all of the production/injection wells sampled (except for K2 completion 5BO104-1) had values similar to Well 5MW66 (Figure 5) ranging from 1.5 to 4.9 mg/l. Upgradient (5MW65) and downgradient (5MW2, 5MW64 and 5MW68) monitor ring wells were all below the analytical reporting limit for these samples. This demonstrates that, with the exception of 5MW66, the elevated uranium is generally attenuated near the wellfield and has limited migration. It should be emphasized that 5MW66 is completed within an ore-body.

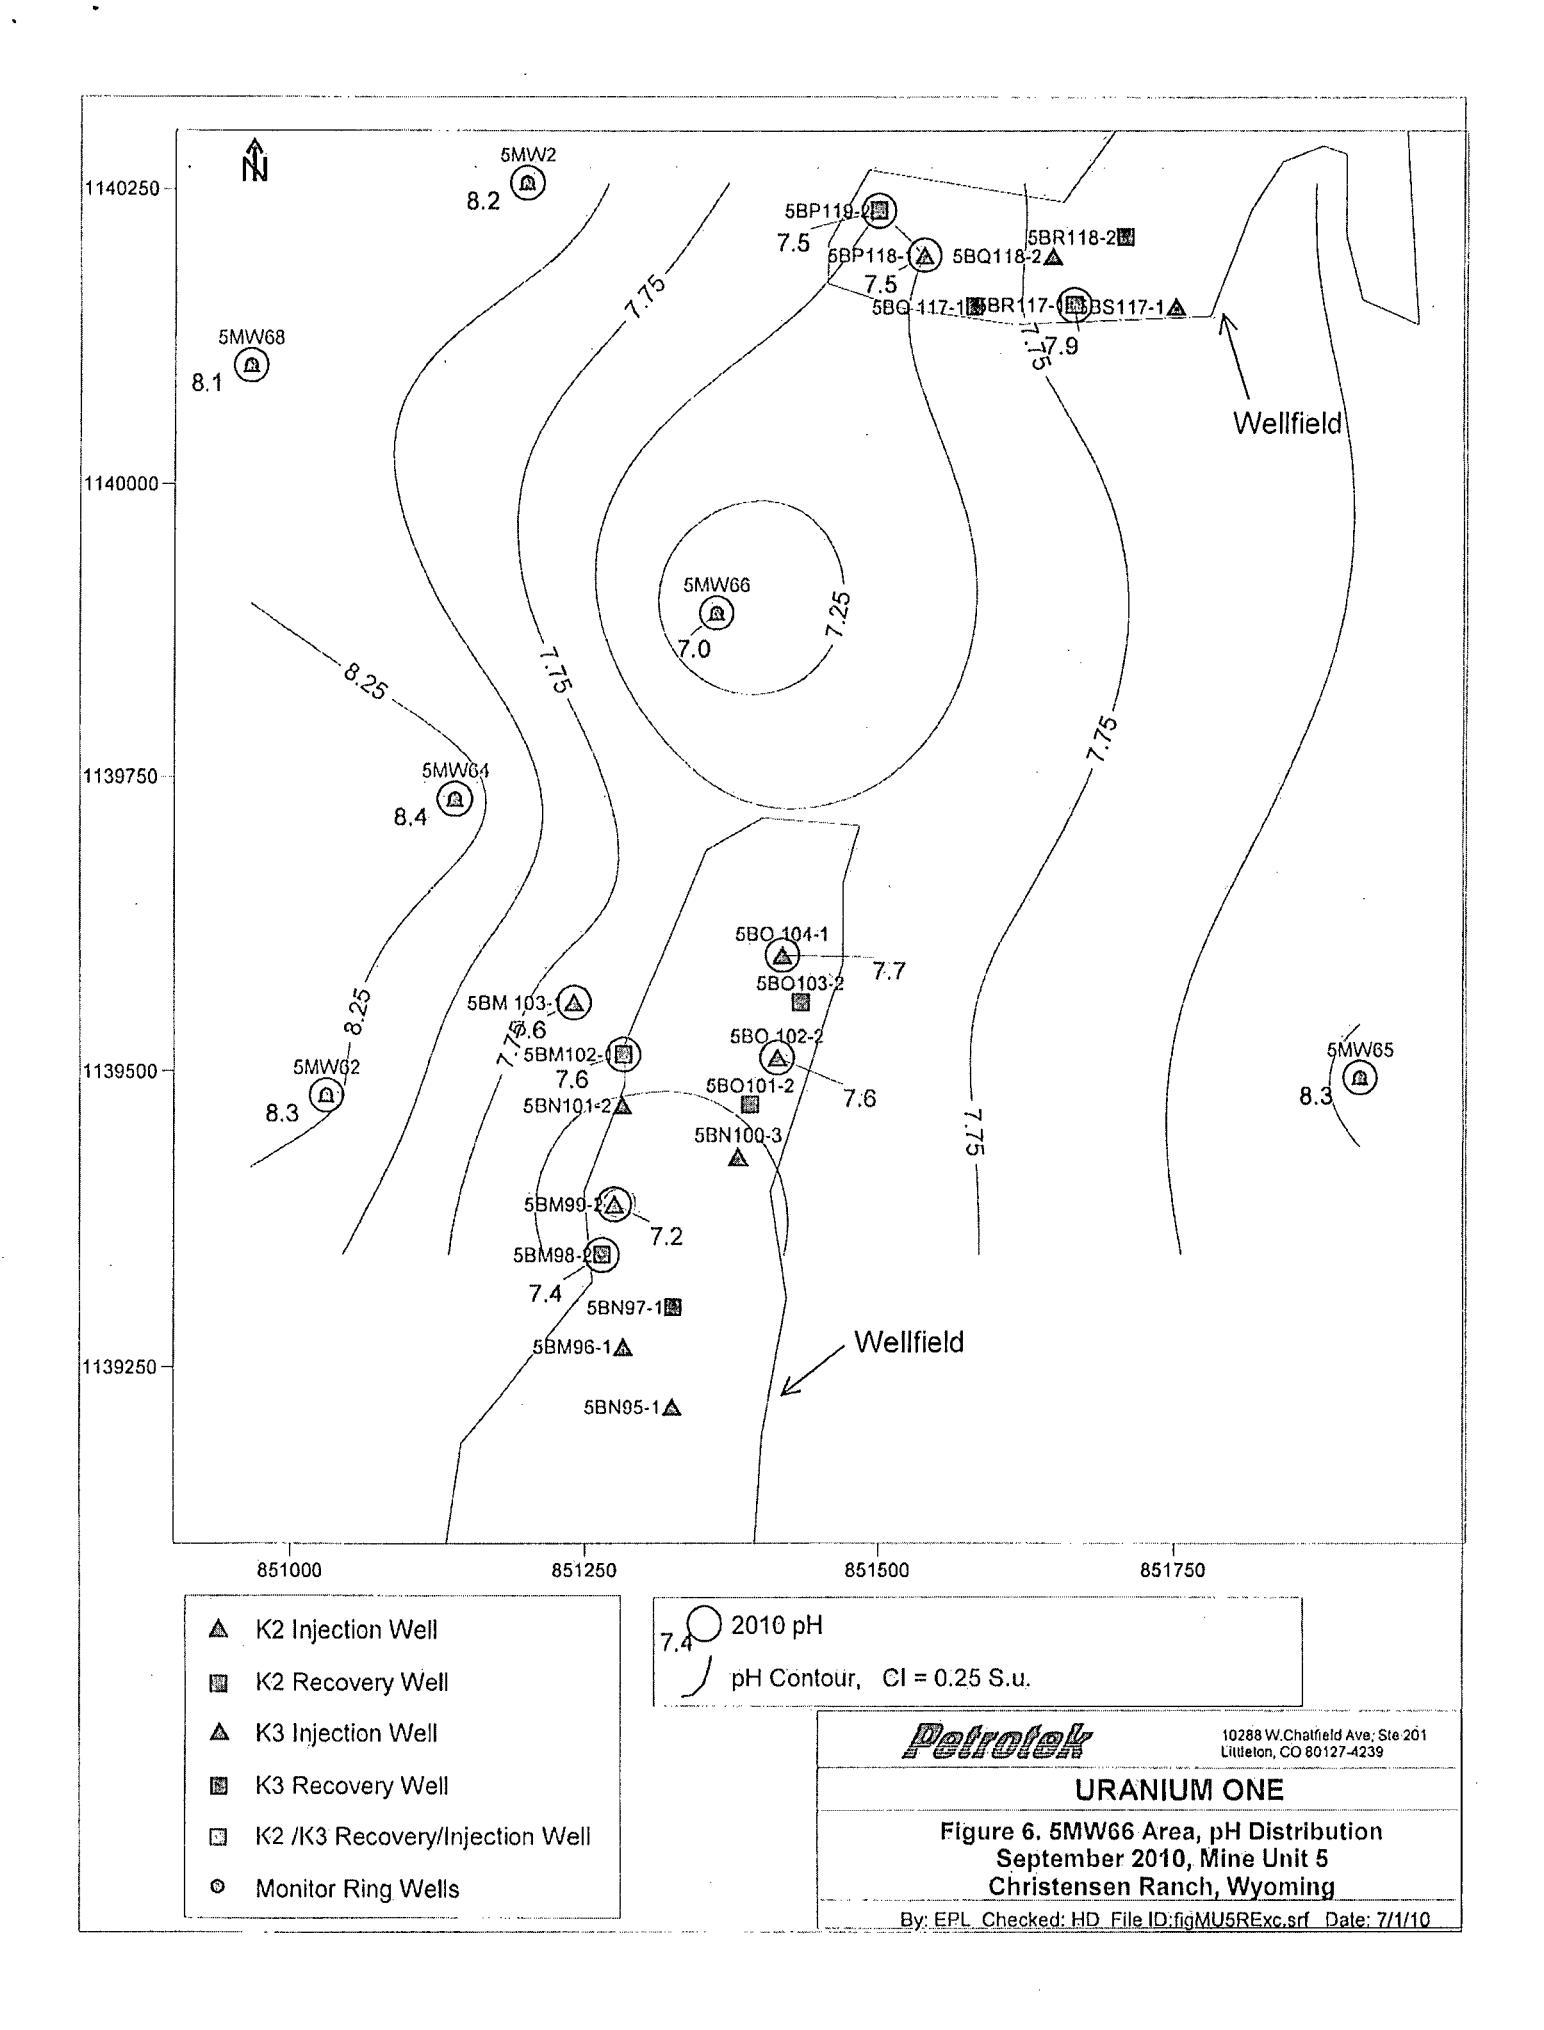
The September 2010 distribution of pH is shown on Figure 6. The pH at 5MW66 is unusually low (7.0) compared to all other sampled wells. Each of the other monitor ring wells have pH in excess of 8 and all of the sampled production/injection wells had pH between 7.2 and 7.9.

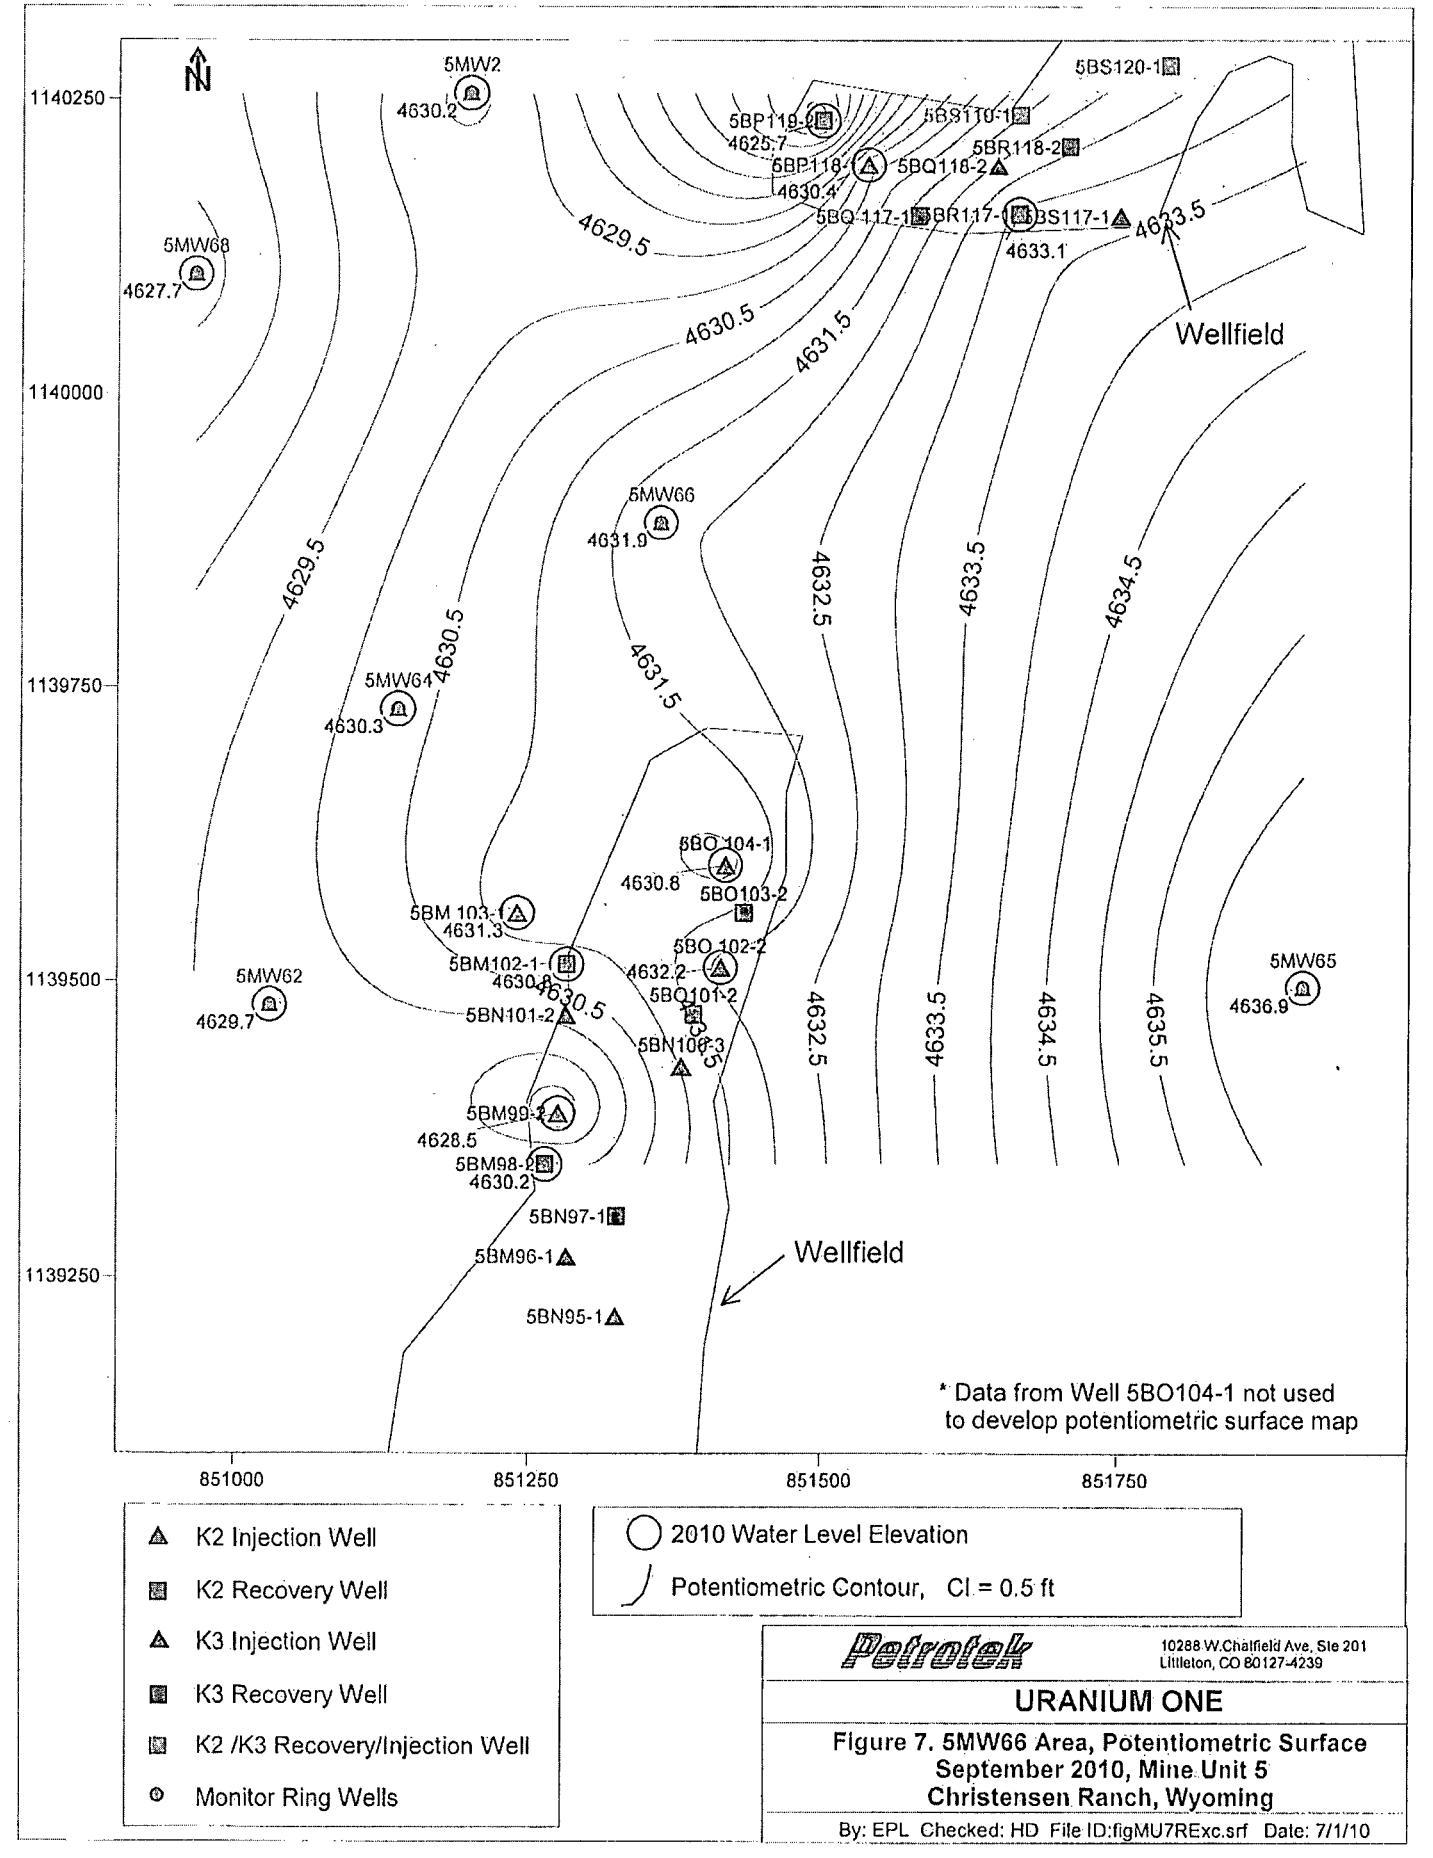
Water levels were measured in each of the wells prior to the September sampling. A potentiometric surface map was developed from the data (Figure 7). The map shows a potentiometric surface that is reasonably consistent with the regional groundwater flow system, with a hydraulic gradient toward the west-northwest. However, well 5MW66 has a higher water level elevation than all of the production wells with the exception of 5BO-102-2 and 5BR117-1. As with the water quality data, the potentiometric data do not clearly identify the source of the excursion at 5MW66.

Additional corrective actions proposed by Uranium One include the following. Uranium One will prepare geologic cross sections within the area of well 5MW66 to identify potential preferential pathways that may result in groundwater flow in directions other than expected based on the potentiometric surface. Additionally, Uranium One will develop a groundwater flow model to assess various capture scenarios that could be implemented to recover the excursion at 5MW66 without resulting in mobilizing uranium into non impacted areas. Scenarios that will be evaluated include:
