FM 1.5 Exhibit 2 Page 1 of 4

Containment Exterior Surface Survey Data

1.5 Foundation Settling

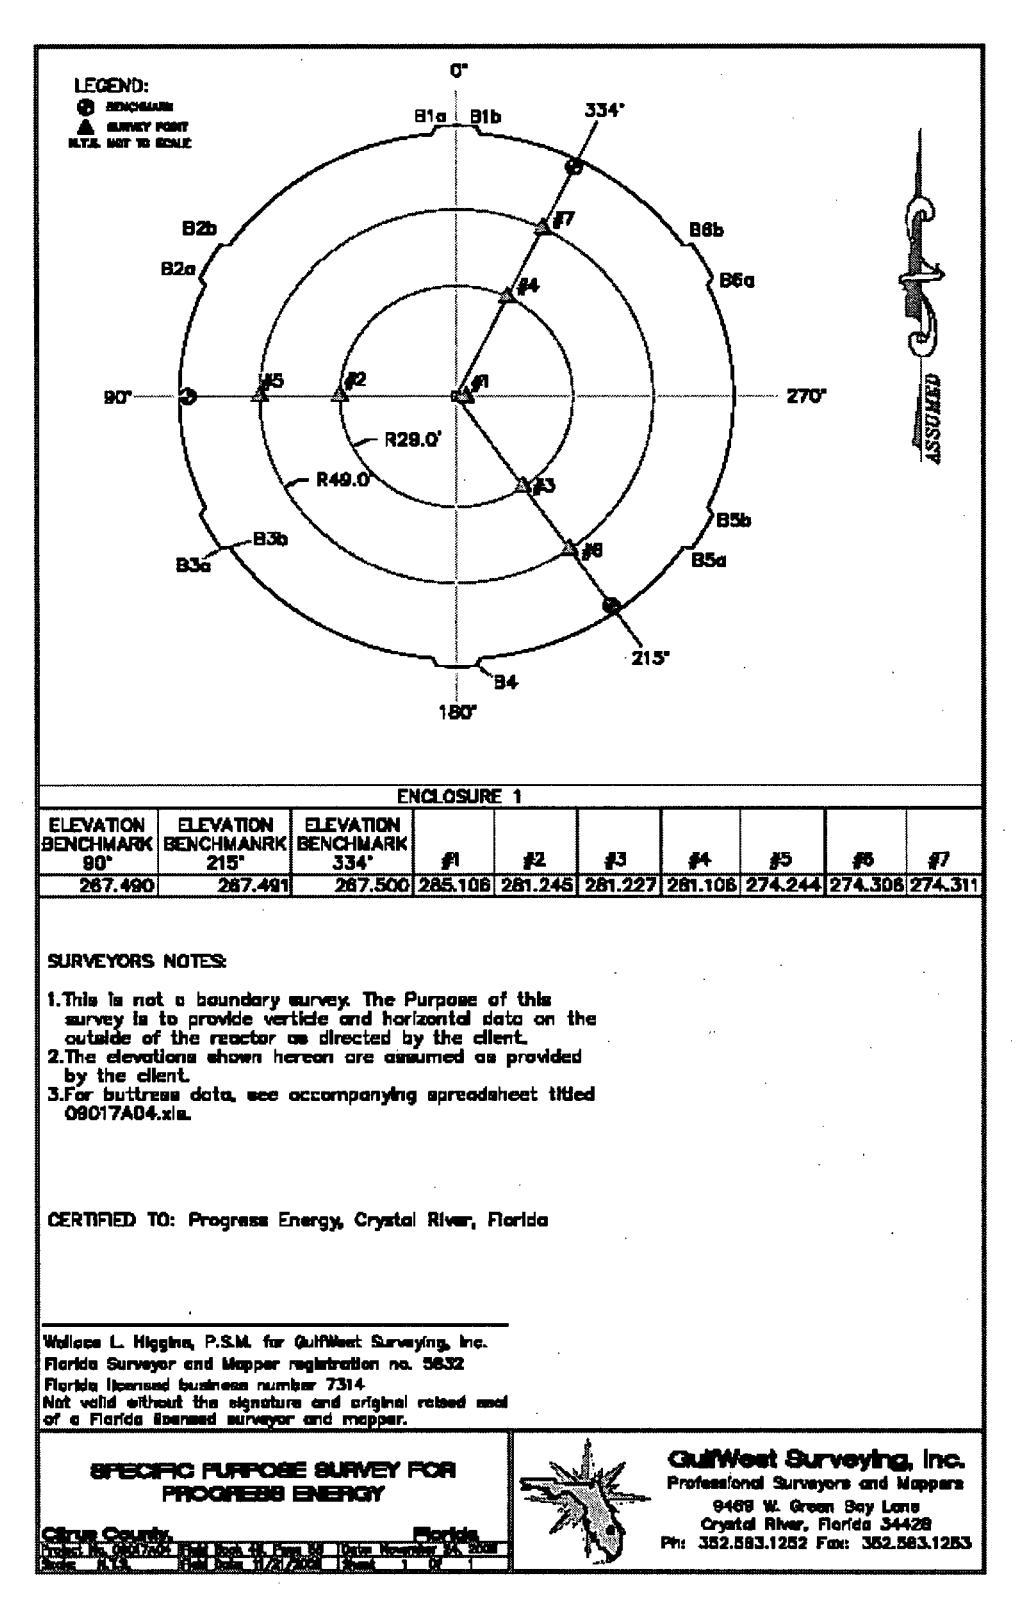
Surveys were performed of the containment dome and buttresses (field date 11/21/09). Attachment 1 includes a map of the dome and buttresses. The dome survey was performed to identify if there are significant changes on the surface of the dome by comparing the current survey data to the final dome survey performed in 1981. The dome was surveyed between 1977 and 1982 as technical specification surveillance required based on the dome delamination event. Procedure SP-180, Reactor Building Structural Integrity Dome Surveillance Program, was initiated to perform a survey of the dome to identify changes in dome elevation and an inspection of the dome surface identifying crack width and crack pattern. The final surveillance was performed in 1981 with an additional survey performed 3 months later due to exceeding acceptance criteria. The buttress survey was performed to determine the relative position of the buttress corners.

Unlike the dome survey, the buttress survey does not have a historical procedure that contains baseline information or acceptance criteria. The buttress survey is used to determine the relative position of the outermost surface of the buttress at the corner of the buttress adjacent to the tendon bearing plate. Attachment 1 identifies the buttress corners that were within line of sight during the survey. Both corners of buttresses 1, 2, 5, and 6 were visible. One corner of buttress 3 was not visible; therefore, the surveyors chose to survey the face of the buttress and the containment wall at the buttress to wall interface. Only the buttress survey data at buttress 3 will be evaluated. Buttress 4 only had one corner visible.
