#### PART 21 REPORT - LIMITORQUE LIMIT SWITCH DEFECT

SUBJECT: FINAL REPORT Flowserve, Limit switch on Limitorque Actuators Type SMB-00 and Type SMB-2-06

Subject: Final Report for CAR 25500-73903 / Part 21 Evaluation of Geared Limit Switch (NRC Event # 46403)

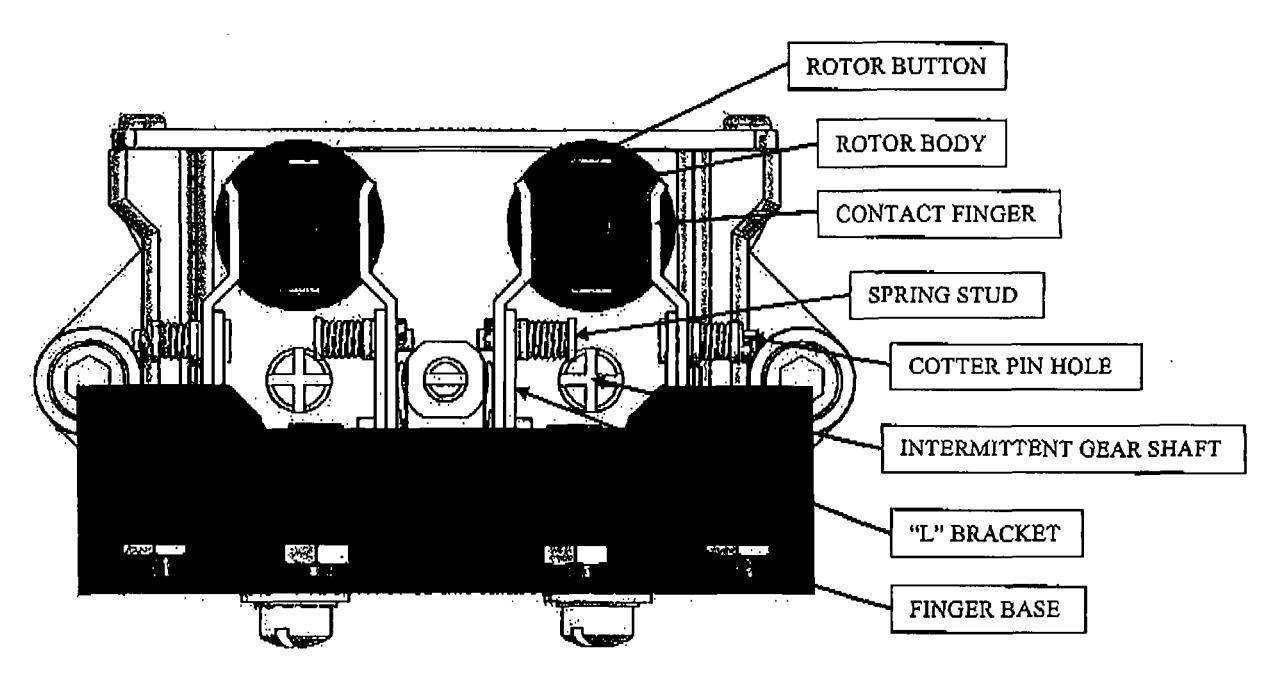
The model below should be utilized by Velan as a guideline for visual inspection to confirm proper switch operability. The assembly should be inspected to ensure that there is proper contact with the rotor body. Adjustments to the "L" bracket are permissible.

Model shows finger assemblies touching rotor body in the electrically open position
